# VISUAL TREE ASSESSMENT 2026

**37, Horndean Road, Emsworth,  
Portsmouth, PO10 7PU.**

**Prepared by:  
V Cainey BSc  
Atworth Arboriculture Ltd**

**Date: 10<sup>th</sup> of March 2026**

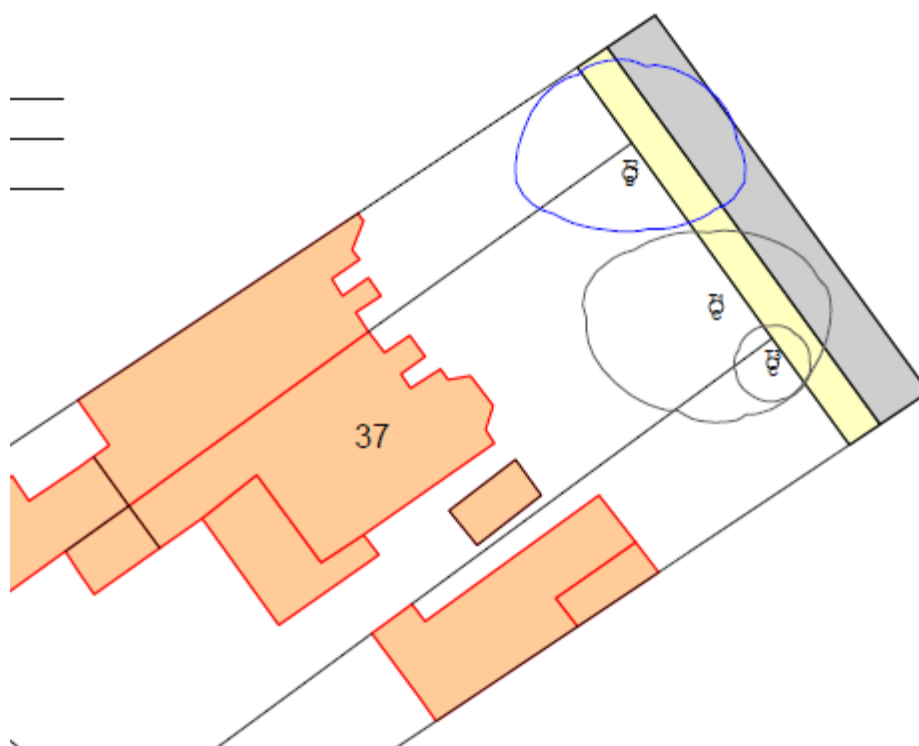
#### 4. Subject Tree, T1

- 5.1 T1, pictured above. Atlas Cedar (*Cedrus atlantica*). Height 14m Diameter 720mm

This tree is 12m to the northeast of the house. The pavement is 1m north of the tree and Horndean Road 3m northeast. The entrance to the property is 50cm east. The front of the neighbouring property, No 35 is 8m east. No faults were observed at the base of the tree. Up the stem, some ivy is growing. At 1m above ground level (agl) the tree has been ring barked (Picture 3). The bark has been removed around all of the circumference. The wound is around 50mm wide. The heartwood has been exposed and there is very little repair/occlusion. A lime tree, T2 on the plan above has also been ring barked but the wound has repaired far better. The crown breaks at 6m agl. There are lots of old pruning wounds throughout the crown, especially over the road and pavement. The south/southwestern side of the crown is dead with no foliage (Picture 4).

Mr. and Mrs. Duke moved into No 37 approximately 5 years ago. The trees had already been ring-barked. Over the last 5 years, the lime tree, T2 has repaired and recovered well. Lime trees are very good at regenerating damage from wounding and pruning. The cedar tree has not regenerated and 50% of the crown is dead. The tree will not recover and will continue to decline. I would recommend that the Cedar T1 be removed. Once the building work is complete, a replacement tree should be planted. The selection of species should be made with consultation of the local authority and the Arboriculturalist.

The work should be done as soon as possible by a fully qualified and insured arborist working to BS3998 (2010), Tree work.
