# ARBORICULTURAL ASSESSMENT AND CONTACT DAMAGE INVESTIGATION FOR 7 GLENWOOD GARDENS, WATERLOOVILLE, PO8 8TN

Carried out by Matthew Rowden for Nicky Mandziej,  
Applicant

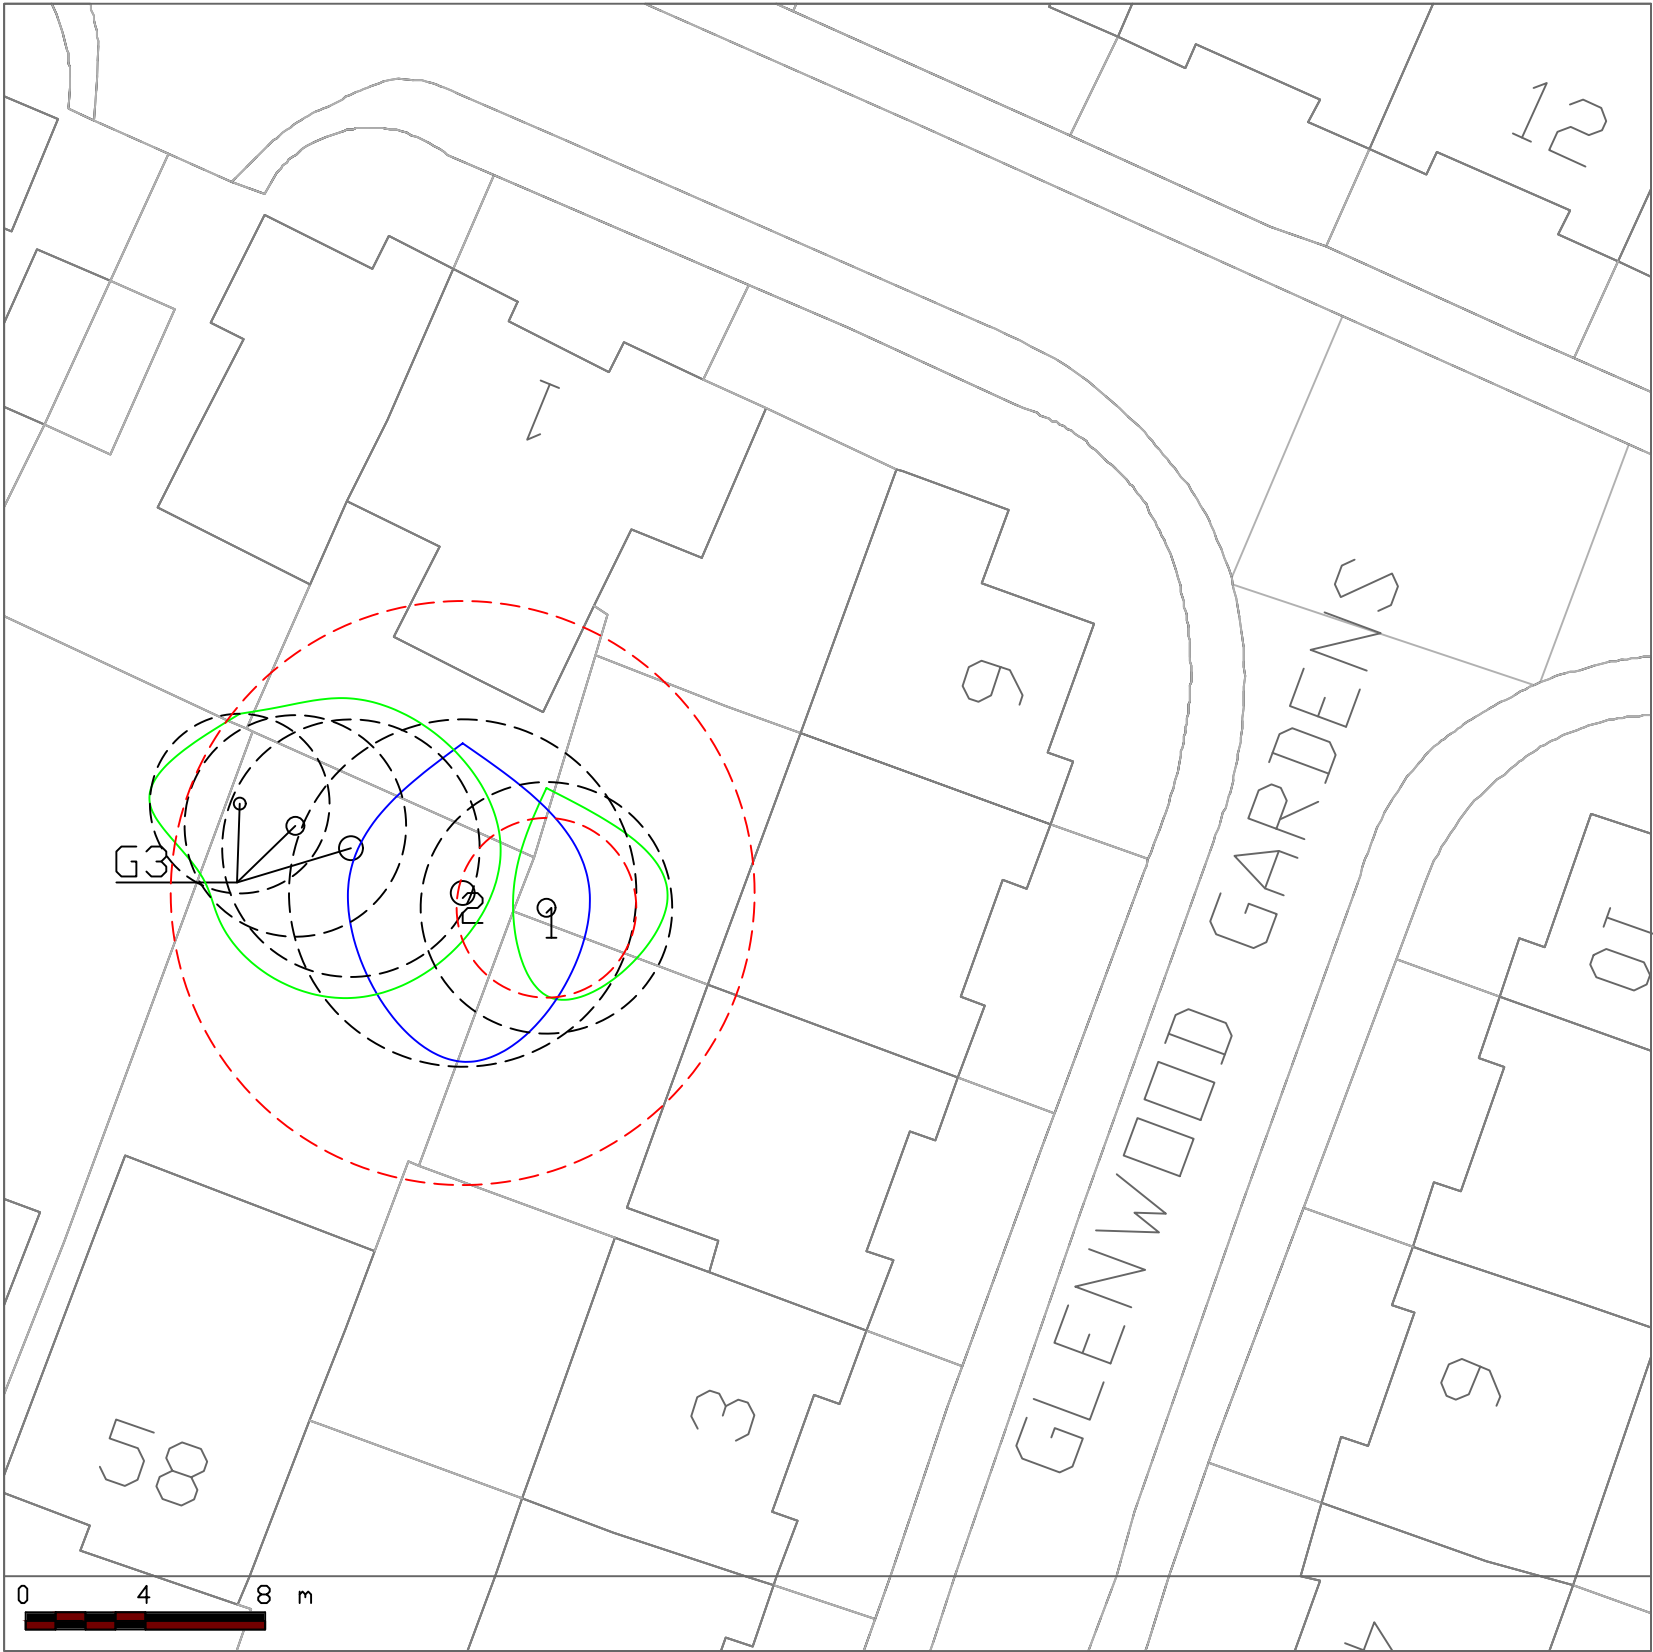
| RTC/NM/7GGV/SBI/V1 | A3<br>Tree<br>Location<br>Plan |

| TREE NO. ON PLAN | SPECIES | HT (M) | CROWN SPREAD (M)<br>N<br>E<br>S<br>W | STEM DIA. @1.25M (MM)<br><br>RPA (RADIUS IN M)<br><br>NHBC WATER DEMAND CLASSIFICATION<br><br>ZONE OF ROOTING INFLUENCE (RADIUS IN M) | LIFE STAGE | ESTIMATED REMAINING CONTRIBUTION IN YEARS | GENERAL OBSERVATIONS<br><br>PHYSIOLOGICAL CONDITION- P<br><br>STRUCTURAL CONDITION - S | PRELIMINARY MANAGEMENT RECOMMENDATIONS | PRIORITY |
|---|---|---|---|---|---|---|---|---|---|
| 2 | <i>Pinus sylvestris</i> | 13 | 5<br>4<br>6<br>4 | 480<br><br>5.8<br><br>Moderate<br><br>9.75 | YM | <5 | P- Good<br><br>S- Fair<br><br>Zone of influence spreads right up to properties to SE aspect. Visible cracking of hard surfacing in number 7, and a significant downward rotation of number 5 towards the north aspect which may be attributed to the trees onsite. | Fell | Moderate |

| TREE NO. ON PLAN | SPECIES | HT (M) | CROWN SPREAD (M)<br>N<br>E<br>S<br>W | STEM DIA. @1.25M (MM)<br><br>RPA (RADIUS IN M)<br><br>NHBC WATER DEMAND CLASSIFICATION<br><br>ZONE OF ROOTING INFLUENCE (RADIUS IN M) | LIFE STAGE | ESTIMATED REMAINING CONTRIBUTION IN YEARS | GENERAL OBSERVATIONS<br><br>PHYSIOLOGICAL CONDITION- P<br><br>STRUCTURAL CONDITION - S | PRELIMINARY MANAGEMENT RECOMMENDATIONS | PRIORITY |
|---|---|---|---|---|---|---|---|---|---|
| G3 | <i>Pinus sylvestris</i> x 3 | 12<br>11<br>5 | 3 - 5m radius | 360, 310, 250<br><br>4.3, 3.7, 3<br><br>Moderate<br><br>9, 8.25, 3.75 | YM | >20 | P- Good<br><br>S- Fair<br><br>Zone of influence unlikely to reach any of the properties at this moment in time, although that may be liable to change as these trees mature. | None | Low |

- i. Fell tree 2.
- ii. Formal re-inspection date for March 2029. Informal observations may be made by visiting arboricultural contractors, or the homeowner.

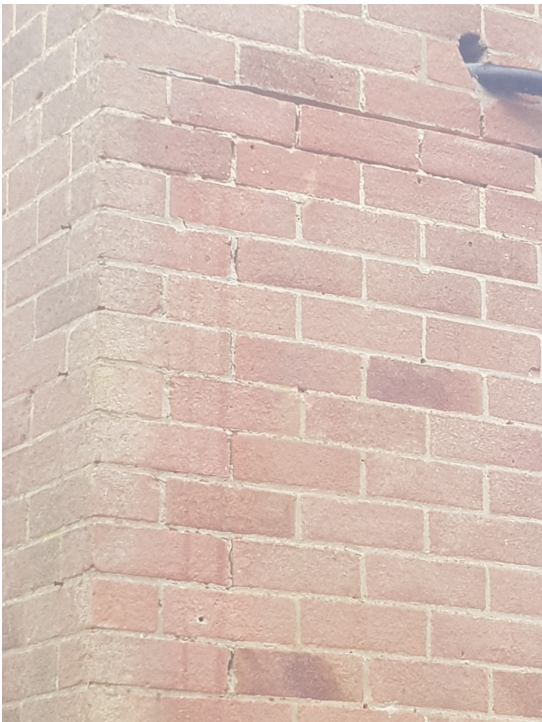
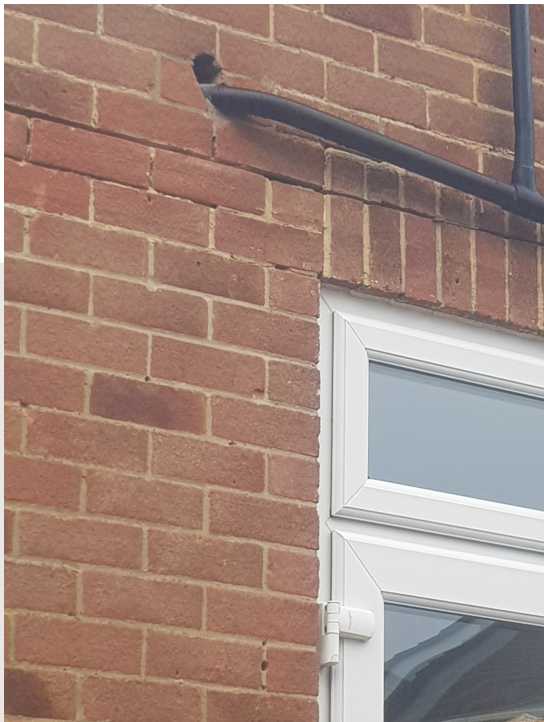
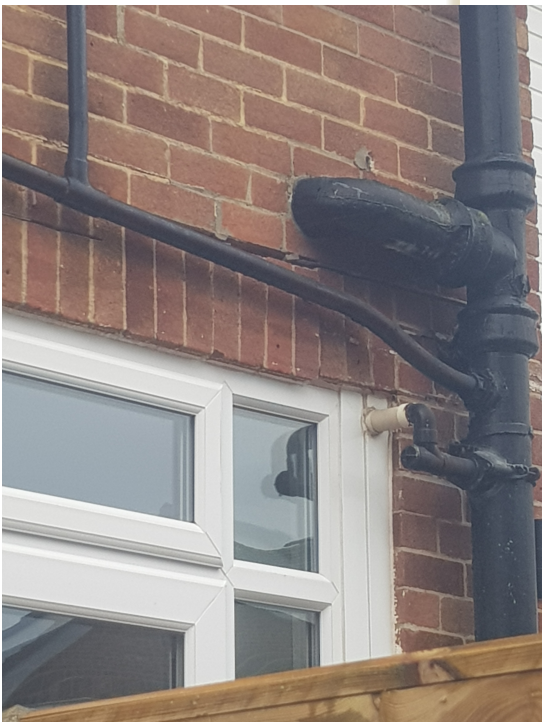
**APPENDIX 3: IMAGES (DOWNWARD ROTATION OF 5 GLENWOOD GARDENS)**

4. The property of 5 Glenwood gardens also sits within the zone of influence of tree 2, and appears to have significant cracking to the north west aspect, with a strong northerly downward rotation consistent with subsidence damage. I would advise the homeowners to obtain advice from a structural engineer to ensure that the damage is dealt with effectively.
