**Picus Testing Report – 40 Maylands Road, Havant, PO9 3NR.**

### **1.6 Oak (Quercus robur). Front garden overhanging road and footpath.**

**Test 1 @ level: 50cms approximately from ground level.**

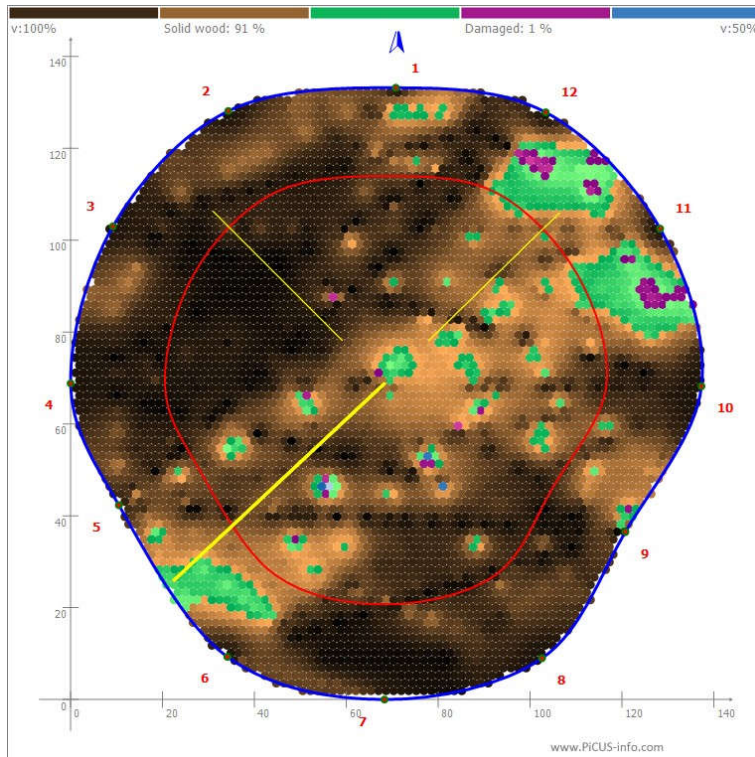
**Test point 1 orientation South.**

The measuring point readings give evidence of high sound velocities overall in the area of test representation showing as mainly sound timber.  
(see Picus sonic representation chart figure 2).

The resulting Picus test is of acceptable limits in relation the altered timber. This ratio called a 'trunk ratio' TR (reference Claus Mattheck) has been calculated to be a guideline in terms of stability and rigidity of cylindrical structure. Although a debated theory in arboriculture in general terms the TR of 30% is an average.

This specimen has a decay fungus: *Ganoderma* sp. and *Fistulina hepatica* at the base on the southern side approximately 50cm from ground level of Picus test. There is evidence that the crown has been extensively and severely reduced in the past resulting in a dense structure possibly with some poor branch attachments.

The Picus sonographic tomograph shows evidence of predominately sound timber in area of test.

Continue to manage the crown by overall crown reduction of 3m to 4m back to previous pruning points and the removal of lower epicormic growth below crown break up to 8m on a two-year cycle.

Continue to monitor for future changes on a regular basis.
