## Fallen&Found Arboriculture®

**Site address:** 23 Manor Close, Havant, Hampshire, PO9 1BD

**Date:** Monday, 27 April 2026

**Document:** Arboricultural Statement in support of Conservation Area notification (tree removal)

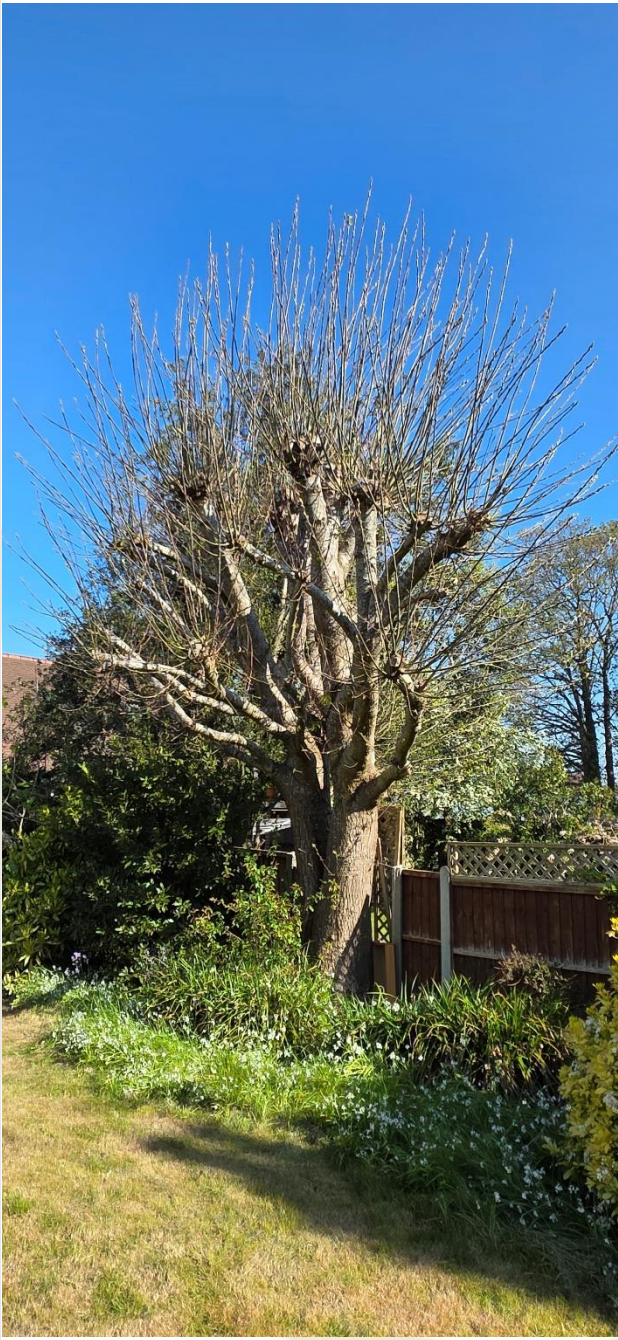
T1 has been subject to repeated heavy pruning/reduction historically, resulting in poor form and reduced amenity contribution. The tree comprises two codominant stems of near-equal diameter which form a compression-type union with obvious included bark. This type of union is inherently weak and, in this instance, shows signs consistent with progressive instability. While the tree does not appear to pose an immediate

| Photo Ref | Photograph | Description / Observations |
|---|---|---|
| Photo 1 | | <b>T1</b> Sweet Chestnut ( <i>Castanea sativa</i> ) heavily reduced/pollarded. |

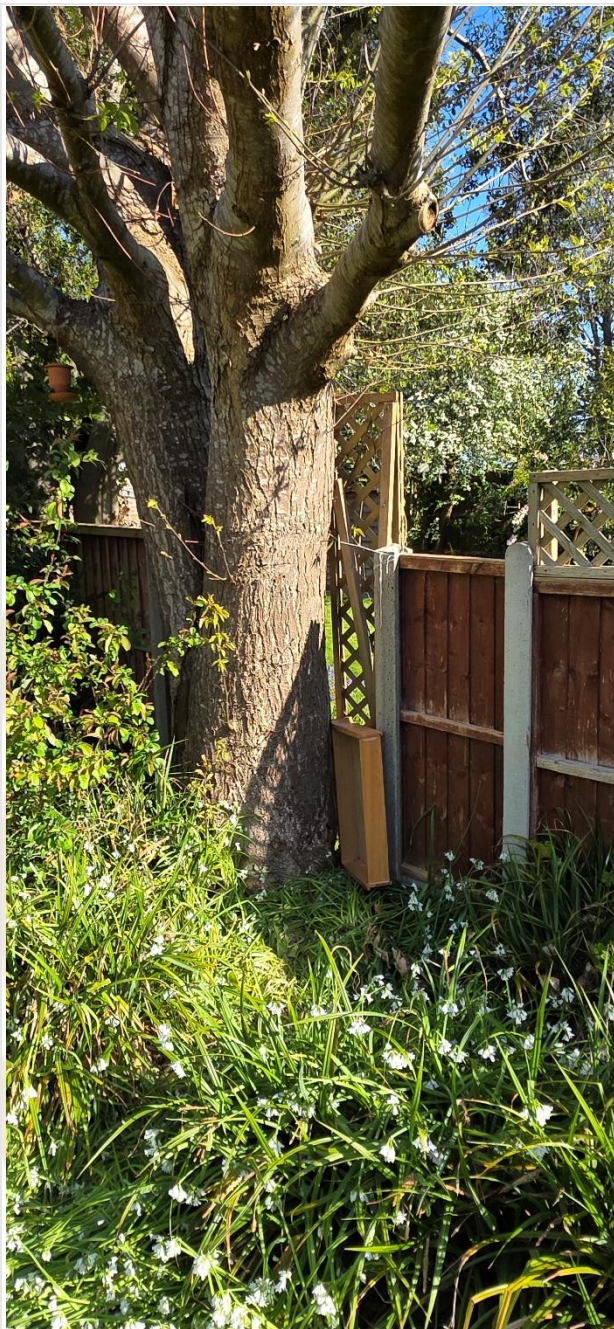
Photo 2

The tree is located on/very close to a boundary line and the stem position has constrained boundary fence reinstatement. Although this is not, in isolation, determinative arboricultural justification for felling, it is a relevant site constraint when considered alongside the tree's low amenity, poor form, and the foreseeable structural issues identified above.

Location of tree, codominant stems and proximity to boundary. Note obstruction to fence line orientation and difficulty in construction.

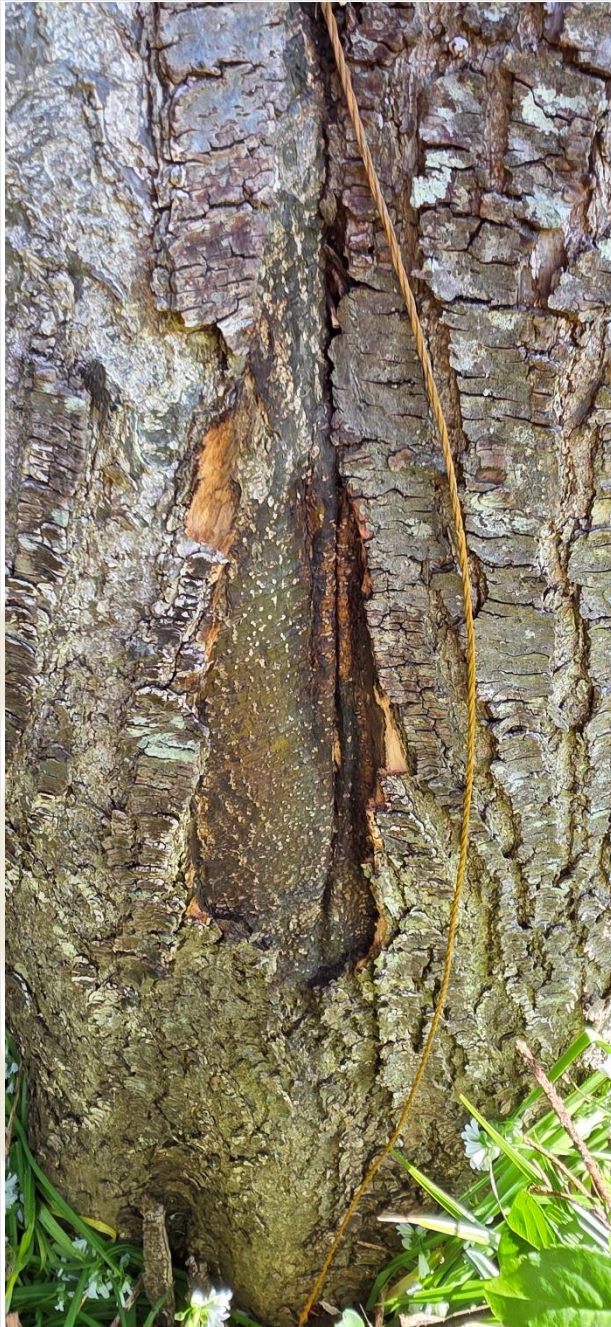
Photo 3

significant risk to persons at the time of inspection, future failure of one or both stems is considered foreseeable as the union continues to occlude and loading increases over time.

Included bark compression type fork between codominant stems. Note fresh incremental bark growth indicating instability.

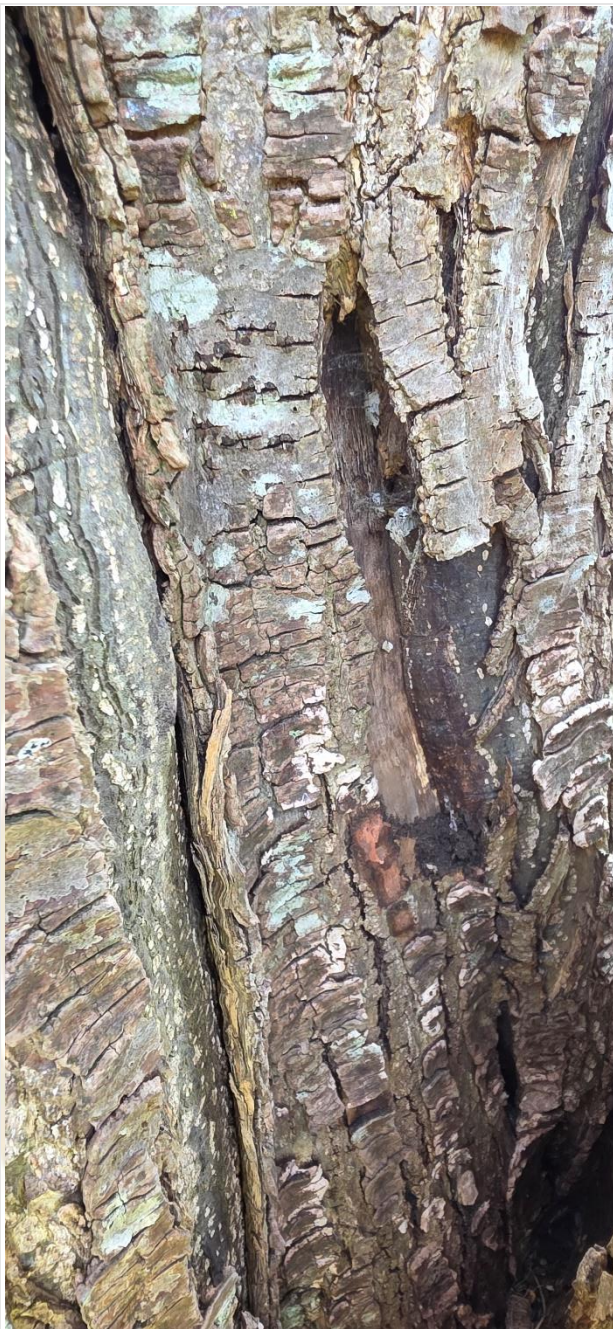
Photo 4

Within the main union there are wounds and areas of necrotic bark (with sections of loose/flaking bark) associated with past pruning operations. These have exposed areas of underlying wood which the tree is attempting to occlude. Given the tree's heavily reduced/pollarded condition, continued cyclical maintenance would be required to manage size and loading; this ongoing requirement is likely to be disproportionately burdensome relative to the tree's present amenity value and structural condition. On balance, removal is considered a reasonable arboricultural option, particularly where replacement planting is proposed.

Exposed heartwood resulting from injury to inner/uppermost portion of tree stems within fork.

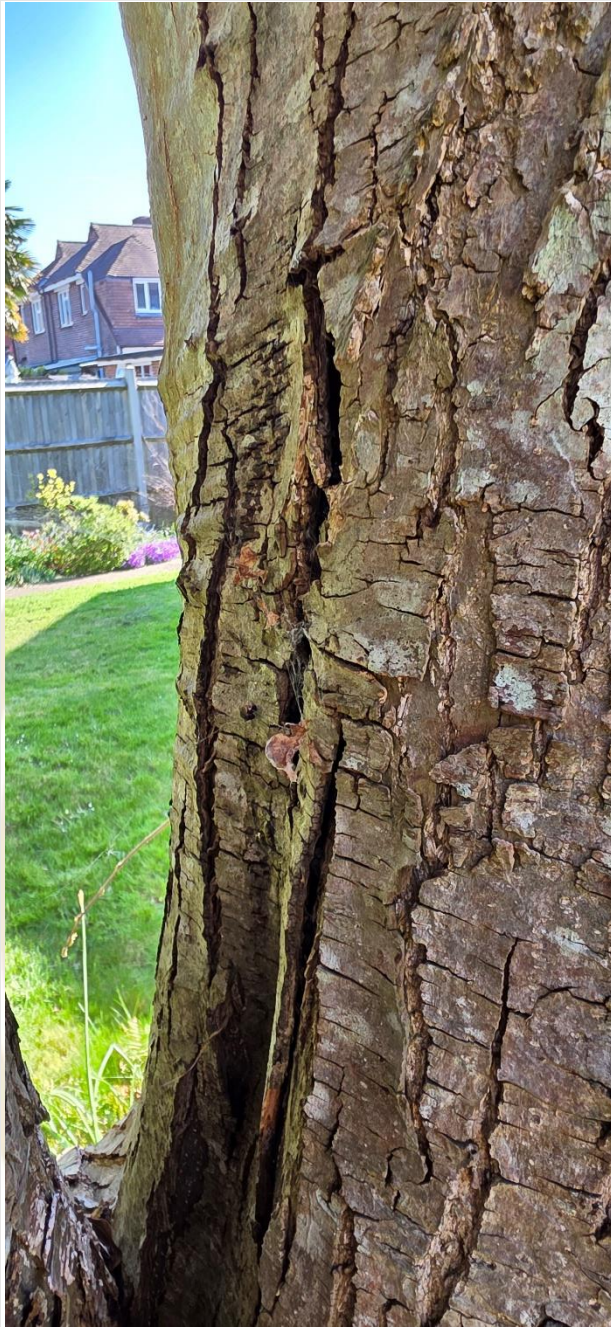
Photo 5

Necrotic bark on adjacent stem surface likely caused by same instances during previous tree work operations. Note, loose bark can be removed by hand as it has become necrotic.

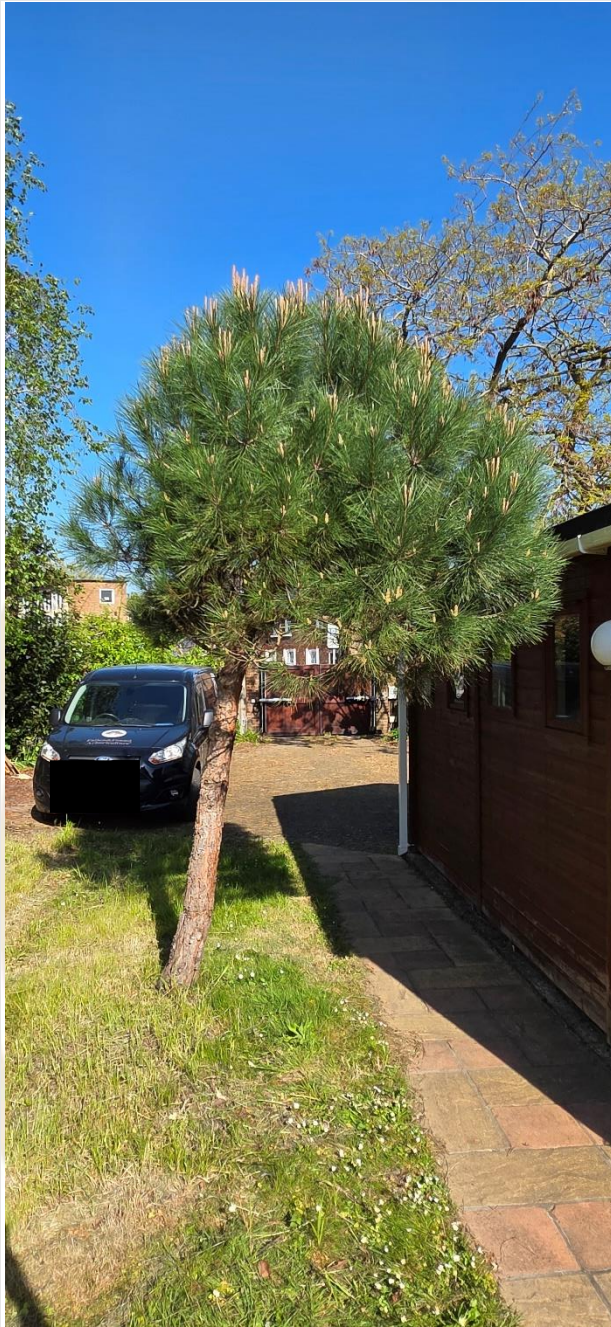
Photo 6

T2 is a small Scots Pine with a significant lean to the north. The tree has also been subject to hedge-cutting/topiary-type trimming which has adversely affected its natural form and overall amenity contribution. Due to its size, position and screening, it has limited visibility from adjacent public viewpoints and neighbouring properties. Removal is proposed to facilitate more appropriate planting within the rear garden, which is expected to provide a net benefit in terms of garden amenity and biodiversity.

Small leaning Scots Pine tree previously  
hedge cut into a ball shape.
