## **Padnell Grange - Structural Condition Survey**

### **Structural Appraisal Report**

**Ref:** 251363/J Ham

**Date:** 05 Jan 2026

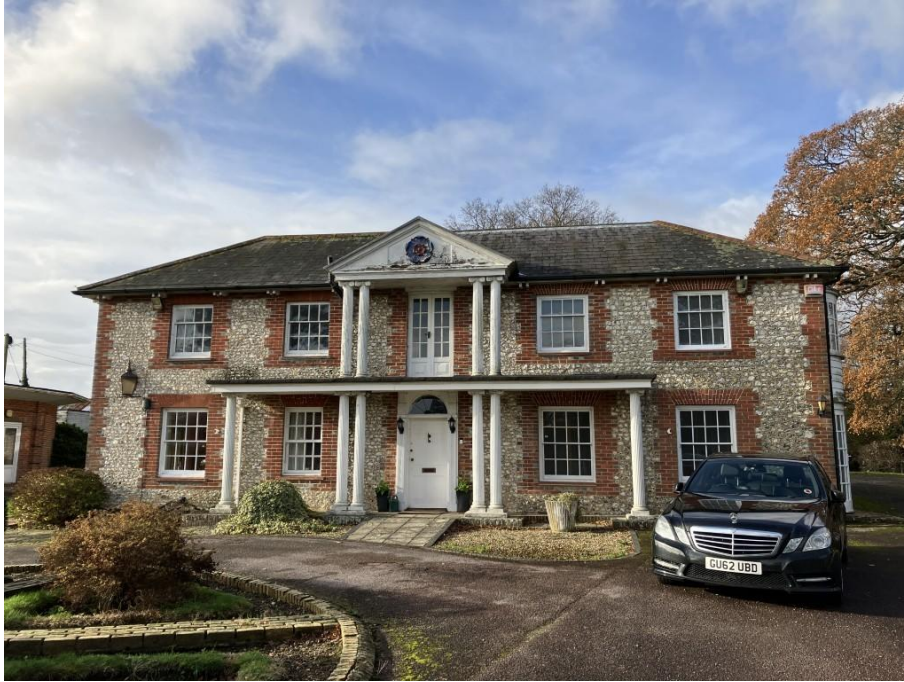
- 3.1.4 A decorative portico has been added to the front elevation (see Photograph 1). The mock stone columns appear to be made of fibreglass and the whole assembly is thought to be a late Twentieth Century addition. The pediment over the portico has a slate tiled roof which is dressed into the main roof, indicating a minor extension of the roof structure.

**Photograph 1 – Front/east elevation of farmhouse. Left hand three bays are the original façade and the two right hand bays are the extension.**

- 4.7 The portico on the front of the building is an insensitive addition thought to date from the late Twentieth Century. It does not form a significant part of the structure and could be removed. Some making good would be required where the assembly is fixed into the front elevation. The main roof would require minor works to remove the intersecting gable and patch in slate tiles.

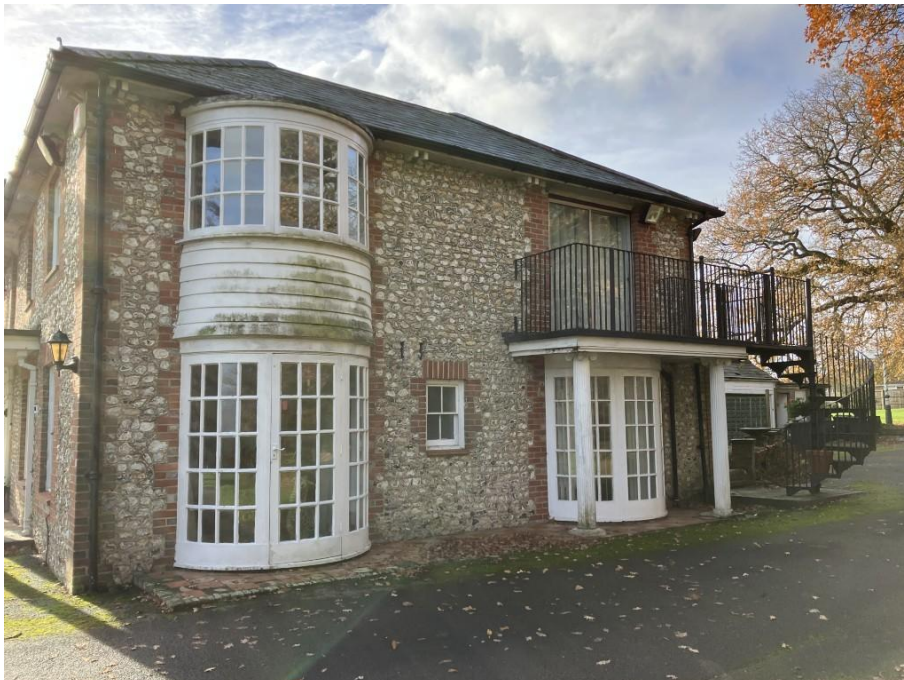
- 3.1.5 The north and west elevations of the extension (to the main body of the house) are formed with a similar knapped flint, edged with brick quoins (see Photographs 2 and 3). The mortar appears to be cement based. There are curved bay windows formed in timber. There is a wide sliding door to the rear/west elevation at ground level, within the extension. It appears the opening is formed with a steel beam.

**Photograph 2 – Flank/north elevation of farmhouse extension.**

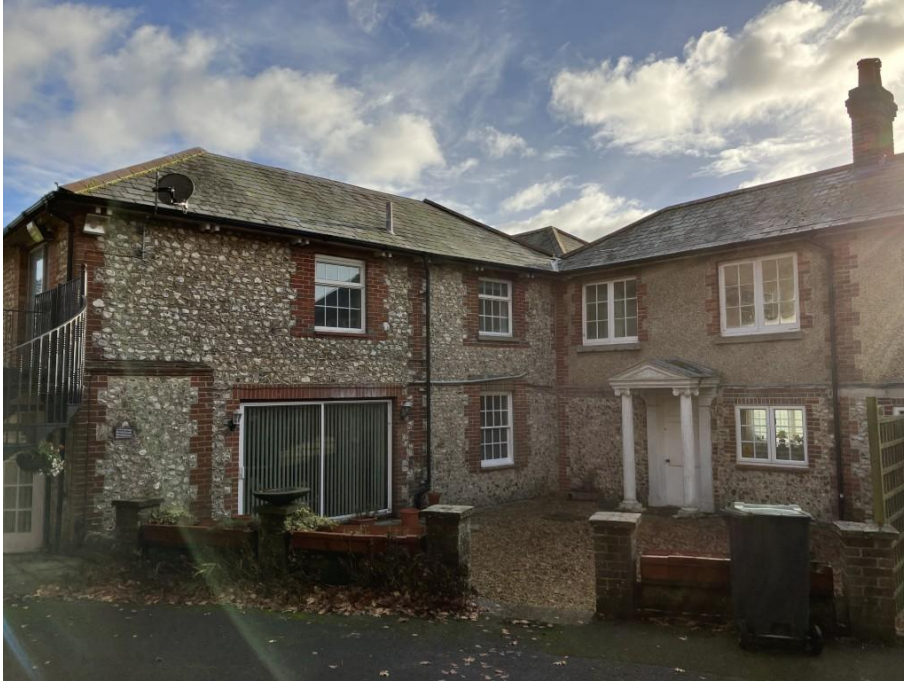
**Photograph 3 – Rear/west elevation of extension and north flank wall of rear addition.**

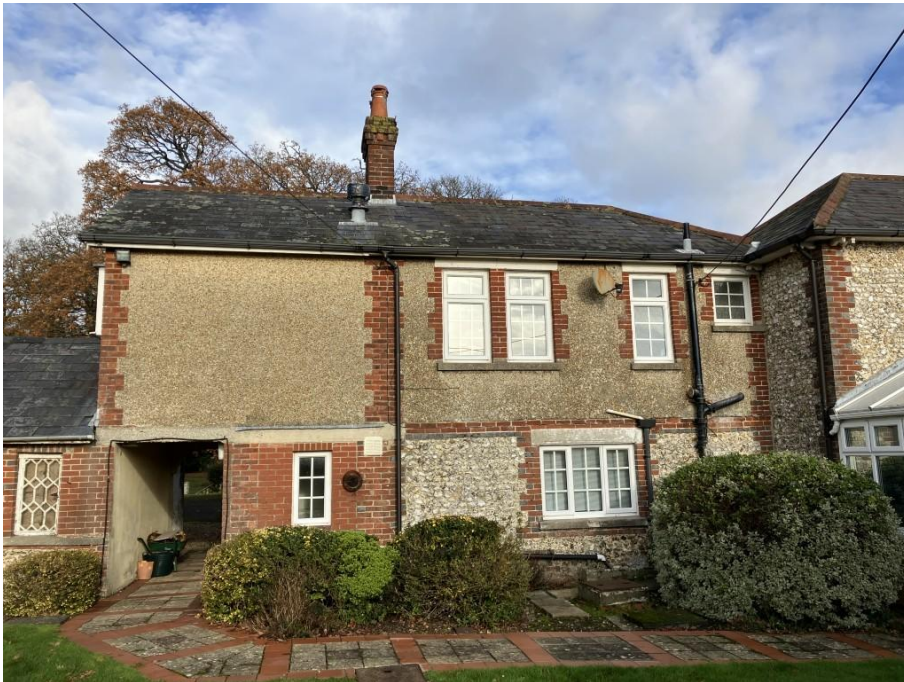
**Photograph 4 – South flank wall of rear addition.**

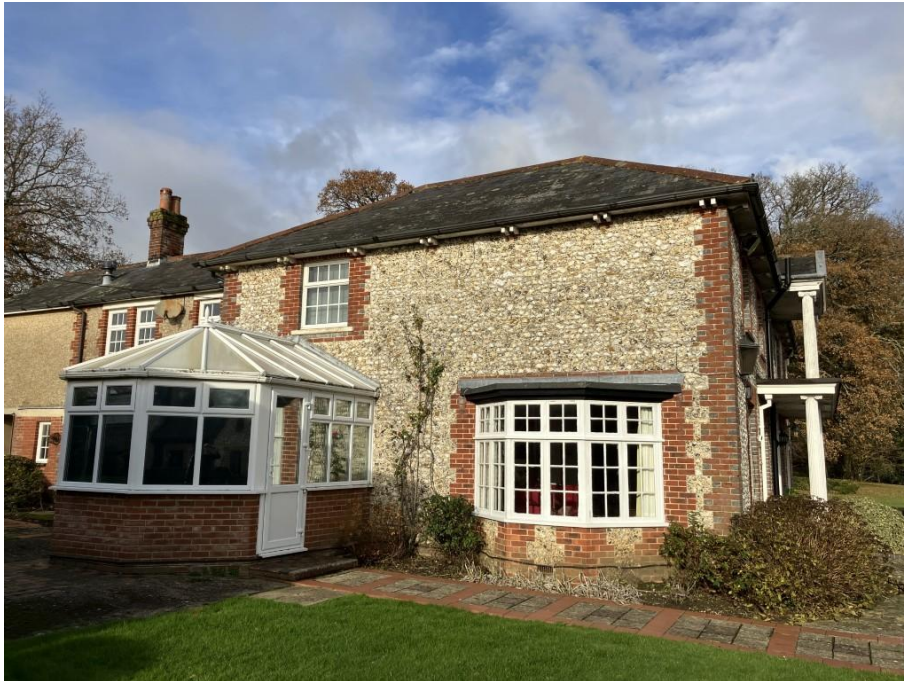
- 3.1.6 The south elevation of the main body is a flint and brickwork wall of older construction, but again repointed with a cement based mortar (see Photograph 5). A large opening has been formed to connect the conservatory to the original house. It is assumed that this is formed with a steel beam to support the original flank wall. The bay window to the front ground floor reception room appears to be of a more historic form, possibly dating from the original construction. The bressummer beam forming the opening to the bay window is likely to be formed with timber.

**Photograph 5 – South flank wall of original house.**

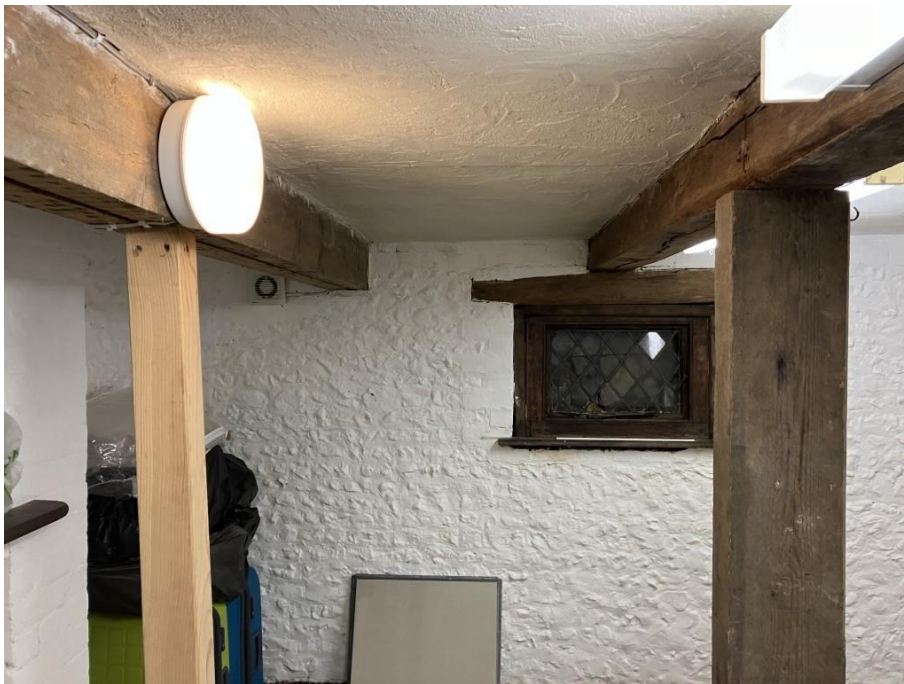
- 3.1.8 There is a cellar which was dry at the time of inspection (see Photographs 6 and 7). There are timbers supporting the ground floor above (see Photograph 7), of which some are incongruous and appear to be additional support provided later.

**Photograph 6 – Cellar room. Left hand timbers appear to be later additions.**

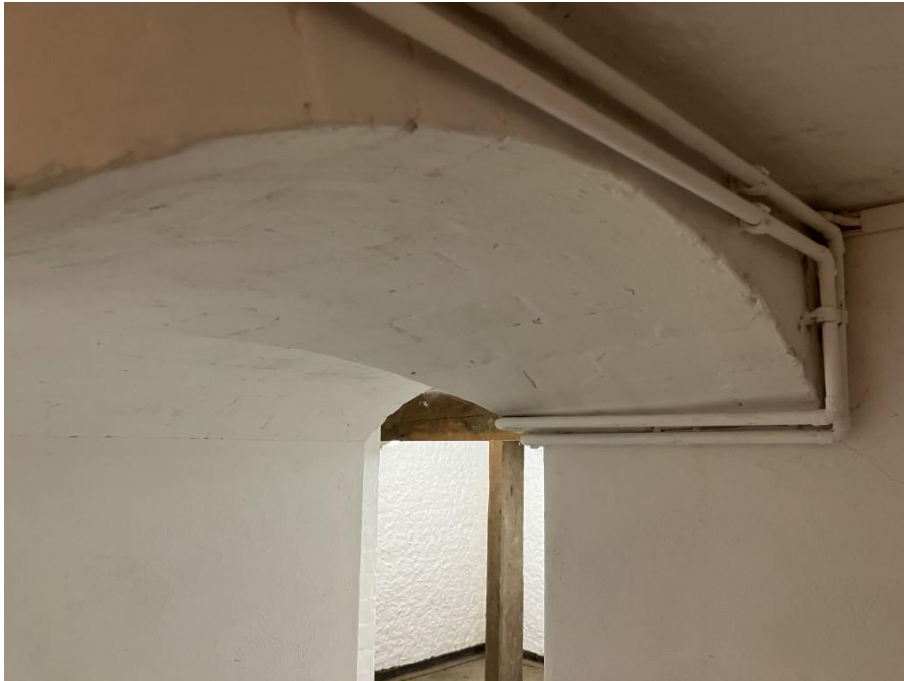
**Photograph 7 – Brick arch below load bearing wall providing entrance passage to cellar.**

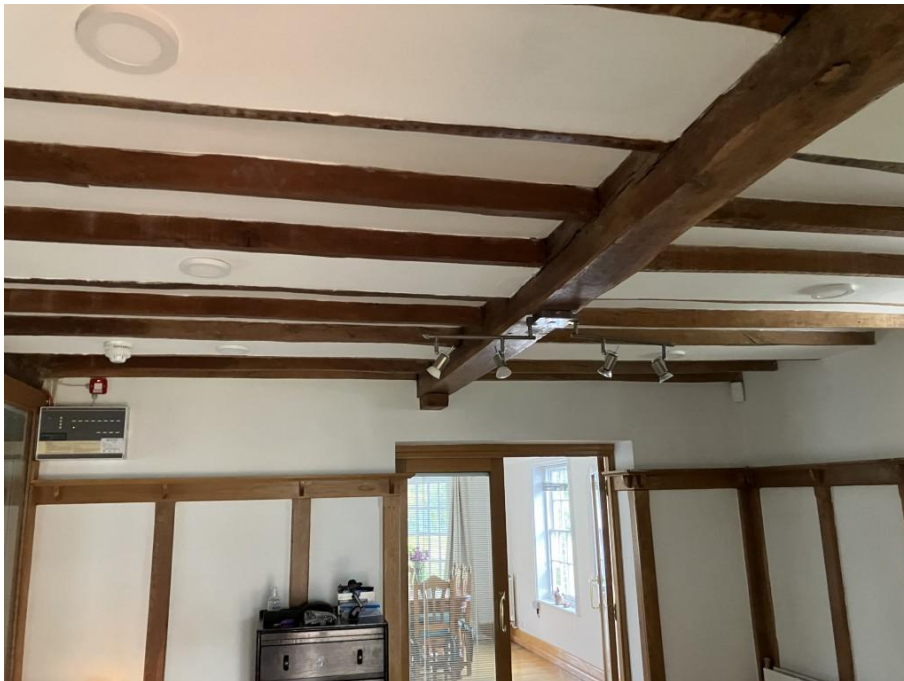
**Photograph 8 – Exposed ceiling joists in current ground floor entrance hall (former front room).**

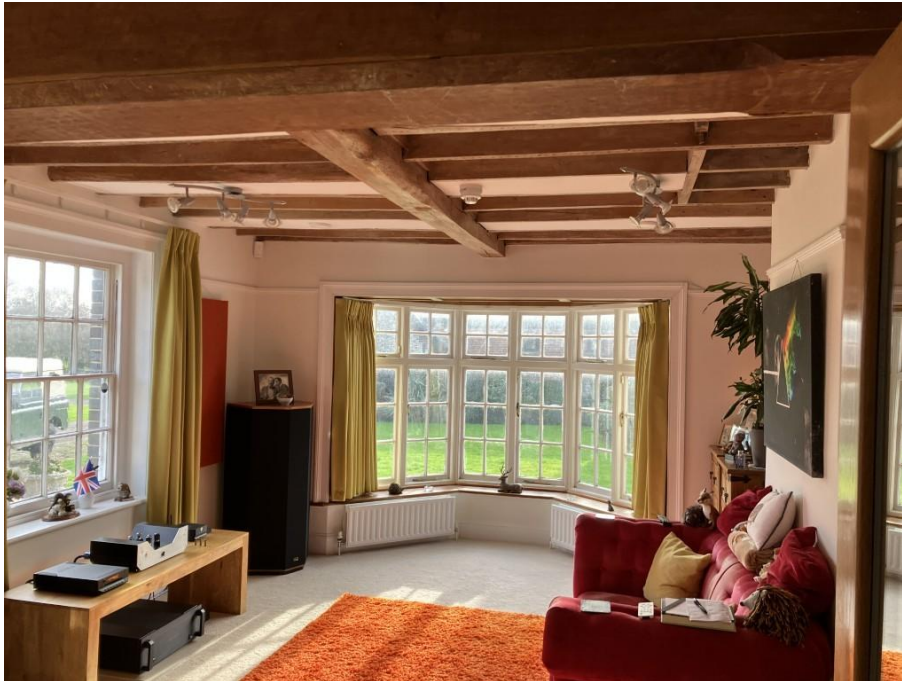
**Photograph 9 – Exposed ceiling joists in current family room.**

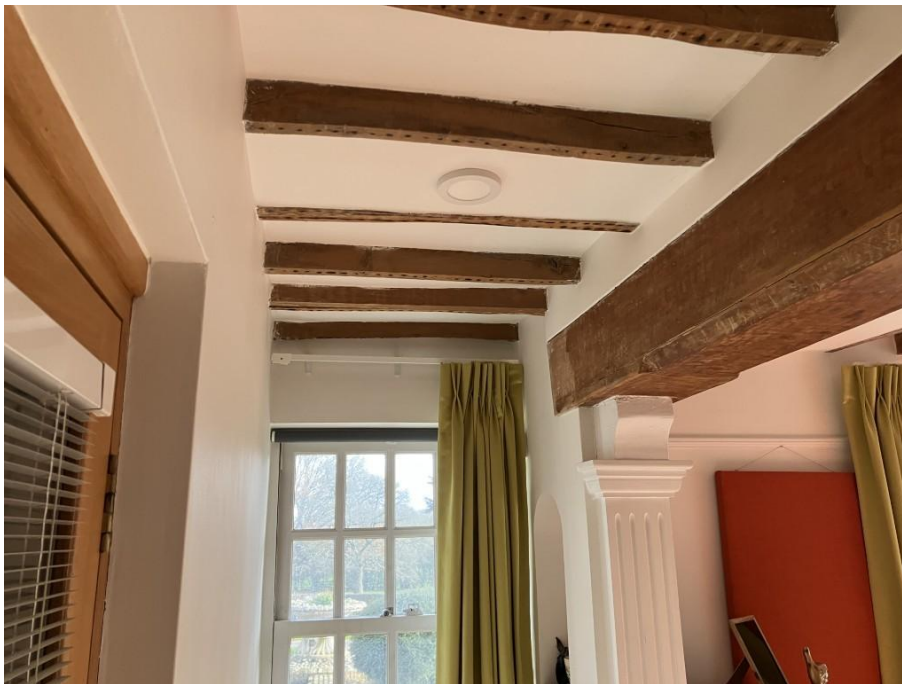
**Photograph 10 – Exposed ceiling joists in original hallway. Wall to right hand side removed and supporting beam assumed to have been installed and boxed with cosmetic timber.**

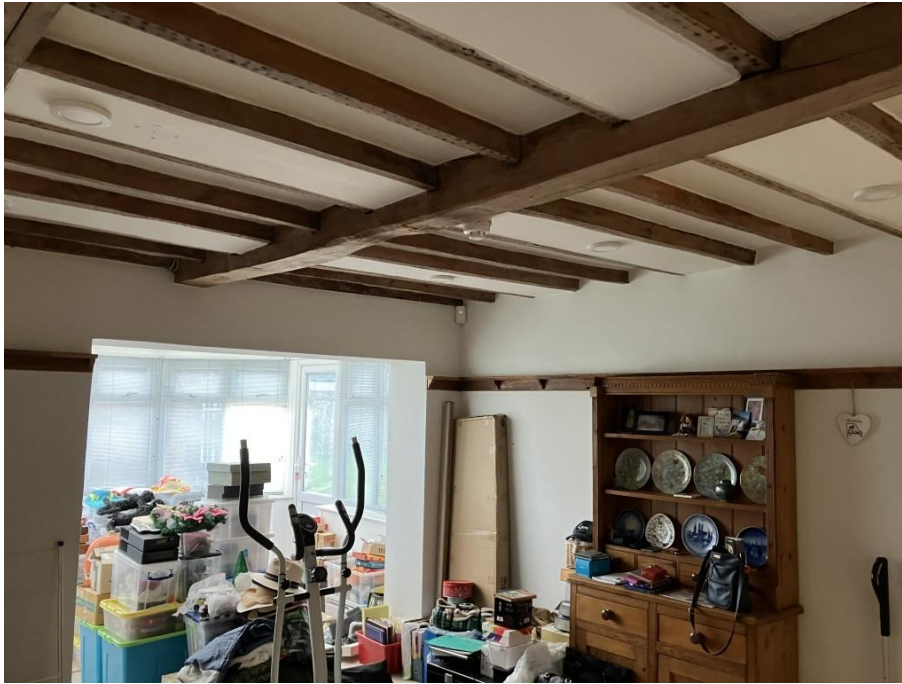
**Photograph 11 – Ceiling joists exposed in ground floor south room.**

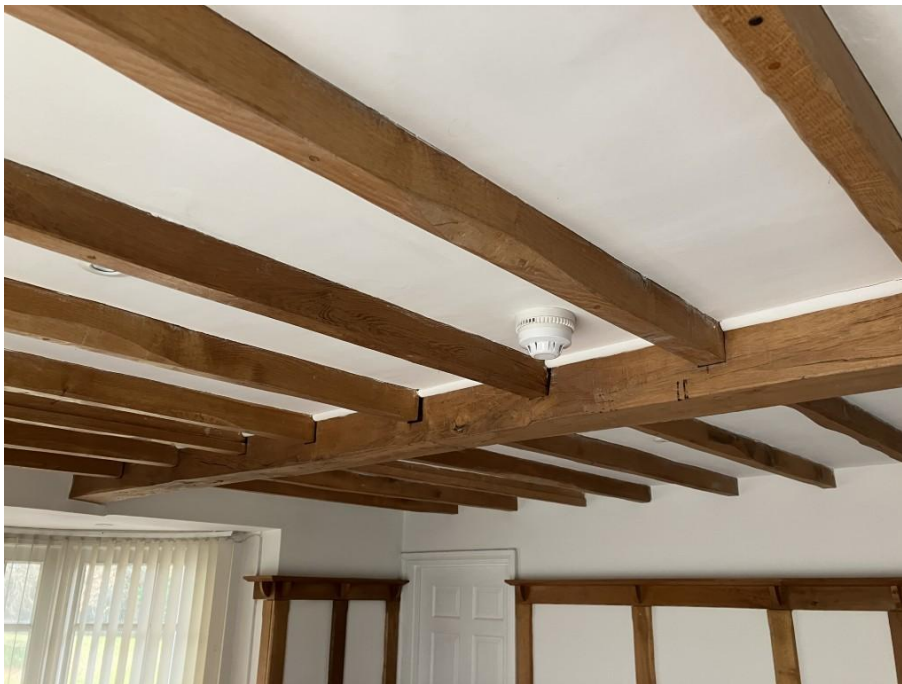
- 3.1.10 Within the main body extension the ceiling to the front room is finished with flush plasterboard and the exposed timbers in the rear room appear to be cosmetic (see Photograph 12). There are open joints between the timber joists and the central beam indicating that it is decorative to reflect the appearance of the older parts of the house (see Photograph 13).

**Photograph 12 – Exposed joists over ground floor rear room in extension thought to be cosmetic.**

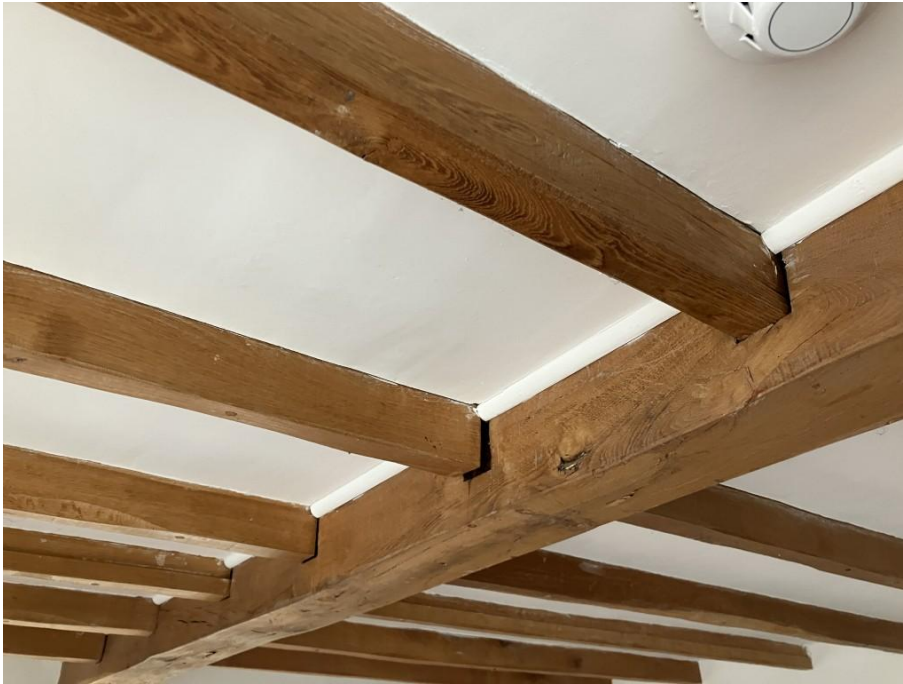
**Photograph 13 – Open joints in timber indicates shallow connection of cosmetic joists.**

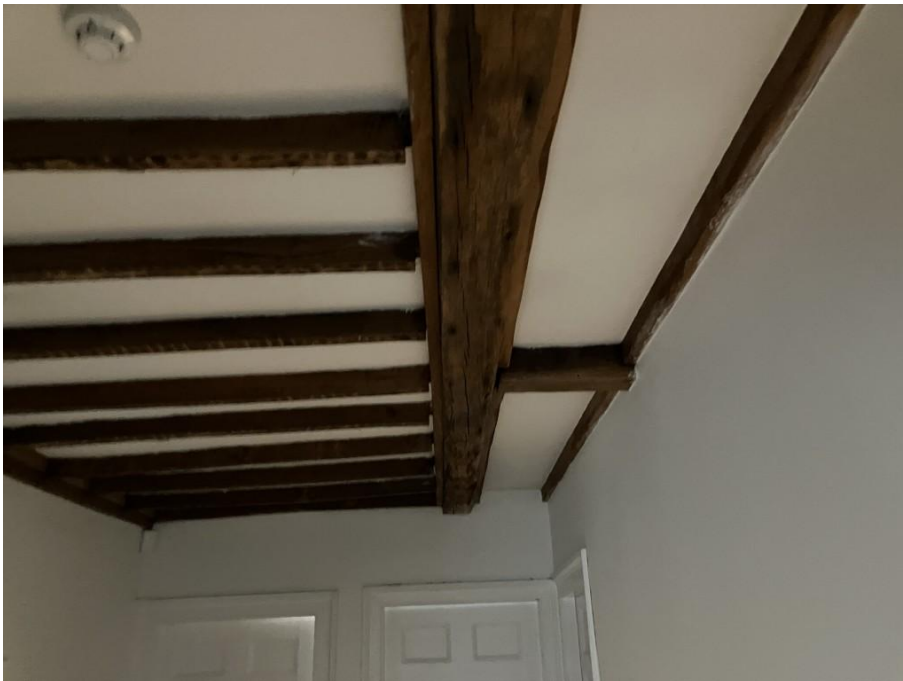
**Photograph 14 – Timber beam to valley in original roof layout exposed at top of stair over first floor landing.**

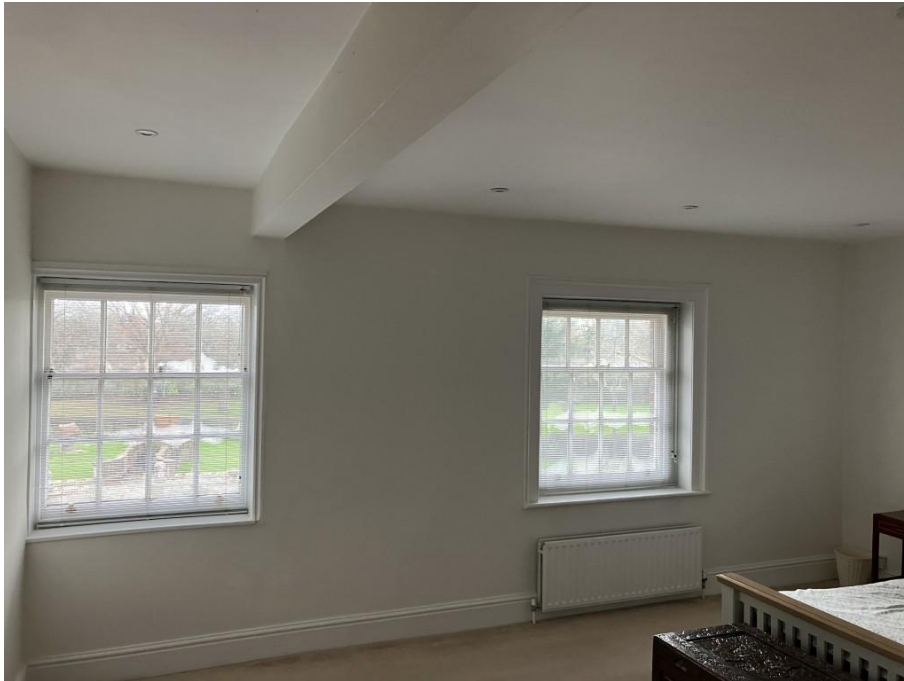
**Photograph 15 – Former load bearing wall removed in first floor bedroom and replaced with a downstand beam.**

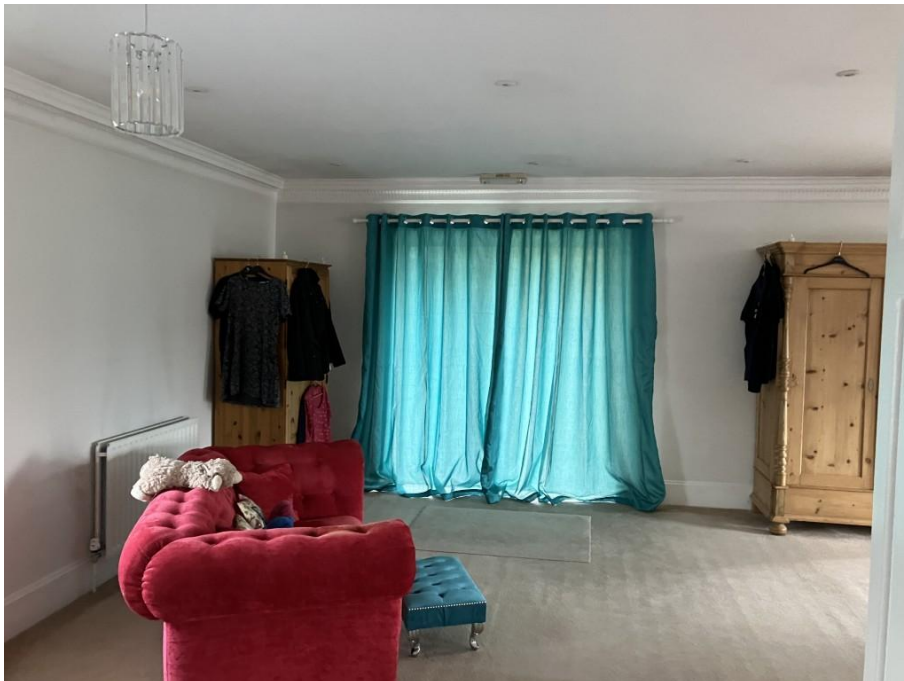
- 3.1.12 The master bedroom occupies the whole first floor area of the extension. An impression in the carpet appears to indicate the floorboards, from which the first floor structure may be inferred (see Photograph 16)

**Photograph 16 – Master bedroom occupies full first floor area of extension. Impressions in carpet indicate boards and span of joists.**

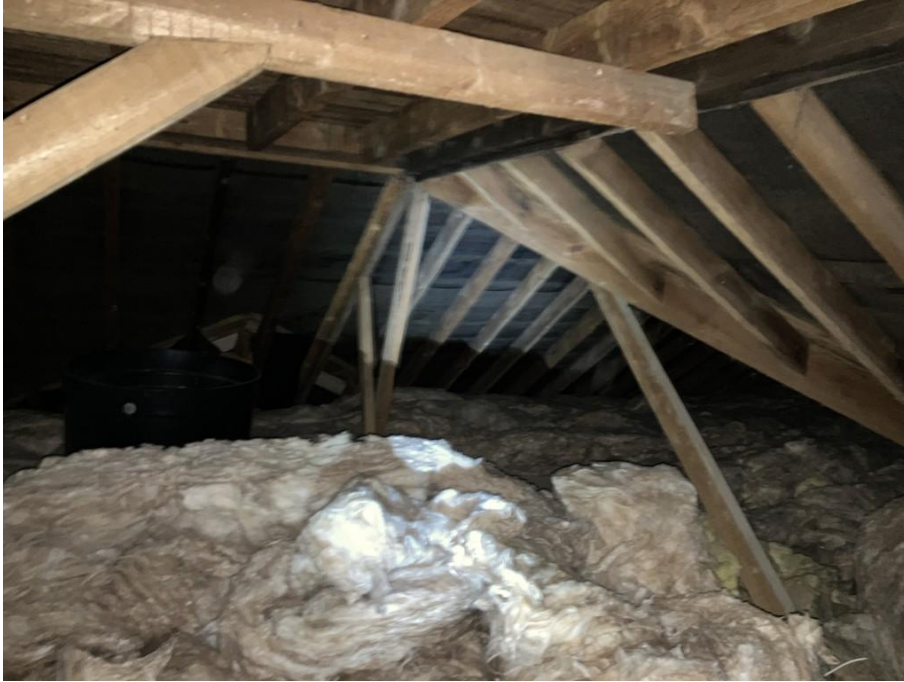
**Photograph 17 – Junction of original construction and extension in roof void. Right hand timbers appear to be replacement roof to the original layout. The flat roof to the left is a reconfiguration of the roof for the extension.**

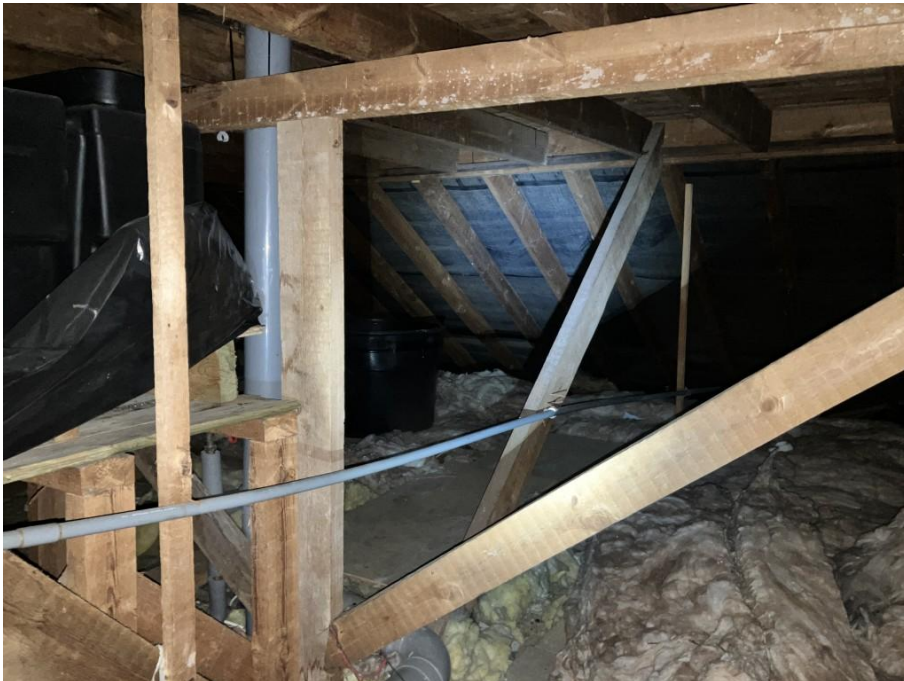
**Photograph 18 – Struts support the flat roof over the extension.**

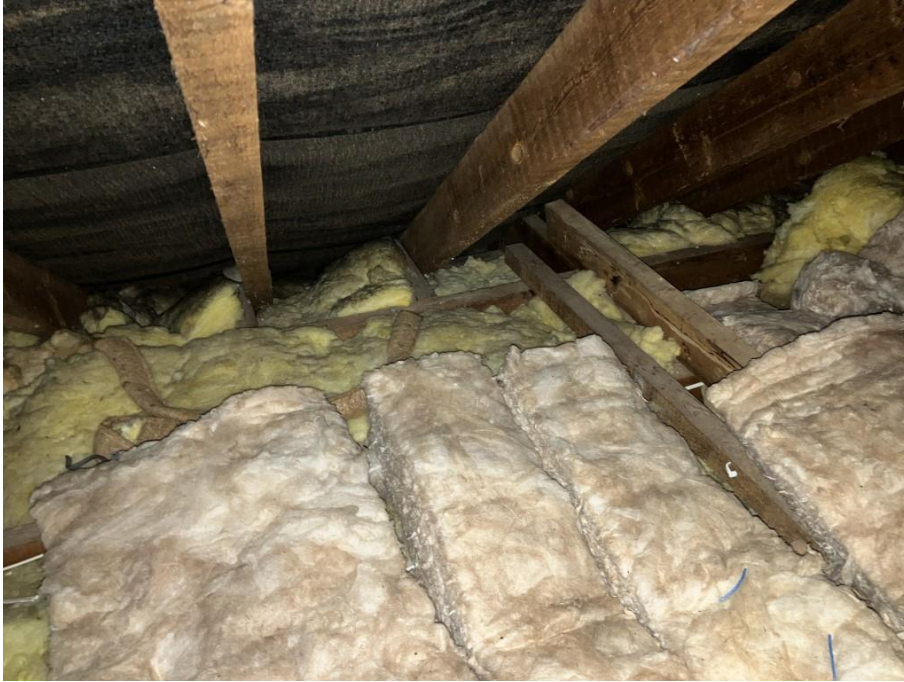
- 3.1.14 The appearance of the timbers appears consistent over the original house and the extension, suggesting the roof may have been entirely rebuilt at the time of the extension (see Photographs 17 and 18). The rafters are formed with a single spanning timber from eaves to the ridge, whereas an intermediate purlin is more usual in roofs of this type and age. Ties perpendicular to the ceiling joists appear to have been provided to resist lateral spread of the hipped roof (see Photograph 19).

**Photograph 19 – Ties over the joists appear to be lateral restraint to the hipped roof to mitigate roof spread.**

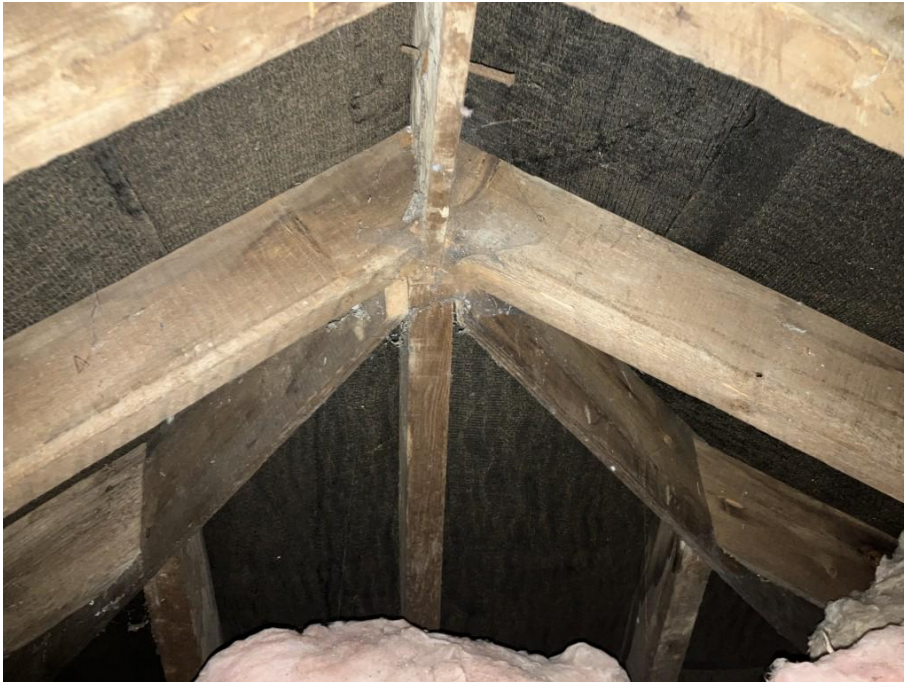
**Photograph 20 – Hipped end of east end of rear addition.**

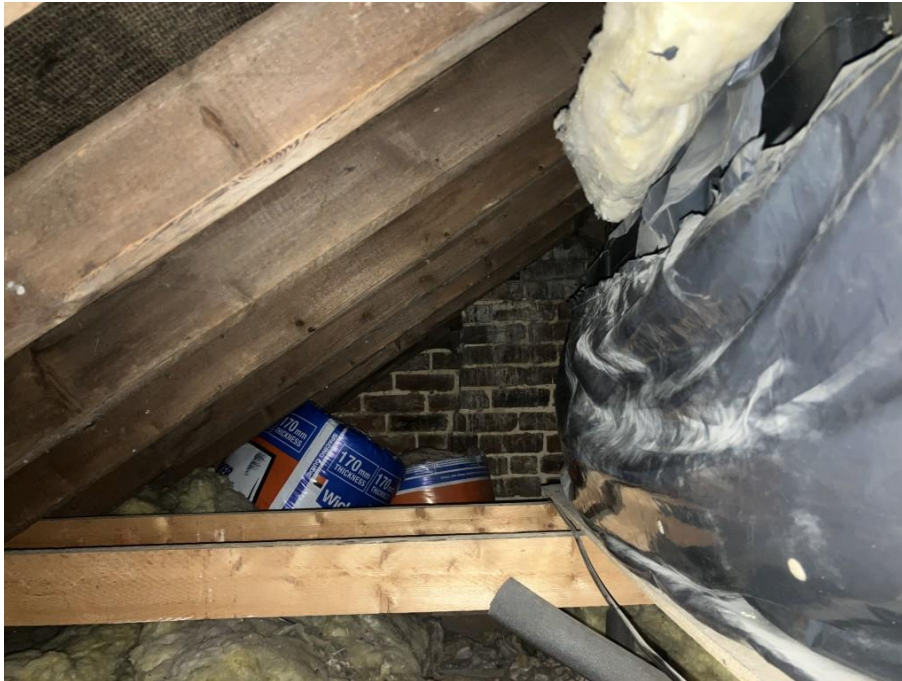
**Photograph 21 – Chimney stack within east roof void of rear addition.**

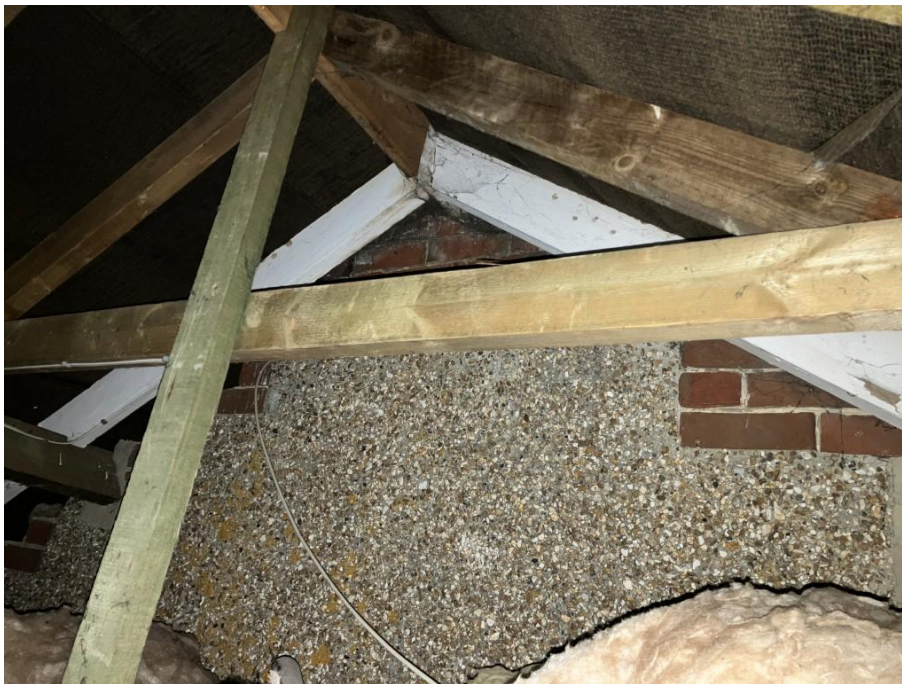
**Photograph 22 – Former external pebble dash wall of rear addition in western roof void.**

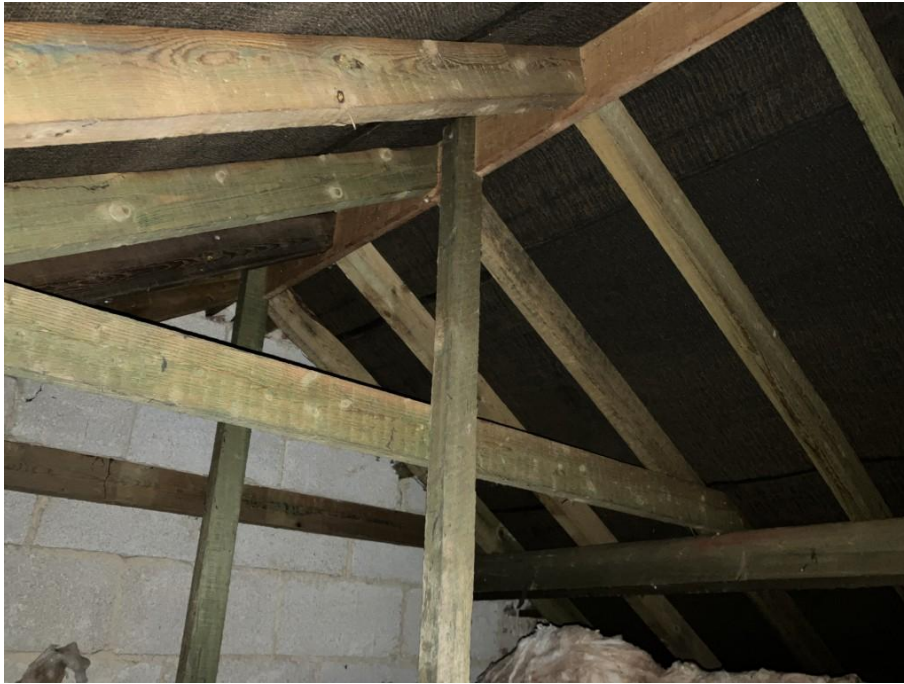
- 3.1.19 The roof structure in the voids of the rear addition is exposed for inspection. The roof structure is typical cut timber construction of purlins, rafters and struts. The phasing of construction is expressed in the appearance of the timber. The section as far as the gable wall with the chimney stack is older (see Photographs 20 and 21). Within the void of the later construction the former external pebbledash finishes can be seen on the gable wall (see Photograph 22), and the timber and gable end is of a more modern appearance (see Photograph 23). There were no visible defects and no sign of structural inadequacy.

**Photograph 23 – Later construction to west gable of western roof void of rear addition.**

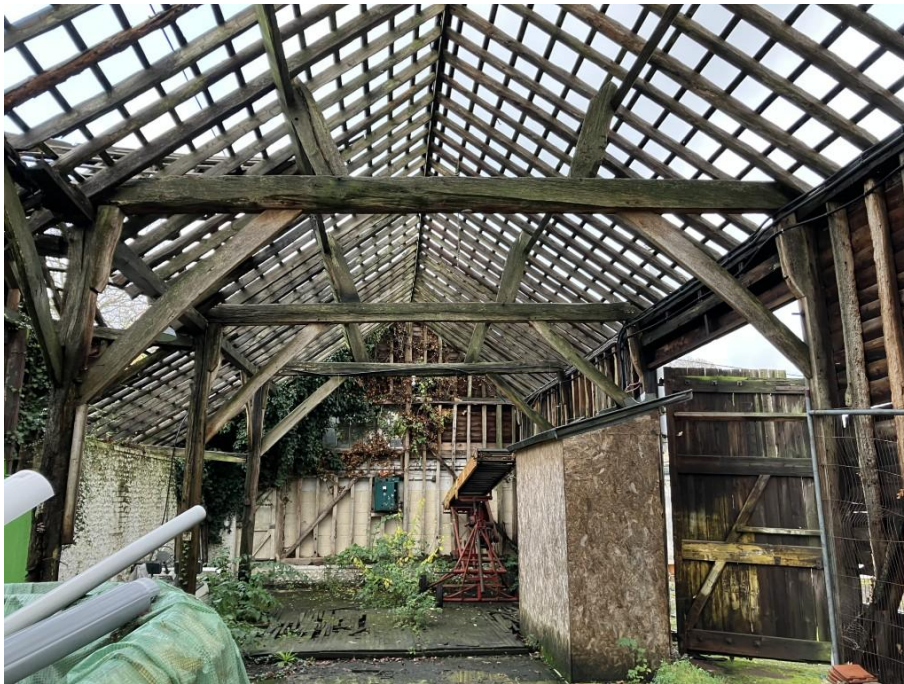
- 3.2.1 The barn is in a very poor structural condition (see Photographs 24 to 27). The timber frame has become highly saturated since the removal of the roof finishes, however it is thought that the decay results from water ingress over a longer period of time due to deterioration of the external envelope. Due to limited access, accumulation of vegetation and concealed defects, it is not possible to list every defect in detail. The following summary is provided of the most significant defects.

**Photograph 24 – General view of barn structure looking to north.**

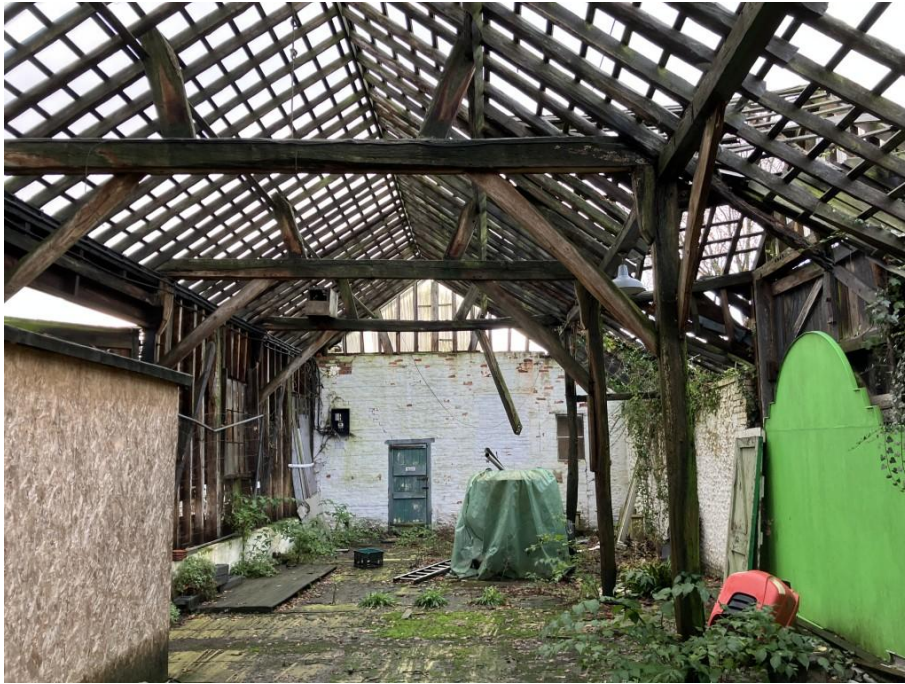
**Photograph 25 – General view of barn structure looking to south. Note detached diagonal brace.**

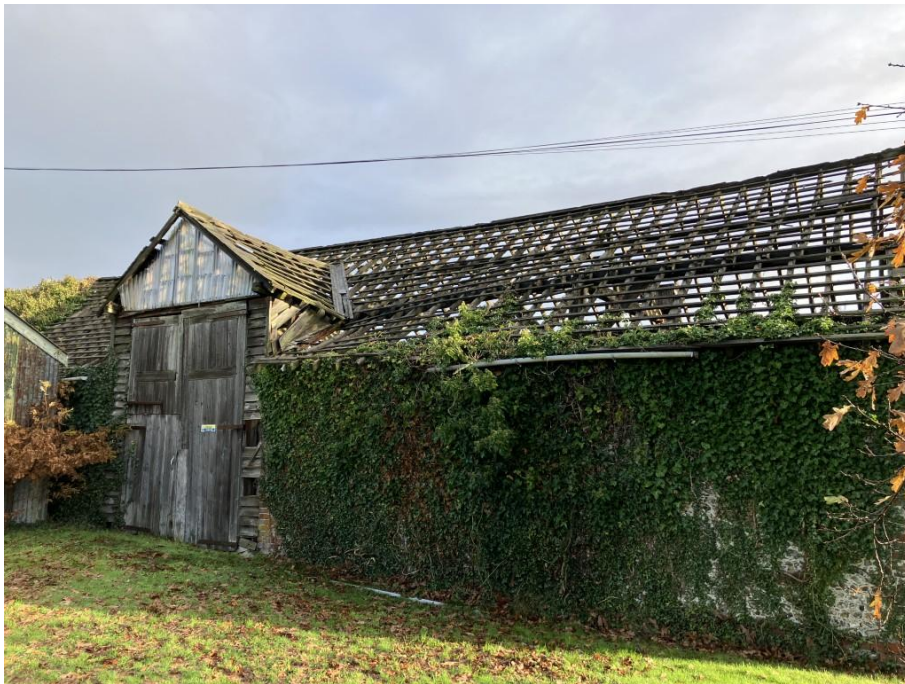
**Photograph 26 – West elevation of barn. Note ivy coloured flint wall, degraded lower roof pitch and intersecting gable over western door.**

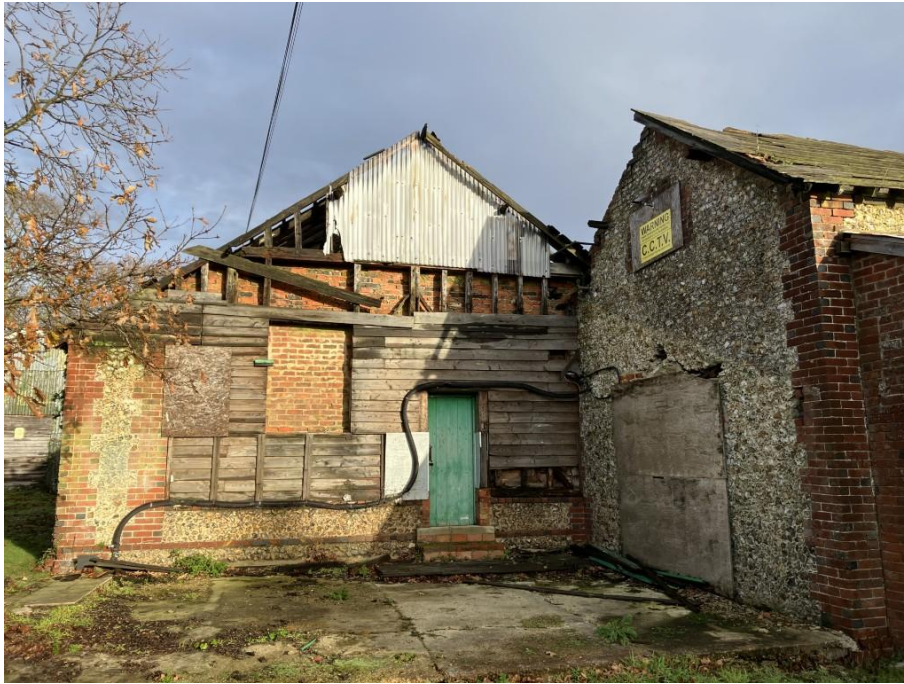
- 3.2.4 The external timber stud walls are partly infilled with masonry (see Photographs 24, 25 and 27). To the north blockwork has been erected outside the timber frame and it is assumed to be part of the adjacent flat roof building. Brickwork has been erected inside the timber frame at the south elevation. There is diagonal cracking in the south elevation (see Photograph 29), indicating some movement in the brickwork which is likely to result from shallow foundations and the shrinkable clay ground conditions.

**Photograph 27 – South elevation of barn with brickwork infill inside timber frame.**

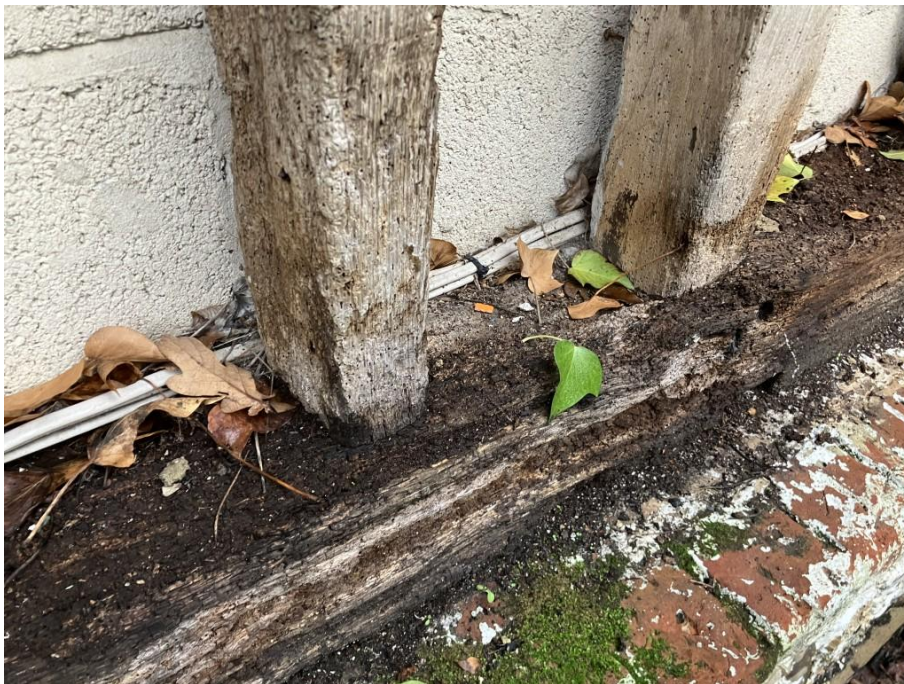
- 3.2.2 There is significant decay where the east elevation timber studs meet the sole plate (see Photograph 28). The damage is not necessarily directly visible. At a sample selection of mortice and tenon connections a screw driver could easily be pushed into the timber.

**Photograph 28 – Timber decay in mortice and tenon joists at sole plate of east elevation.**

- 4.21 The timber frame connections are typically formed with mortice and tenon connections. At the timber sole plates this admits water to the centre of the timber, where it is trapped, resulting in decay. Replacement of sole plates and the lower part of timber studs would be required. Although not confirmed, it is likely that other mortice and tenon connections are water traps and have been weakened by localised decay.

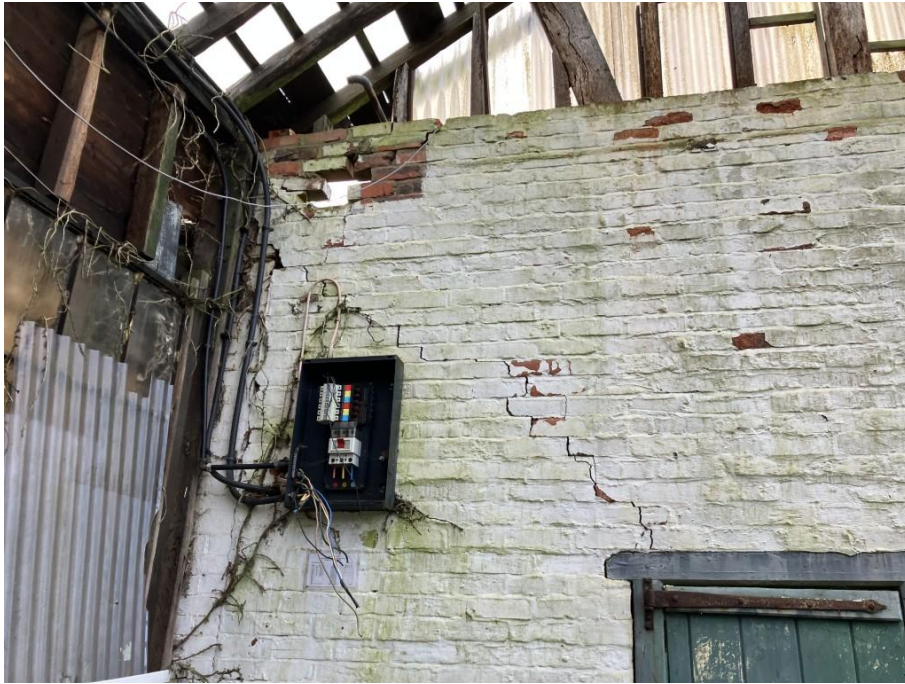
**Photograph 29 – Cracking of brickwork infill wall to south elevation.**

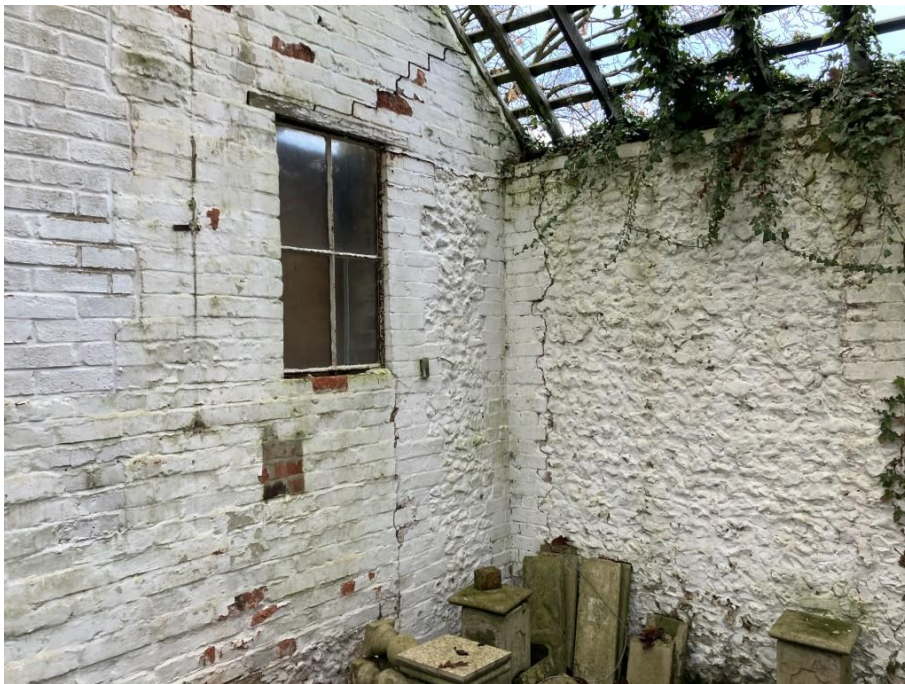
- 3.2.5 The brick and flint west elevation appears original, along with the return to the south elevation. There is some minor separation of the flint wall and the corner brick quoin (see Photograph 30).

**Photograph 30 – Cracking of brickwork infill wall to south elevation (left hand side) and minor separation of brick and flint of original wall to right hand side.**

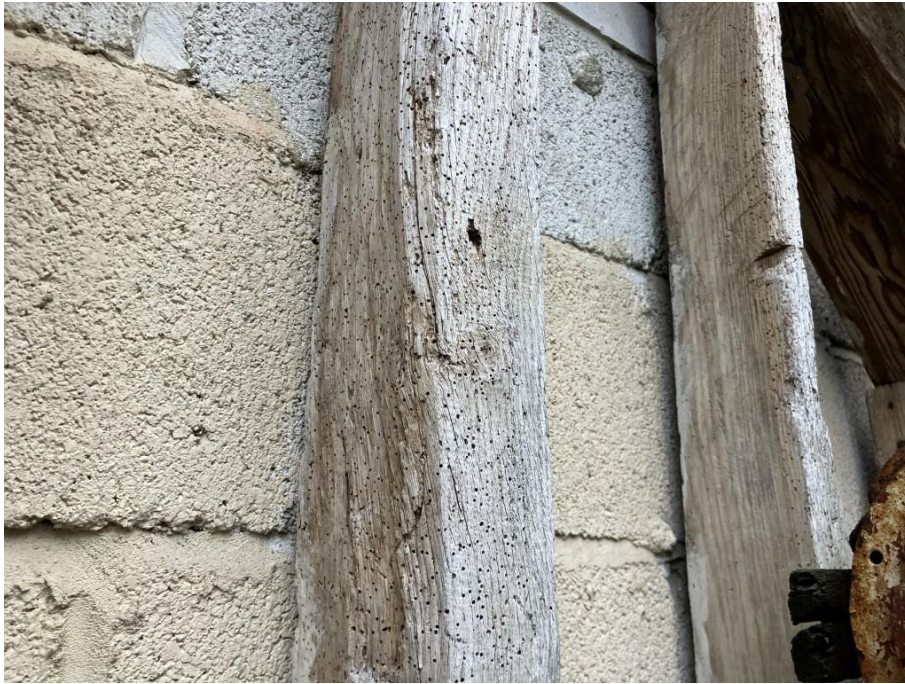
- 3.2.6 There is evidence of insect attack in the timber studs (see Photograph 31). There is no evidence of significant loss of section as a result. The distribution suggests that it may have been an insect which favours sapwood and that the damage is relatively superficial.

**Photograph 31 – Insect infestation of timber studs at north elevation.**

- 4.24 The evidence of insect infestation is likely to be historic and the pattern of penetrations does not indicate that it has resulted in significant weakening. To confirm this, investigations would be required to expose the inner condition of the timber, revealing evidence of recent infestation and the depth of penetration.

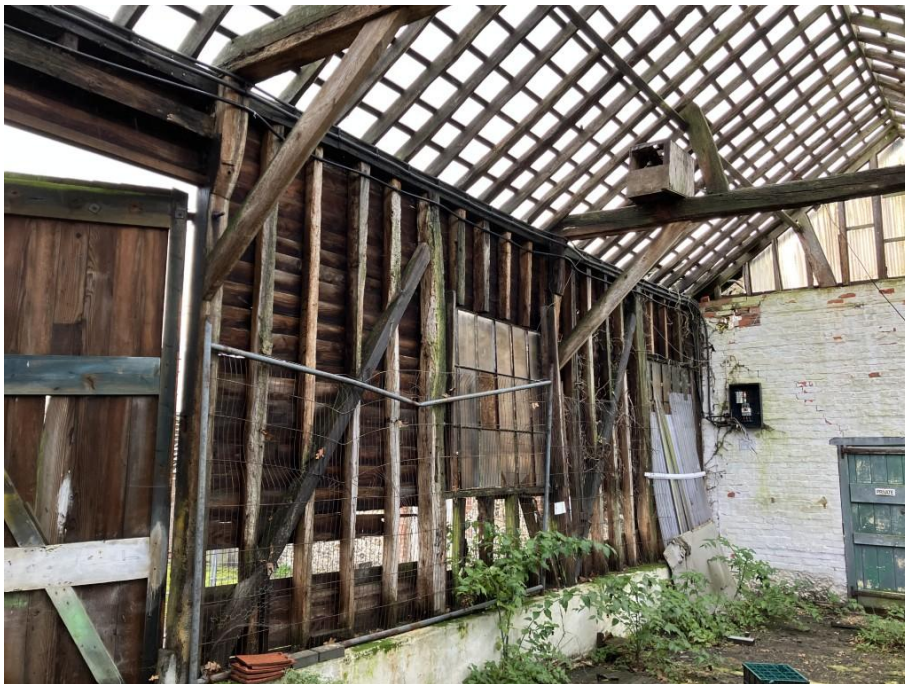
- 3.2.7 Large windows have been installed in the east elevation, with two to the south side of the large door and one to the north. The timber studs were not adequately trimmed out to form a window opening (see Photograph 32). There is a shallow sill, no timber to form a head to an opening and the side studs have not been strengthened.

**Photograph 32 – Large window openings former in east elevation without adequate timber framing. East elevation displaced by failure of timber structure shown in Photograph 34.**

- 4.23 There have been numerous alterations during the service life of the barn, as other buildings have enclosed upon it and to form windows. The masonry infill may be providing some stability in the current degraded condition. If any retention were considered the infill masonry should be removed. Other historic alterations, such as the window openings, would require making good and strengthening.
