## **Padnell Grange - Structural Condition Survey**

### **Structural Appraisal Report**

**Ref:** 251363/J Ham

**Date:** 05 Jan 2026

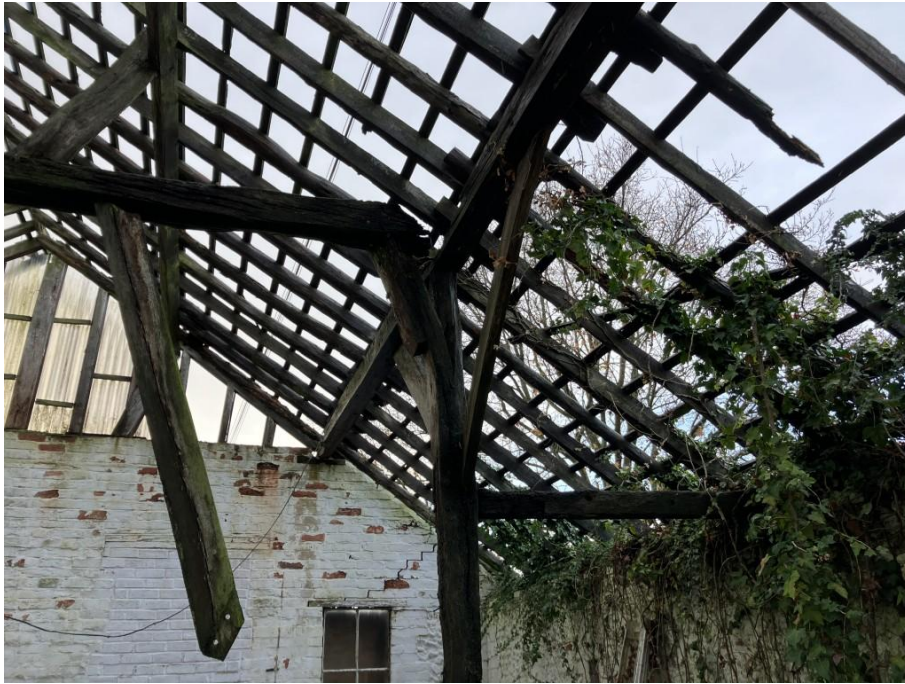
**Photograph 33 – Severe damage to timber frame including failed diagonal brace, and severely degraded and split timber post.**

- 4.22 The failure of the diagonal bracing element appears to be related to the poor condition of the timber post in this location. This has in turn split the top of the post and compromised the geometry of the building. The building should be regarded as unsafe in this condition and requires lateral restraint and propping with temporary works.

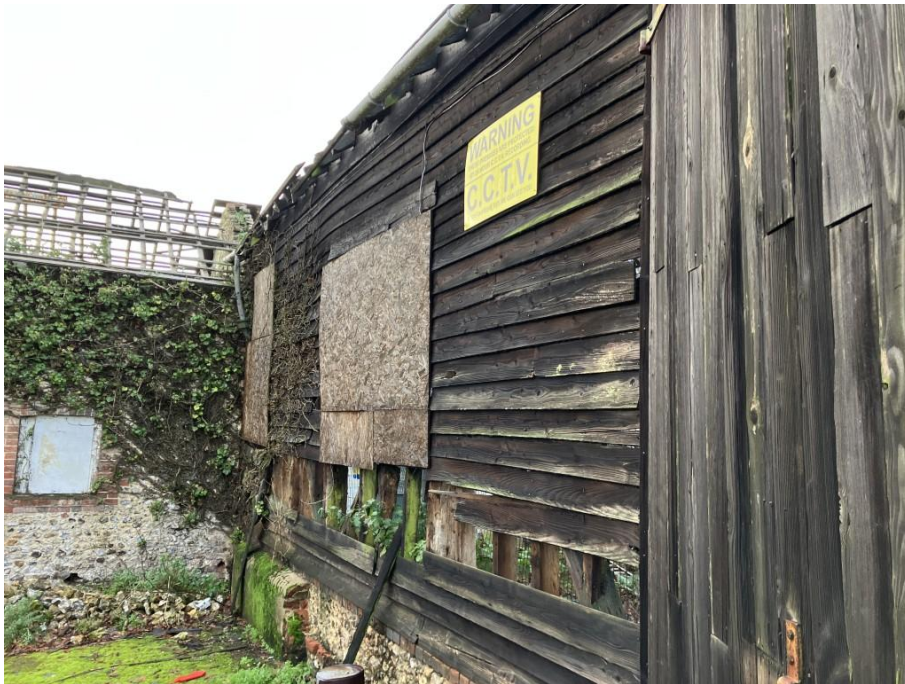
- 3.2.8 There is an internal frame formed with timber posts supporting longitudinal (north-south) and transverse (east-west) timber beams. The frame comprises five bays, of which the centre bay houses doors to the east and west. There are diagonal braces between the posts and the beams. In one location towards the south end a diagonal brace has failed at the lower connection (see Photograph 33). This appears to result from severe decay of the post into which the brace was fixed. The affected post appears to be weakened by decay and is no longer straight. The post has split above the failed connection and the transverse beam has displaced to the east, resulting in some distortion of the east elevation (see Photograph 34).

**Photograph 34 – External view corresponding with Photograph 32.**

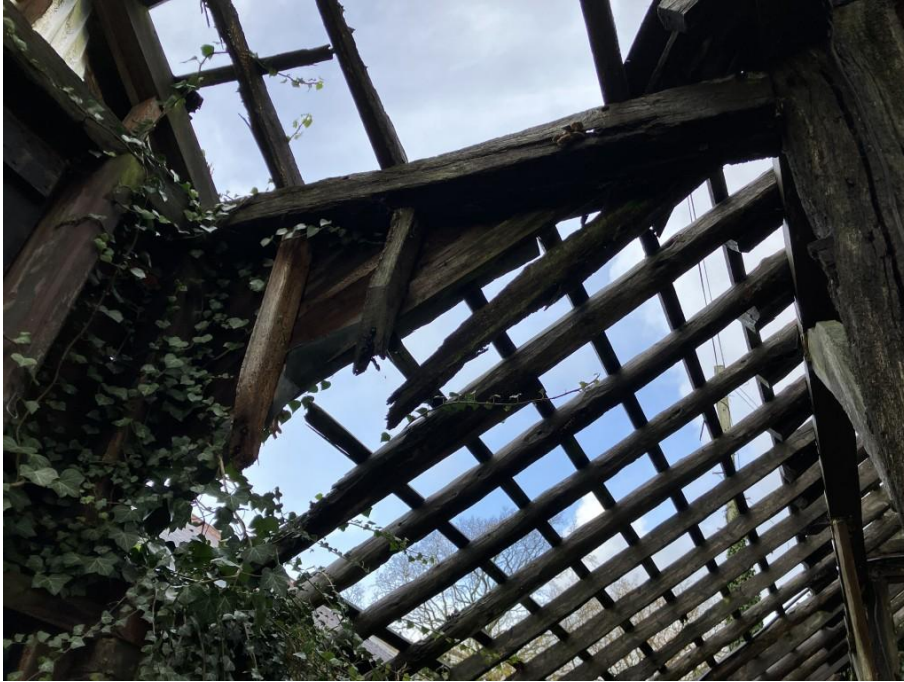
- 3.2.12 There is an intersecting gable over the door in the west elevation which forms a break in the lower rafters and partly bears on the upper rafters. The gable is severely decayed and its shape is significantly distorted (see Photographs 25 and 35). The cheeks of the gable are in very poor condition and some elements are missing.

**Photograph 35 – Severe decay and missing elements to cheek of intersecting gable.**
