**Stantec UK Limited**

## **Appendix C Exploratory Hole Location Plan, Exploratory Hole Logs and Photographs**

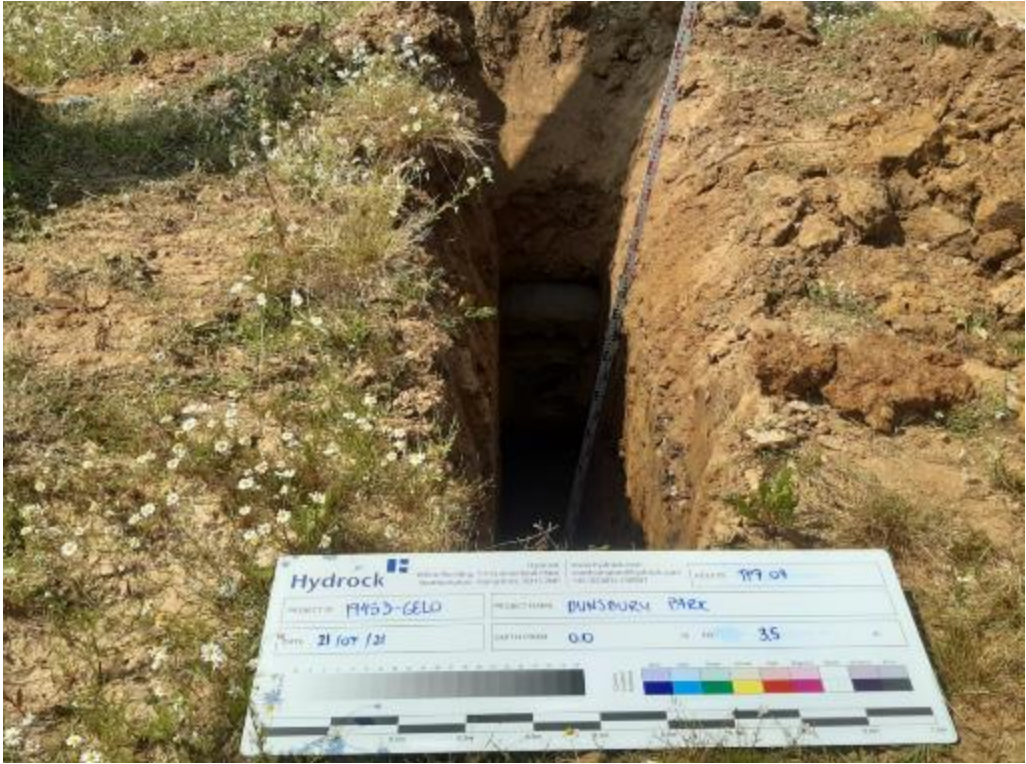
| <b>Site Investigation<br/>Photograph 1</b> | |

| <b>Description:</b> TP7.07 | |

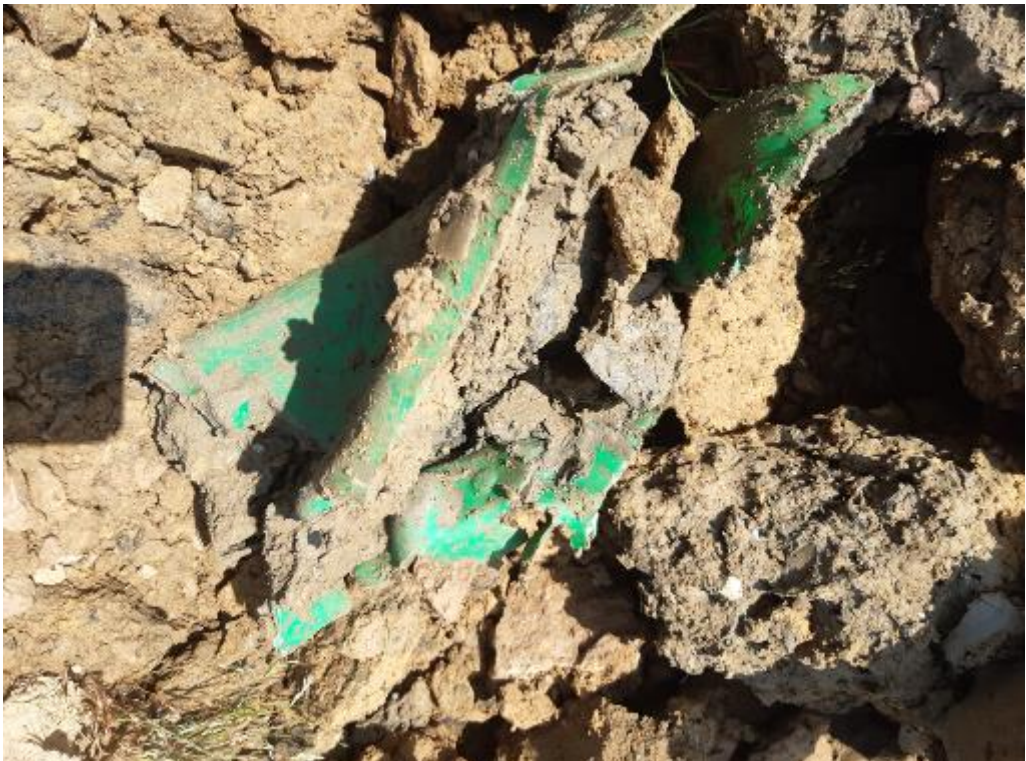
| <b>Site Investigation<br/>Photograph 2</b> | |

| <b>Description:</b> TP7.07<br>– man- made<br>materials. | |

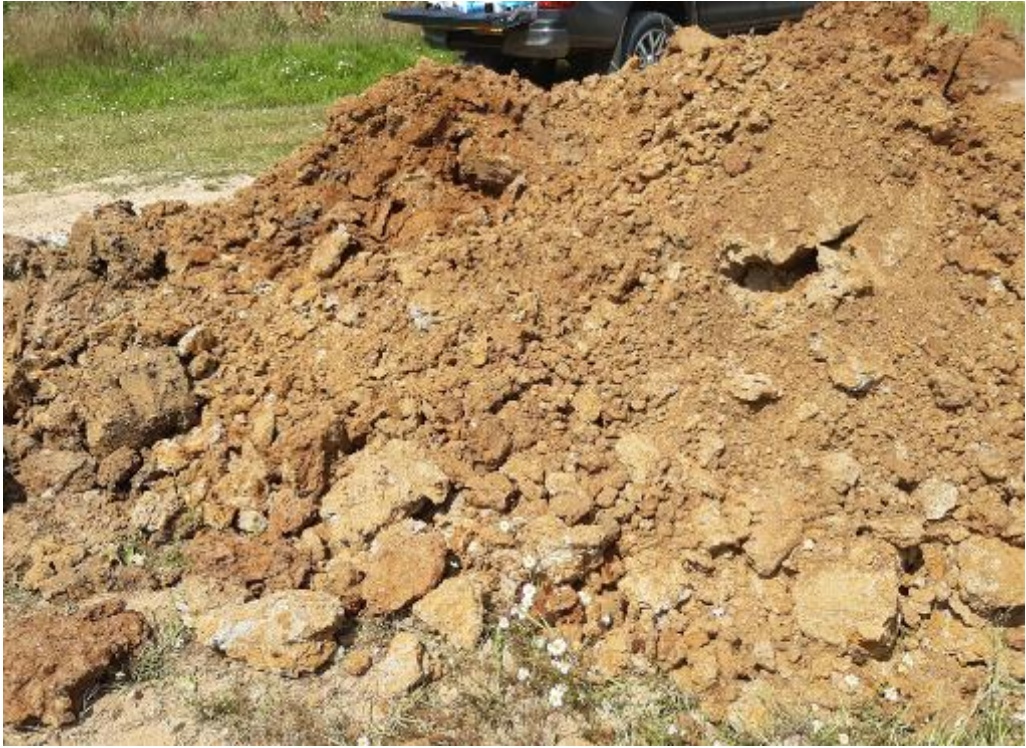
| <b>Site Investigation<br/>Photograph 3</b> | |

| <b>Description:</b> TP7.07<br>– arisings. | |

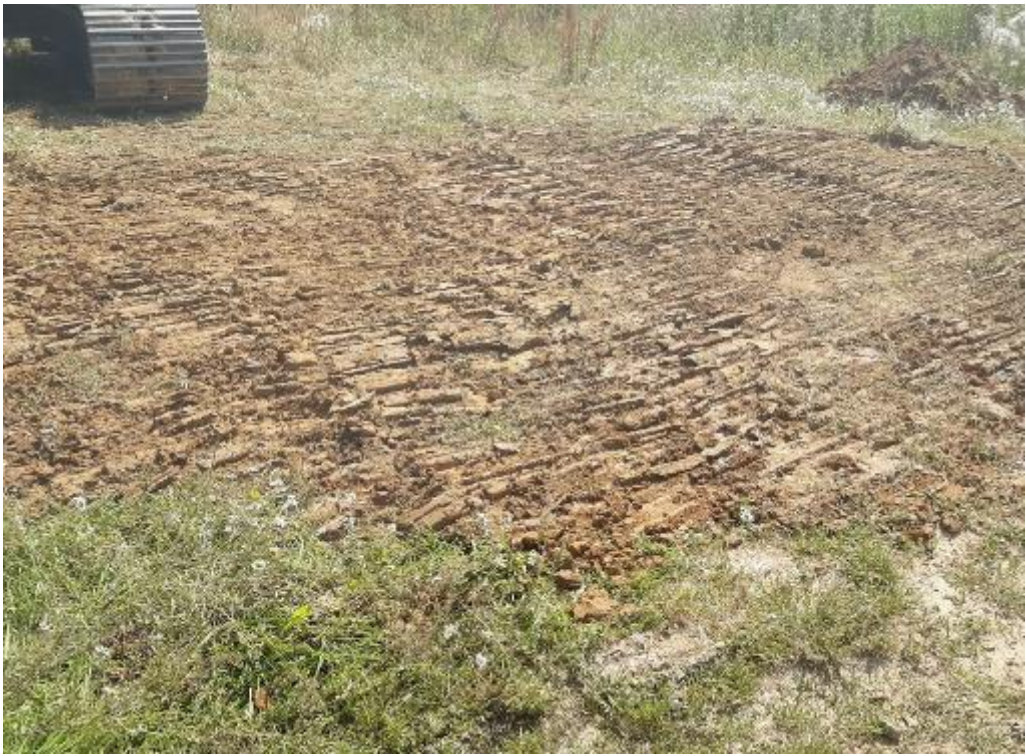
| <b>Site Investigation<br/>Photograph 4</b> | |

| <b>Description:</b> TP7.07<br>backfilled with<br>arisings after<br>completion of works. | |

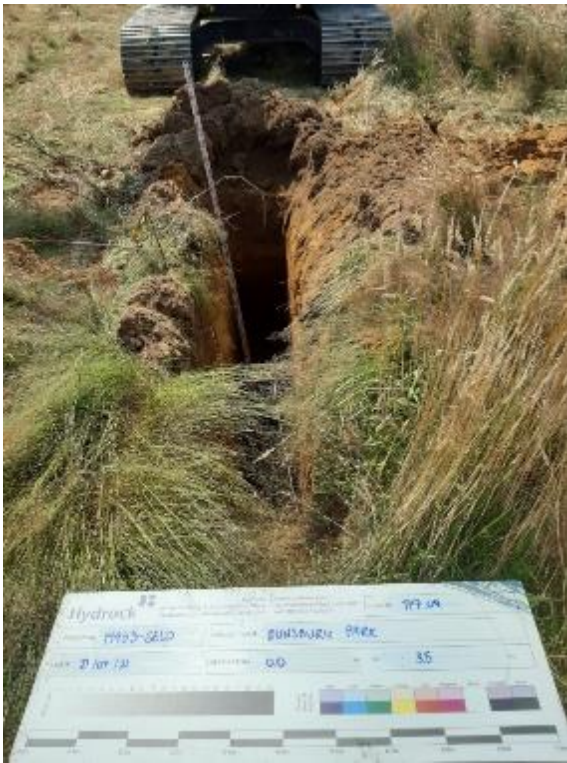
| <b>Site Investigation<br/>Photograph 5</b> | |

| <b>Description:</b> TP7.09. | |

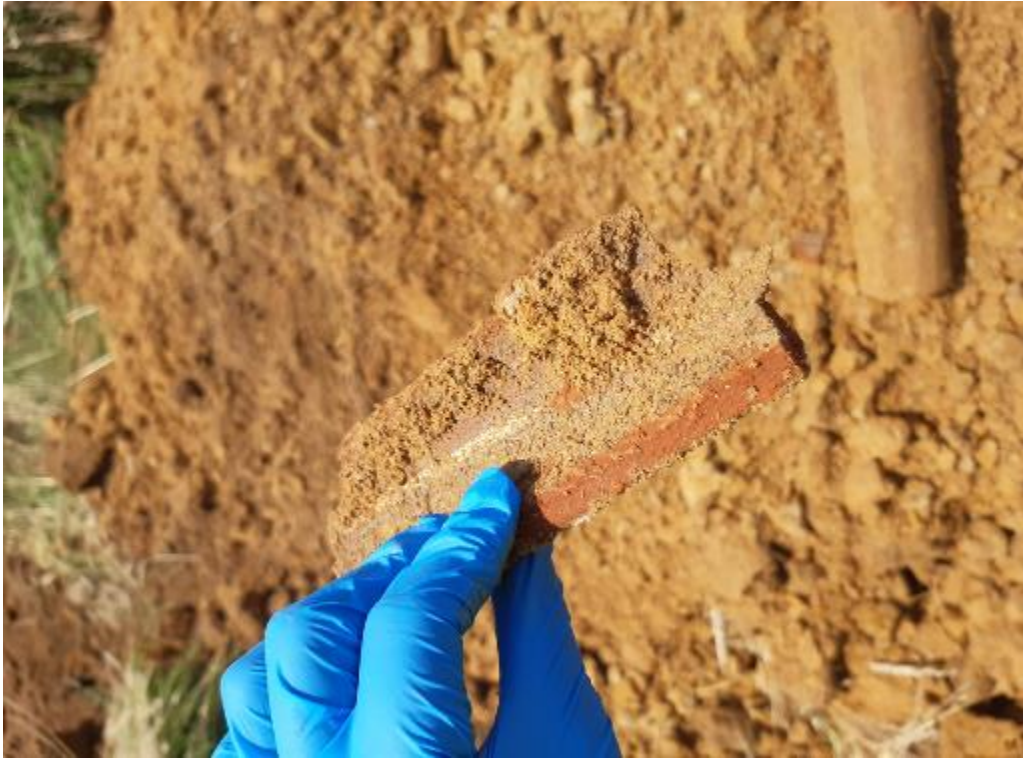
| <b>Site Investigation<br/>Photograph 6</b> | |

| <b>Description:</b> TP7.09<br>– brick fragments<br>(possible clay pipe). | |

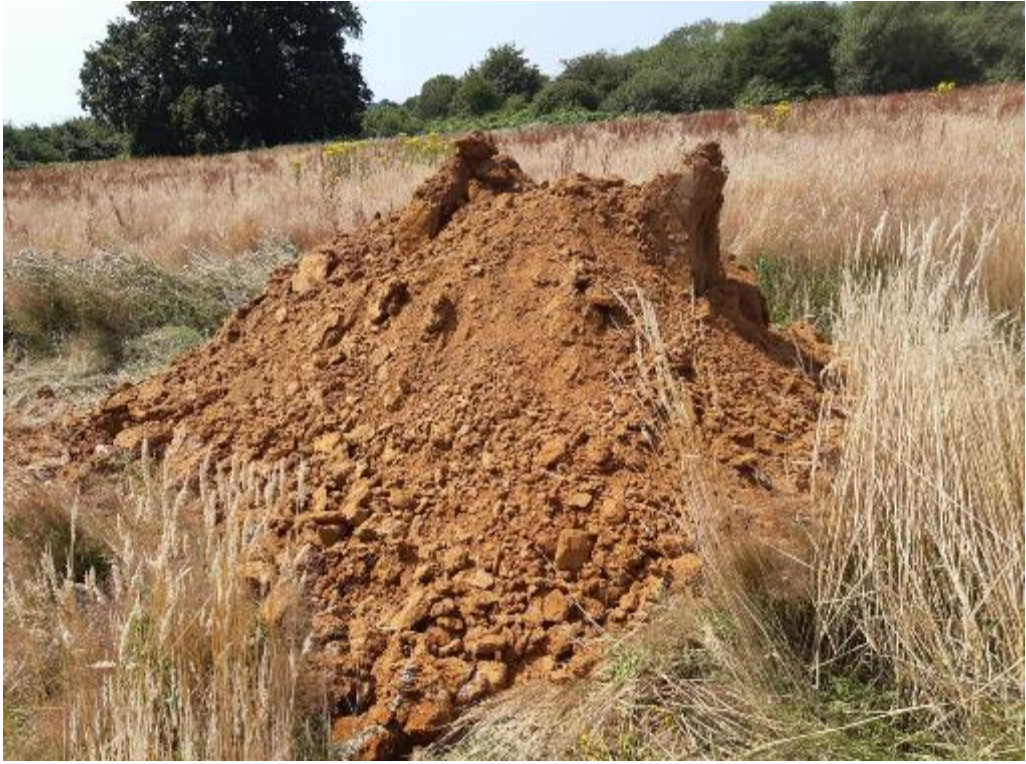
| <b>Site Investigation<br/>Photograph 7</b> | |

| <b>Description:</b> TP7.09 arisings. | |

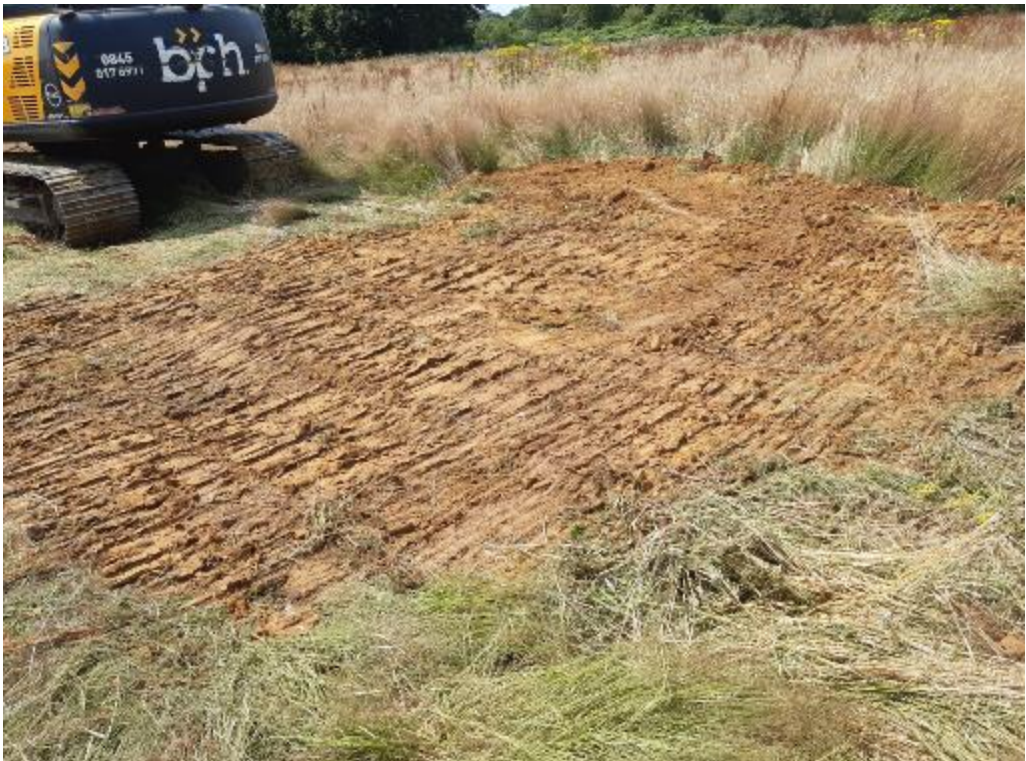
| <b>Site Investigation<br/>Photograph 8</b> | |

| <b>Description:</b> TP7.09 backfilled with arisings after completion of works. | |

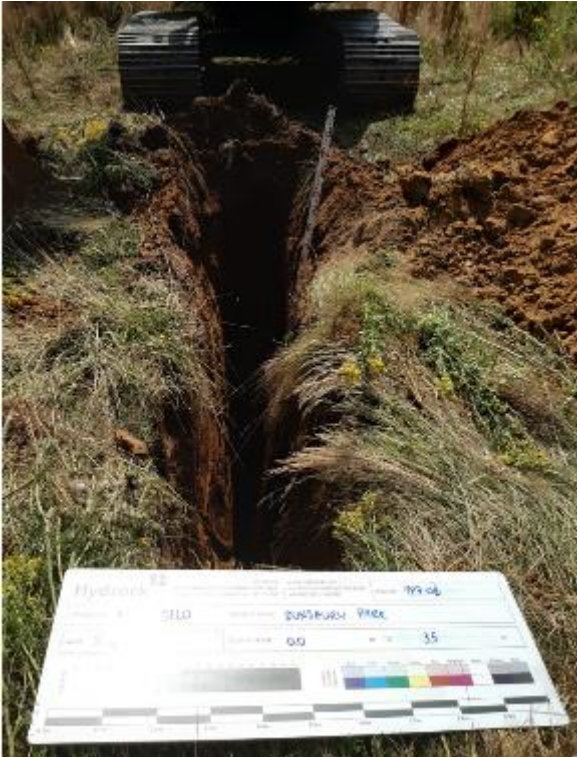
| Site Investigation<br>Photograph 9 | |

| Description: TP7.08. | |

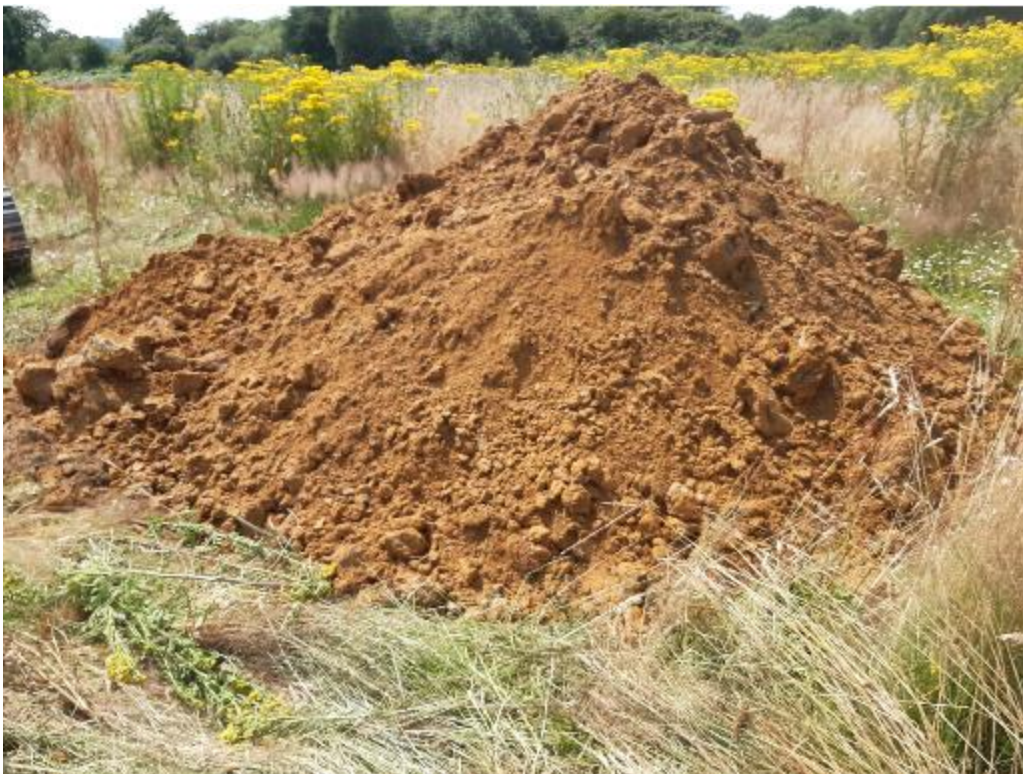
| Site Investigation<br>Photograph 10 | |

| Description: TP7.08<br>arising. | |

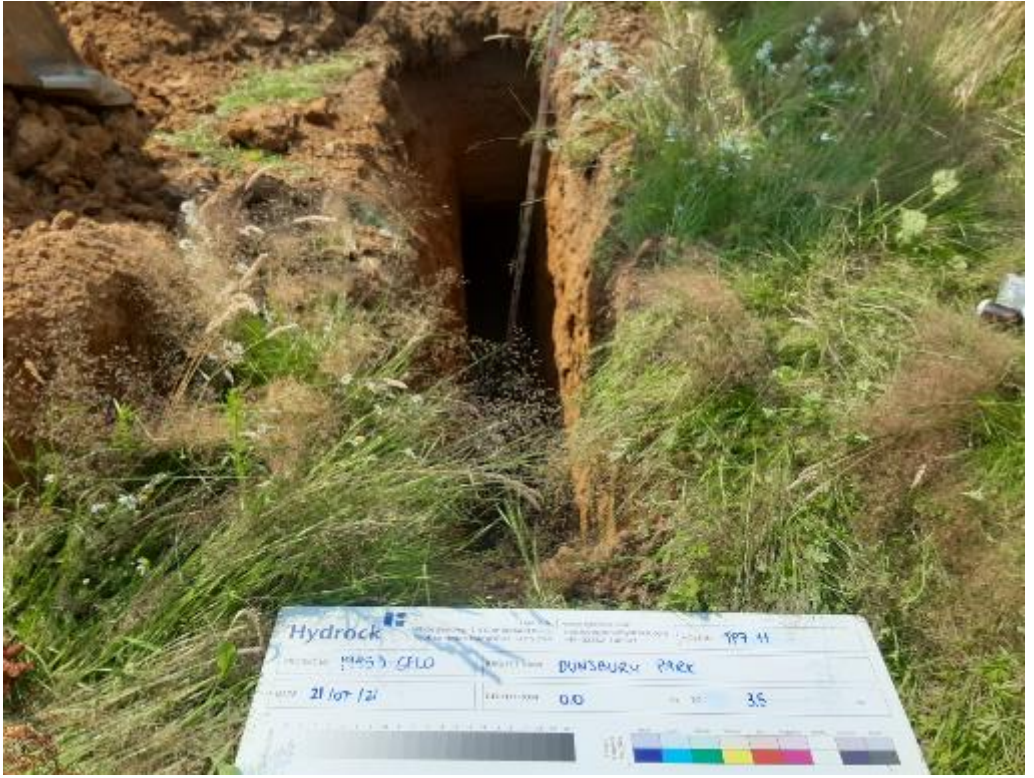
| <b>Site Investigation<br/>Photograph 11</b> | |

| <b>Description:</b> TP7.11. | |

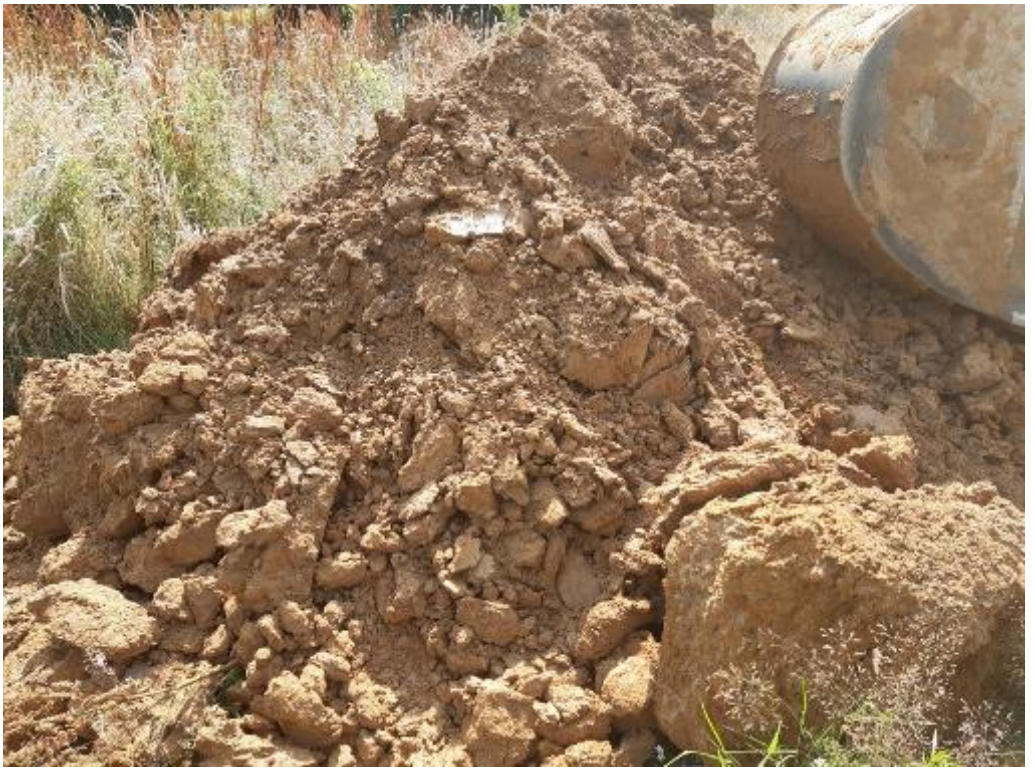
| <b>Site Investigation<br/>Photograph 12</b> | |

| <b>Description:</b> TP7.11 arisings. | |

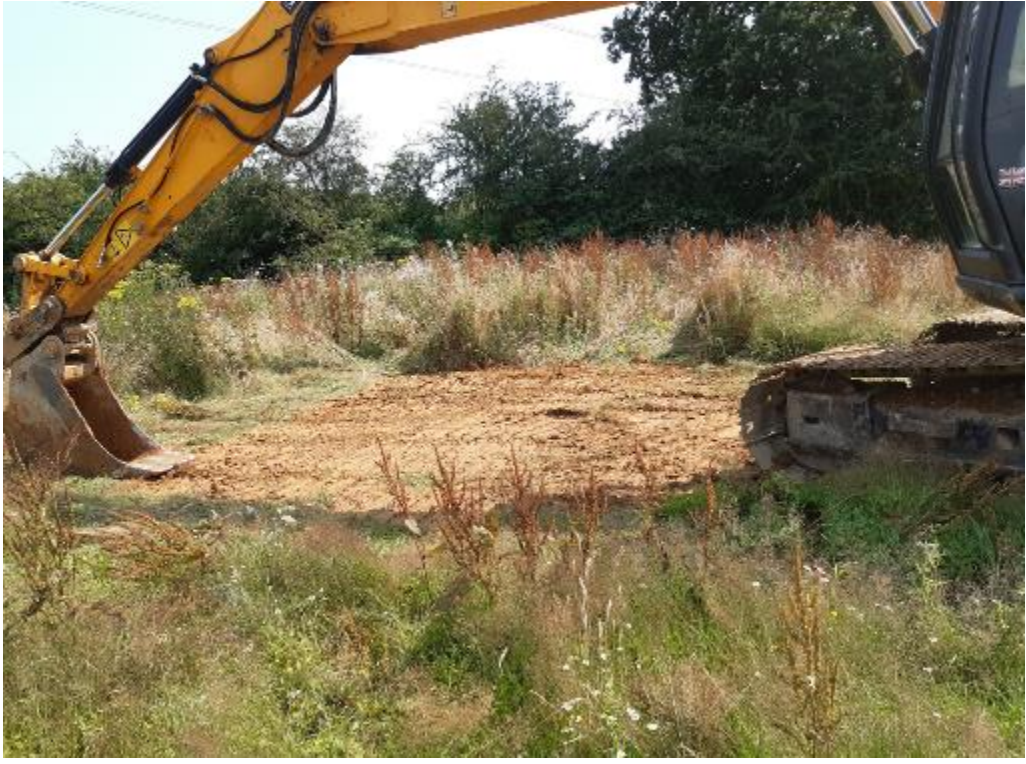
| <b>Site Investigation<br/>Photograph 13</b> | |

| <b>Description:</b> TP7.11<br>backfilled with<br>arisings after<br>completion of works. | |

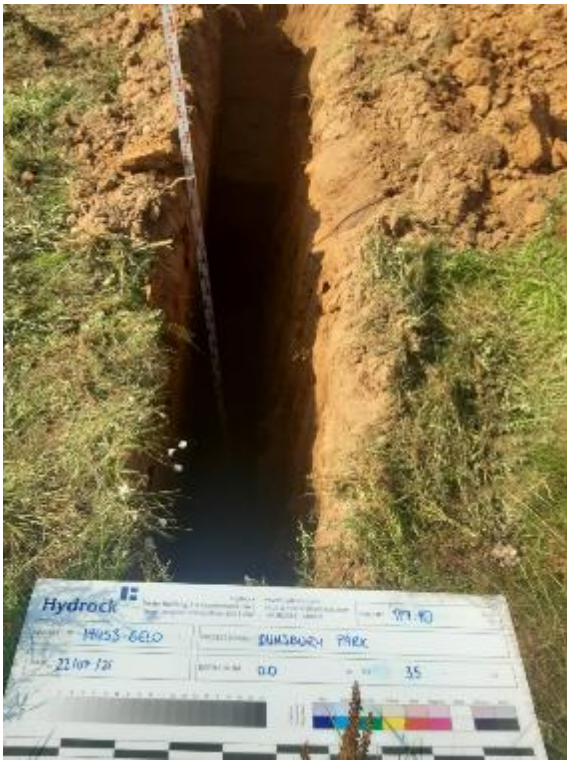
| <b>Site Investigation<br/>Photograph 14</b> | |

| <b>Description:</b> TP7.10. | |

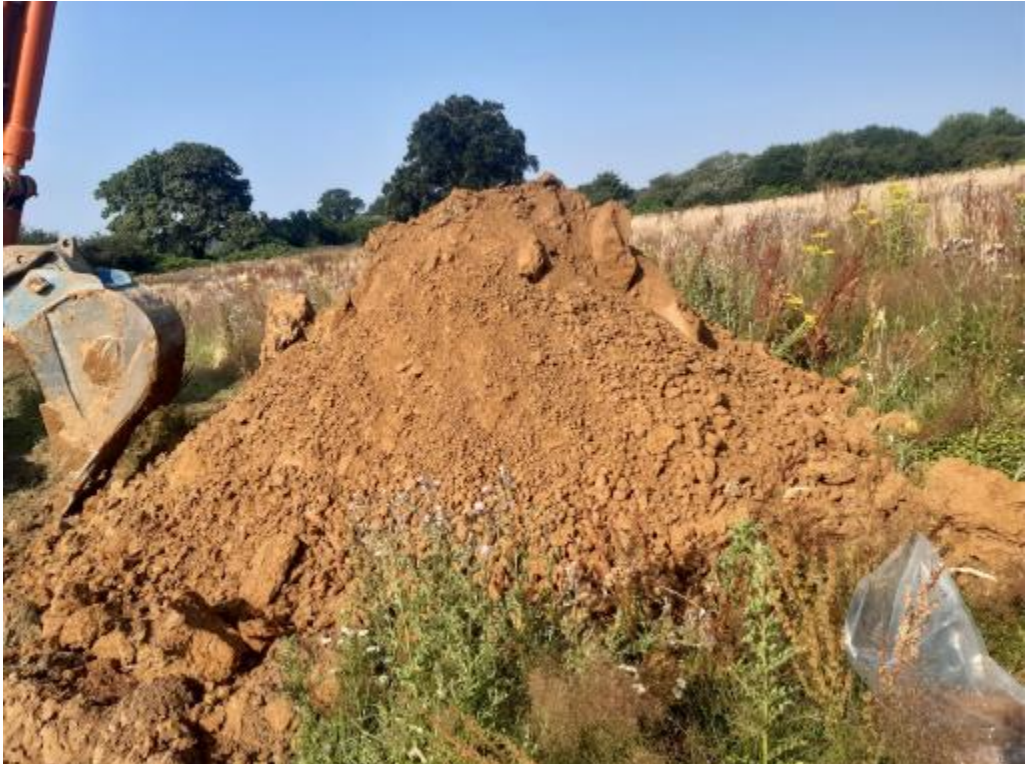
| <b>Site Investigation<br/>Photograph 15</b> | |

| <b>Description:</b> TP7.10 arisings. | |

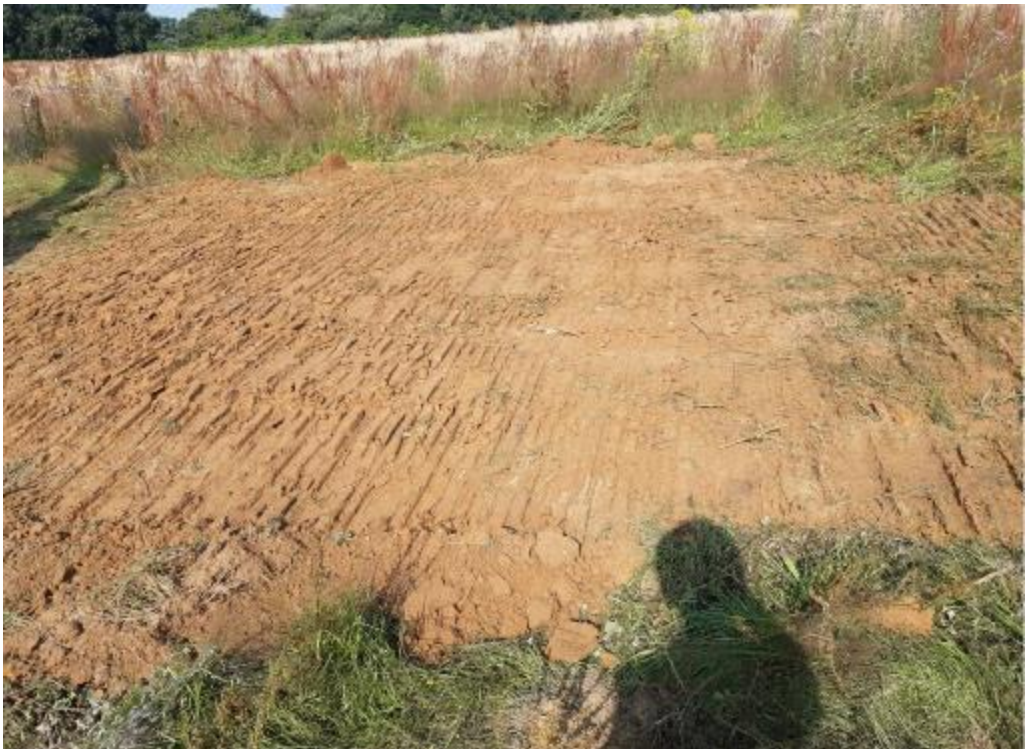
| <b>Site Investigation<br/>Photograph 16</b> | |

| <b>Description:</b> TP7.10 backfilled with arisings after completion of works. | |

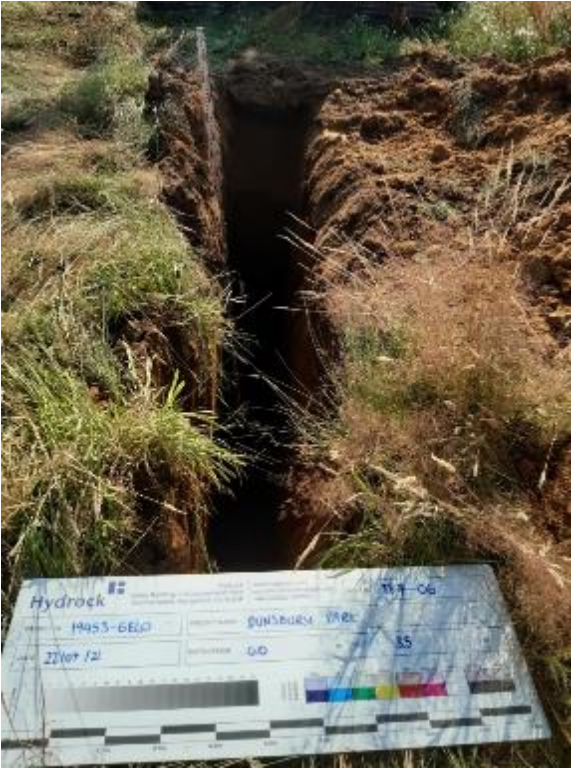
| Site Investigation<br>Photograph 17 | |

| Description: TP7.06. | |

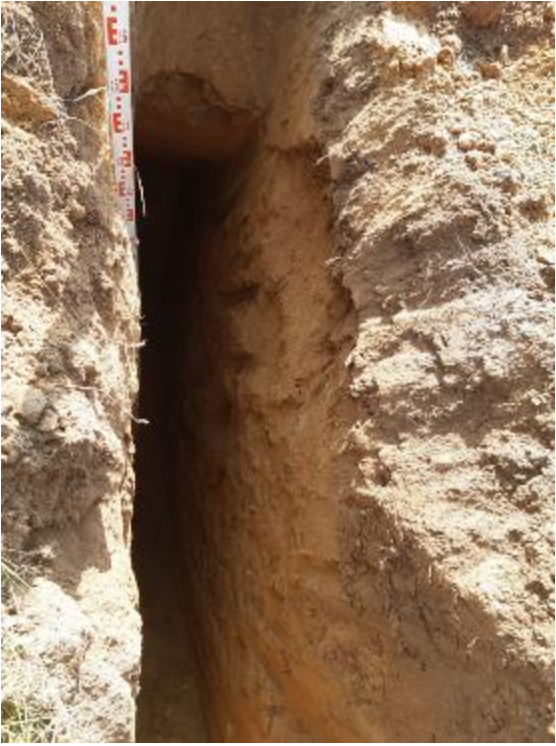
| Site Investigation<br>Photograph 18 | |

| Description: TP7.06<br>side walls. | |

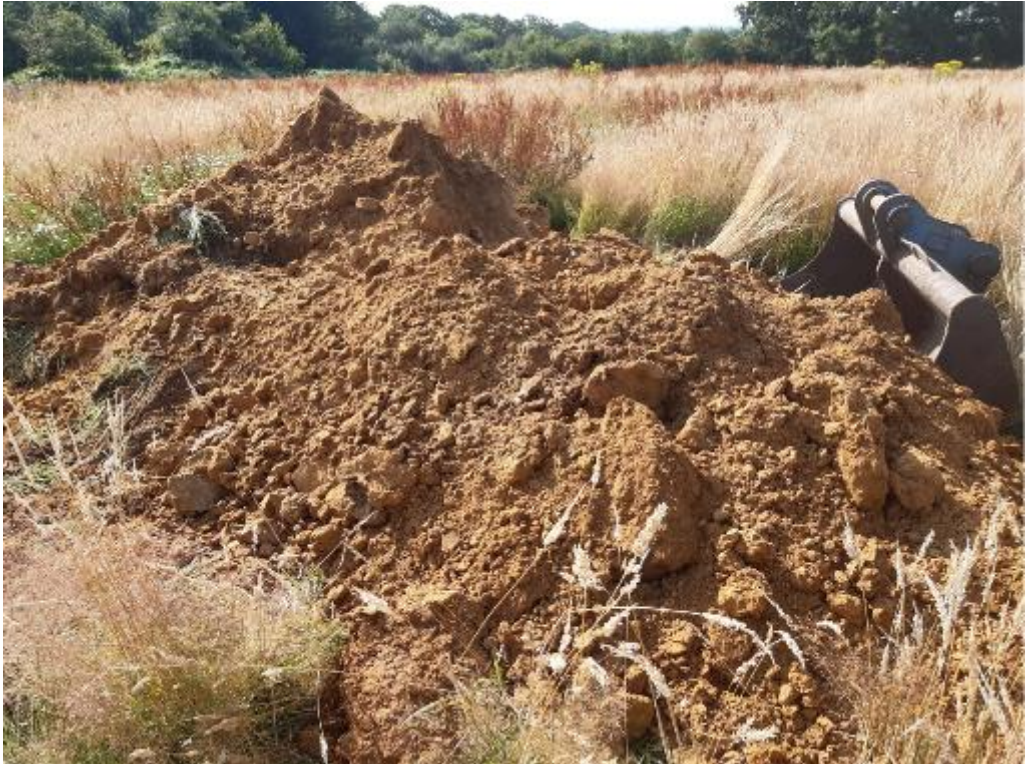
| <b>Site Investigation<br/>Photograph 19</b> | |

| <b>Description:</b> TP7.06 arisings. | |

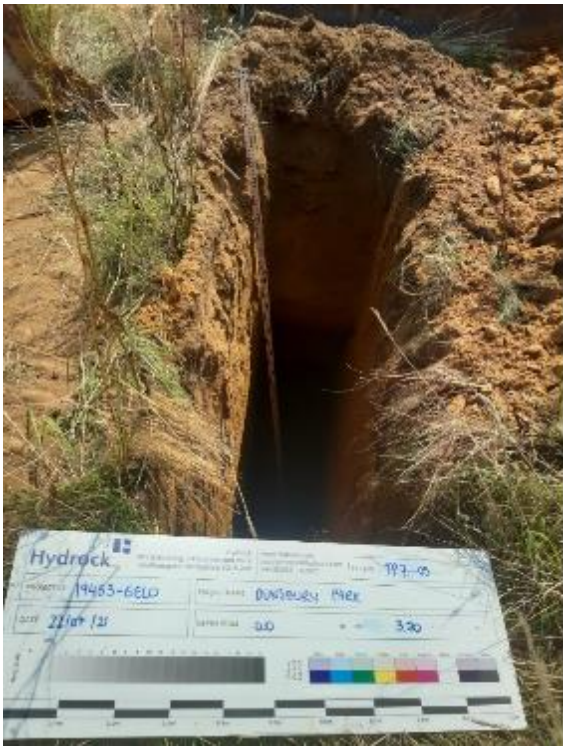
| <b>Site Investigation<br/>Photograph 20</b> | |

| <b>Description:</b> TP7.05. | |

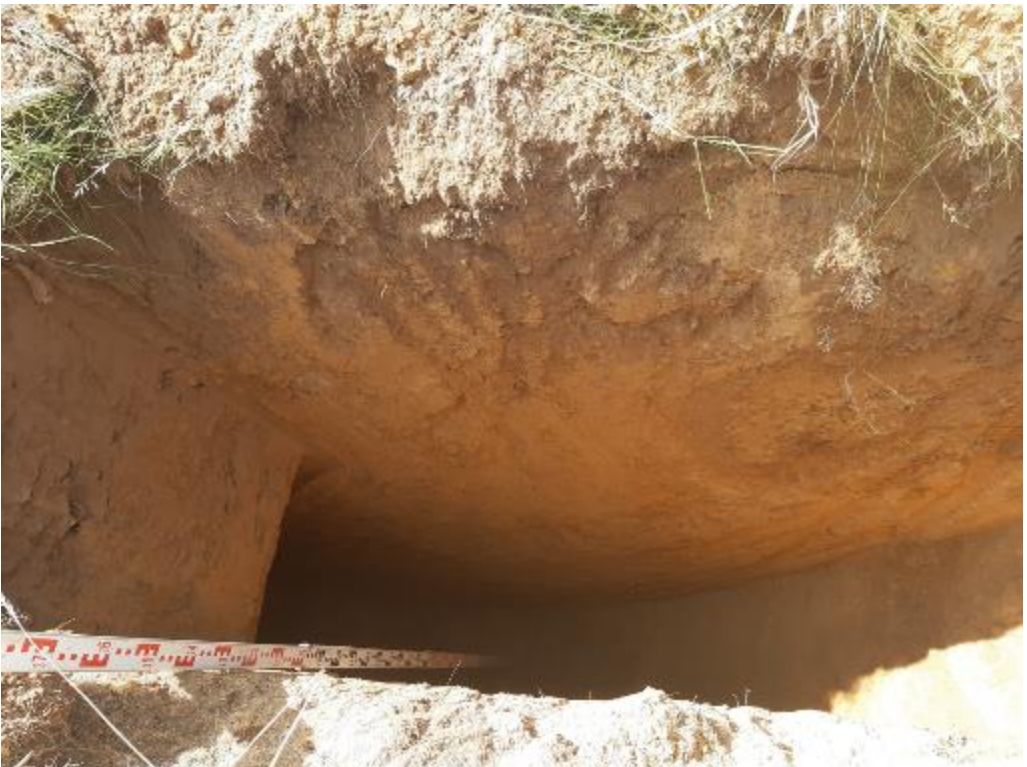
| <b>Site Investigation<br/>Photograph 21</b> | |

| <b>Description:</b> TP7.05<br>side walls. | |

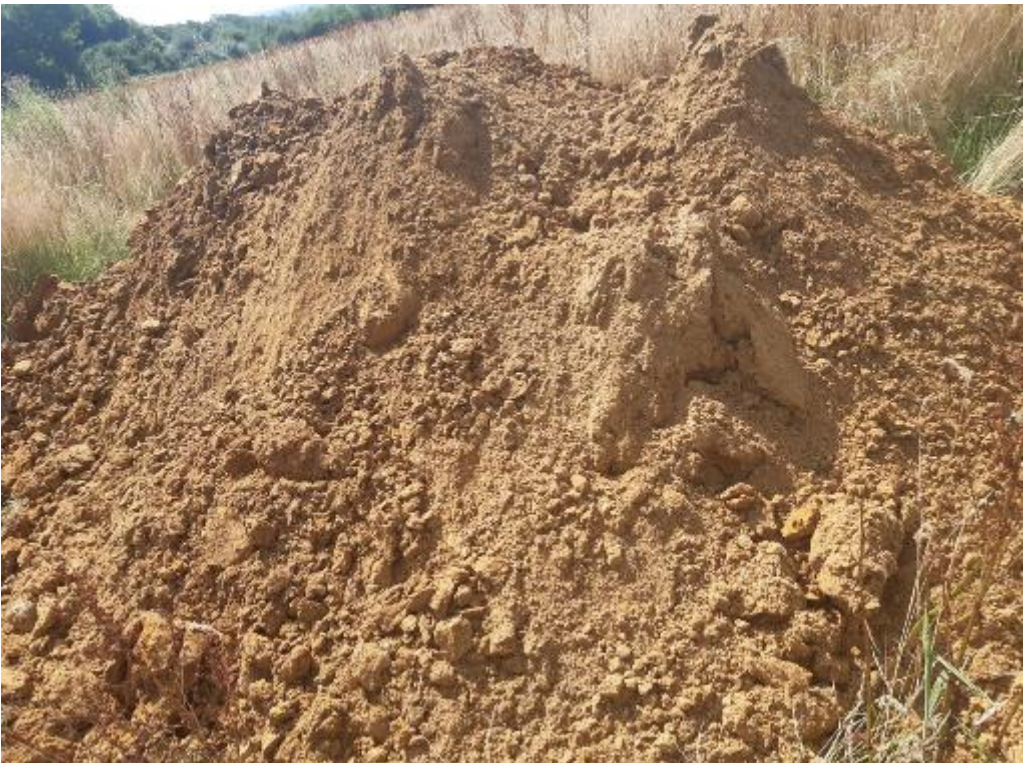
| <b>Site Investigation<br/>Photograph 22</b> | |

| <b>Description:</b> TP7.05<br>arising. | |

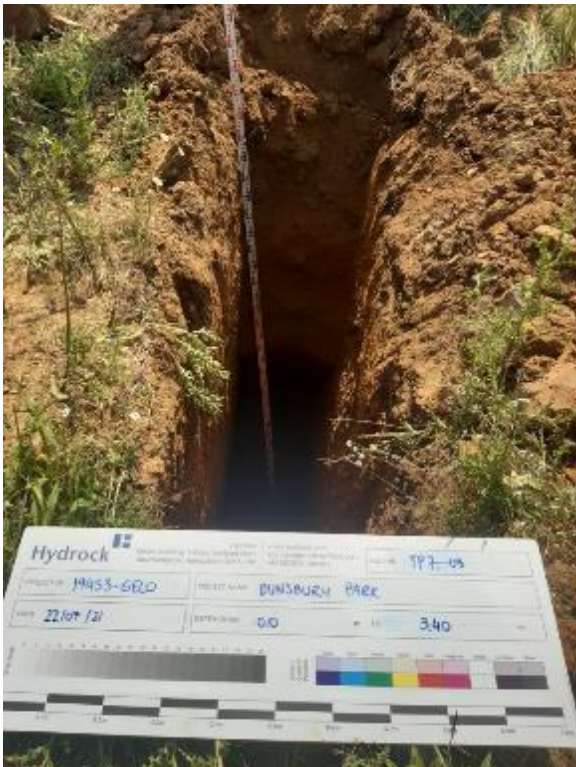
| <b>Site Investigation<br/>Photograph 23</b> | |

| <b>Description:</b> TP7.03. | |

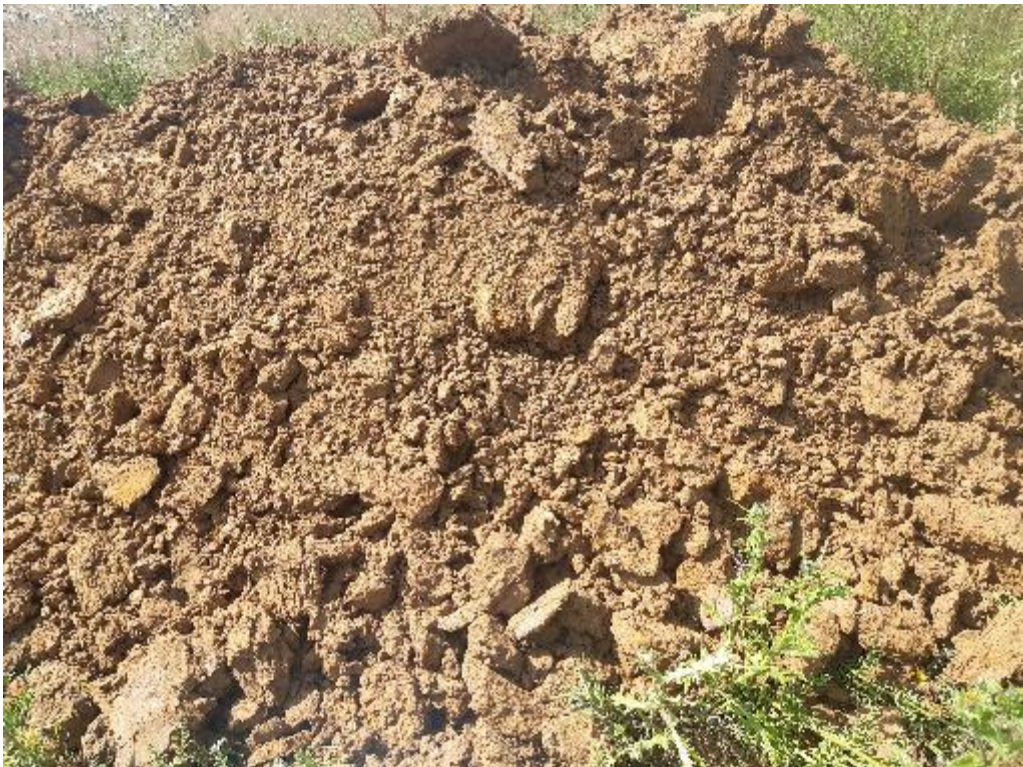
| <b>Site Investigation<br/>Photograph 24</b> | |

| <b>Description:</b> TP7.03<br>arisings. | |

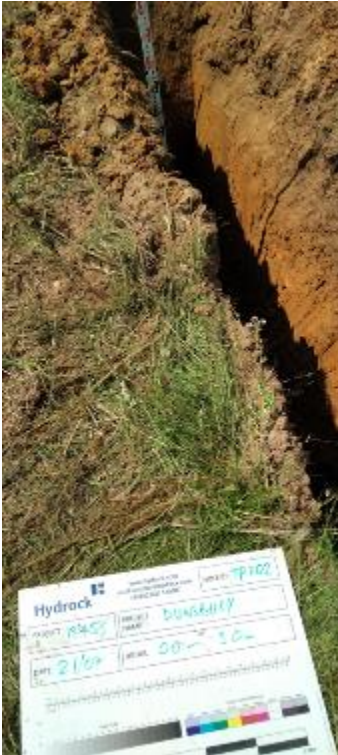
| <b>Site Investigation<br/>Photograph 25</b> | |

| <b>Description:</b> TP7.02. | |

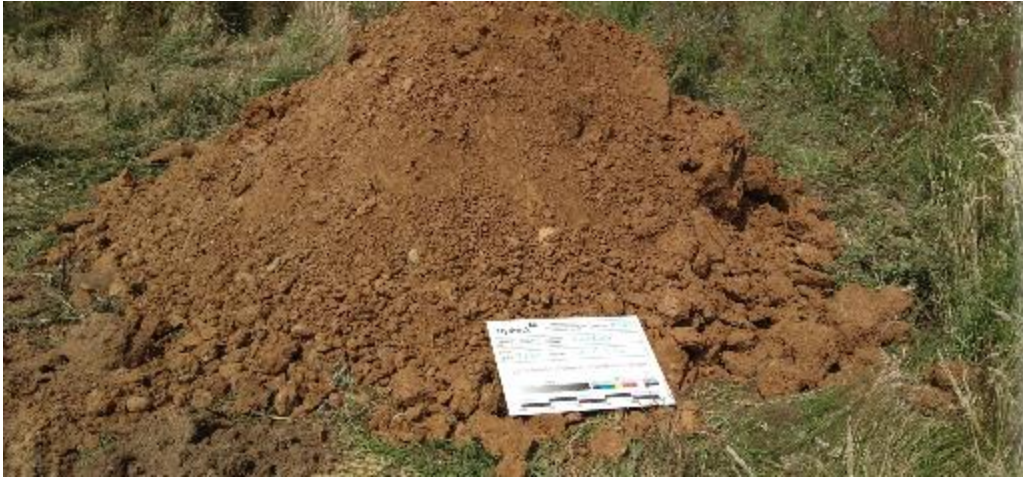
| <b>Site Investigation<br/>Photograph 26</b> | |

| <b>Description:</b> TP7.02<br>arisings. | |

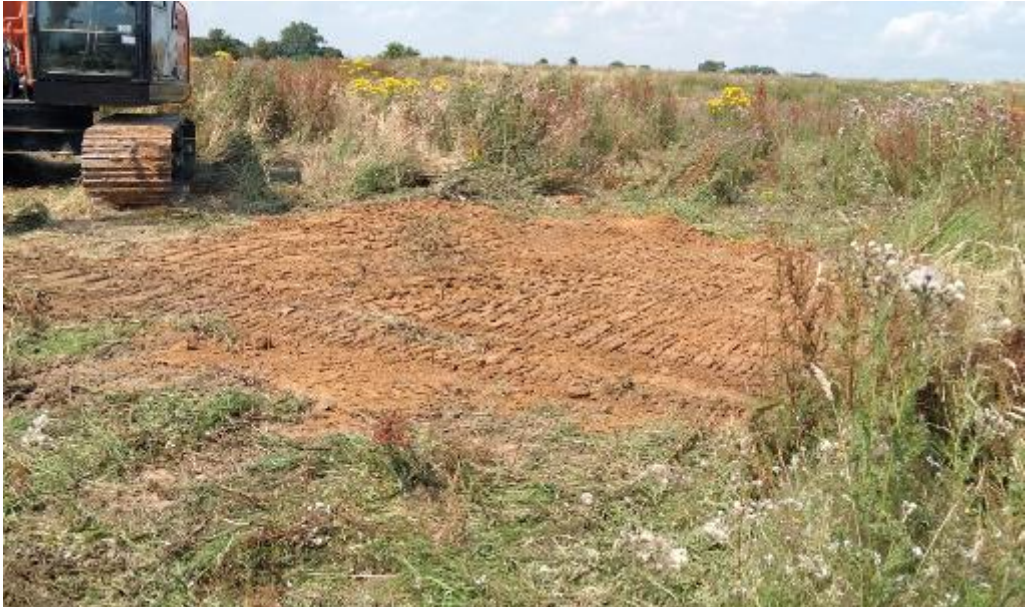
| <b>Site Investigation<br/>Photograph 27</b> | | |

| <b>Description:</b> TP7.02<br>backfilled with<br>arising after<br>completion of works. | | |

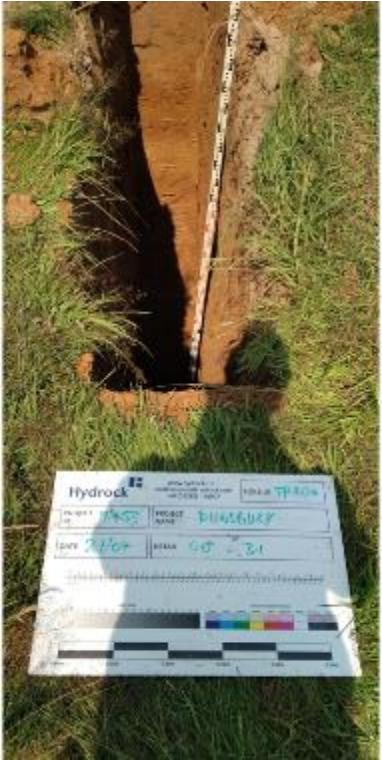
| <b>Site Investigation<br/>Photograph 28</b> | | |

| <b>Description:</b> TP7.04. | | |

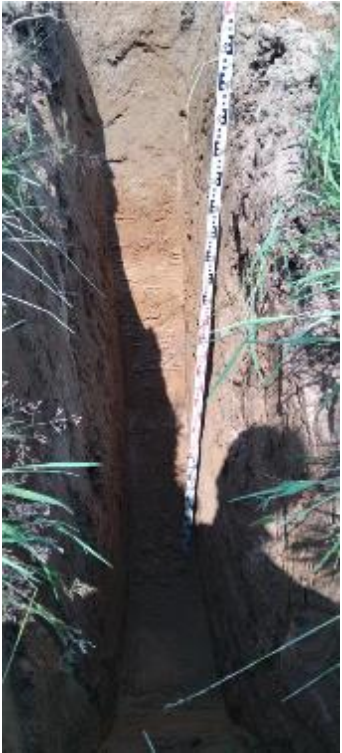
| <b>Site Investigation<br/>Photograph 29</b> | |

| <b>Description:</b> TP7.04<br>side walls. | |

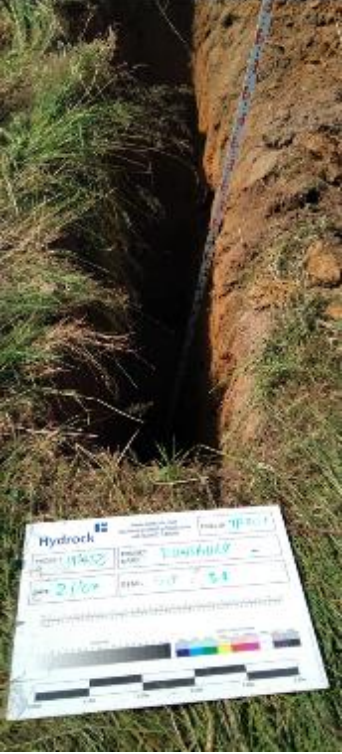
| <b>Site Investigation<br/>Photograph 30</b> | |

| <b>Description:</b> TP7.01. | |

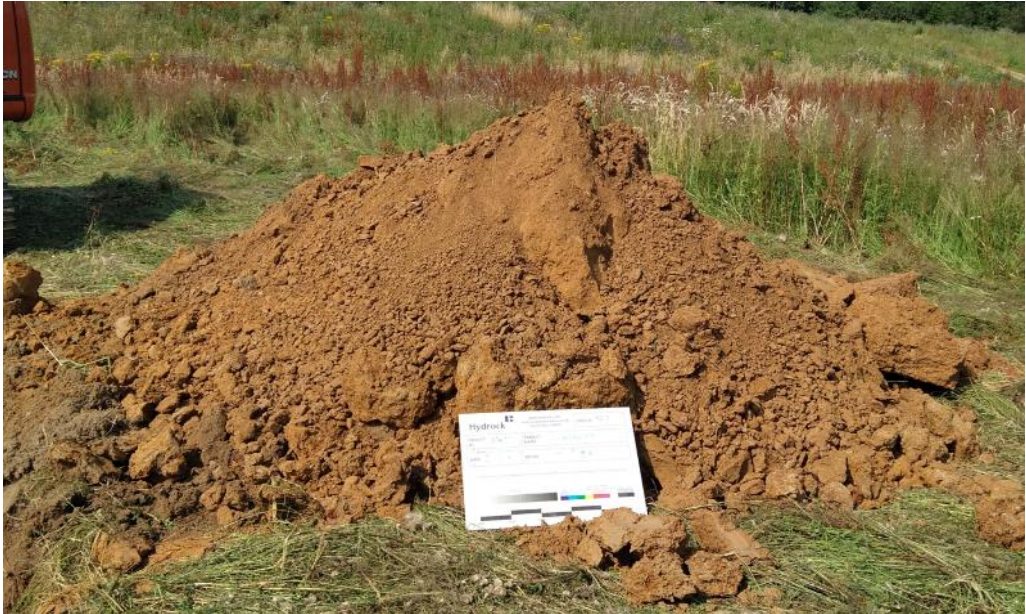
| <b>Site Investigation<br/>Photograph 31</b> | |

| <b>Description:</b> TP7.01<br>arisings. | |

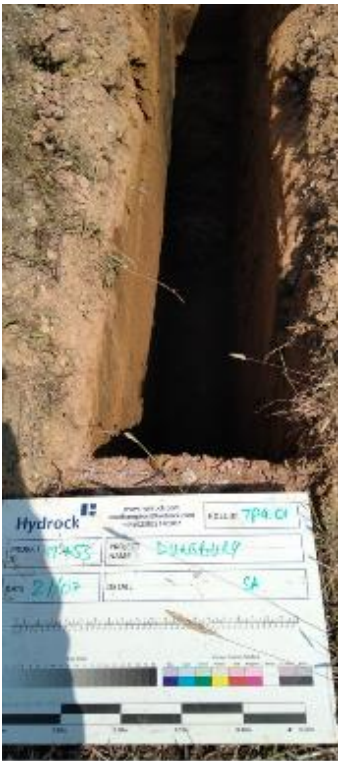
| <b>Site Investigation<br/>Photograph 32</b> | |

| <b>Description:</b> TP4.01. | |

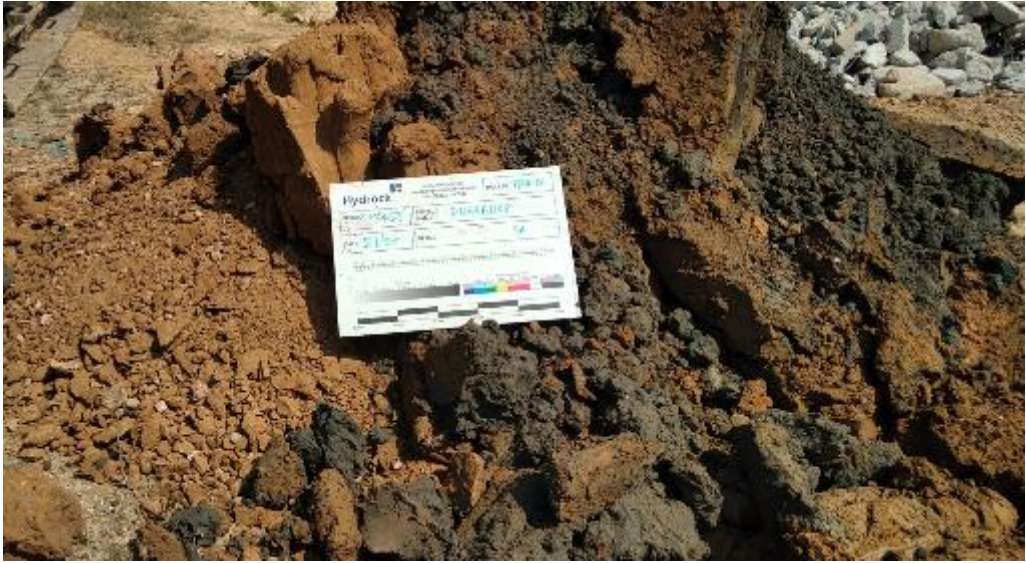
| <b>Site Investigation<br/>Photograph 33</b> | |

| <b>Description:</b> TP4.01 arisings. | |

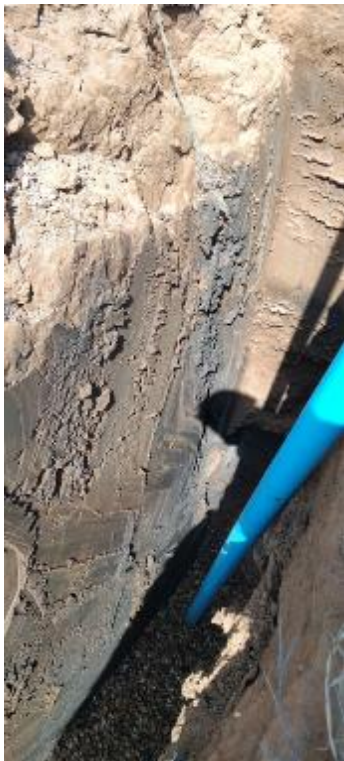
| <b>Site Investigation<br/>Photograph 34</b> | |

| <b>Description:</b> TP4.01 being backfilled with gravel and pipework for infiltration testing. | |

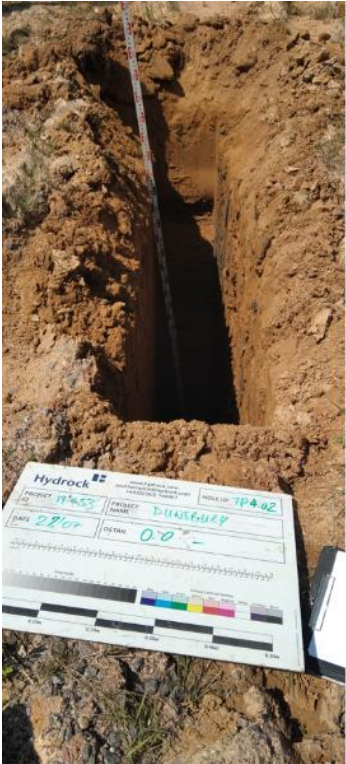
| <b>Site Investigation<br/>Photograph 35</b> | | |

| <b>Description:</b> TP4.02. | | |

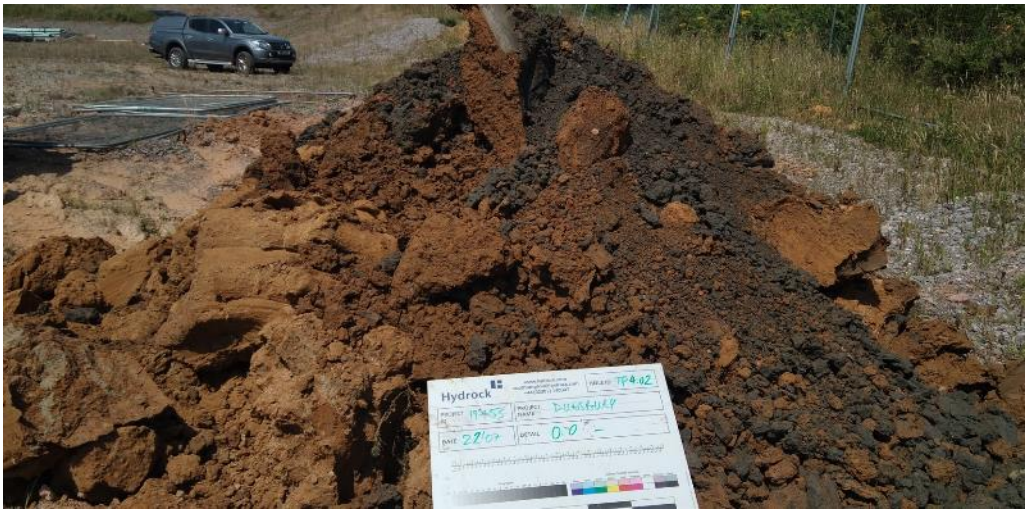
| <b>Site Investigation<br/>Photograph 36</b> | | |

| <b>Description:</b> TP4.02<br>arisings. | | |

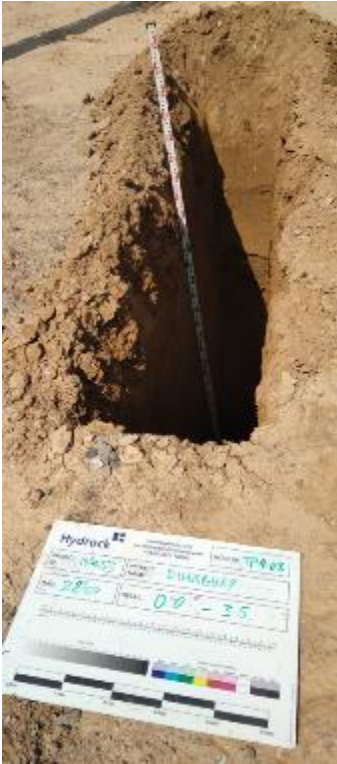
| Site Investigation<br>Photograph 37 | |

| Description: TP4.03. | |

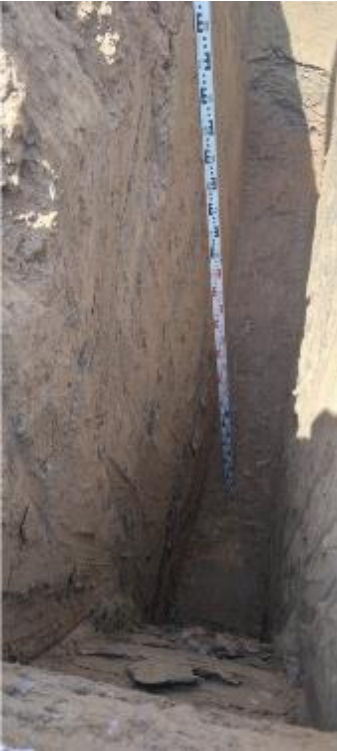
| Site Investigation<br>Photograph 38 | |

| Description: TP4.03<br>side walls. | |

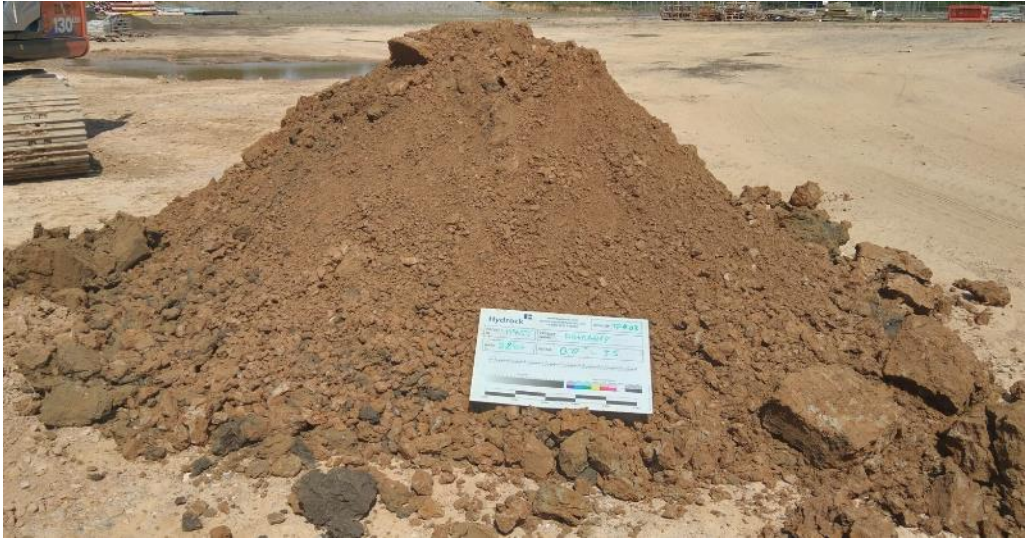
| <b>Site Investigation<br/>Photograph 39</b> | |

| <b>Description:</b> TP4.03 arisings. | |
