**Stantec UK Limited**

## **Appendix C Exploratory Hole Location Plan, Exploratory Hole Logs and Photographs**

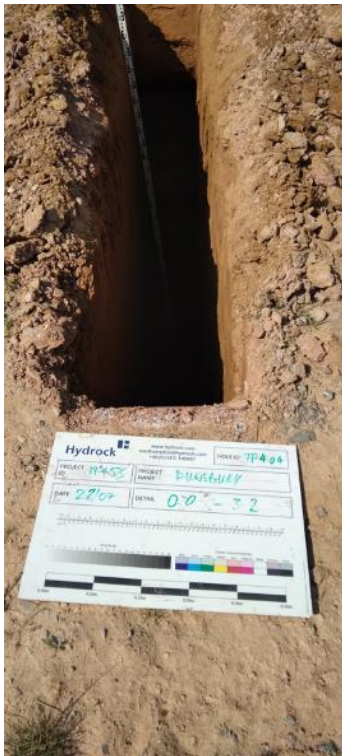
| <b>Site Investigation<br/>Photograph 40</b> | |

| <b>Description:</b> TP4.04. | |

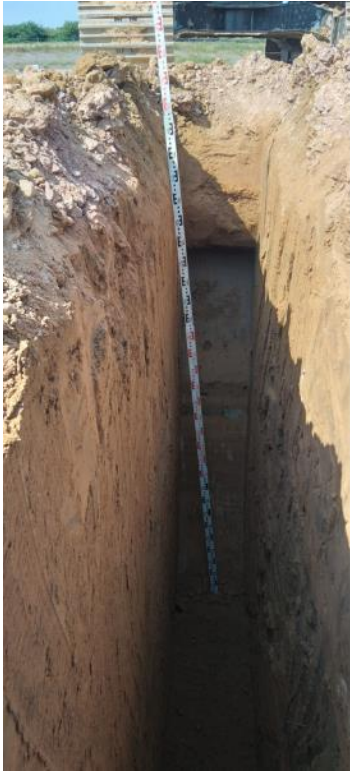
| <b>Site Investigation<br/>Photograph 41</b> | |

| <b>Description:</b> TP4.03<br>side walls. | |

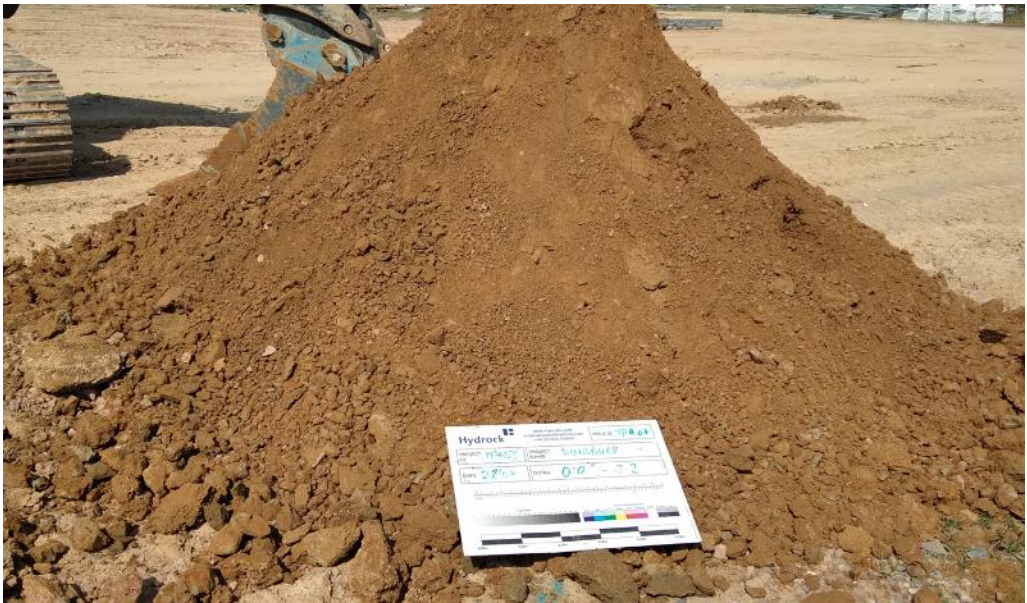
| <b>Site Investigation<br/>Photograph 42</b> | |

| <b>Description:</b> TP4.04<br>arisings. | |

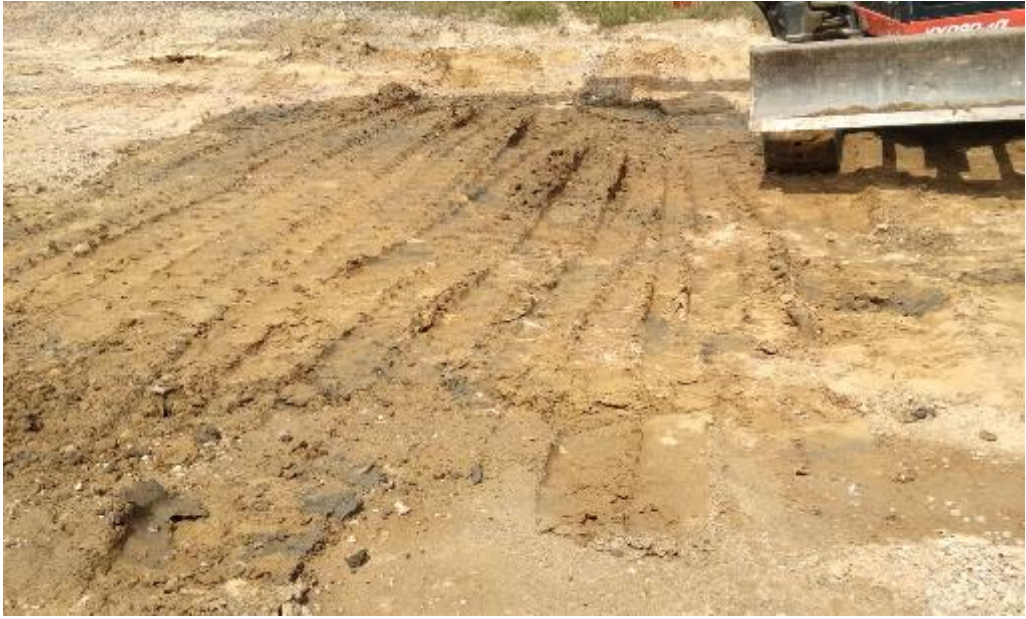
| <b>Site Investigation<br/>Photograph 43</b> | |

| <b>Description:</b> TP4.05<br>backfilled with<br>arisings after<br>completion of works. | |

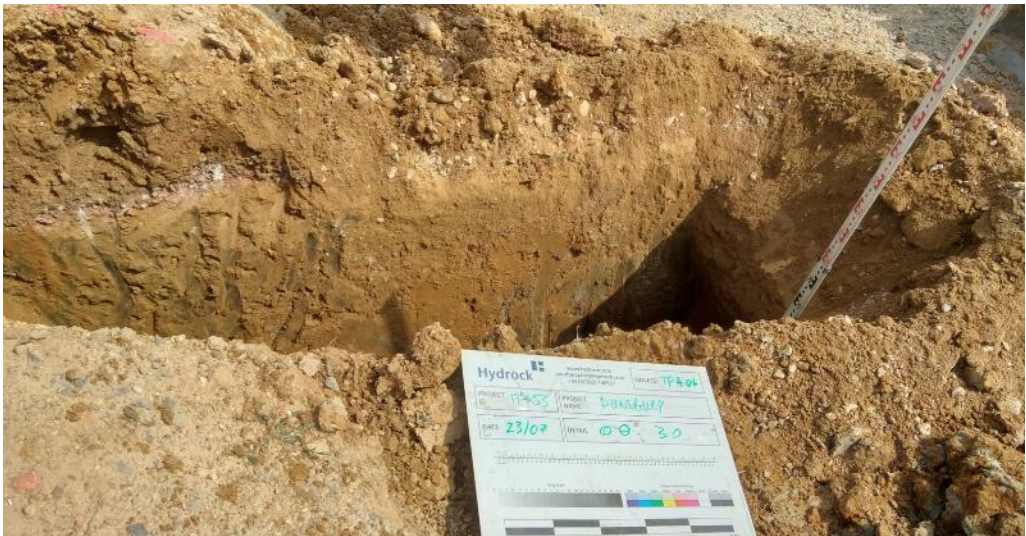
| <b>Site Investigation<br/>Photograph 44</b> | |

| <b>Description:</b> TP4.06. | |

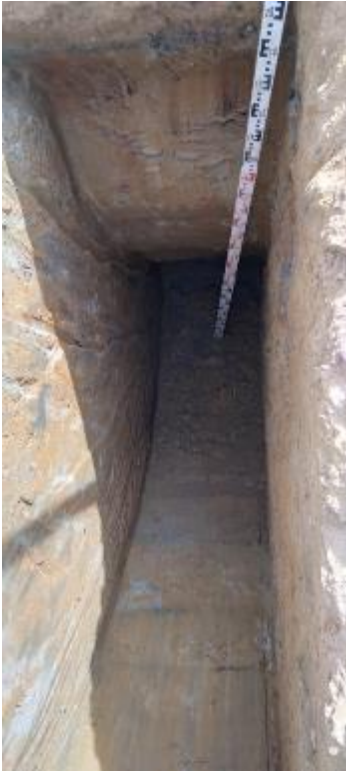
| <b>Site Investigation<br/>Photograph 45</b> | |

| <b>Description:</b> TP4.06<br>side walls. | |

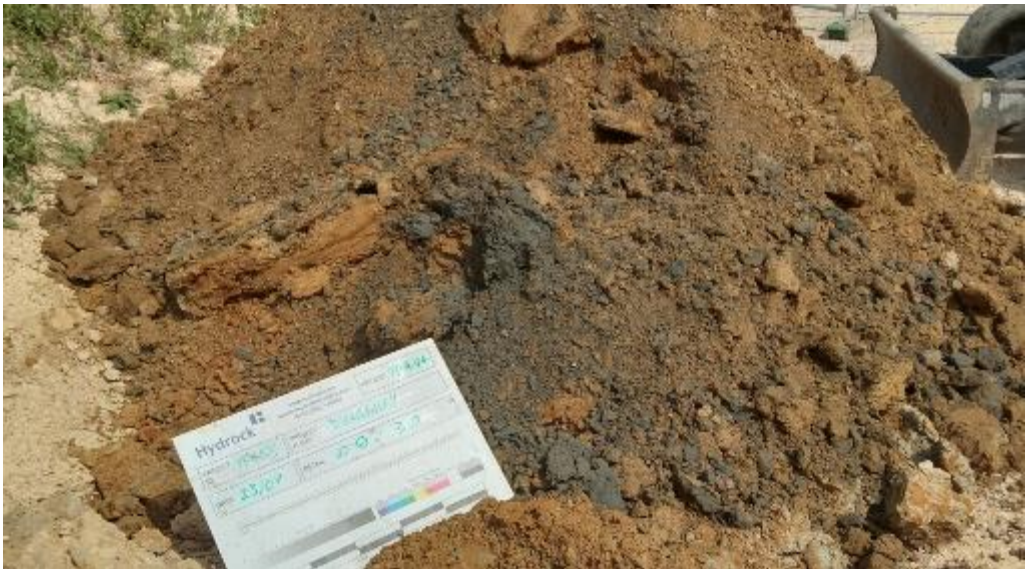
| <b>Site Investigation<br/>Photograph 46</b> | |

| <b>Description:</b> TP4.06<br>arisings. | |

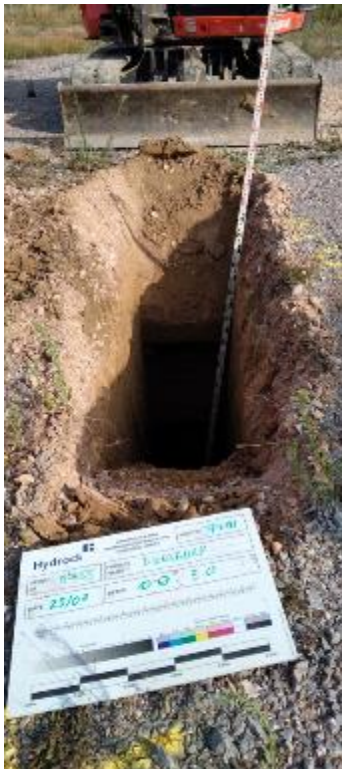
| <b>Site Investigation<br/>Photograph 47</b> | |

| <b>Description:</b> TP1.01. | |

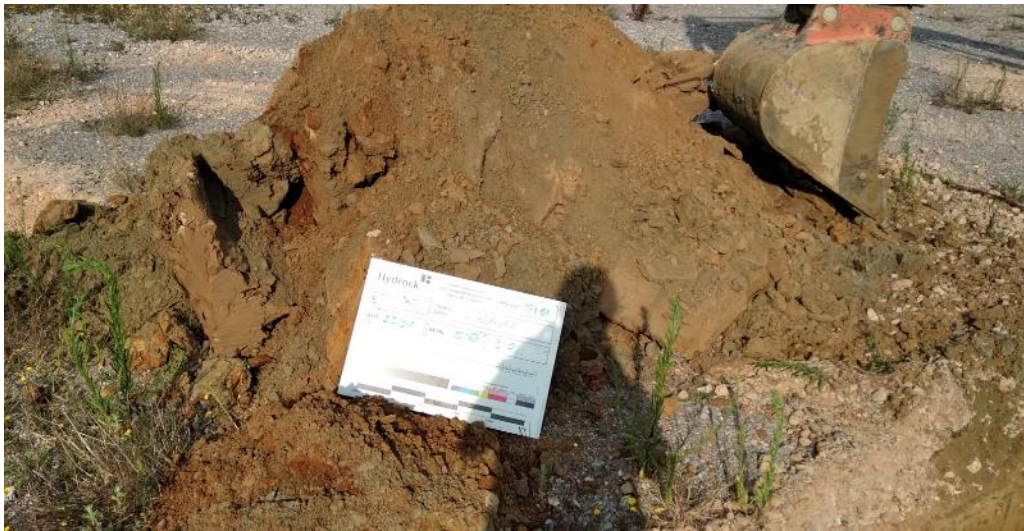
| <b>Site Investigation<br/>Photograph 48</b> | |

| <b>Description:</b> TP1.01<br>arisings. | |

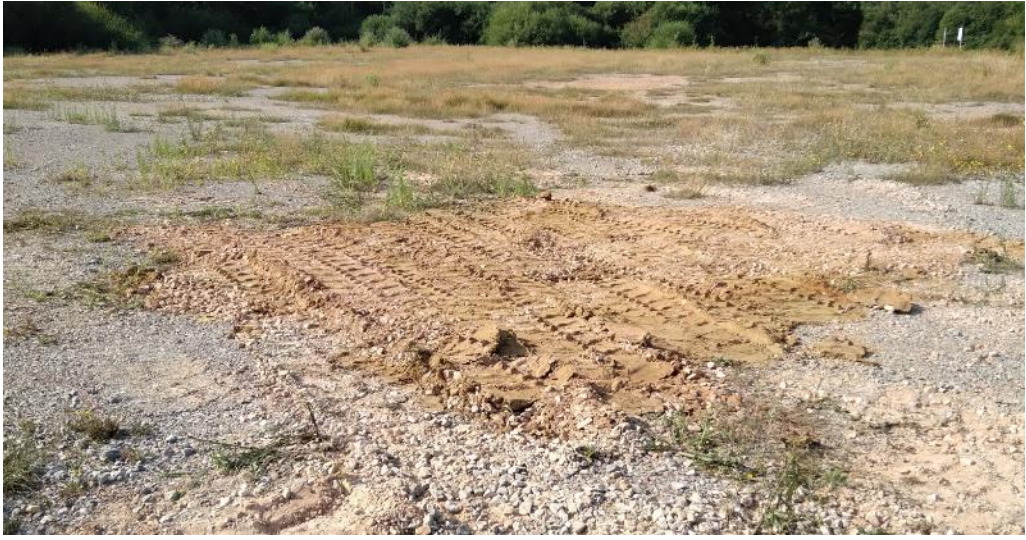
| <b>Site Investigation<br/>Photograph 49</b> | | |

| <b>Description:</b> TP1.01<br>backfilled with<br>arising after<br>completion of works. | | |

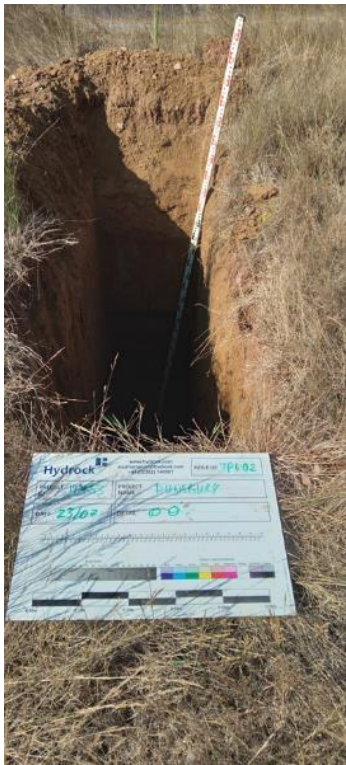
| <b>Site Investigation<br/>Photograph 50</b> | | |

| <b>Description:</b> TP1.02. | | |

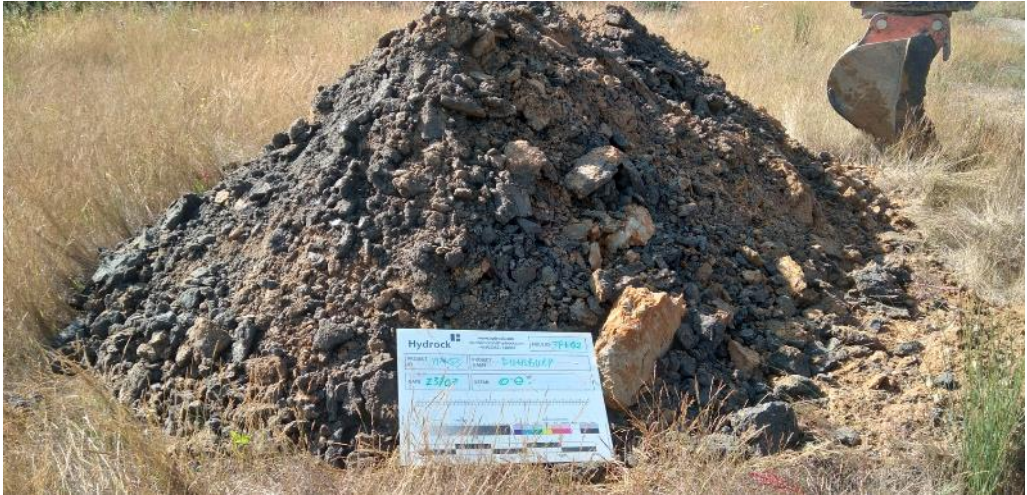
| <b>Site Investigation<br/>Photograph 51</b> | |

| <b>Description:</b> TP1.02<br>arisings. | |

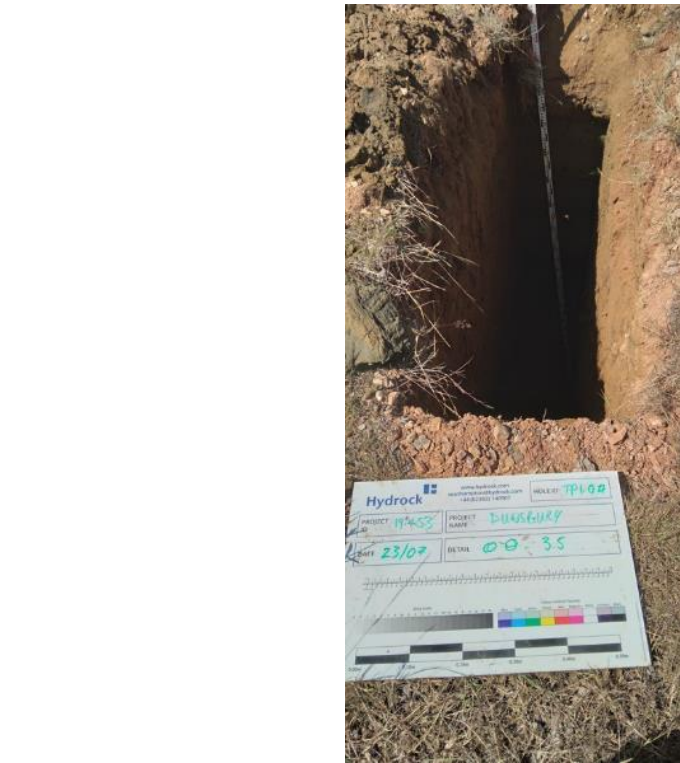
| <b>Site Investigation<br/>Photograph 52</b> | |

| <b>Description:</b> TP1.04. | |

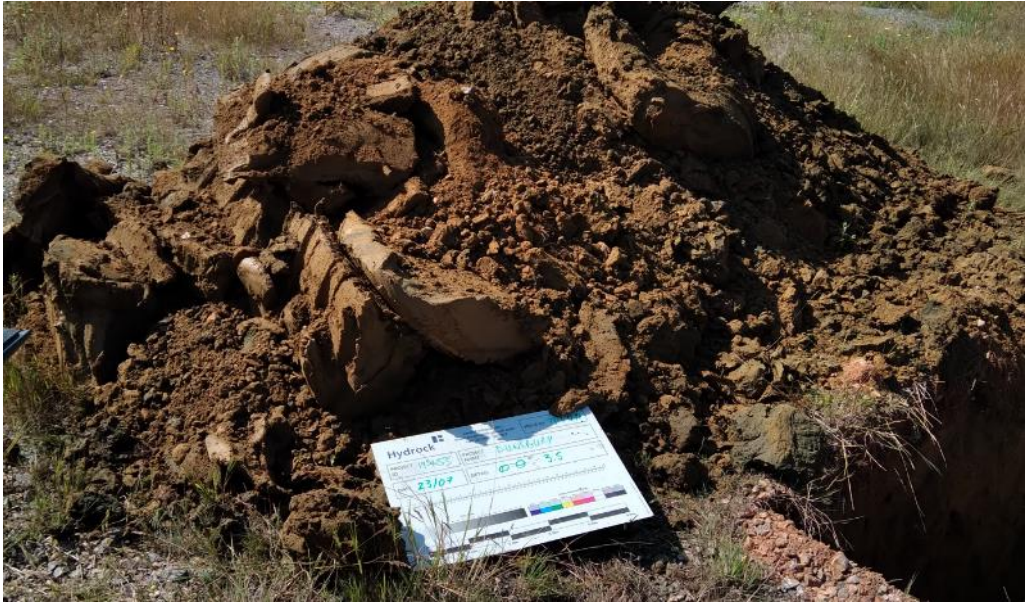
| <b>Site Investigation<br/>Photograph 53</b> | |

| <b>Description:</b> TP1.04 arisings. | |

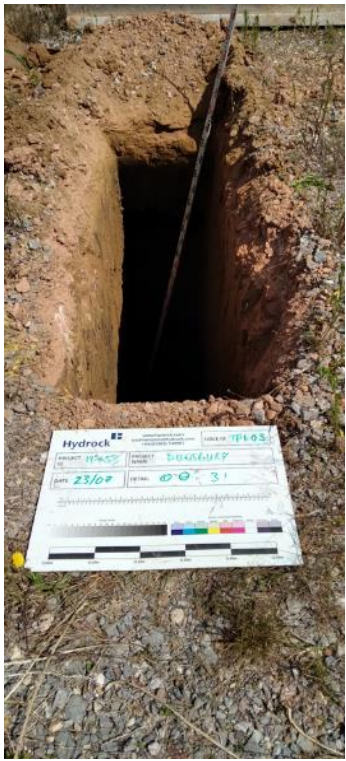
| <b>Site Investigation<br/>Photograph 54</b> | |

| <b>Description:</b> TP1.03. | |

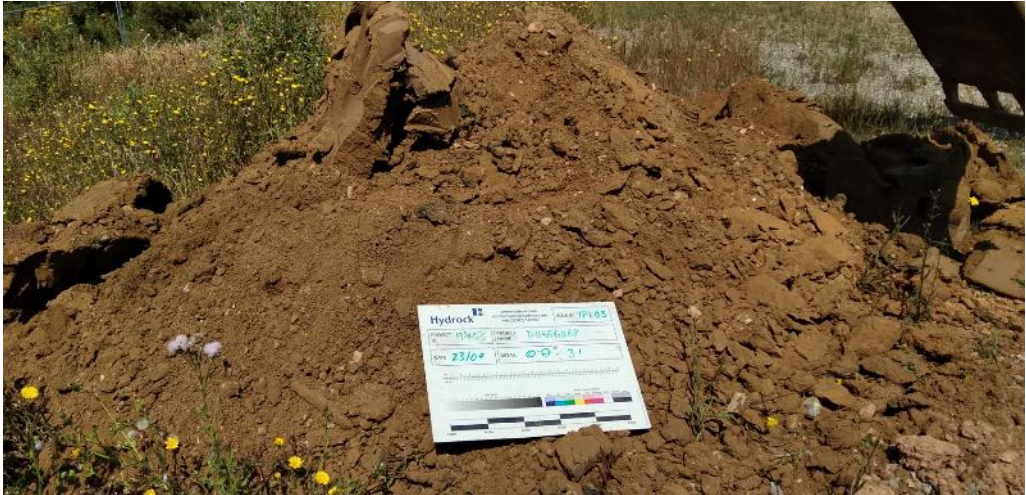
| <b>Site Investigation<br/>Photograph 55</b> | | |

| <b>Description:</b> TP1.03 arisings. | | |

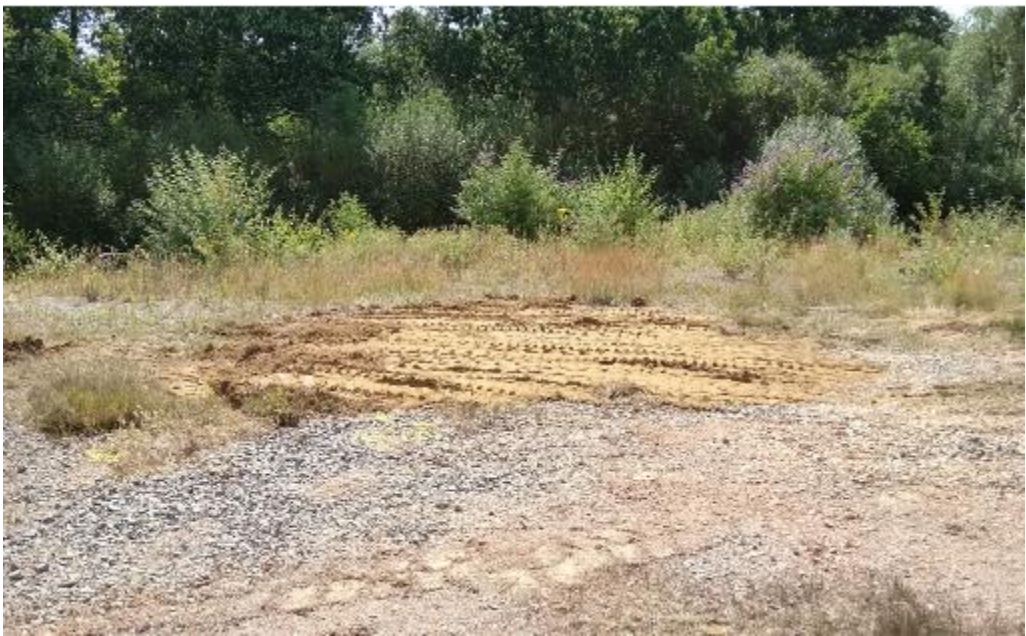
| <b>Site Investigation<br/>Photograph 56</b> | | |

| <b>Description:</b> TP1.03 backfilled with arisings after completion of works. | | |
