8<sup>th</sup> May 2026

## **13885 – Havant Phase 3A: - Engineers Response to planning condition 29**

**Proposal:** Existing Sewer Conditions

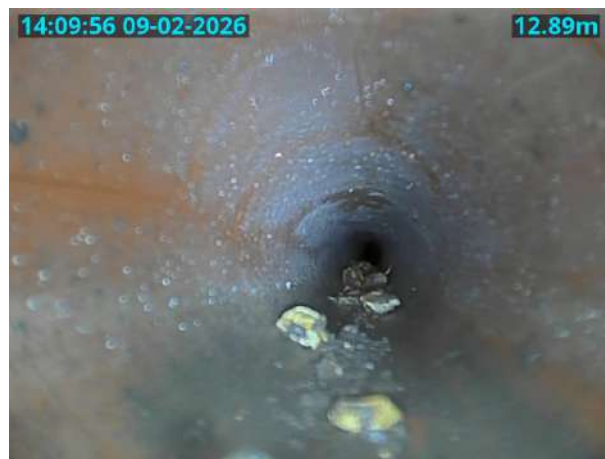
12AX\_U\_09022026\_1411\_024.jpg, 00:01:09, 10.88 m  
Hole in drain or sewer from 1 o'clock to 3 o'clock

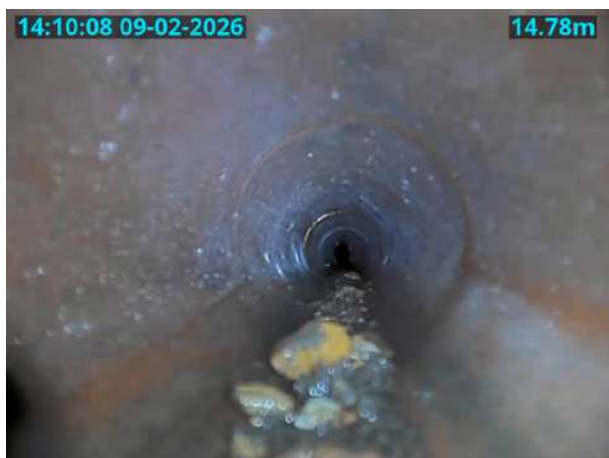
12AX\_U\_09022026\_1411\_026.jpg, 00:01:31, 14.78 m  
Fracture, circumferential from 7 o'clock to 5 o'clock

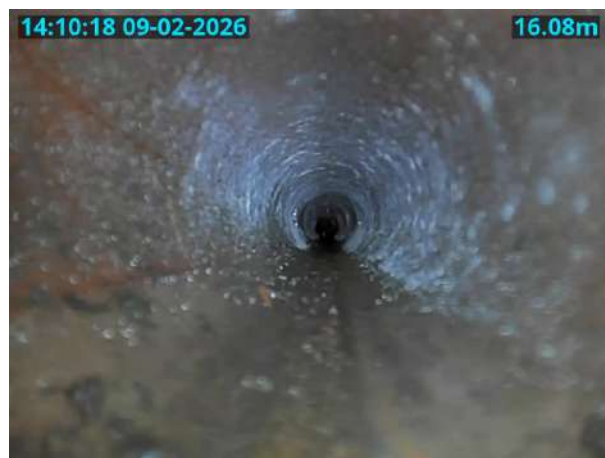
12AX\_U\_09022026\_1411\_027.jpg, 00:01:41, 16.08 m  
Fracture, longitudinal at 10 o'clock

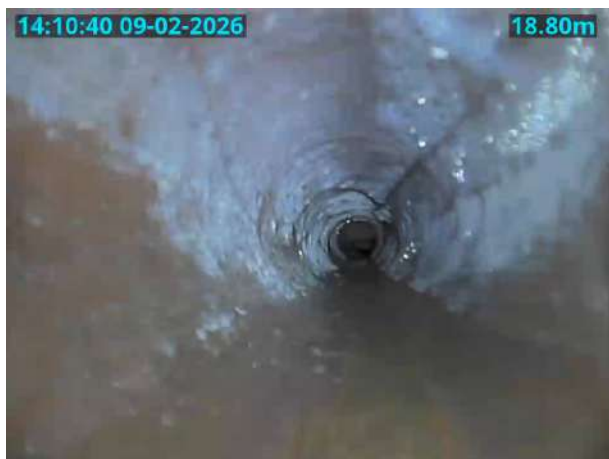
12AX\_U\_09022026\_1411\_028.jpg, 00:02:03, 18.80 m  
Fracture, longitudinal at 10 o'clock

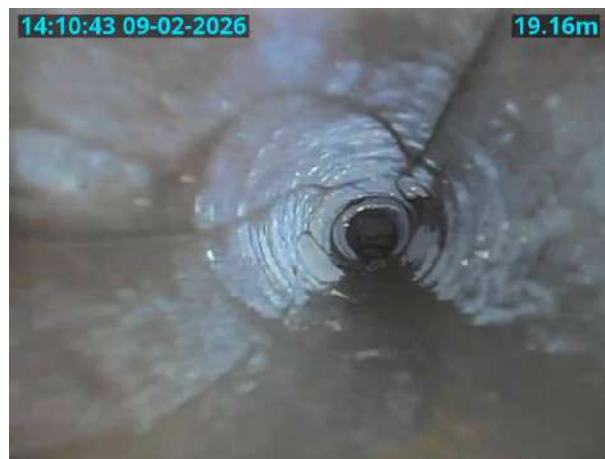
12AX\_U\_09022026\_1411\_029.jpg, 00:02:06, 19.16 m  
Fractures, multiple from 12 o'clock to 12 o'clock

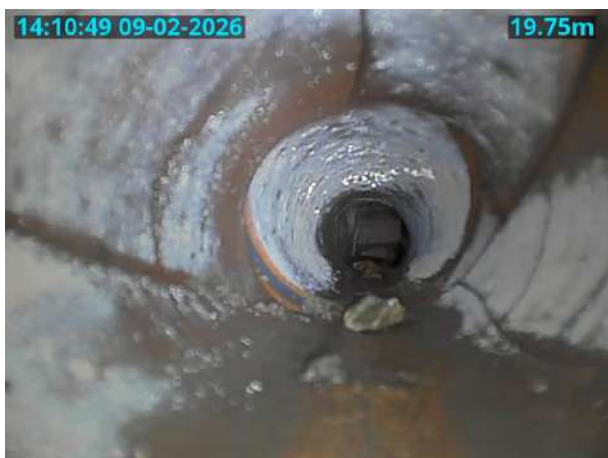
12AX\_U\_09022026\_1411\_030.jpg, 00:02:12, 19.75 m  
Broken pipe from 2 o'clock to 8 o'clock

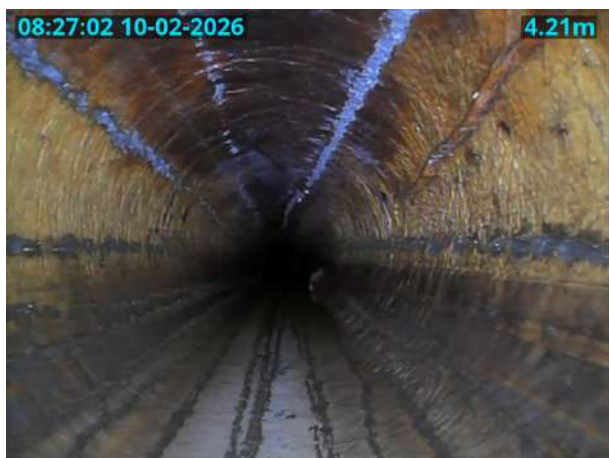
MH19X\_U\_10022026\_0831\_098.jpg, 00:00:48, 4.21 m  
Defective lining, wrinkled (longitudinal) at 2 o'clock

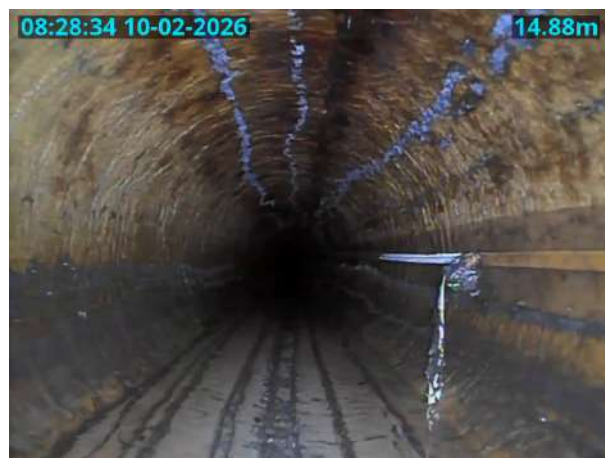
MH19X\_U\_10022026\_0831\_099.jpg, 00:02:20, 14.88 m  
Defective lining, separated seam cover at 4 o'clock

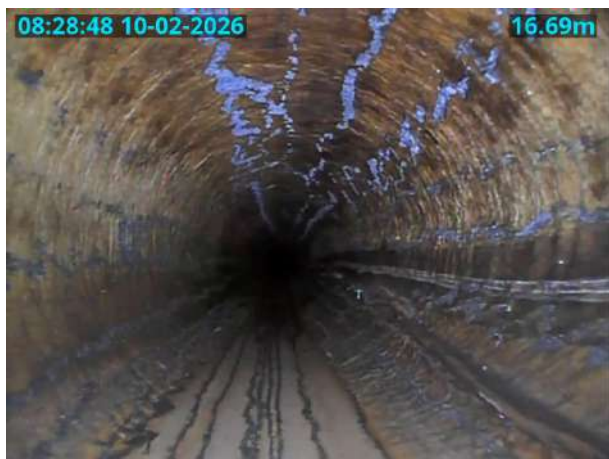
MH19X\_U\_10022026\_0831\_100.jpg, 00:02:34, 16.69 m  
Defective lining, wrinkled (longitudinal) at 5 o'clock

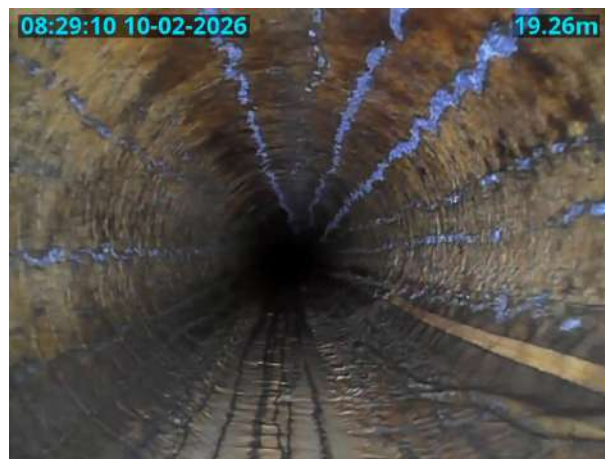
MH19X\_U\_10022026\_0831\_101.jpg, 00:02:55, 19.26 m  
Defective lining, separated seam cover at 4 o'clock

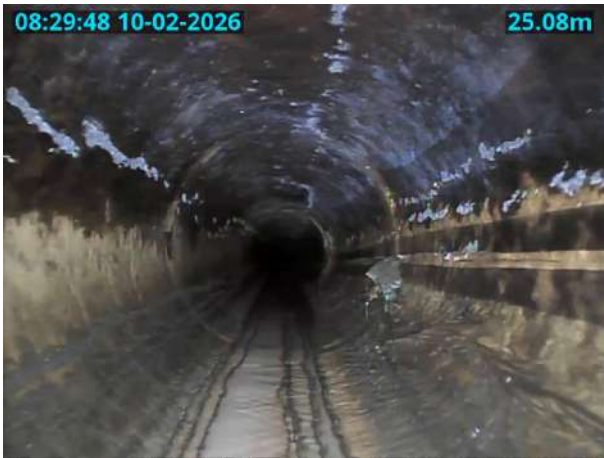
MH19X\_U\_10022026\_0831\_102.jpg, 00:03:34, 25.08 m  
Defective lining, wrinkled (longitudinal) at 4 o'clock

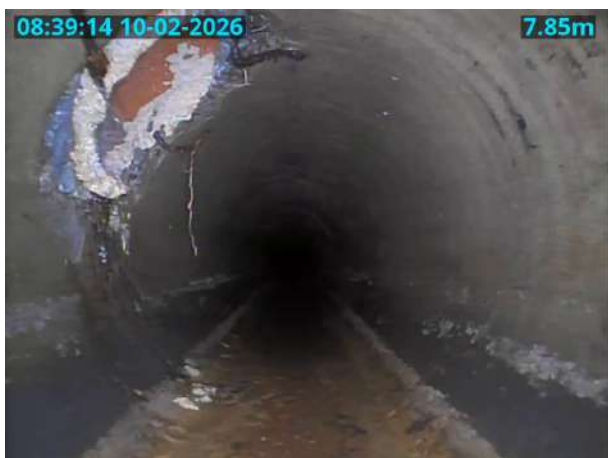
MH17X\_D\_10022026\_0844\_035.jpg, 00:01:03, 7.85 m  
Connection defective, connecting pipe is intruding at 10 o'clock, 100mm dia, intrusion: 10%

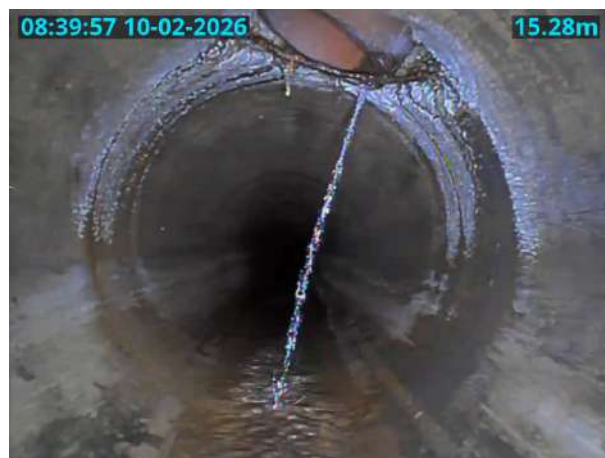
MH17X\_D\_10022026\_0844\_036.jpg, 00:01:46, 15.28 m  
Connection defective, connecting pipe is intruding at 1 o'clock, 100mm dia, intrusion: 10%, Live

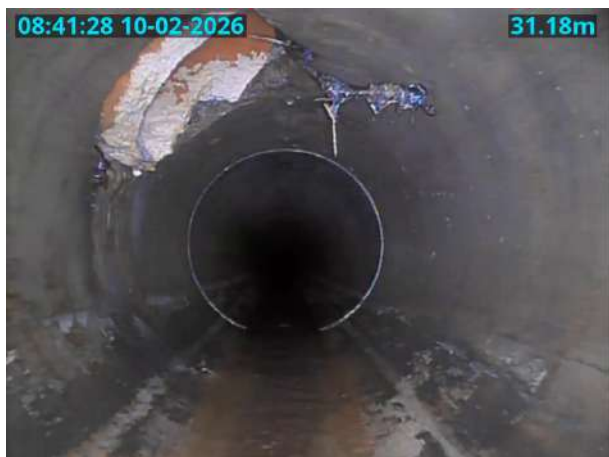
MH17X\_D\_10022026\_0844\_037.jpg, 00:03:17, 31.18 m  
Connection defective, connecting pipe is intruding at 10 o'clock, 100mm dia, intrusion: 10%

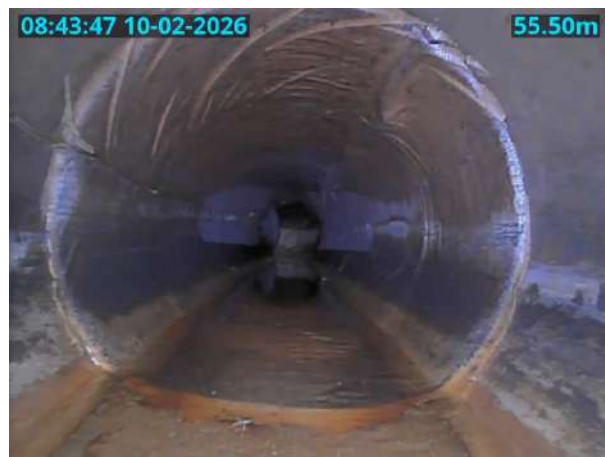
MH17X\_D\_10022026\_0844\_038.jpg, 00:05:36, 55.50 m  
Point repair, localised lining from 12 o'clock to 12 o'clock

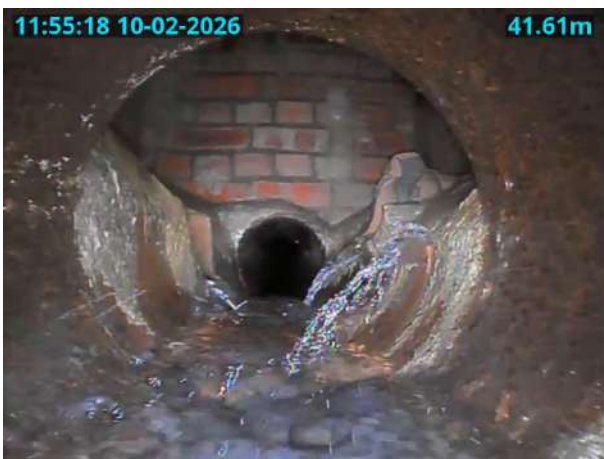
MH10X\_U\_10022026\_1155\_050.jpg, 00:05:22, 41.61 m  
General remark, Heavy infiltraton from MH

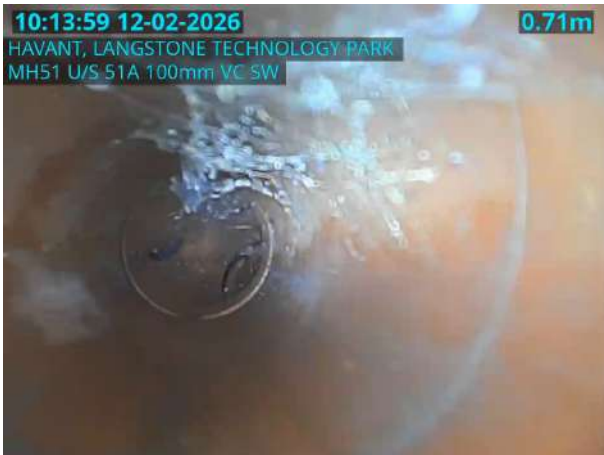
51AX\_eb801b17-7a63-42b0-9ec3-c69d9da7f15c\_20260223\_1  
24831\_738.jpg, 00:00:09, 0.71 m  
Crack, circumferential from 2 o'clock to 5 o'clock

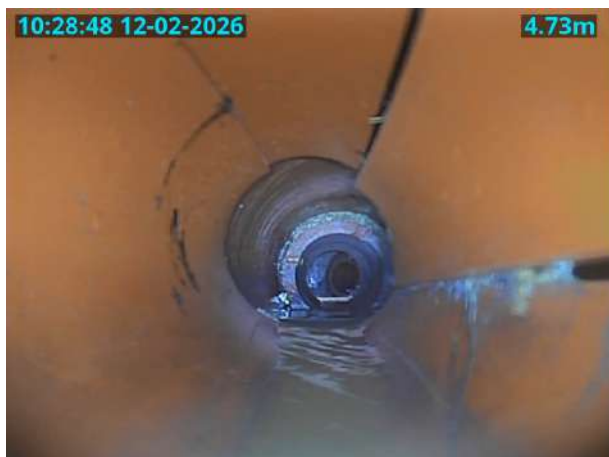
MH54X\_98b183b6-1514-4a1d-be7d-1fe61282fcc6\_20260223\_125738\_012.jpg, 00:01:17, 4.73 m  
Defective repair, other from 12 o'clock to 12 o'clock, PIPE JOINING DEFECTIVE

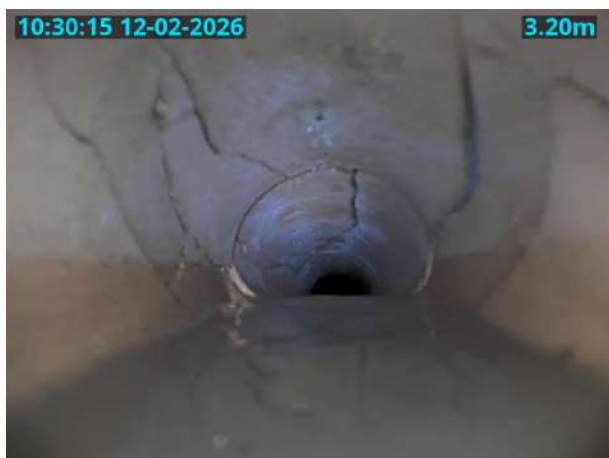
MH53X\_5374aaaf-4b5d-4cd3-a655-1d9ca2669697\_20260223\_133317\_973.jpg, 00:00:17, 3.20 m  
Fractures, multiple from 12 o'clock to 12 o'clock

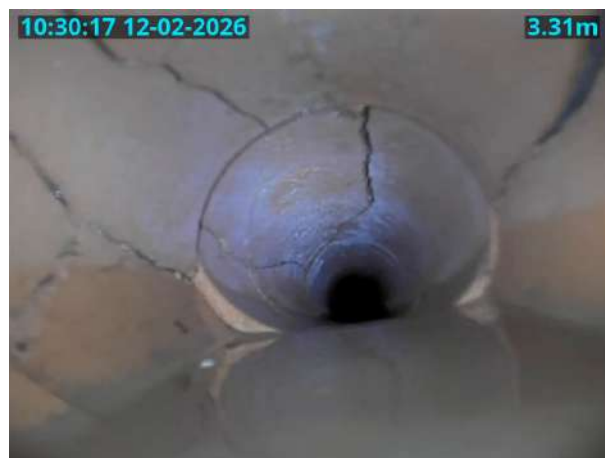
MH53X\_8e46ed57-625e-4987-9bd9-86e2f09b960e\_20260223\_133332\_225.jpg, 00:00:19, 3.31 m  
Joint displaced, large

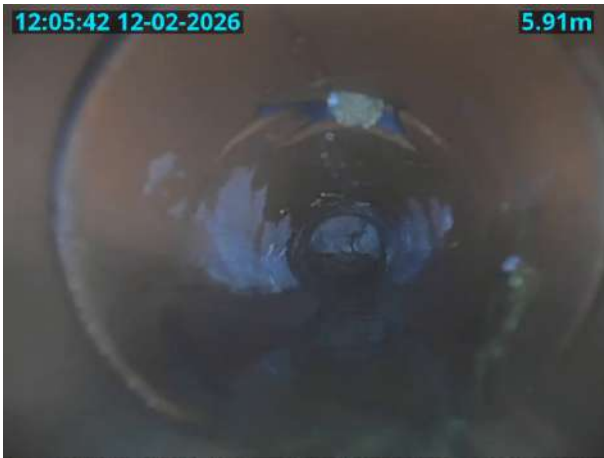
65AX\_b0ba8ba5-bb55-4c29-a4eb-2899b26edf05\_20260223\_134718\_267.jpg, 00:00:41, 5.91 m  
Broken pipe at 12 o'clock

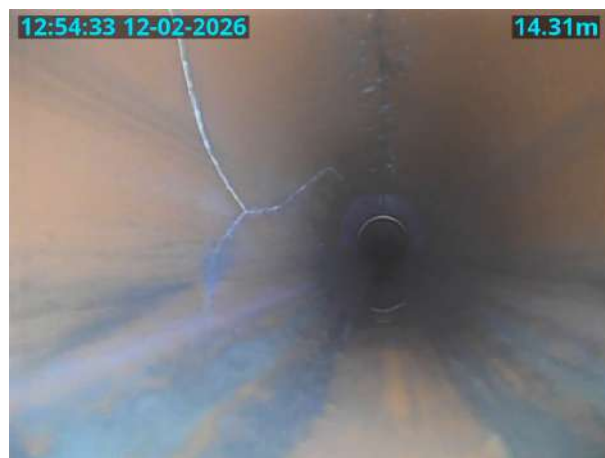
MH72X\_5f7bf511-1f5d-40f5-87d9-1c871739e7cf\_20260223\_141551\_135.jpg, 00:01:25, 14.31 m  
Crack, longitudinal at 9 o'clock

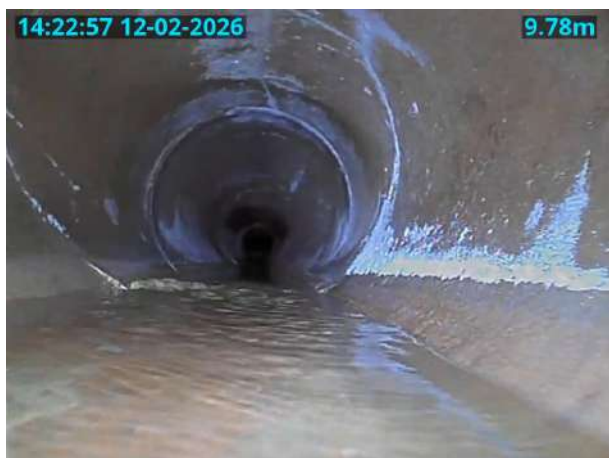
MH77X\_862cbb0e-d4d0-42e5-bf4e-b5bfd886099d\_20260223\_152521\_276.jpg, 00:01:46, 9.78 m  
Cracks, multiple from 12 o'clock to 12 o'clock

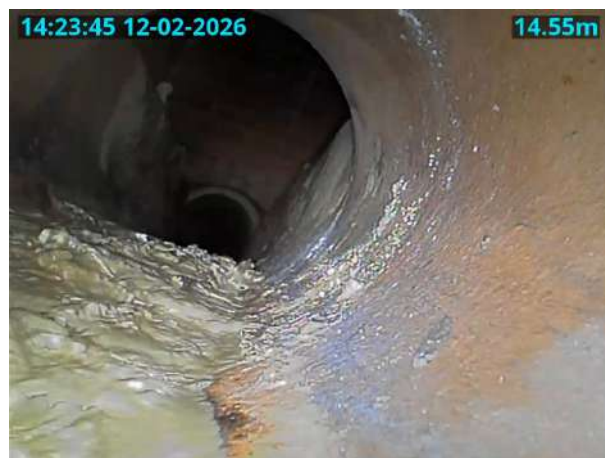
MH77X\_8bdec740-7ab5-4919-9999-e70e024a8245\_20260223\_152625\_484.jpg, 00:02:34, 14.55 m  
Settled deposits, fine, 15% cross-sectional area loss, DEBRIS BUILD UP IN MANHOLE
