# Tree Condition Survey Report (VTA)

**Site:** Sinah Warren Hotel, Ferry Road, Hayling Island, Hants,  
PO11 0BZ

**Client:** Warner Hotels

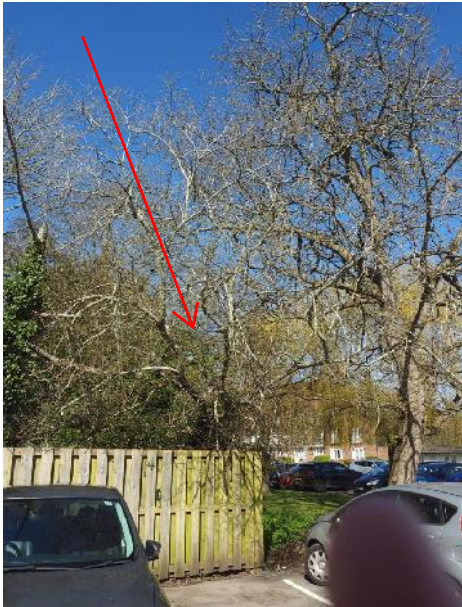
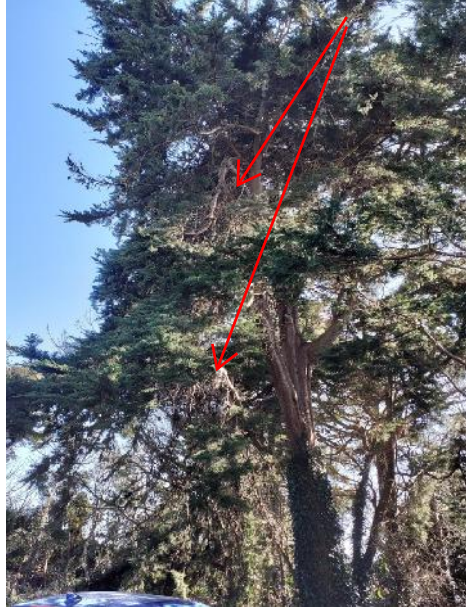
| Tree ID | Common Name Tree | Work Task | Work Priority | Description and Ecological notes | Tag No |
|---|---|---|---|---|---|
| Group 24 | Leyland cypress | Remove Broken/Hanging Branch | Within 1 - 3 Months | Clear 2 broken and hanging branches from Cypress at approximately 5m and 10m from ground level. One overhangs the car park and the other the grass verge. Cypress is located next to the check in shed in the car park. | |

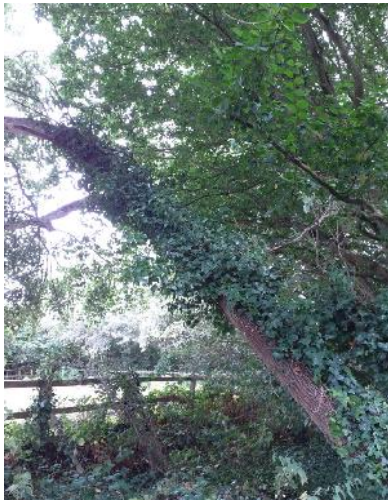
T4

| Tree Survey Schedule | | | | | | | | | | | | | | | | | | |
|---|---|---|---|---|---|---|---|---|---|---|---|---|---|---|---|---|---|---|
| 4 | 6690 | Common aspen | Populus tremula | 16-20m | 385 | Mature | Good | Fair | Significant lean over new entrance road currently being constructed. Root plate subsidence. | None Significant | Ivy Covered Stem, Leaning Stem - Major | Major Dead Wood Over 50mm Diameter | None Observed | None Observed | Informal Road, Inaccessible woodland | Medium | No access to base/stem | Client |

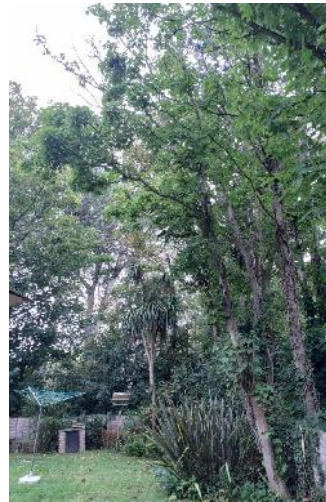
T9

| Tree Survey Schedule | | | | | | | | | | | | | | | | | | |
|---|---|---|---|---|---|---|---|---|---|---|---|---|---|---|---|---|---|---|
| 9 | | Sycamore | Acer pseudoplatanus | 5-10m | 250 | Mature | Fair | Good | | None Significant | None Significant | Dieback | None Observed | None Observed | Building | High | Good | Client |

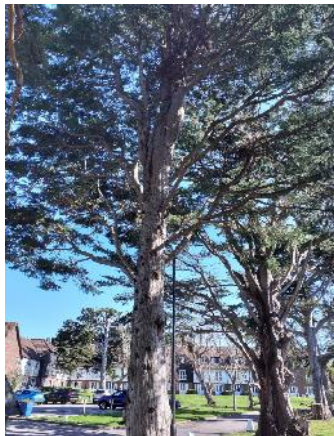
T120

| Tree ID | Common Name Tree | Work Task | Work Priority | Description and Ecological notes | Tag No |
|---|---|---|---|---|---|
| 120 | Monterey cypress | Remove Broken/Hanging Branch | Within 1 - 3 Months | Branch is overhanging the grass verge in upper crown. Tree located on grass verge next to footpath/road | 4401 |
