**GREEN MAN**

## **Arboricultural Report**

**6 The Thicket, Widley, Waterlooville, PO7 5JL**

**01/06/2026**

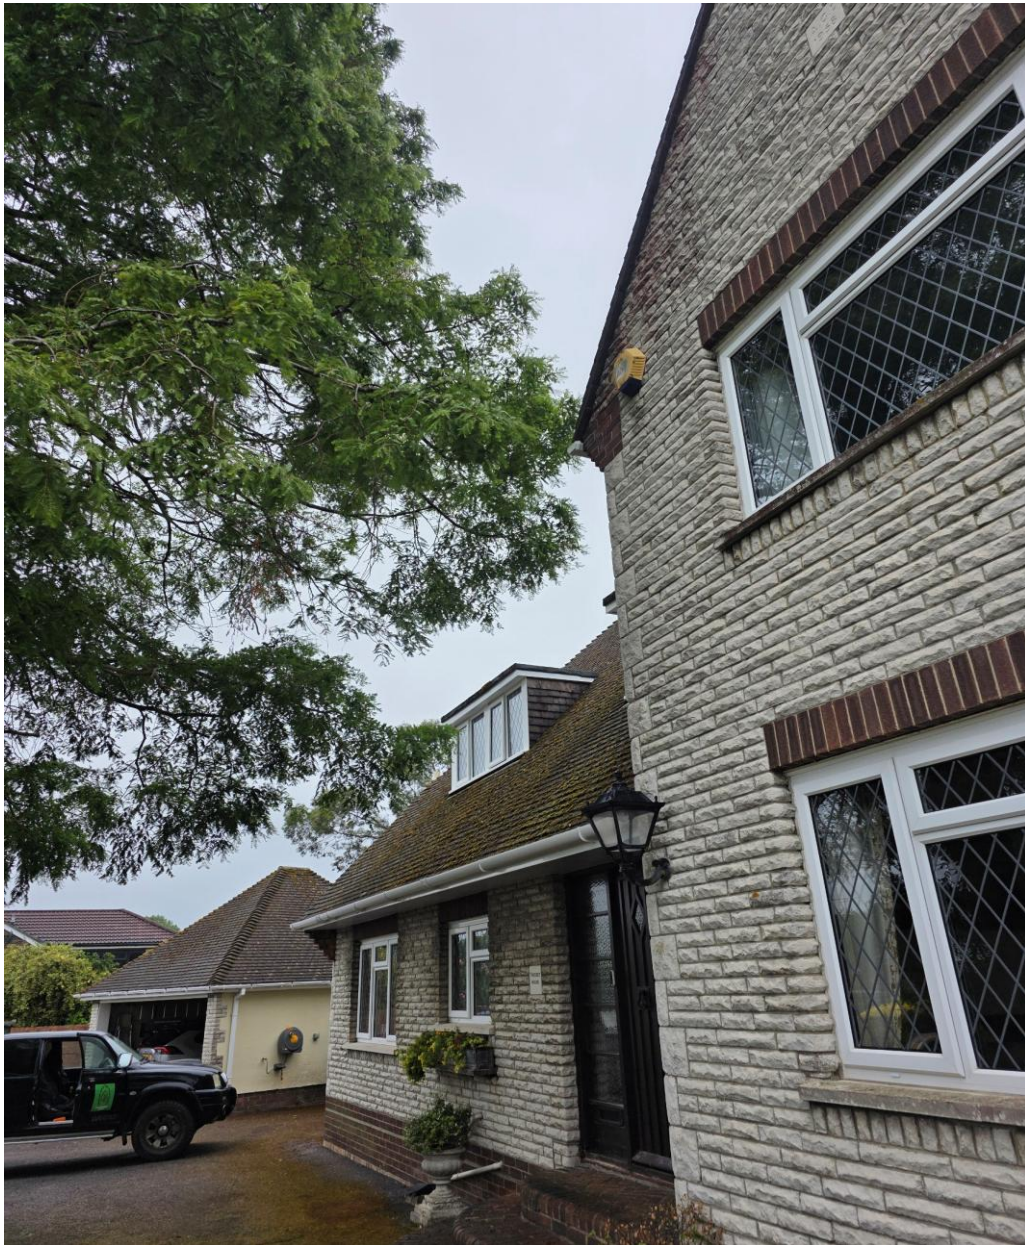
**T001 P01**

**Branch rubbing on roof**

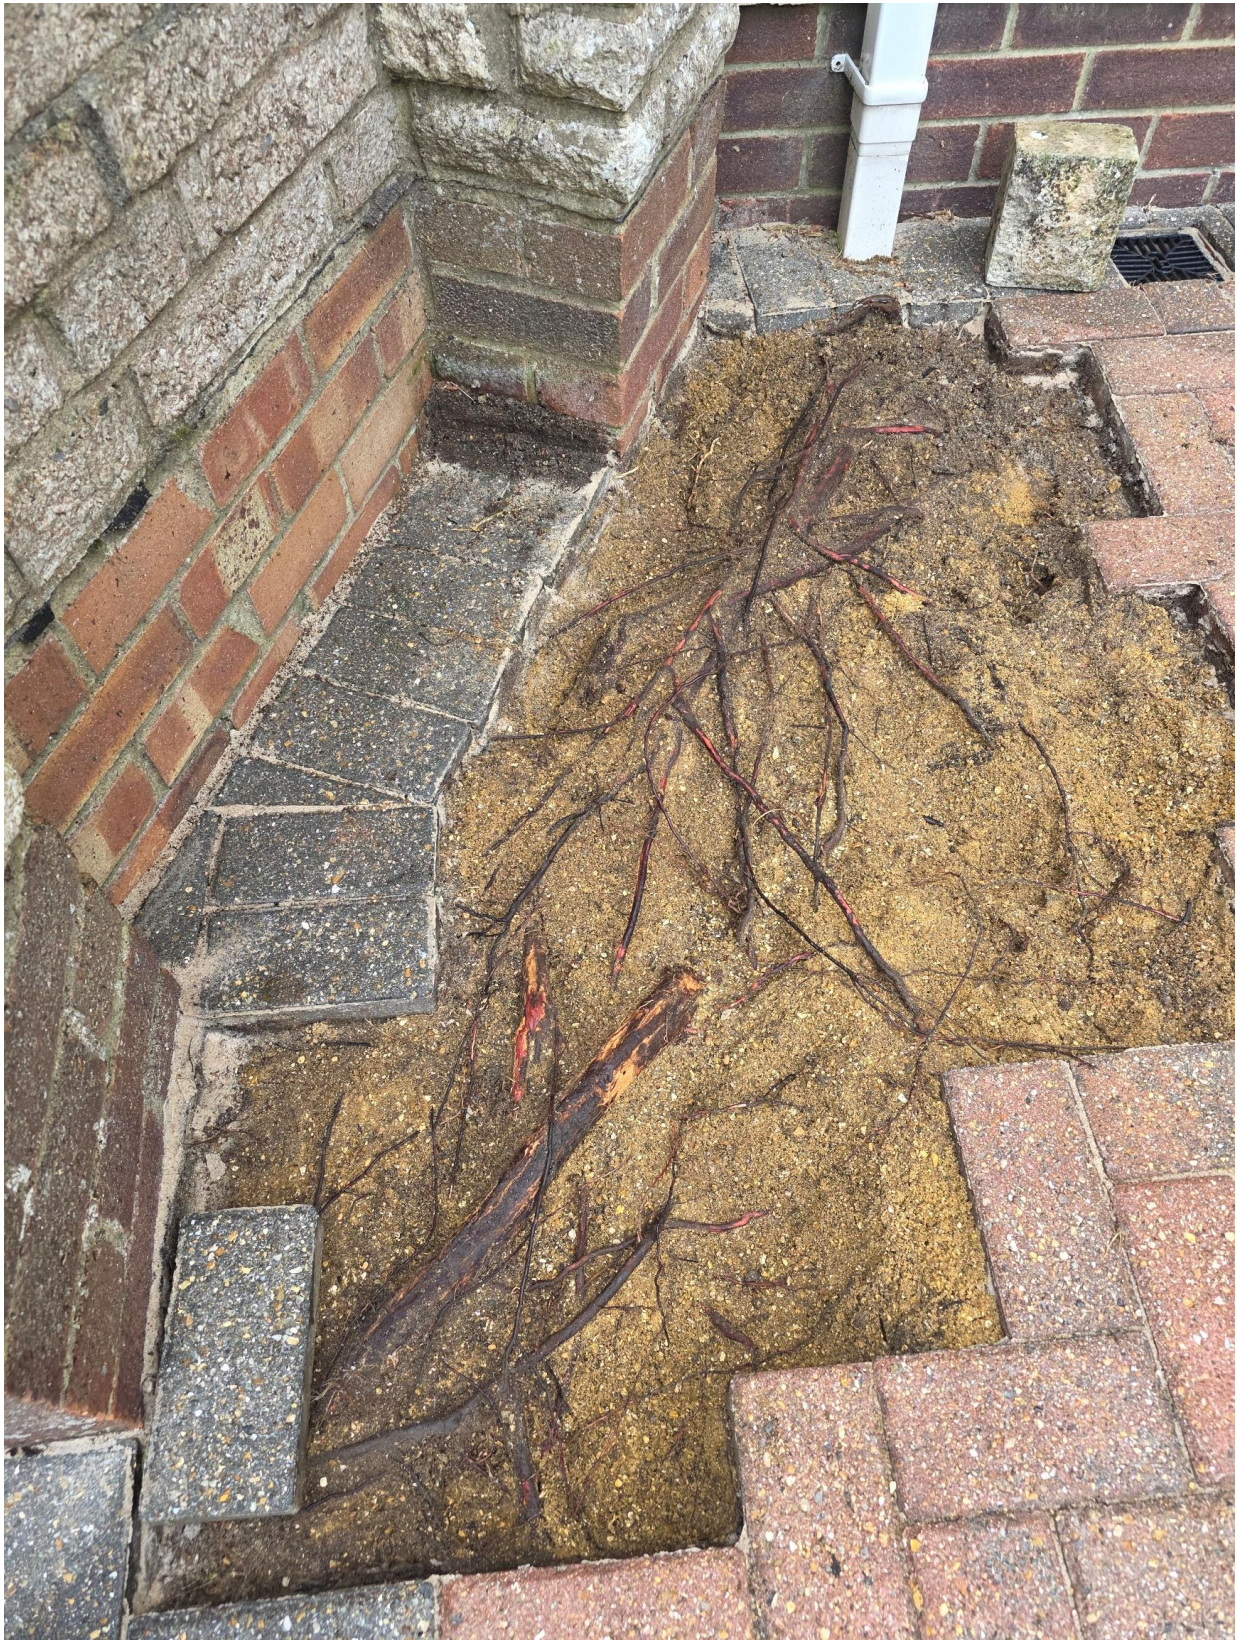
**T001 P02**

**Exposed Roots that have been lifting up the laid bricks**

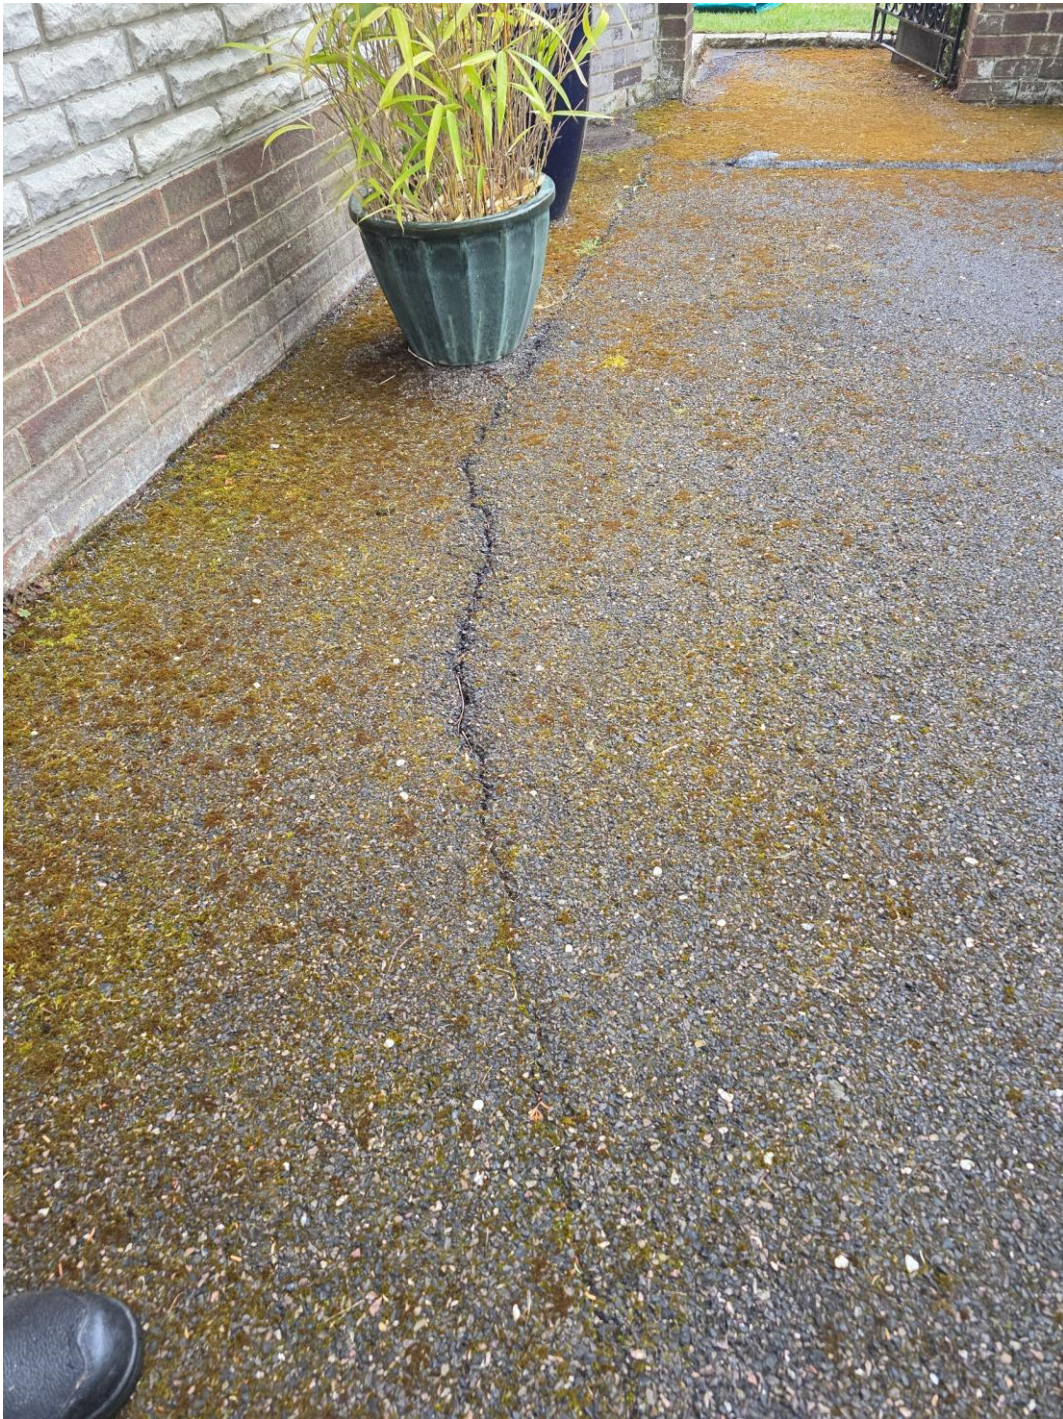
**T001 P03**

From the evidence collected, there is knowledge to believe that T001 Dawn redwood (*Metasequoia glyptostroboides*) – is causing direct damage to the property of Mr David Lamonby via the roots visibly lifting the concrete and tarmac on his driveway (T001 P03, there is also potential evidence showing large roots pushing up the laid bricks to the south of the main building (T001 P02). In addition to the problems the tree is causing, there is branches on the eastern side of the crown rubbing on the roof (See pic T001 P01). Another visual observation is there are signs of cracks on the lower part of the west side of the building, closest point to the offending where it joins a long, large crack in the driveway connecting to the tree root (See pic), as well as a wall next to the corner of the building on the south of the property, is being lifted potentially by the roots. As mentioned during the visit there is a Cypress roughly 5-6 meters away from the building on the south, but it is highly unlikely that the roots that have been exposed (See pic) are connected to the young Cypress tree.

**Evidence of a large crack formed from the roots in the direction of the roots that have been exposed underneath the brickwork in T001 P02.**

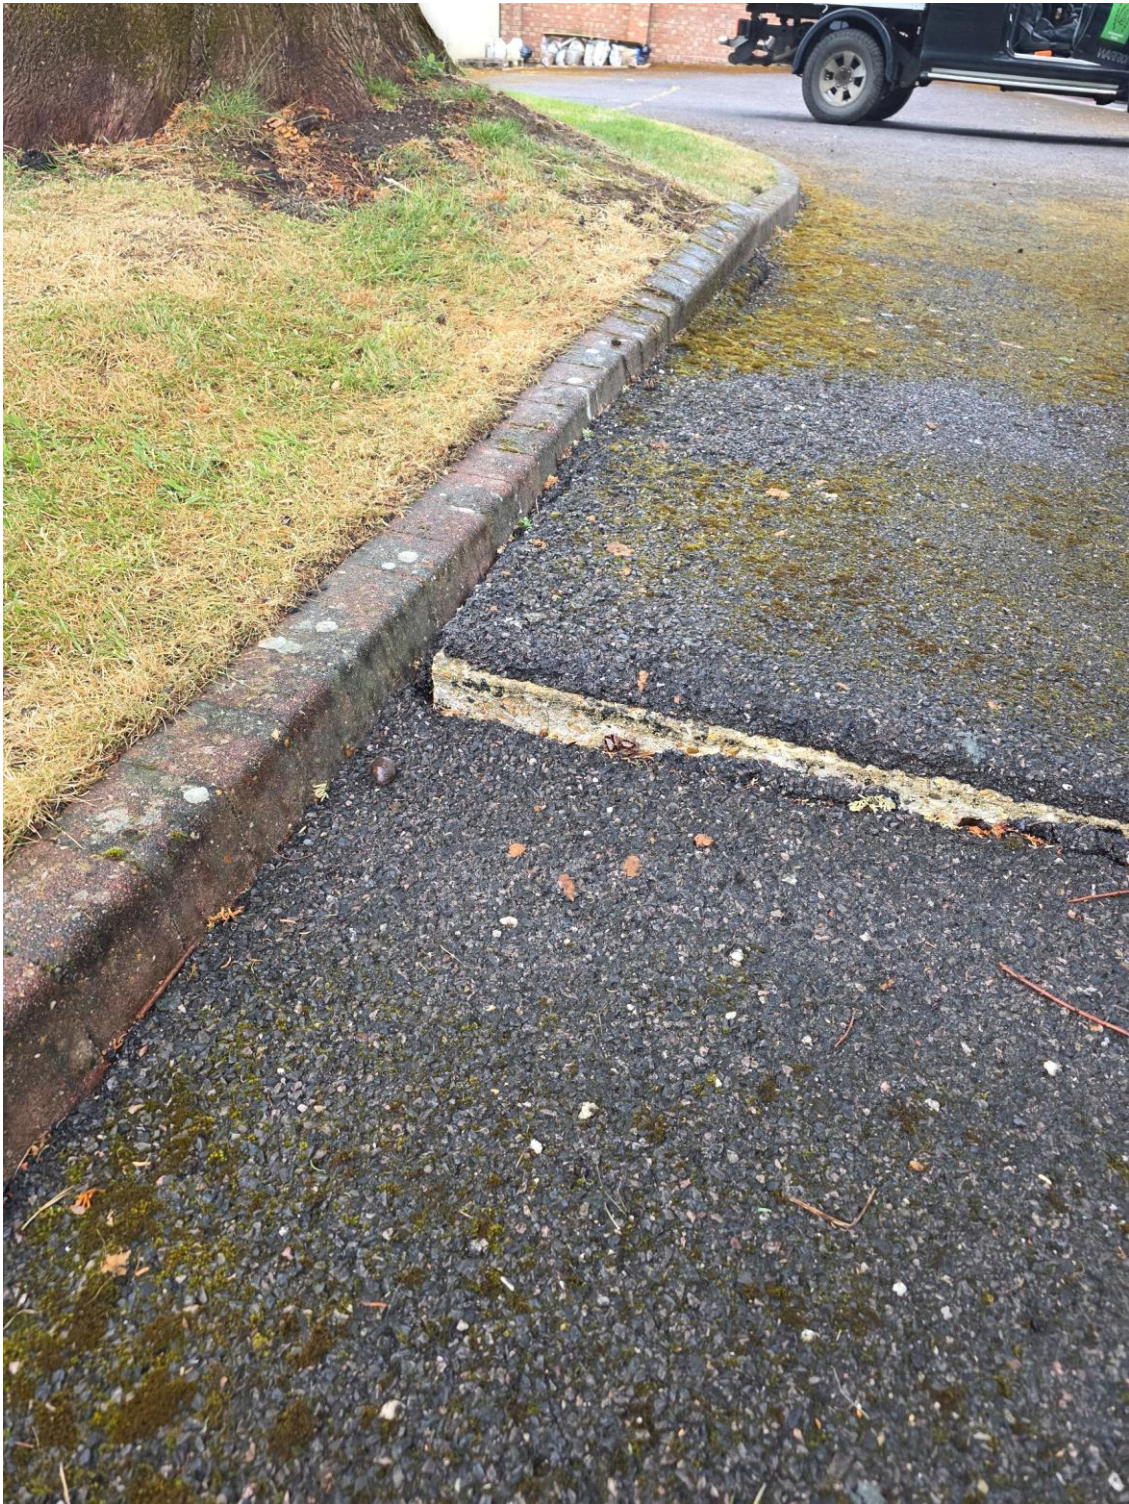
**T001 P04**

**Evidence of roots lifting up drive way causing a potential trip hazard**

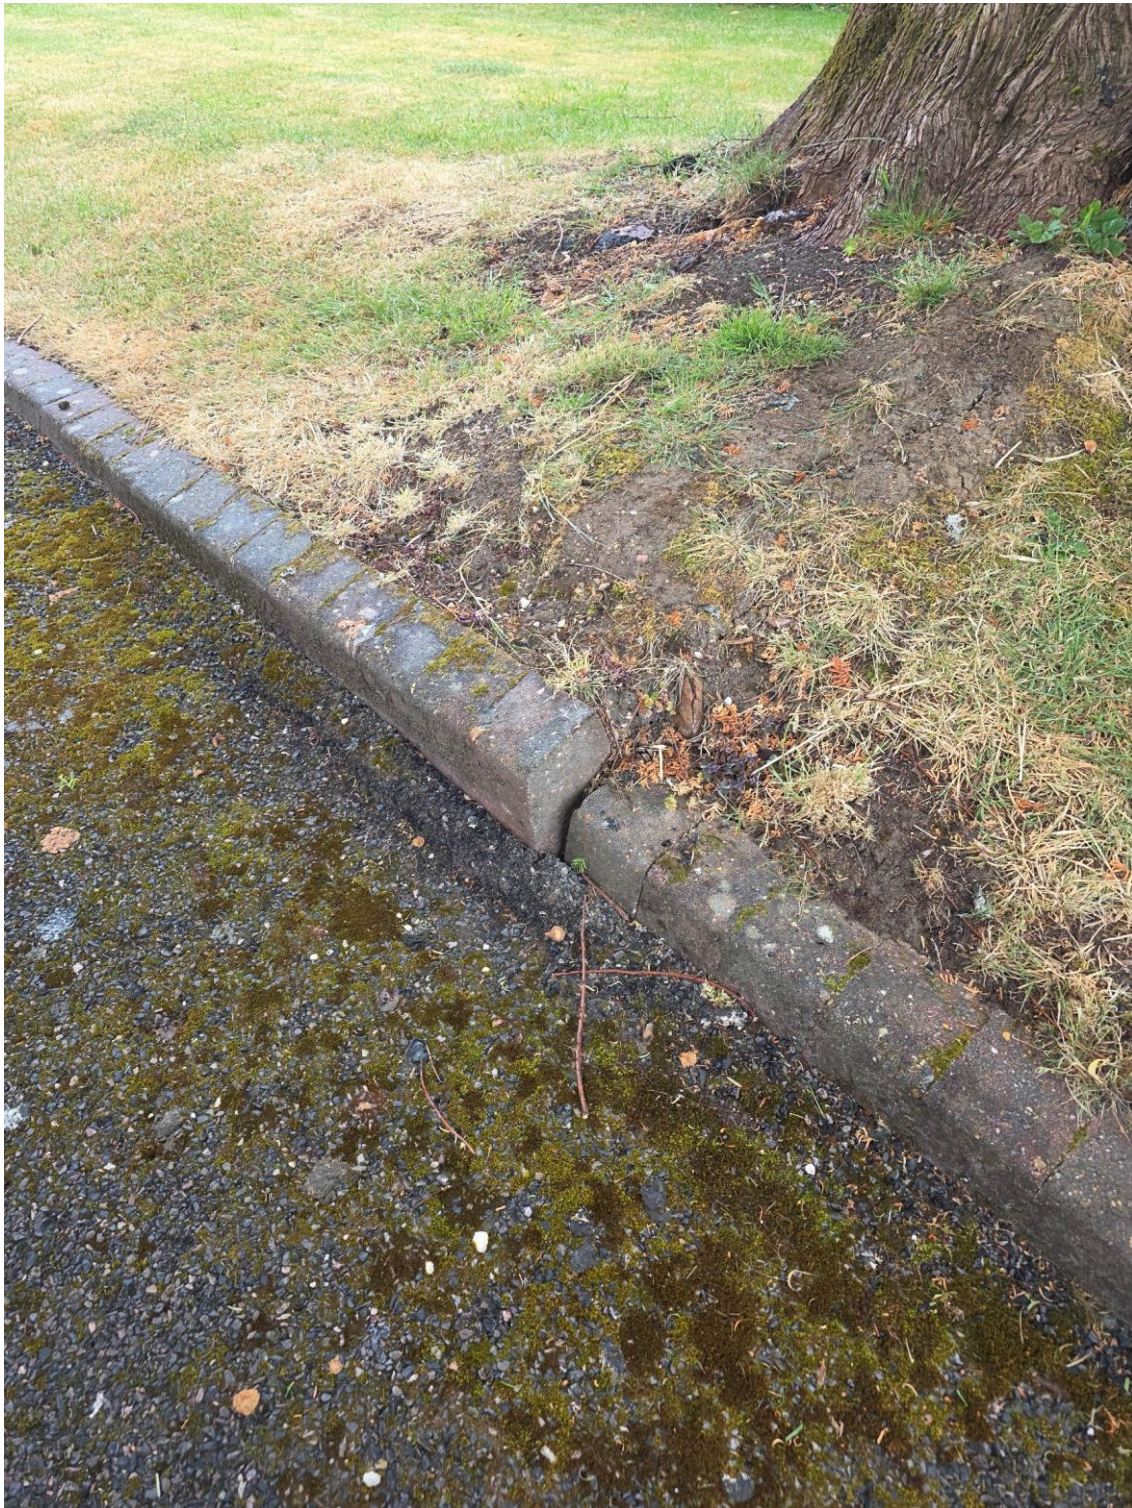
**T001 P05**

**Evidence of rootplate lifting the curb**

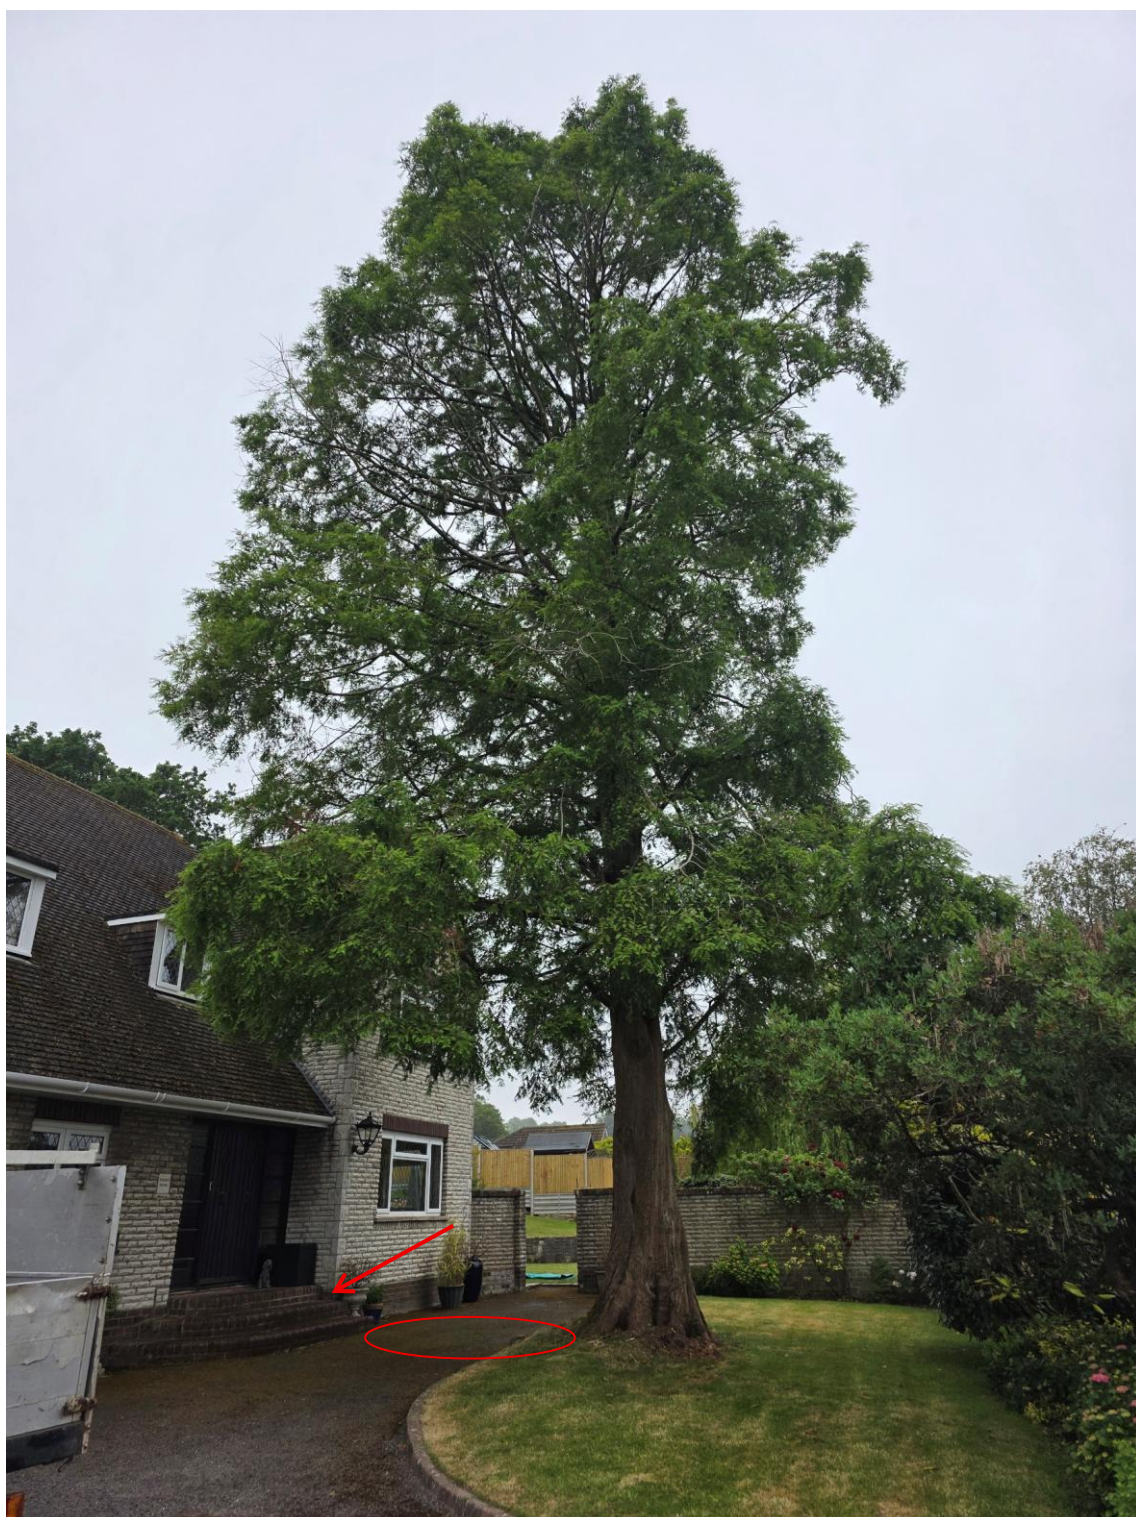
**T001 P06**

**Location if tree to house**

**Red arrow indicating the location of the crack on the side of the building.**

**Red circled area is where the long crack from the rootplate connects to the crack on the building.**
