**Project Name:** 25 Albretia Avenue

**Project Date:** 19/06/2026

**Inspection Standard:** MSCC5 Domestic GB (DRB Scoring)

## Section Inspection - 19/06/2026 - Mh1 X

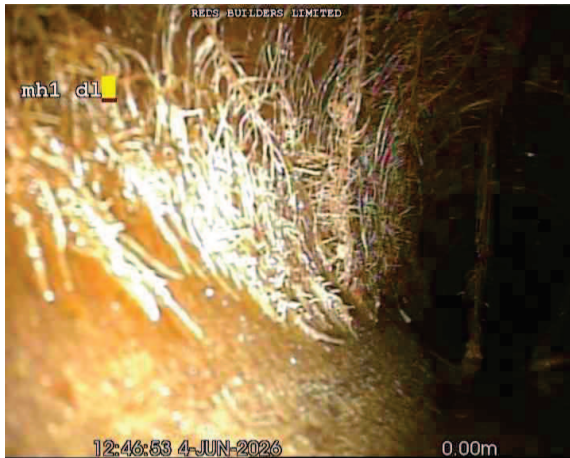
| Scale: 1:255 | Position [m] | Code | Observation | MPEG | Photo | Grade |
|---|---|---|---|---|---|---|
| | 0.00 | MH | Start manhole, Mh1 | 00:00:00 | 1 | |

1, 00:00:00, 0.00 m  
Start manhole, Mh1

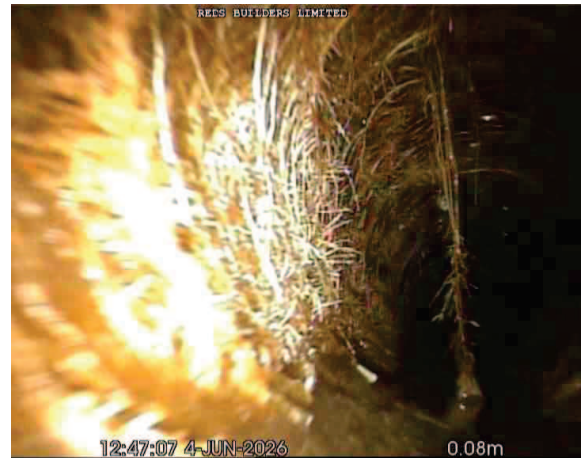
| <b>Comments:</b> Roots in line also a broken section of pipe. |

| Scale: 1:255 | Position [m] | Code | Observation | MPEG | Photo | Grade |
|---|---|---|---|---|---|---|
| | 0.10 | R | Roots: Roots in the line | 00:00:21 | 2 | B |

2, 00:00:21, 0.10 m  
Roots, Roots in the line

| <b>Recommendations:</b> Repair needed on broken pipe. roots will need jetting out. |

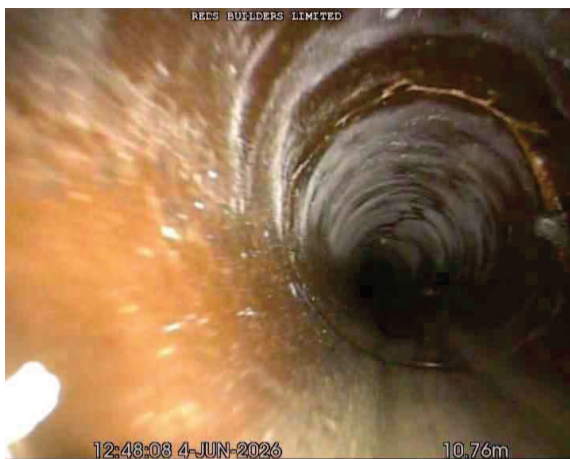
| Scale: 1:255 | Position [m] | Code | Observation | MPEG | Photo | Grade |
|---|---|---|---|---|---|---|
| | 10.76 | CC | Circumferential crack from 9 o'clock to 3 o'clock: Cracked pipe. | 00:01:22 | 3 | A |

3, 00:01:22, 10.76 m  
Circumferential crack from 9 o'clock to 3 o'clock, Cracked pipe.

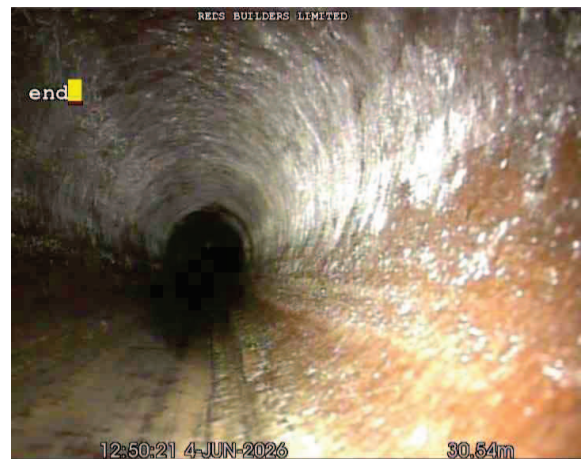
| Scale: 1:255 | Position [m] | Code | Observation | MPEG | Photo | Grade |
|---|---|---|---|---|---|---|
| | 30.54 | BRF | Finish connection without manhole, Down Line, the pipe is flowing fine | 00:03:34 | 4 | |

4, 00:03:34, 30.54 m  
Finish connection without manhole, Down Line, the pipe is flowing fine
