# Arboricultural Appraisal Report

## Subsidence Damage Investigation at:

3 Coronation Road  
Waterlooville  
PO7 7FA

| REPORT DATE: | 24/02/2026 |

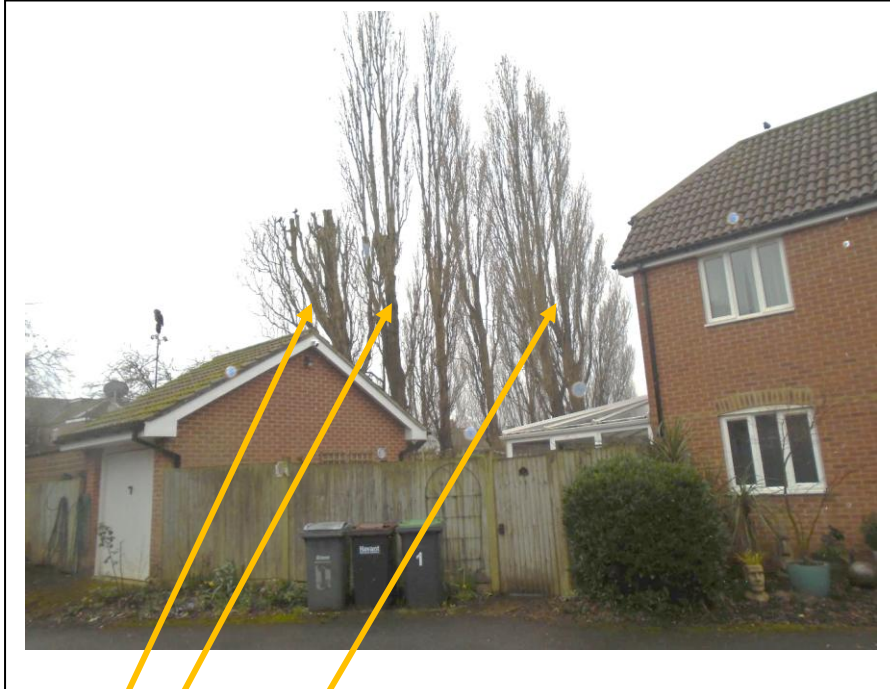
Roots were observed below foundation depth in TP/BH1. Samples recovered from TP/BH1 have been positively identified (using anatomical analysis) as *Populus* spp., the origin of which has the potential to be trees within TG1 and/or TG2. The *Rosa* spp. samples recovered from TP/BH1 will originate from SG1.

| Tree No. | Species | Height (m) | Dia (mm) | Crown Spread (m) | Dist. to building (m) | Age Classification | Ownership |
|---|---|---|---|---|---|---|---|
| TG1 | Poplar (Lombardy) x 3 | 16 * | 600 | 7 | 11 | Older than extension(s) | Policy Holder |
| TG2 | Poplar (Lombardy) x 2 | 18 * | 700 * | 8 * | 13 * | Older than extension(s) | Third Party<br>5 Coronation Road<br>PO7 7FA |

View of T1, TG1 (3 trees) & TG2 (2 trees)

| Tree No. | Species | Height (m) | Dia (mm) | Crown Spread (m) | Dist. to building (m) | Age Classification | Ownership |
|---|---|---|---|---|---|---|---|
| Recommendation | | Remove (fell) to near ground level. Owner to physically remove any regrowth (no chemical treatment due to translocation risk). | | | | | |
| Recommendation | | Reduce height by 8m. Remove regrowth on a biennial cycle to maintain at broadly reduced dimensions (subject to review if movement persists). | | | | | |

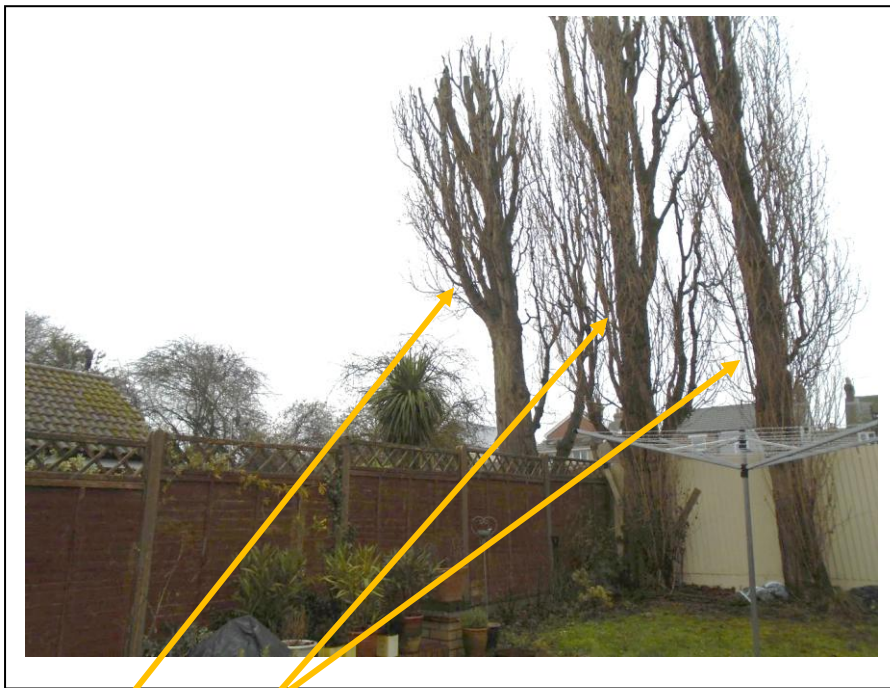
| Tree No. | Species | Height (m) | Dia (mm) | Crown Spread (m) | Dist. to building (m) | Age Classification | Ownership |
|---|---|---|---|---|---|---|---|
| T1 | Poplar (Lombardy) | 9 * | 650 * | 5 * | 11 * | Older than extension(s) | Third Party<br>1 Coronation Road<br>PO7 7FA |

View of T1 and lower stems of two trees within TG1

| Tree No. | Species | Height (m) | Dia (mm) | Crown Spread (m) | Dist. to building (m) | Age Classification | Ownership |
|---|---|---|---|---|---|---|---|
| Recommendation | | Remove regrowth on a biennial cycle to maintain at broadly reduced dimensions (subject to review if movement persists). | | | | | |

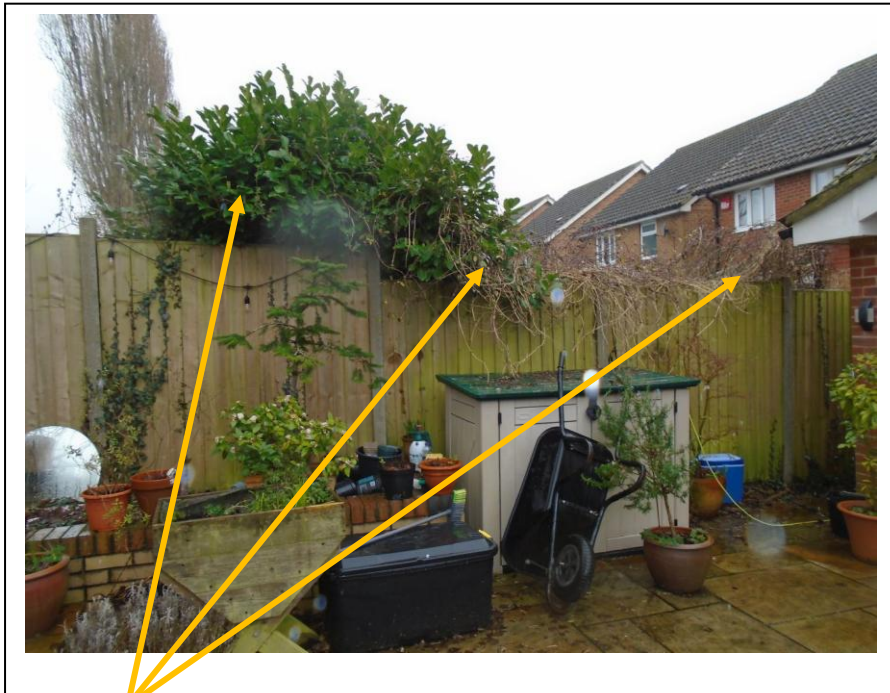
| Tree No. | Species | Height (m) | Dia (mm) | Crown Spread (m) | Dist. to building (m) | Age Classification | Ownership |
|---|---|---|---|---|---|---|---|
| SG1 | Mixed species shrubs including ornamental shrubs and Laurel | 2 | Ms | 3 | 1.25 | Younger than Property | Third Party<br>5 Coronation Road<br>PO7 7FA |

View of SG1

| Tree No. | Species | Height (m) | Dia (mm) | Crown Spread (m) | Dist. to building (m) | Age Classification | Ownership |
|---|---|---|---|---|---|---|---|
| Recommendation | | Remove (fell) to near ground level all stems within 3m of the property. Owner to physically remove any regrowth (no chemical treatment due to translocation risk). Reduce the Laurel and any remaining shrubs to a maximum height of 2m. Maintain all remaining shrubs at their reduced dimensions by periodic pruning. | | | | | |

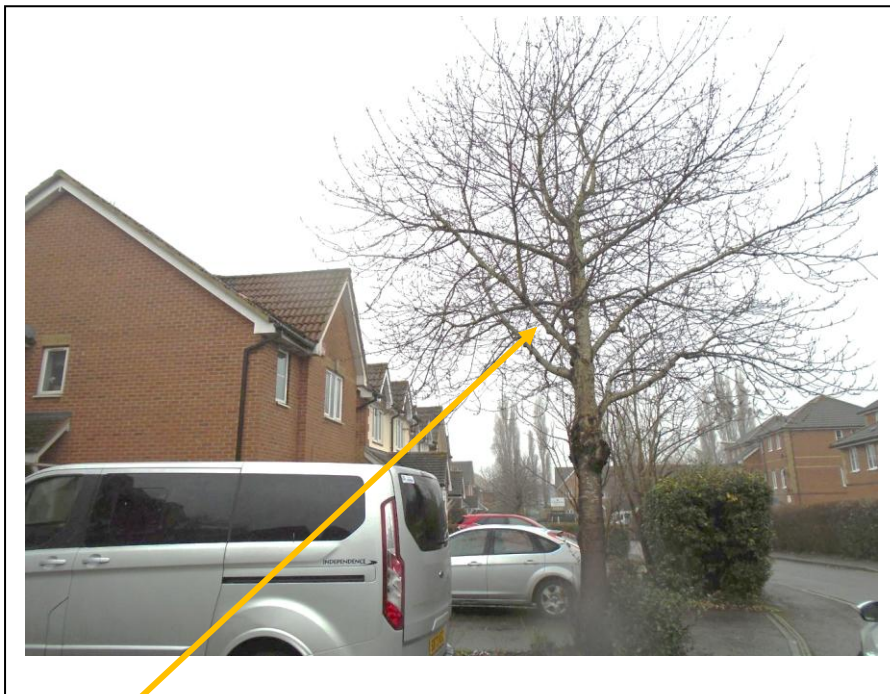
| Tree No. | Species | Height (m) | Dia (mm) | Crown Spread (m) | Dist. to building (m) | Age Classification | Ownership |
|---|---|---|---|---|---|---|---|
| T2 | Cherry | 7.5 | 345 | 8 | 7 | Younger than Property | Third Party<br>5 Coronation Road<br>PO7 7FA |

View of T2

| Tree No. | Species | Height (m) | Dia (mm) | Crown Spread (m) | Dist. to building (m) | Age Classification | Ownership |
|---|---|---|---|---|---|---|---|
| Recommendation | | Reduce height by 2m and crown radius by 0.5m leaving balanced crown. Prune on a triennial cycle to maintain at broadly reduced dimensions. | | | | | |
