### SUBSIDENCE ENGINEER'S REPORT

**Client Name:** Hastings Insurance Services Limited  
**Reference:** S2518361  
**Name of Insured:** [REDACTED]  
**Policy Number:** 0045758\_HPA  
**Risk Address:** 3 Coronation Road, Waterlooville, Hampshire, PO7 7FA, United Kingdom

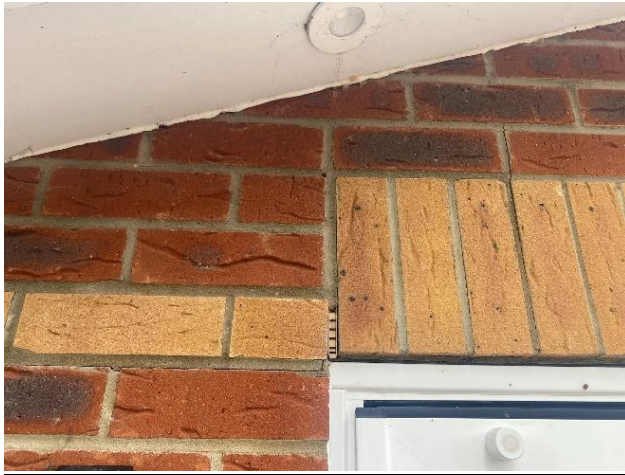
This image attempts to show cracking through the soldier course above the rear door, at the right side of the extension.

On completion of the recommended vegetation management works we will monitor the property for a short period of time to confirm stability before proceeding with superstructure crack repairs and redecoration to the subsidence damaged areas of the property. The superstructure repairs on their own, if mitigation is successfully completed, is estimated in the region of £14,000.00.

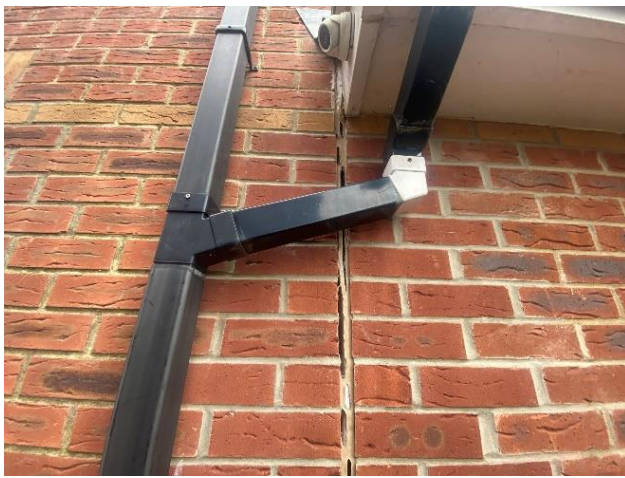
This image attempts to show the tapered gap that has formed at the movement joint, between the extension and the main building.

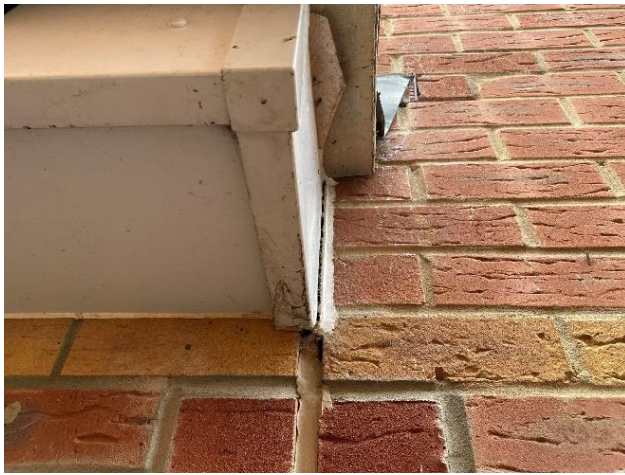
This image attempts to show the movement at the left side of the extension and the main building, noting the gap between the mastic and the fascia board.

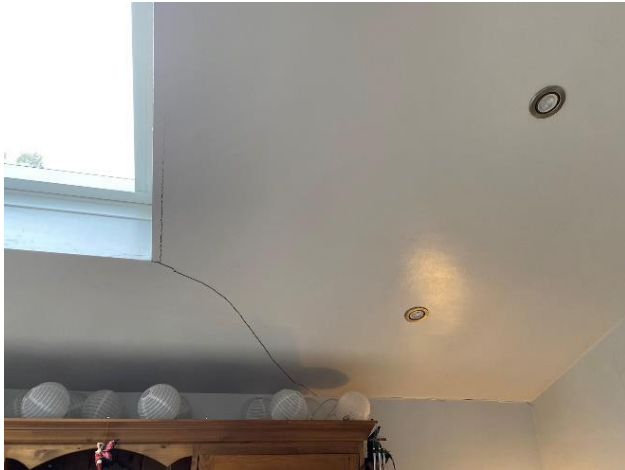
This image attempts to show cracking to the ceiling, at the right side of the extension.

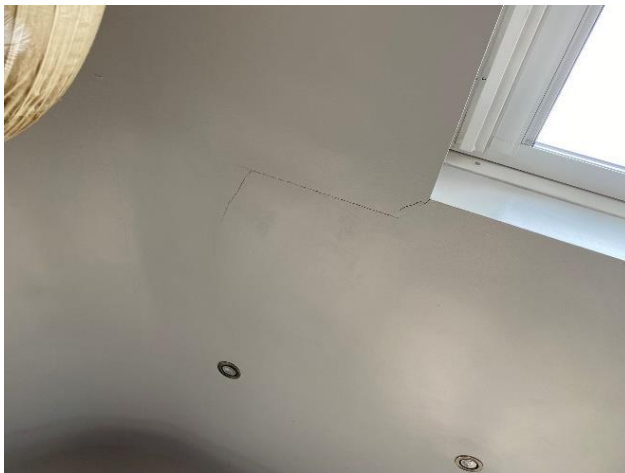
This image attempts to show a continuation of the above cracking, the other side of the window / roof light.
