## SITE INVESTIGATION REPORT

| REPORT NUMBER | GHG1046 |
| CLIENT | GHG SOLUTIONS LIMITED |
| SITE ADDRESS | 3 CORONATION ROAD PO7 7FA<br>S2518361 |

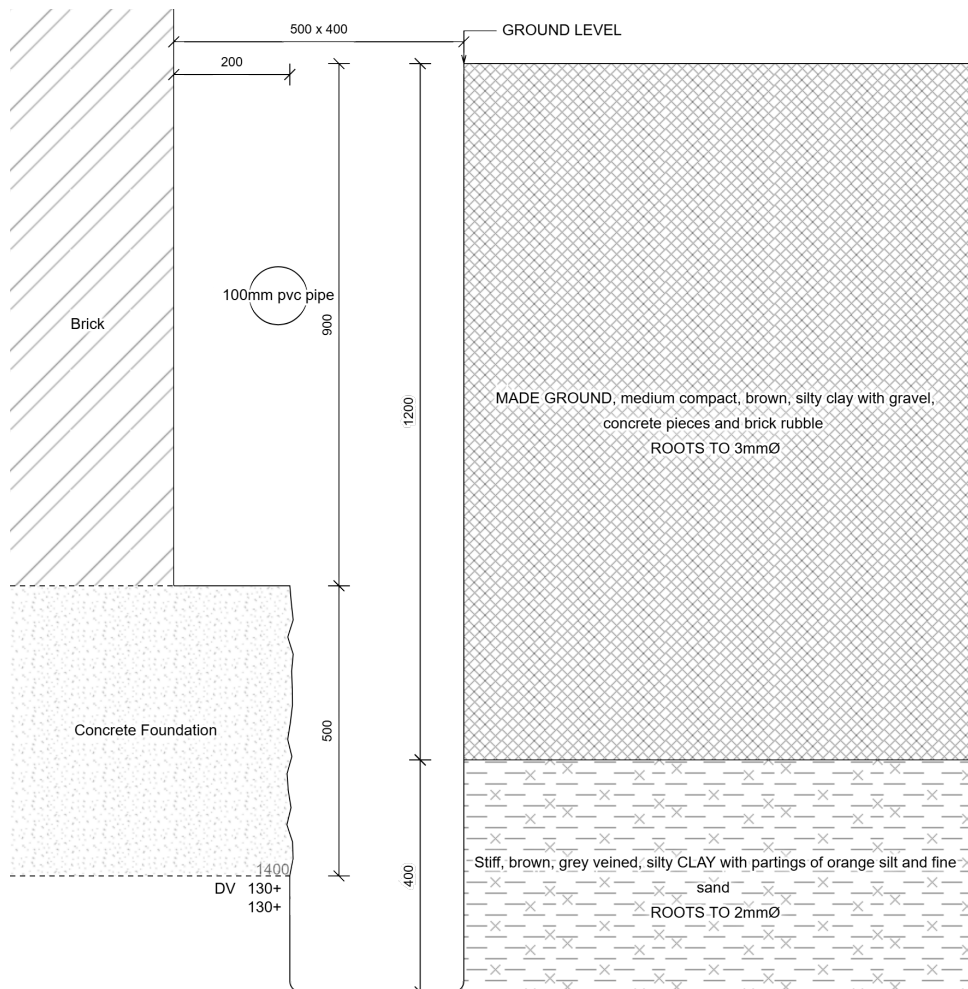
REPORT NUMBER: C5017846 / 389121.1.1.1  
TRIAL PIT REF: TP1  
CLIENT: GHG SOLUTIONS LIMITED  
JOB NO: GHG1046  
EXCAVATION METHOD: Hand tools

For Strata below 1600mm see Bore Hole log

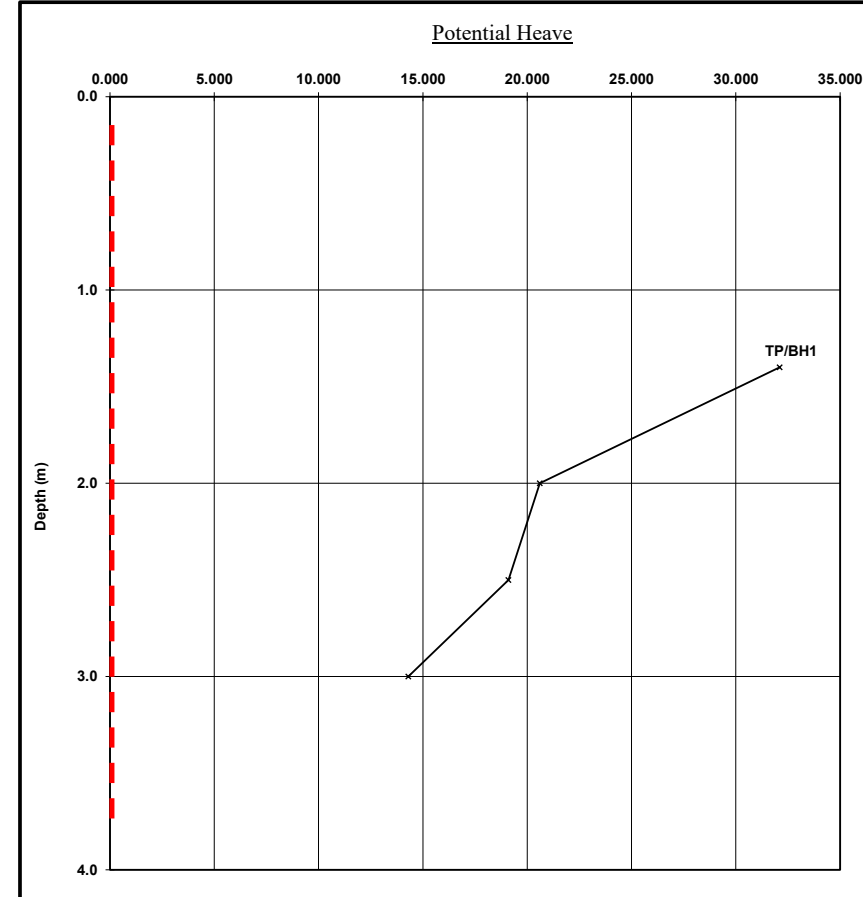
## Potential Heave Profiles

| Sample Ref | | Type | #Moisture Content<br>(%) [1] | Modified *<br>Moisture Content<br>(%) [2] | #Soil Fraction<br>> 0.425mm<br>(%) [3] | #Liquid Limit<br>(%) [4] | #Plastic Limit<br>(%) [5] | Plasticity Index<br>(%) [6] | Liquidity Index<br>[6] | Modified *<br>Plasticity Index<br>(%) [7] | Soil *<br>Class<br>[8] | Filter Paper Contact Time<br>(d) | #Soil Sample Suction<br>(kPa) [9] | Estimated *<br>Heave Potential (Dd)<br>(mm)[10] | Organic *<br>Content<br>(%) [11] | In situ *<br>Shear Vane Strength<br>(kPa) [12] | Mackintosh Probes * | | | |
|---|---|---|---|---|---|---|---|---|---|---|---|---|---|---|---|---|---|--|--|--|
| Free surface heave potential over the borehole depth is about 7cm to 10cm | | | | | | | | | | | | | | | | | | | | |

1. Soil Bulk Density (moist unit weight) is equal to 2039kg/m<sup>3</sup>
2. The water table is assumed as 1.0m below ground level.
3. Shrinkage Factor (sf) of 2 has been applied to the predicted heave, where applicable
4. Any possible surcharge stresses due to construction are not considered

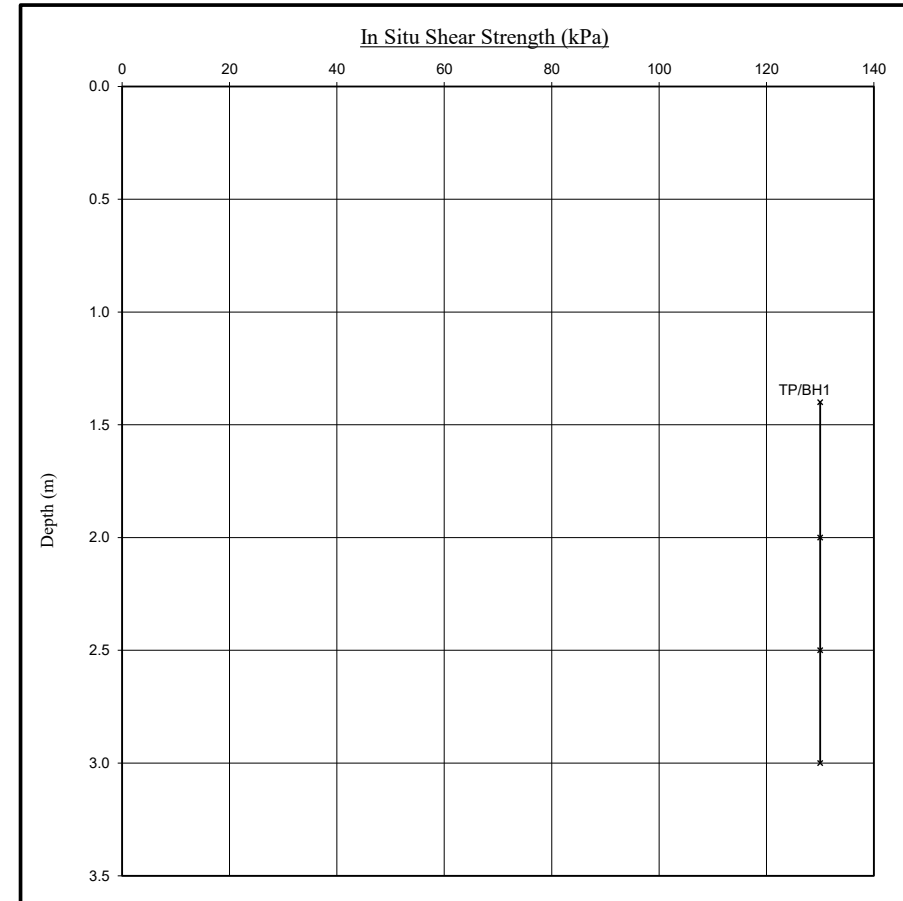
## Shear Strength Profiles

1. Unless otherwise stated, values of Shear Strength were determined in situ by CTS using a Pilcon Hand Vane the calibration of which is limited to a maximum reading of 130 kPa.
2. Unless specifically noted the profiles have not been related to a site datum.
