# Fallen & Found Arboriculture<sup>®</sup>

## Ground Based Professional Tree Inspection

| Project Name: | 3 Granville Close, Warblington<br>(Tree Preservation Order TPO<br>No. 1074) | Document Reference: | Q0647\Burt\PTI\2026_V2 |
| Location: | 3 Granville Close, Warblington,<br>Havant, Hampshire, PO9 2TR | Date: | 19/08/2026 |

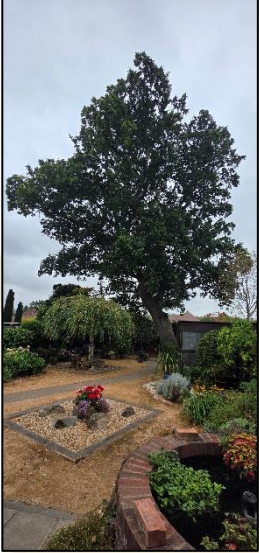
| Photo Ref | Photograph | Description / Observations |
|---|---|---|
| Photo 1 | | A southerly view of the subject tree growing within the rear garden of the property. |

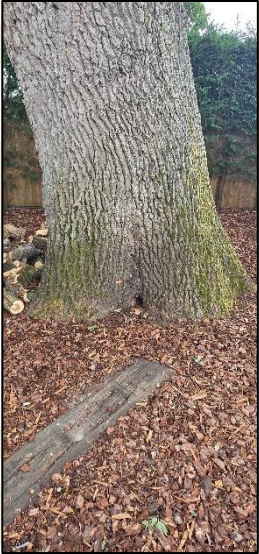
During my inspection, I observed that a significant percentage of the tree's rooting zone has been mulched using tree bark. Several garden structures have been constructed within the rooting zone of the tree. The trees stem has normal taper and root buttress formation characteristic of the trees age and species<sup>2</sup>. Mallet sounding of the buttress roots and basal stem flare did not produce a resonance characteristic of internal hollowing or cavities, neither did I find any loose or necrotic bark or cambium.

| Photo Ref | Photograph | Description / Observations |
|---|---|---|
| Photo 2 | | The tree stem has showing normal rooting flare and mulched rooting zone. Note the cut up remnants of the failed limb to the left of the tree's stem. |

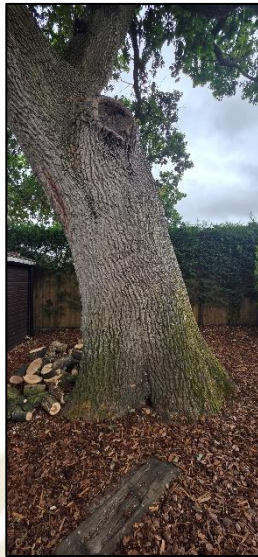
Photo  
3

The tree stem has a tendency to lean toward the east. Note the historic wound from historic limb removal at 3m agl which is occluding.

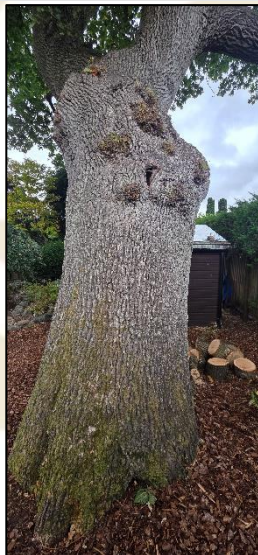
Photo  
4

A small cavity is present on the western side of the trees stem at a height of 2.7m agl. This cavity measures 50mm x 60mm and extends into the trees stem to an unknown depth. Due to the height of this feature, I was not able to measure its depth. However, mallet sounding of this area produced a hollow resonance below the cavity opening to a distance of 400mm below the opening<sup>4</sup>. Further evidence of historic limb loss can be observed above the cavity with exposed heartwood present evident and callus forming around the wound site with a profusion of epicormic growths in the same area<sup>5</sup>.

A photo of the trees stem looking east. Note the small cavity in the trees stem which was sounded during my inspection. Further evidence of historic limb removal or failure can be observed above the cavity.

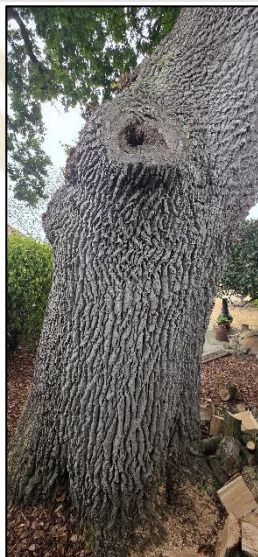
Photo  
5

Another site of historic pruning or limb loss can be viewed on the southern side of the trees stem at a height of 2.5-2.7m agl<sup>6</sup>. The exposed heart wood contains a small cavity and is visibly decayed, as is the exposed heartwood at all of the previous sites discussed previously. This particular historic wound measures approximately 400mm x 400mm.

A photo of the trees stem looking north toward the main dwelling. Further historic limb removal can be observed on the trees stem.

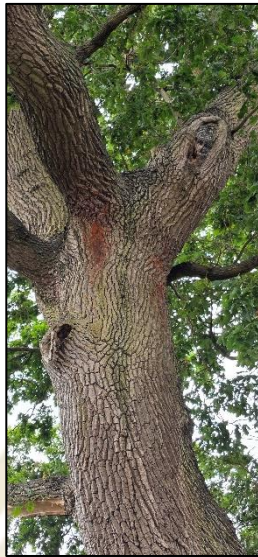
Photo  
6

Stepping back from the tree into the rear garden in a northerly direction, and additional sites of biomechanical interest can be observed<sup>7</sup>. The first area of interest is located at approximately 8m above ground level and consists of a historic limb failure or removal. This area has obviously decayed with a cavity now being present and possibly being widened and used as a home by wildlife. The second site is located approximately 2-3m above this first site and has the external appearance of a historic limb failure due to its jagged/torn nature. Both of these sites can be viewed in the photographic record contained within the appendix of this document.

A photo looking south and upwards into the main canopy break of the tree. A small cavity can be observed below and left of the brown mark below the primary limb. This is evidence of gnawing from Squirrels. A further site of likely limb failure can be observed on the tree's primary limb structure in the top right side of the photo.

- **Work:** Reduce the overall height and radial spread of the crown by up to **2.0 metres**, pruning back to suitable live lateral growth points.
- **Rationale:** Reducing the overall canopy mass will decrease wind-sail exposure, lower leverage forces acting upon the defective upper stem cavities (at 8m agl) and reduce stress on the leaning stem and root plate.

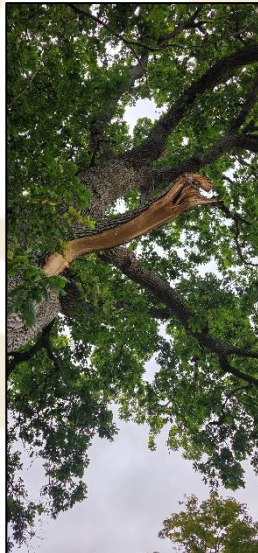
Photo  
7

I was initially instructed to carry out my inspection of the tree following the failure of a limb located on the eastern side of the tree. The resulting stub is still present on the tree located at 4.5m agl<sup>8</sup>. The presence of this stub and the fractured section left on the ground below the tree allows full inspection to find the causative agent or agents for the failure of this limb. I inspected both fractured sections of the limb, being the torn stub on the tree and the section on the ground. The section of residual wood on the ground contains dry wood fibres and a coalesced area of decay originating from two separate wound sites on opposite sides of the woody section<sup>9</sup>.

An image of the fractured stub resulting from the recent limb failure.

- **Work:** Target-prune the fractured stub left by the recent limb failure back to the branch collar or a suitable lateral branch to facilitate clean callus occlusion and minimise further decay ingress.

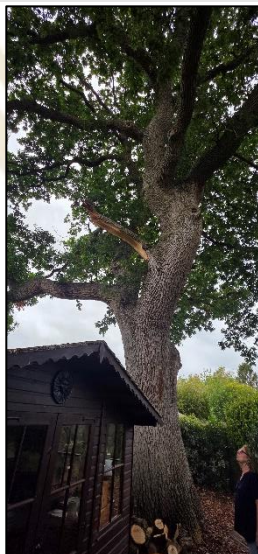
Photo  
8

Another image of the fractured stub showing its location in relation to the summer house which was subsequently damaged.

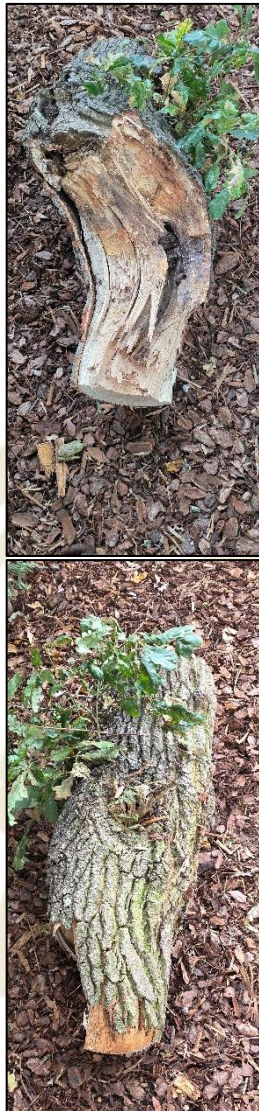
Photos  
9

- **Recent Limb Failure & Decay:** Inspection of the primary limb that failed on 15th August 2026 confirms that the failure was driven by extensive internal decay originating from historic wound sites. The resulting fractured stub at 4.5m above ground level (agl) remains a site of potential fungal colonisation.

Two images of the fracture surface taken at the point of failure post removal from the summer house roof. Note the internal decay in the uppermost image, desiccated internal wood fibres, and coalescence of decay resulting from two external areas of historic wounding.

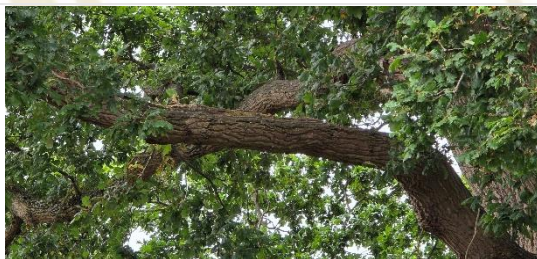
Photo  
10

A small diameter lateral limb located at 7.39m agl projecting Northeast over an adjacent Yew tree has a decayed upper surface with exposed and decayed heartwood extending up to 2m in length along its uppermost side originating from close to its attachment point to its parent stem<sup>10</sup>.

- **Defective Lateral Canopy Elements:** An additional lateral branch projecting north-east at 7.39m agl exhibits severe upper-surface decay along a 2m length. Furthermore, deadwood of varying diameters is distributed throughout the canopy directly over internal target areas (garden structures and boundary lines).

A limb projecting northeast over an adjacent Yew tree which has a heavily decayed upper surface for approximately 2.5m of its length. Damage likely due to bark stripping by Squirrels.

- **Work:** Prune back the north-eastern lateral branch exhibiting upper-surface decay, incorporating it into the overall 2-metre crown reduction to significantly reduce end-weight over the adjacent Yew tree.

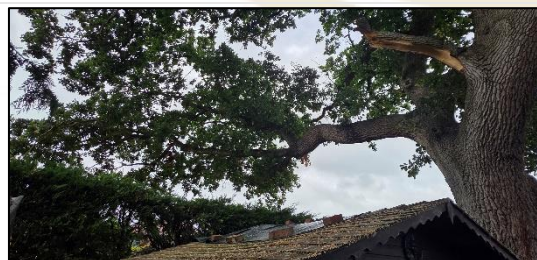
Photo  
11

A large diameter lateral limb located at 4.7m agl projecting south over neighbouring property gardens contains a fracture characteristic of a Hazard Beam type fracture at an approximate distance of 1.5m from its point of origin with its parent stem<sup>11</sup>. This limb is of considerable length and weight and extends a significant distance over the neighbouring properties.

- **Active Hazard Beam Fracture:** A large-diameter primary lateral limb extending southwards at 4.7m agl over neighbouring garden curtilages exhibits a distinct Hazard Beam fracture approximately 1.5m from its point of attachment. Given its weight, leverage, and position directly over high-occupancy target areas, this limb presents a high risk of imminent failure.

An image of a large diameter primary limb projecting south over X2 adjacent property gardens at an approximate height of 4.7m agl. The subject limb has a hazard Beam fracture type biomechanical feature at 1.2-1.5m from its primary attachment point with its parent stem.

- **Primary Southern Lateral (Hazard Beam Limb at 4.7m agl):** Due to the severe structural instability presented by the longitudinal Hazard Beam fracture overhanging adjacent properties, formal notification was submitted to Havant Borough Council under the 5-day notice provision for dangerous protected trees. Written permission to proceed was granted on the morning of 19th August 2026.
- **Action Taken:** The limb is to be systematically reduced in length by 3.0 metres back to suitable lateral growth points in accordance with BS 3998:2010. Furthermore, an 8-tonne Cobra dynamic, non-invasive bracing system is to be installed<sup>12</sup>. These measures are to be implemented to eliminate the immediate threat of structural failure over neighbouring curtilages and to ensure the long-term, safe retention of the remaining branch structure.

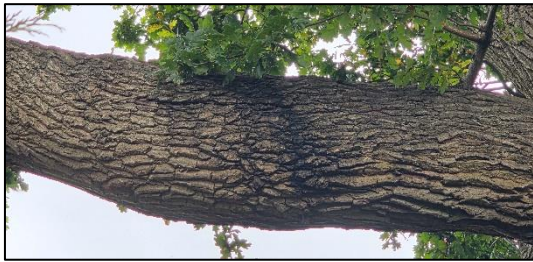
Photo  
12

A close-up image of the subtle but significant open crack in the limb.
