# Arboricultural Consultancy for Esure

| Insured | | Address | 1 Hartwood Gardens, Waterloooville, PO8 8RA | | |
| Client | Subsidence Management Services | Contact | | Claim No. | IFS-ESU-SUB-25-0122071 |
| ES Ref | SA-256755 | Consultant | Craig Howe | Contact No. | 0330 380 1036 |

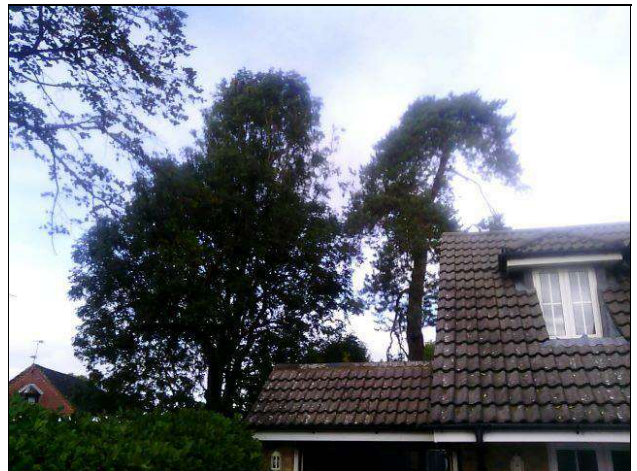
T3 - Ash

With due regards to species profile, size and proximity, T3 (Ash) and T4 (Pine (Scots)) are considered the dominant features proximate to the focal area(s) of movement and accordingly, where vegetation is confirmed as being causal, we have identified them as the primary cause of the current subsidence damage.

Consequently, we have advocated the complete removal of both T3 & T4 as it will offer the most certain arboricultural solution likely to restore long-term stability.

| Tree No. | Species | Age Cat | Approx. Height (m) | Distance to Building (m) * | Ownership | Action | Requirement |
|---|---|---|---|---|---|---|---|
| T3 | Ash | 3 | 12 | 4 | A - Third Party tp1 | Remove | Remove close to ground level; do not treat stump(s) due to translocation risk. Where such a risk exists, we advise that any emergent regrowth is removed annually. |
