# Arboricultural Consultancy for Esure

| Insured | | Address | 1 Hartwood Gardens, Waterloooville, PO8 8RA | | |
| Client | Subsidence Management Services | Contact | | Claim No. | IFS-ESU-SUB-25-0122071 |

## 5. Technical Synopsis

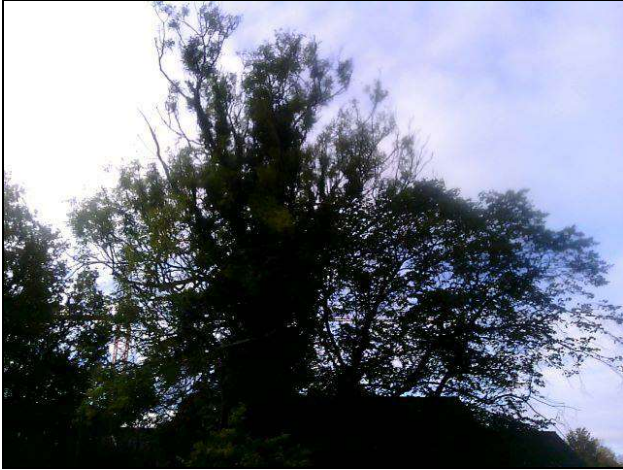
T1 - Ash

| Tree No. | Species | Age Cat | Approx. Height (m) | Distance to Building (m) * | Ownership | Action | Requirement |
|---|---|---|---|---|---|---|---|
| T1 | Ash | 3 | 13 | 10 | A - Third Party tp1 | Action to avoid future risk | Maintain at broadly current dimensions by way of regular pruning. |

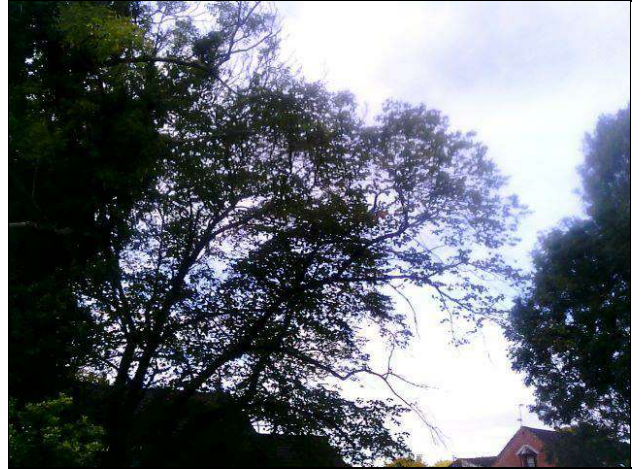
T2 - Elm

| Tree No. | Species | Age Cat | Approx. Height (m) | Distance to Building (m) * | Ownership | Action | Requirement |
|---|---|---|---|---|---|---|---|
| T2 | Elm (Wych) | 3 | 8 | 9 | A - Third Party tp1 | Action to avoid future risk | Maintain at broadly current dimensions by way of regular pruning. |

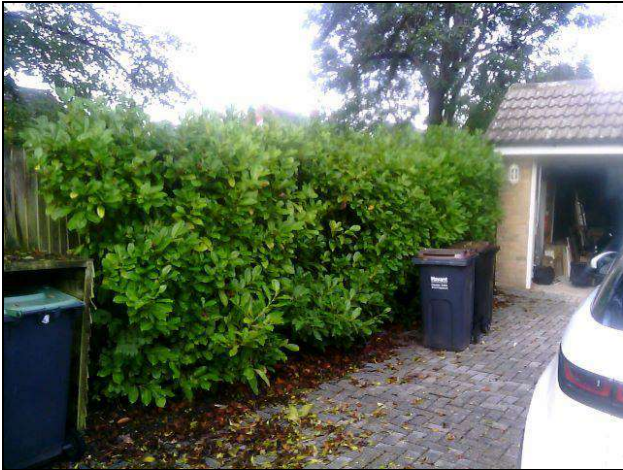
H1 - Laurel

| Tree No. | Species | Age Cat | Approx. Height (m) | Distance to Building (m) * | Ownership | Action | Requirement |
|---|---|---|---|---|---|---|---|
| H1 | Laurel | 2 | 2.5 | 1.5 | C - Insured | Action to avoid future risk | Maintain at, or below current dimensions by way of regular pruning. |

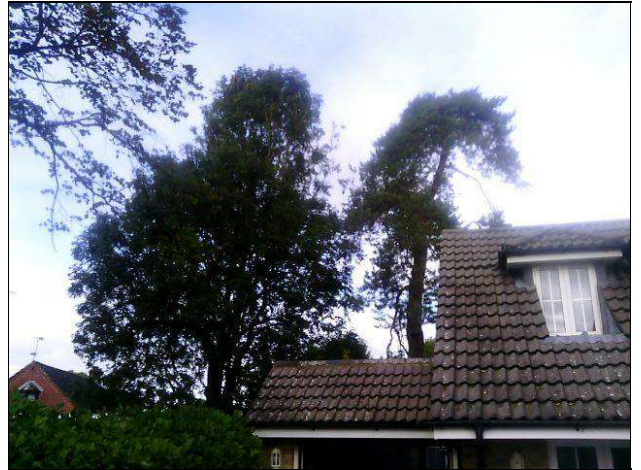
T3 - Ash

With due regards to species profile, size and proximity, T3 (Ash) and T4 (Pine (Scots)) are considered the dominant features proximate to the focal area(s) of movement and accordingly, where vegetation is confirmed as being causal, we have identified them as the primary cause of the current subsidence damage.

The size and proximity of the above vegetation is consistent with the advised location(s) of damage and it is our opinion, on balance of probability, that roots from the above vegetation will be in proximity to the footings of the insured property.

| Tree No. | Species | Age Cat | Approx. Height (m) | Distance to Building (m) * | Ownership | Action | Requirement |
|---|---|---|---|---|---|---|---|
| T3 | Ash | 3 | 12 | 4 | A - Third Party tp1 | Remove | Remove close to ground level; do not treat stump(s) due to translocation risk. Where such a risk exists, we advise that any emergent regrowth is removed annually. |

Consequently, we have advocated the complete removal of both T3 & T4 as it will offer the most certain arboricultural solution likely to restore long-term stability.

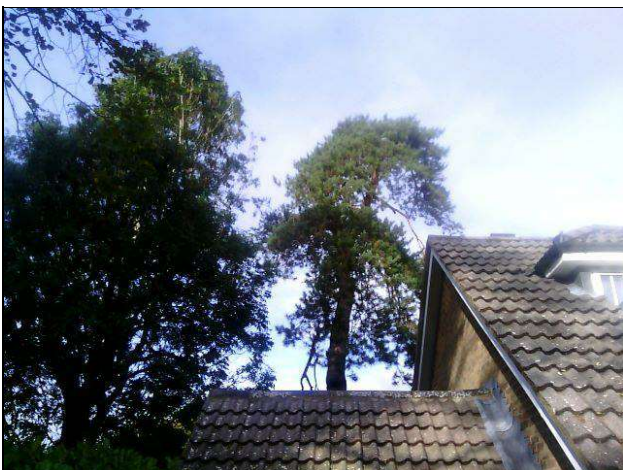
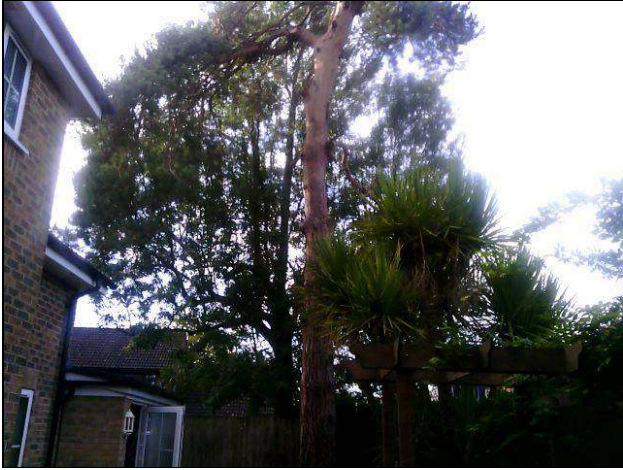
T4 - Pine (Scots)

| Tree No. | Species | Age Cat | Approx. Height (m) | Distance to Building (m) * | Ownership | Action | Requirement |
|---|---|---|---|---|---|---|---|
| T4 | Pine (Scots) | 3 | 12 | 2 | C - Insured | Remove | Remove close to ground level |

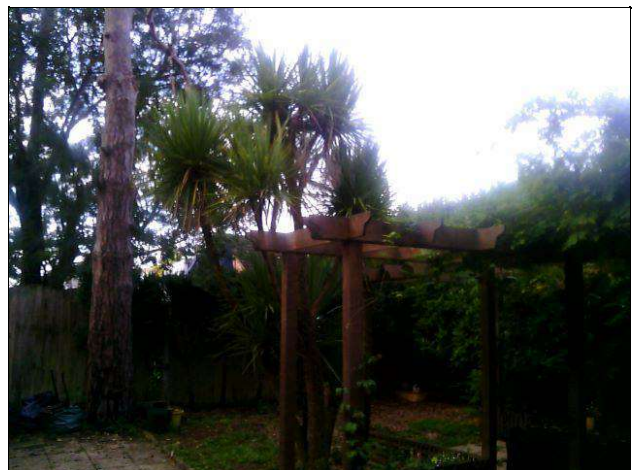
T5 - Palm

| Tree No. | Species | Age Cat | Approx. Height (m) | Distance to Building (m) * | Ownership | Action | Requirement |
|---|---|---|---|---|---|---|---|
| T5 | Palm | 2 | 4 | 5 | C - Insured | No action | No works. |

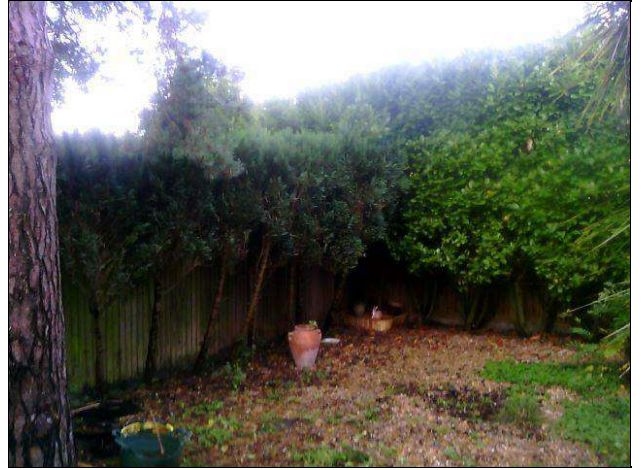
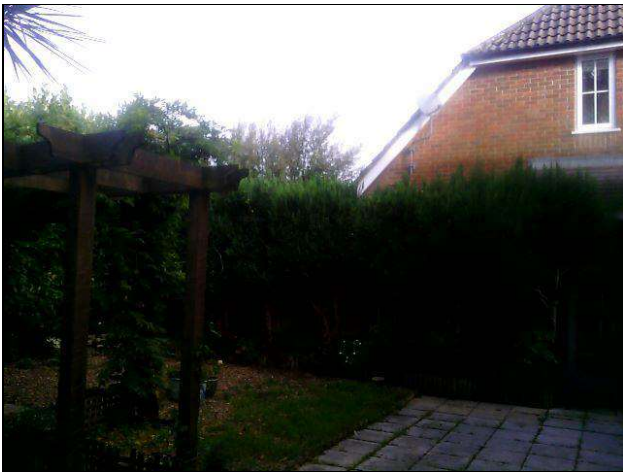
H2 - Mixed Species Hedge (H)

| Tree No. | Species | Age Cat | Approx. Height (m) | Distance to Building (m) * | Ownership | Action | Requirement |
|---|---|---|---|---|---|---|---|
| H2 | Mixed Species Hedge (H) | 2 | 4 | 3 | C - Insured | Action to avoid future risk | Maintain at broadly current dimensions by way of regular pruning. |

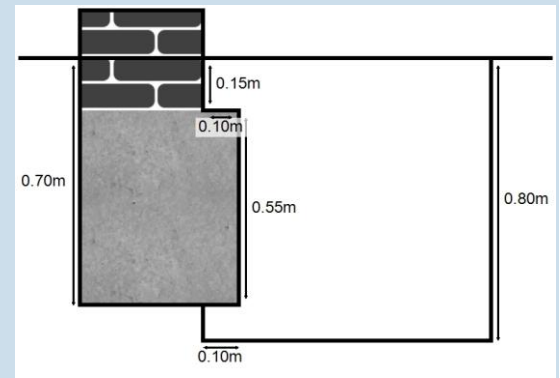
## TP/BH1 Foundation Detail and Borehole Log

Garage foundation comprised of brick wall to 150mm bgl, bearing on concrete to 700mm bgl, with a total projection of 100mm from the elevation. Underside of foundation (USF) was exposed to 100mm back from the face of the foundation and probed 500mm back from the face of the foundation.

Garage foundation was exposed and the underside of foundation (USF) recorded to be 0.7m bgl (TP/BH 1).

Roots encountered to 1.8m bgl (TP/BH 1).
