Brawdia  
One Temple Quay  
Temple Back East  
Bristol  
BS1 6DZ

Following survey No: 4 of 6

## Monitoring Plus Report

| Address | The Lodge,<br>Lavender Rd,<br>Waterlooville<br><br>PO7 8BX | Principal area of damage | to be advised | Installed | 05/08/2025 |

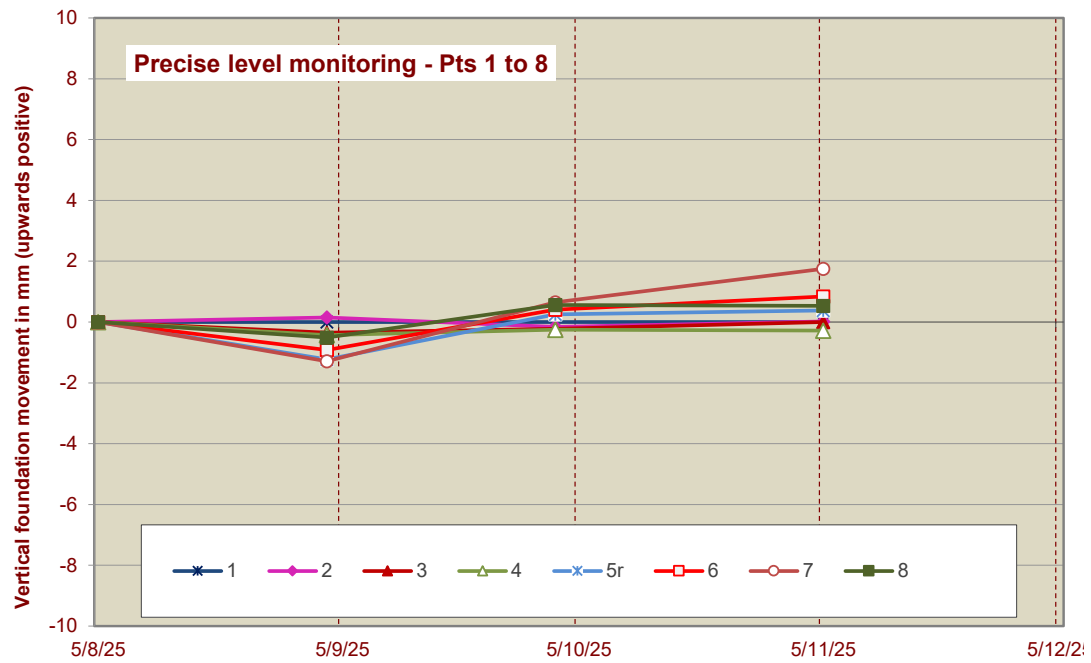
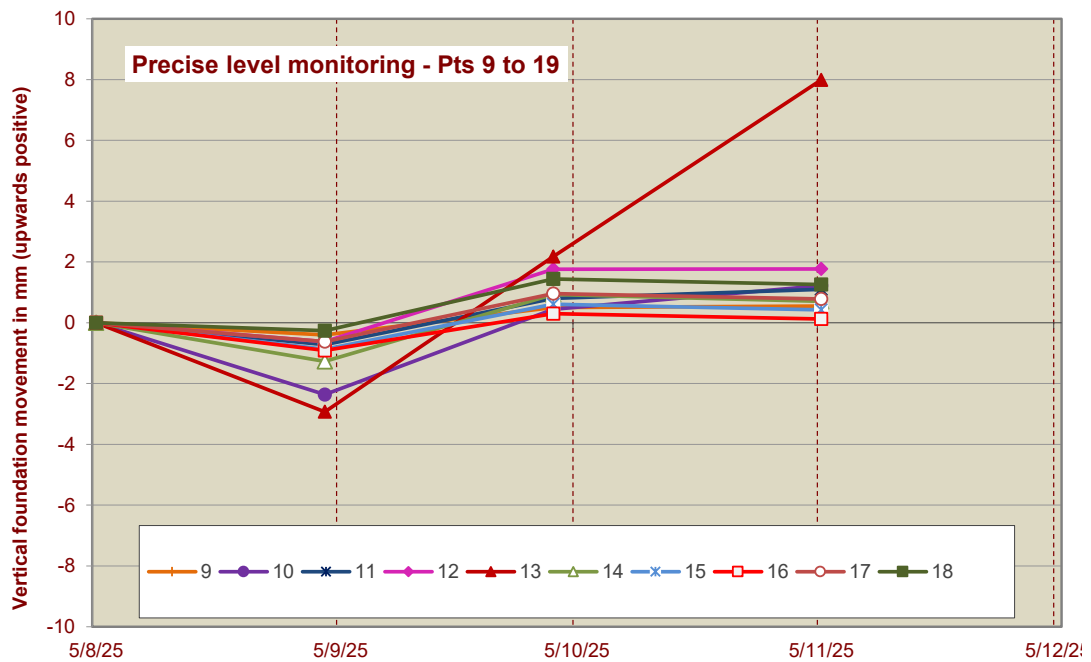
## Precise level monitoring related to Point 1

| Max move 10.9 mm | no feedback for this visit | | | | |
| Focal area Pts 13, | | | | | |

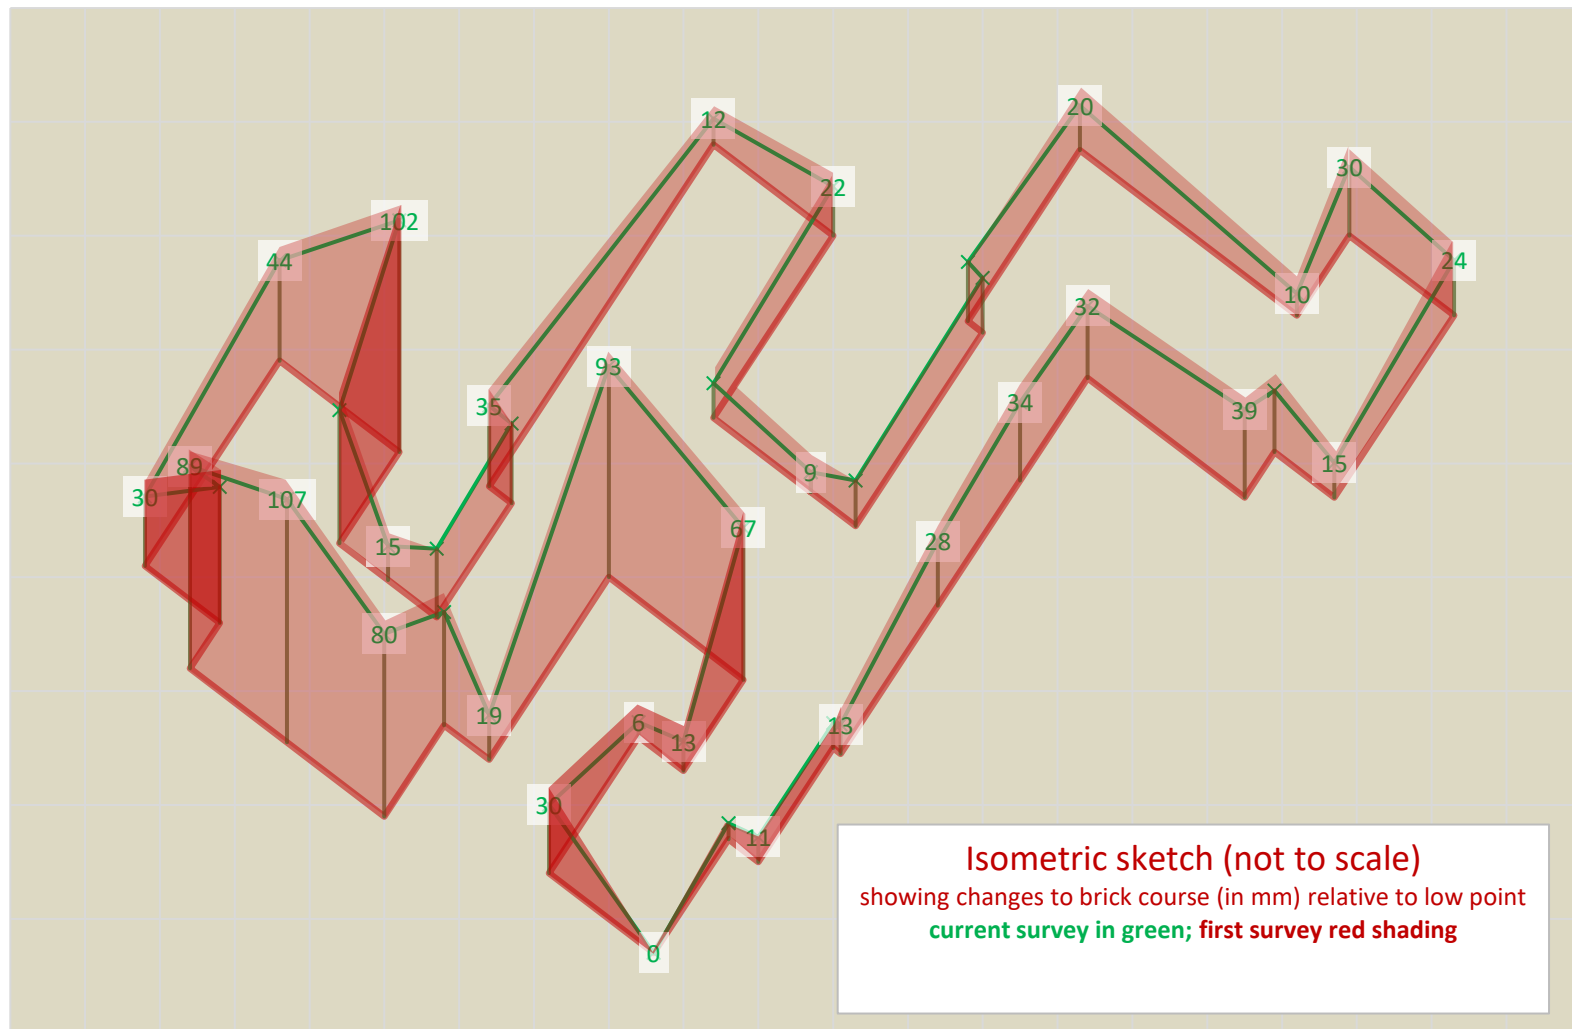
Isometric distortion plot

&lt;&lt;&lt;&lt;&lt; low point

Reduced level of low point =

991.30
