## Arboricultural Appraisal Report

### Subsidence Damage Investigation at:

The Lodge  
Lavender Rd  
Waterlooville  
PO7 8BX

| REPORT DATE: | 13/03/2025 |

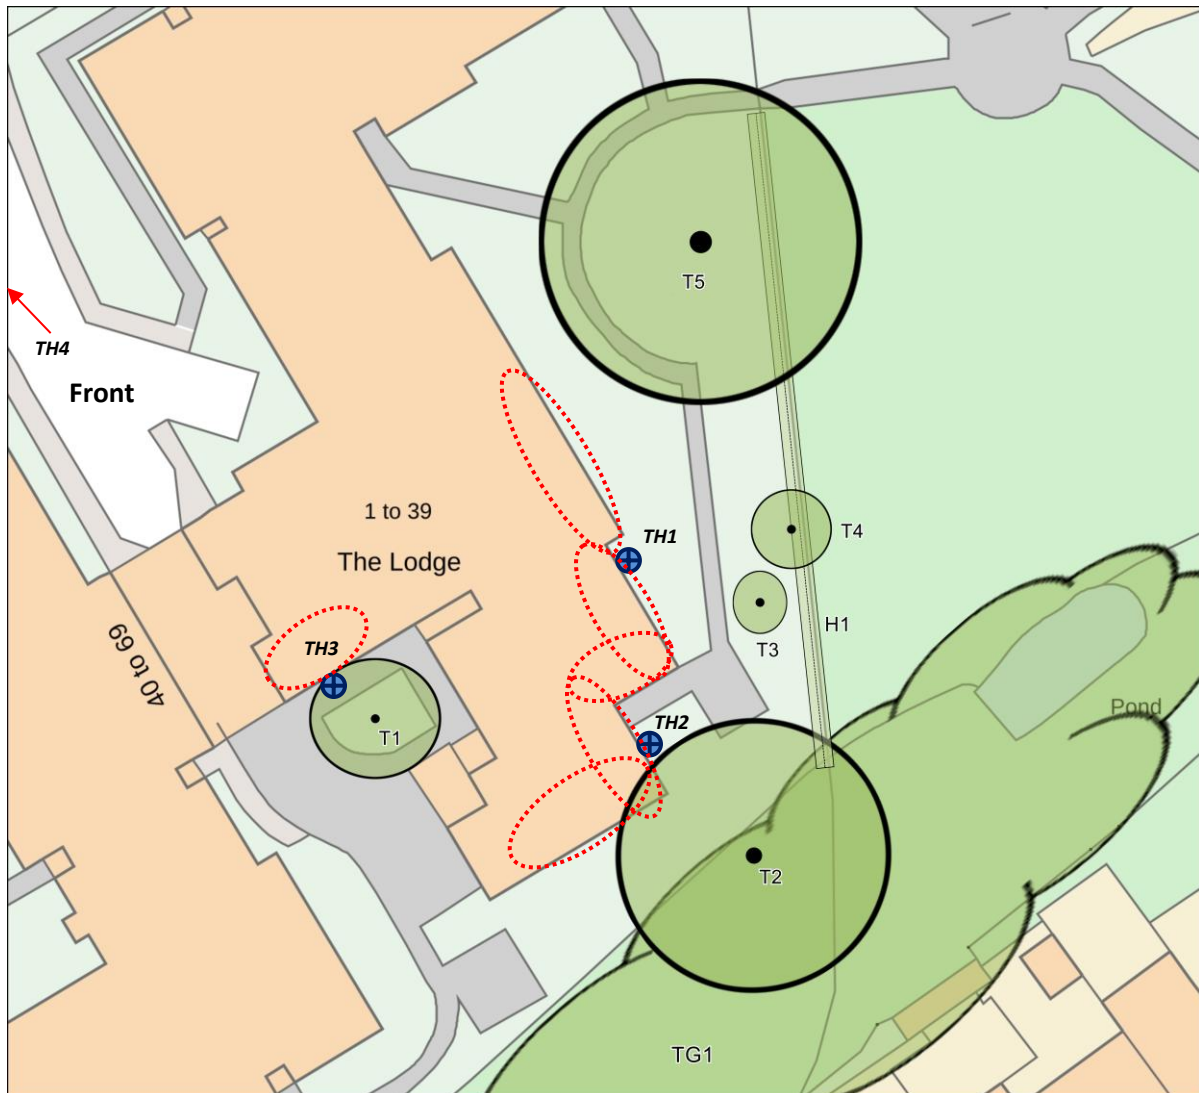
## Site Plan

Approximate areas of damage

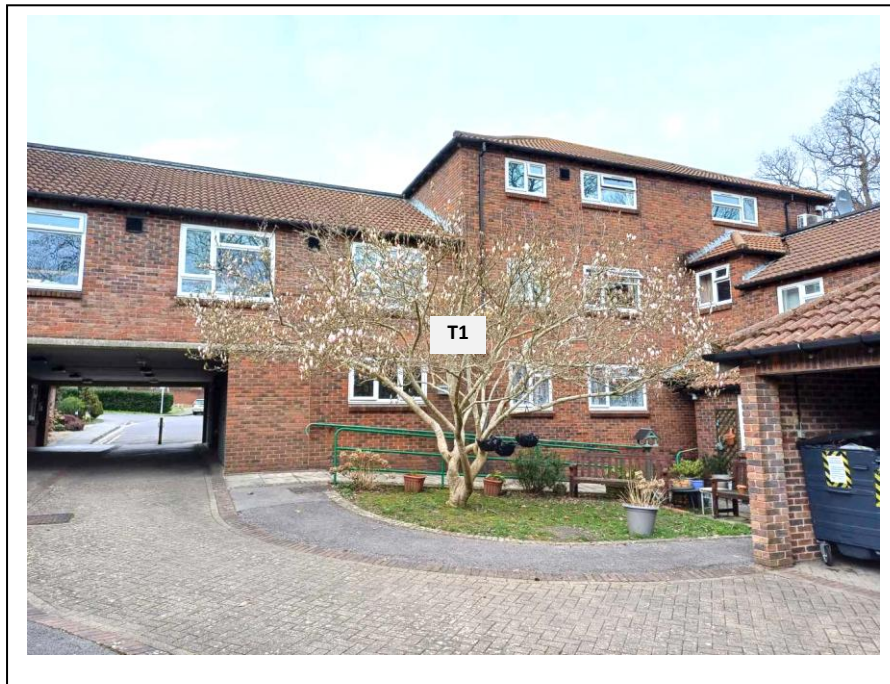
Irrespective of the identification of recovered root samples, the roots of T1 and T4 are also likely to be present below foundation level in proximity to the area of movement/damage with the potential to influence soil moisture and volumes.

Based on the information currently available, engineering opinion and our own site assessment we conclude there is damage consistent with shrinkage of the clay subsoil exacerbated by the soil drying effects of vegetation. Having considered the information currently available, it is our opinion that T1, T2 and T4 are the principal cause of or are contributing to the current building movement and damage.

| Tree No. | Species | Ht. (m) | Dia. (mm) | Crown Spread (m) | Dist. to building (m) | Age Classification | Ownership |
|---|---|---|---|---|---|---|---|
| T1 | Magnolia | 5 | 215 Ms | 9 | 3.5 and 7 to home<br>4.5 to bin store | Similar Age to Property | Policy Holder |

View of T1 from south

| Tree No. | Species | Ht. (m) | Dia. (mm) | Crown Spread (m) | Dist. to building (m) | Age Classification | Ownership |
|---|---|---|---|---|---|---|---|
| Recommendation | | Remove (fell) to near ground level and treat stump to inhibit regrowth. | | | | | |

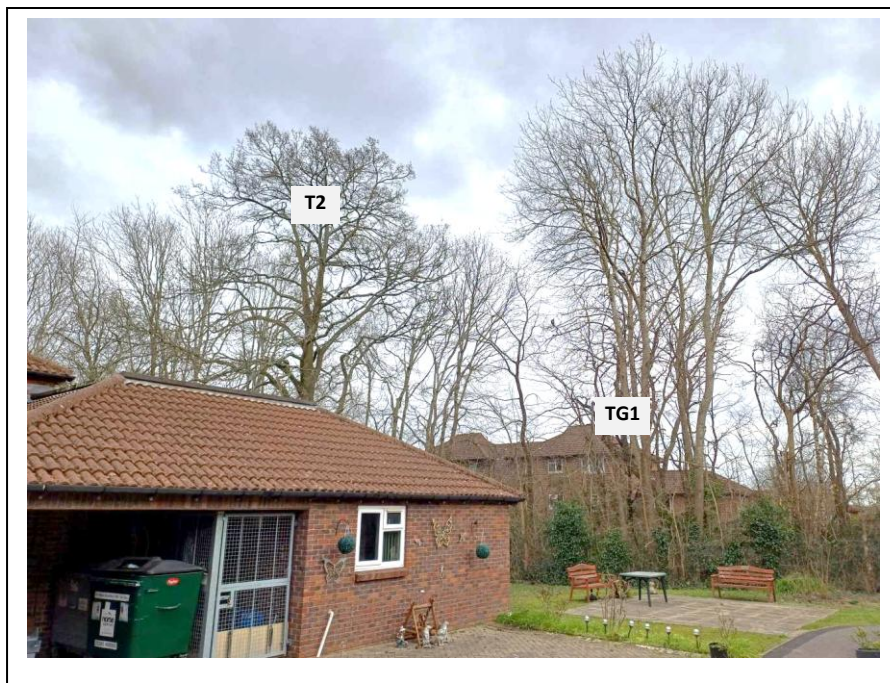
View of trees to south

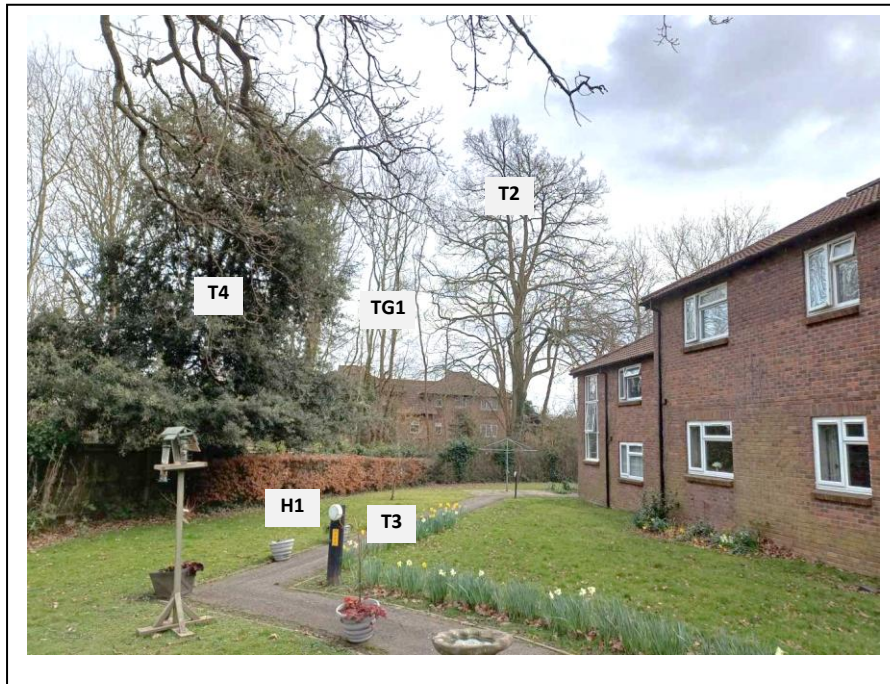
Roots were observed below foundation depth in TH2 and recovered samples have been positively identified (using anatomical analysis) as *Quercus spp.* and *Ulmus spp.*, the origin of which will be T2 and TG1 respectively, confirming their influence on the soils below the foundations. TG1 is however likely to be having a lesser effect than T2 due to the age and size of the trees.

| Tree No. | Species | Ht. (m) | Dia. (mm) | Crown Spread (m) | Dist. to building (m) | Age Classification | Ownership |
|---|---|---|---|---|---|---|---|
| T2 | Turkey Oak | 22 | 700 * | 20 | 8 | Older than Property | Policy Holder |
| T4 | Holm Oak | 3.5 | 310 | 9 | 12 | Younger than Property | Policy Holder |

View of T4 and T2

| Tree No. | Species | Ht. (m) | Dia. (mm) | Crown Spread (m) | Dist. to building (m) | Age Classification | Ownership |
|---|---|---|---|---|---|---|---|
| Recommendation | | Remove (fell) to near ground level. Owner to physically remove any regrowth (no chemical treatment due to translocation risk). | | | | | |
| Recommendation | | Remove (fell) to near ground level and treat stump to inhibit regrowth. | | | | | |

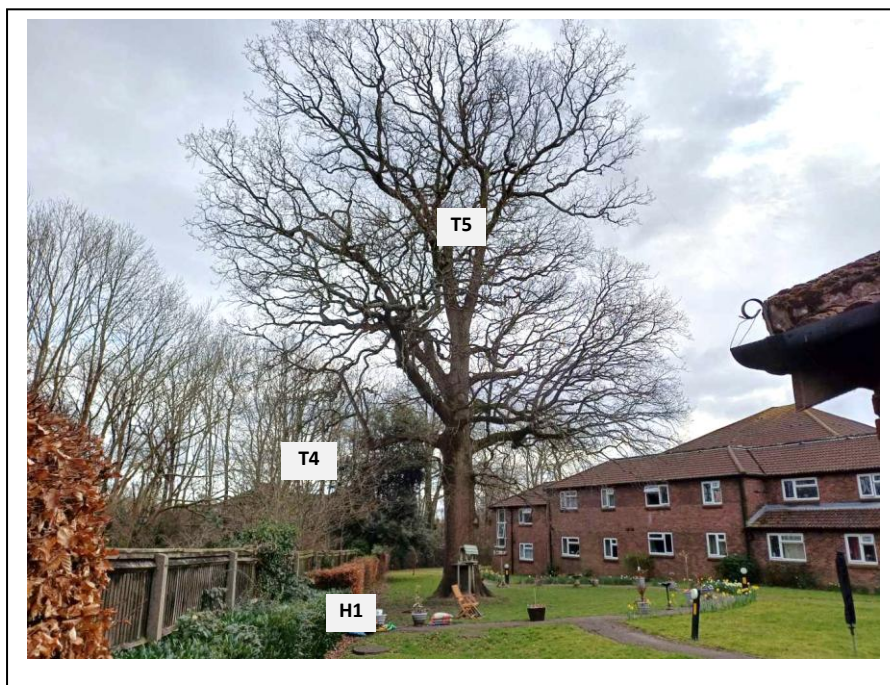
T5 would also be capable of affecting the building but is much older than the building, so is not likely to be increasing its effects upon the structure. Importantly, areas of the building to the north of T5 are at similar distances and no damage has been reported in those areas. We do not therefore consider the influence of this tree be established at this time. This may however be subject to review if movement persists.

| Tree No. | Species | Ht. (m) | Dia. (mm) | Crown Spread (m) | Dist. to building (m) | Age Classification | Ownership |
|---|---|---|---|---|---|---|---|
| T5 | English Oak | 24 | 1350 | 24 | 14 | Older than Property | Policy Holder |

View of T5 from north

| Tree No. | Species | Ht. (m) | Dia. (mm) | Crown Spread (m) | Dist. to building (m) | Age Classification | Ownership |
|---|---|---|---|---|---|---|---|
| Recommendation | | Do not allow to exceed current dimensions (subject to review if movement persists). | | | | | |
