# Site Investigation Report

168490.1.BSI

## Job Summary

Auger were commissioned by HGE Surveying Services Ltd to undertake a site investigation and CCTV inspection of the underground drainage within the area of concern (AOC) at the property.

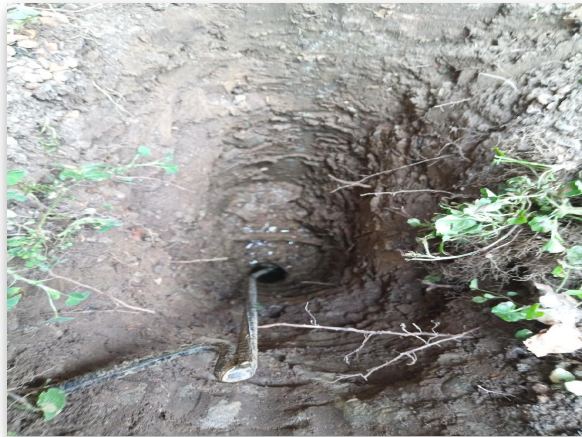
Fig 1.1: Trial Hole 1 Location

Trial hole 1 was completed in the requested location and reached the requested depth. The footing was discovered.

Water was encountered at 0.9m.

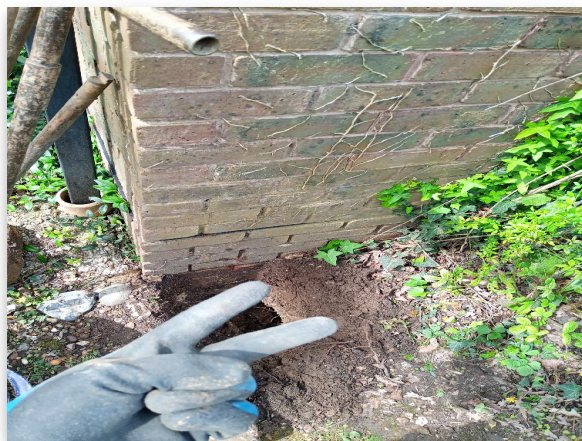
Fig 2.1: Trial Hole 2 Location

Trial hole 2 was completed in the requested location and reached the requested depth. The footing was discovered.

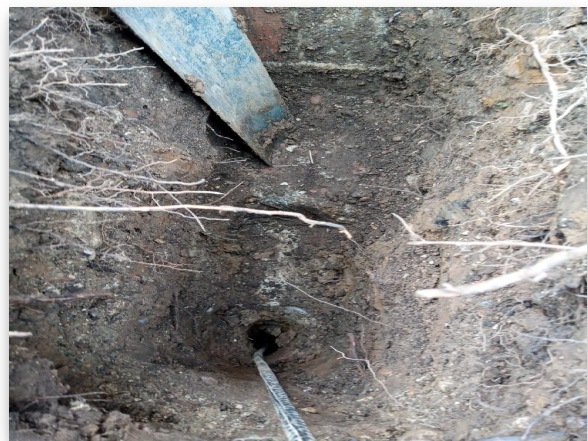
Fig 2.2: Trial Hole 2 Footing

Root samples were taken at 1.2m and 1.7m. Soil samples were taken at 1.2m, 1.7m, 2.2m and 2.7m.

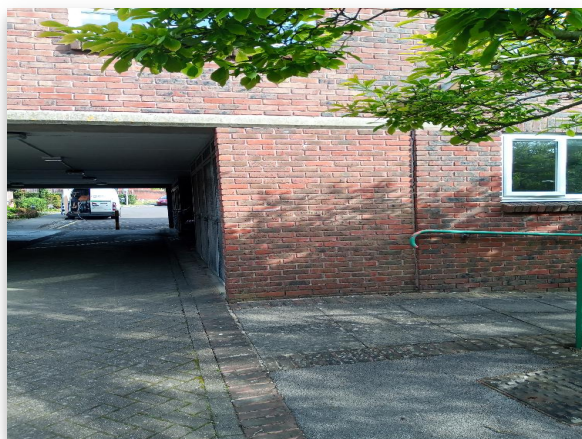
Fig 3.1: Trial Hole 3 Location

Trial hole 3 was completed in the requested location and reached the requested depth. The footing was discovered.

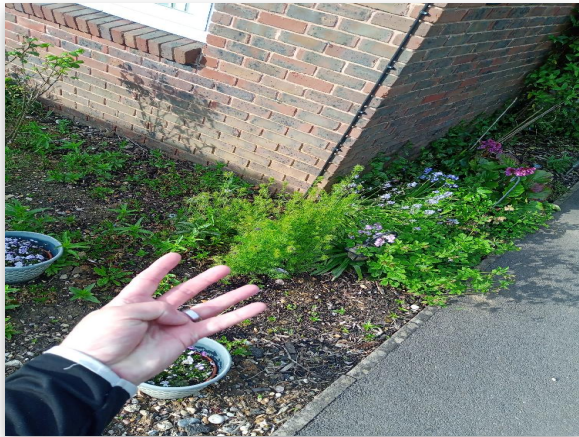
Fig 4.1: Trial Hole 4 Location

Trial hole 4 was completed as a remote borehole to the front of the property and a depth of 3m was reached.

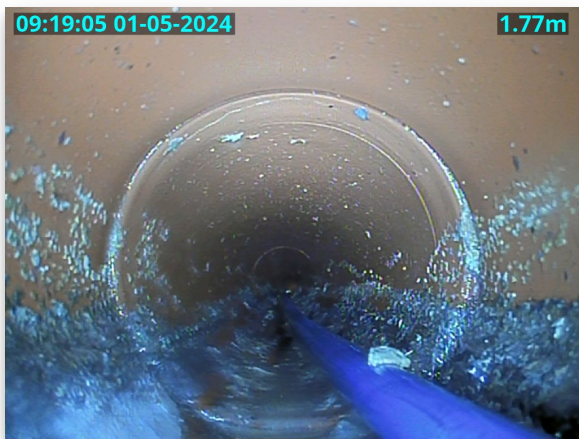
Fig 5.1: Line 1

Our survey of line 1 revealed cracking.

| Refer Back to Client | <p>It is recommended that the following repairs are carried out to prevent an escape of water from the system:</p> <p><b>Line 1</b></p> <p>Install a 100mm patch liner approximately 1.8m upstream of MH1. Deep manhole entry will be required to install the liner.</p> <p>Install a 100mm patch liner approximately 2.5m downstream of MH1. Deep manhole entry will be required to install the liner.</p> <p><b>Line 3</b></p> <p>We need to perform root cutting of the drains for approximately 2 hours prior to lining.</p> <p>Install 6m of 100mm liner directly upstream of MH2.</p> <p><b>Line 5</b></p> <p>We need to perform root cutting of the drains for approximately 1 hours prior to lining.</p> <p>Install a 150mm patch liner approximately 0.7m downstream of MH2.</p> <p>Install a 150mm patch liner approximately 1.6m downstream of MH2.</p> <p>We will now refer the claim back to the client in order to progress the claim.</p> |

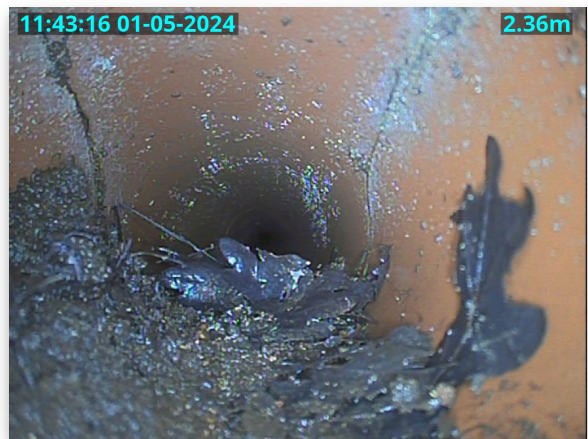
Fig 5.2: Line 3

Our survey of line 3 revealed root ingress and cracking.

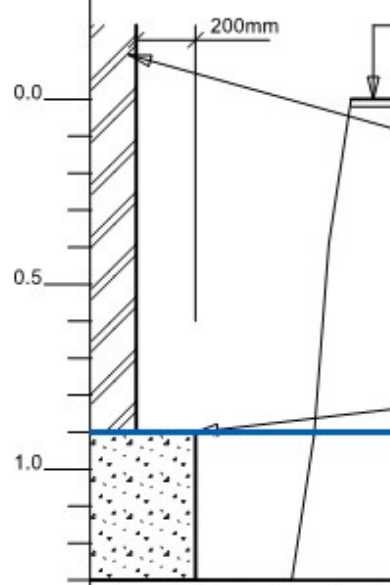
# Trial Hole Log No.1

| Depth<br>(m) | Symbolic Log | Strata Description | Insitu Tests | | Soil<br>Sample | Root<br>Sample |
|---|---|---|---|--|---|---|
| 1.0 | | Water encountered here | | | | |
| 2.0 | | Moist very stiff orange brown<br>fine to medium<br>gravelly silty CLAY | 150kpa | | Soil<br>@ 1.8m | |
| | | Moist very stiff brown fine to medium<br>gravelly silty CLAY | 150kpa | | Soil<br>@ 2.8m | |

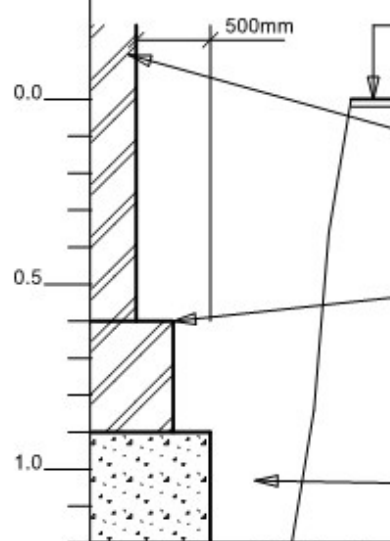
## Trial Hole Log No.2

| Depth<br>(m) | Symbolic Log | Strata Description | Insitu Tests | | Soil<br>Sample | Root<br>Sample |
|---|---|---|---|--|---|---|
| 0.5 | | Step Underpinned | | | | |
| 1.2 | | Moist very stiff orange brown fine to medium gravelly silty CLAY | 100kpa | | Soil @ 1.2m | Root @ 1.2m |
| 2.7 | | Moist very stiff brown fine to medium gravelly silty CLAY | 150kpa | | Soil @ 2.7m | |

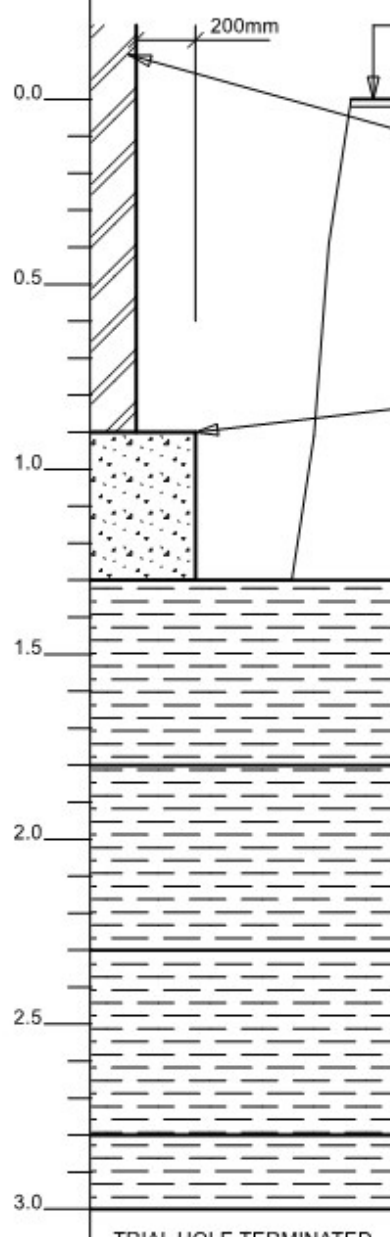
## Trial Hole Log No.3

| Depth<br>(m) | Symbolic Log | Strata Description | Insitu Tests | | Soil<br>Sample | Root<br>Sample |
|---|---|---|---|--|---|---|
| 1.5 | | Moist very stiff brown fine to medium<br>gravelly silty CLAY | 115kpa | | Soil<br>@ 1.3m | |
| 2.0 | | Moist very stiff orange brown<br>fine to medium<br>gravelly silty CLAY | 120kpa | | Soil<br>@ 1.8m | |

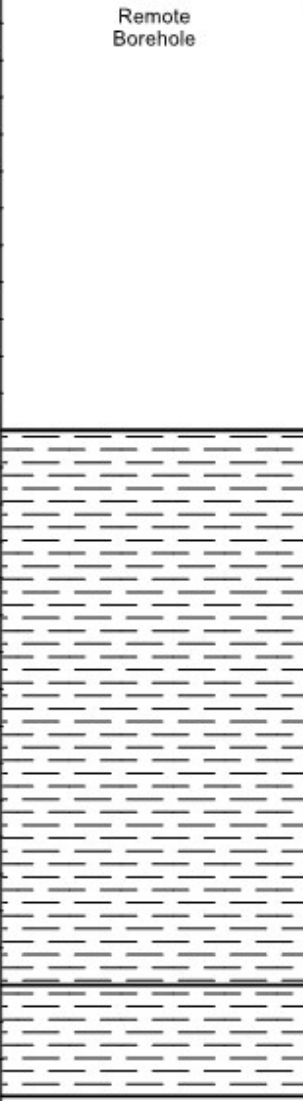
## Trial Hole Log No.4

| Depth<br>(m) | Symbolic Log | Strata Description | Insitu Tests | | Soil<br>Sample | Root<br>Sample |
|---|---|---|---|--|---|---|
| 2.0 | | Moist very stiff orange brown<br>fine to medium<br>gravelly silty CLAY | 95kpa | | Soil<br>@ 1.7m | |
| 3.0 | | Moist very stiff brown fine to medium<br>gravelly silty CLAY | 125kpa | | Soil<br>@ 2.7m | |
