# Havant Thicket Reservoir Pipeline Project

#### Appendix A9.18 **Revised** Pipeline Arboricultural Impact Assessment (Post submission update to record minor scheme changes)

Portsmouth Water Ltd.

Atkins Doc No.: HTR-ATK-ZZ-ZZ-RP-H-0089

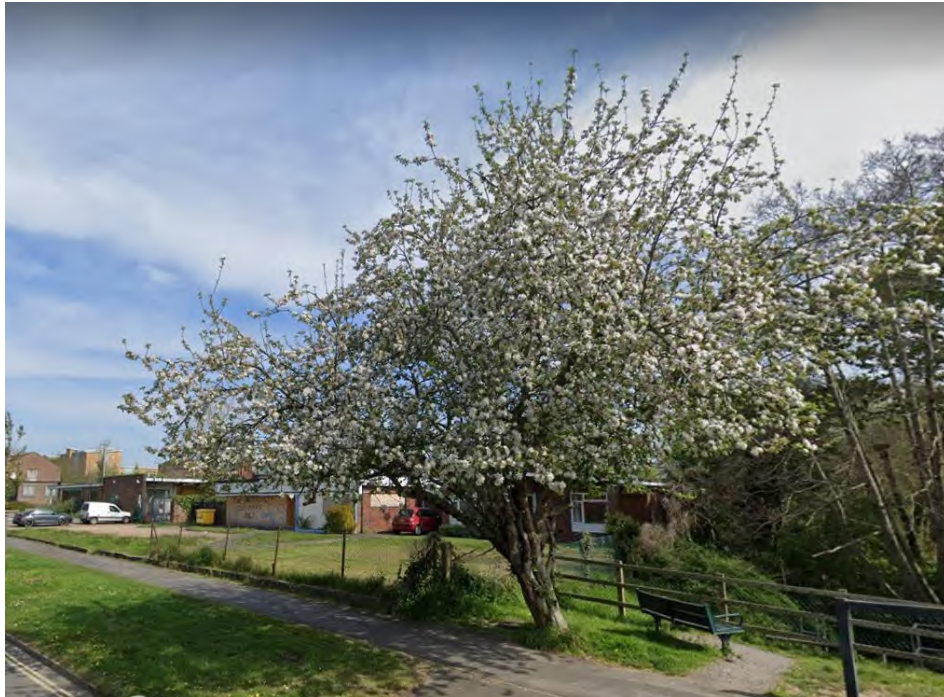
**Figure 3-8 – T065 Apple tree (ATI ref 201615)**

- 3.19. The ATI veteran apple tree is reference T065 as part of this tree survey. The tree is shown below in Figure 3-8 and shows the extensive existing hard surfacing around the tree which is likely to have highly modified its root zone.

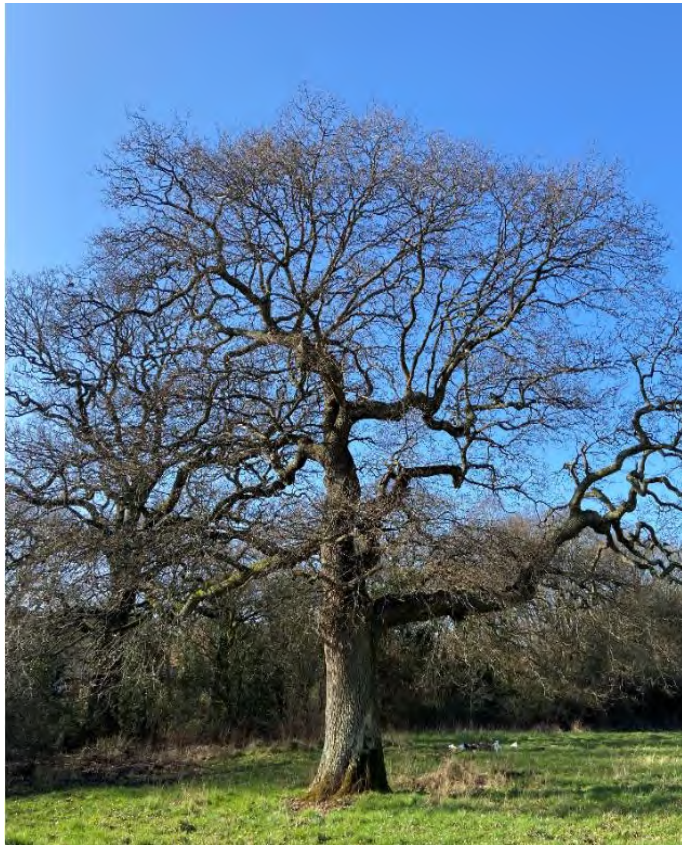
| Tree no. | Species | Location | Summary of value | Tree photographs |
|---|---|---|---|---|
| T075<br>(CP) | Common Oak | Staunton Country Park<br>Easting:47148487<br>Northing:10897386 | <p><b>Size:</b><br/>Large stem girth in comparison to other trees in locality.</p> <p><b>Condition:</b><br/>Decay features present including developing heartwood decay.<br/>Dead branches and old storm damage recorded in crown with desiccated white rot present.<br/>Crown break at approximately 3m.<br/>Pronounced northern scaffold branch</p> <p><b>Biodiversity value:</b><br/>Decayed heartwood rot and white rot providing habitat for saproxylic invertebrates.</p> <p><b>Cultural and heritage value:</b><br/>Tree within Sir George Staunton Conservation Area.</p> <p><b>Age:</b><br/>Its diameter of 1300mm means it has a girth of 4.08m and means it is included within the 'veteran/notable' criterion of girth in relation to age as shown in Figure 1.3 of 'Ancient and Other Veteran Trees: Further Guidance on Management' (Lonsdale, 2013).</p> | |

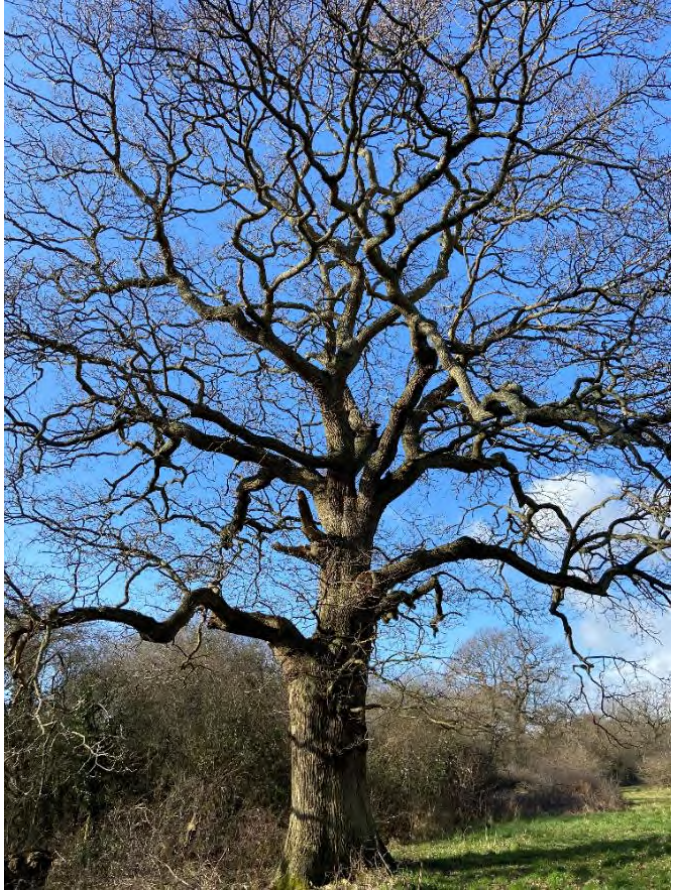
| Tree no. | Species | Location | Summary of value | Tree photographs |
|---|---|---|---|---|
| T077<br>(CP) | Common Oak | Staunton Country<br>Park<br>Easting:47160754<br>Northing:10885194 | <p><b>Size:</b><br/>Large stem girth in comparison to other trees in locality.</p> <p><b>Condition:</b><br/>Decay features present including developing heartwood decay.<br/>Dead branches and old storm damage recorded in crown with desiccated white rot present.</p> <p><b>Biodiversity value:</b><br/>Decayed heartwood rot and white rot providing habitat for saproxylic invertebrates.</p> <p><b>Cultural and heritage value:</b><br/>Tree within Sir George Staunton Conservation Area.</p> <p><b>Age:</b><br/>Its diameter of 1300mm means it has a girth of 4.08m and means it is included within the 'veteran/notable' criterion of girth in relation to age as shown in Figure 1.3 of 'Ancient and Other Veteran Trees: Further Guidance on Management' (Lonsdale, 2013).</p> | |

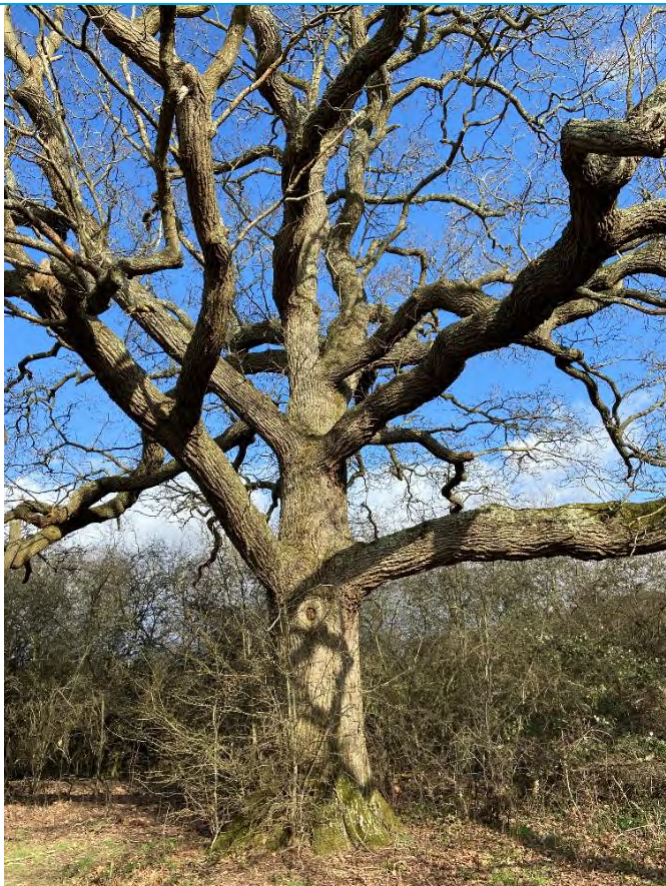
| Tree no. | Species | Location | Summary of value | Tree photographs |
|---|---|---|---|---|
| T082<br>(CP) | Common Oak | Staunton Country Park<br>Easting:47172114<br>Northing:10883285 | <p><b>Size:</b><br/>Large stem girth in comparison to other trees in locality.</p> <p><b>Condition:</b><br/>Decay features present including developing heartwood decay.<br/>Dead branches and old storm damage recorded in crown with desiccated white rot present.<br/>Vast crown, dominant to west with pronounced scaffold branch.<br/>Pronounced buttress roots.</p> <p><b>Biodiversity value:</b><br/>Decayed heartwood rot and white rot providing habitat for saproxylic invertebrates.</p> <p><b>Cultural and heritage value:</b><br/>Tree within Sir George Staunton Conservation Area.</p> <p><b>Age:</b><br/>It's diameter of 1400mm means it has a girth of 4.40m and means it is included within the 'veteran/notable' criterion of girth in relation to age as shown in Figure 1.3 of 'Ancient and Other Veteran Trees: Further Guidance on Management' (Lonsdale, 2013).</p> | |

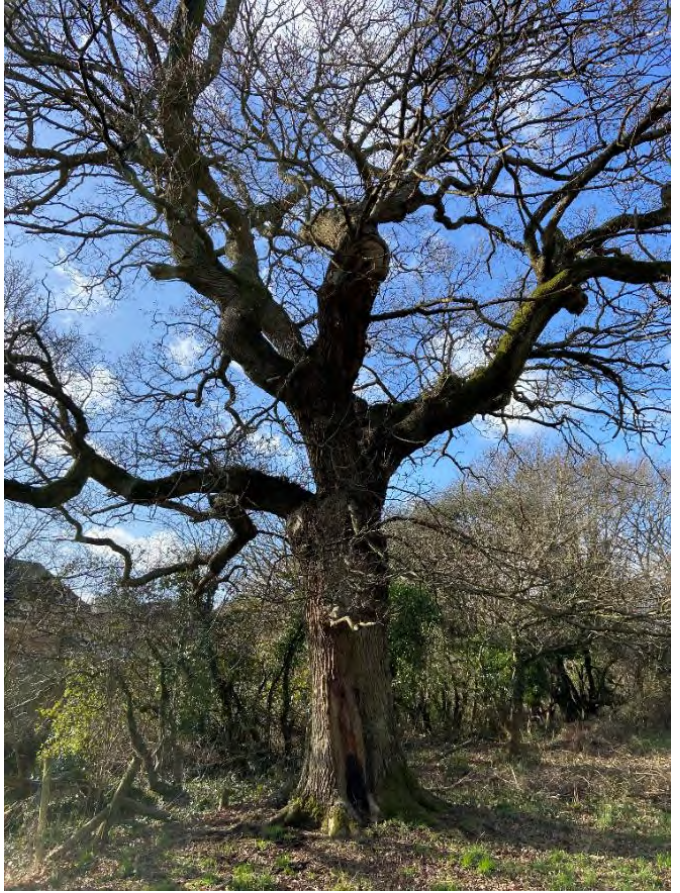
| Tree no. | Species | Location | Summary of value | Tree photographs |
|---|---|---|---|---|
| T083<br>(CP) | Common Oak | Staunton Country Park<br>Easting:47171565<br>Northing:10879370 | <p><b>Size:</b><br/>Large stem girth in comparison to other trees in locality.</p> <p><b>Condition:</b><br/>Decay features present including basal cavity on south side of main stem revealing desiccated white rot and developing heartwood decay.<br/>Dead branches and old storm damage recorded in crown with desiccated white rot present.<br/>Crown break at approximately 4m into multi stems suggesting historic pollard.</p> <p><b>Biodiversity value:</b><br/>Decayed heartwood rot and white rot providing habitat for saproxylic invertebrates.</p> <p><b>Cultural and heritage value:</b><br/>Tree within Sir George Staunton Conservation Area.</p> <p><b>Age:</b><br/>Its diameter of 1250mm means it has a girth of 3.92m and means it is included within the 'locally notable' criterion of girth in relation to age as shown in Figure 1.3 of 'Ancient and Other Veteran Trees: Further Guidance on Management' (Lonsdale, 2013).</p> | |

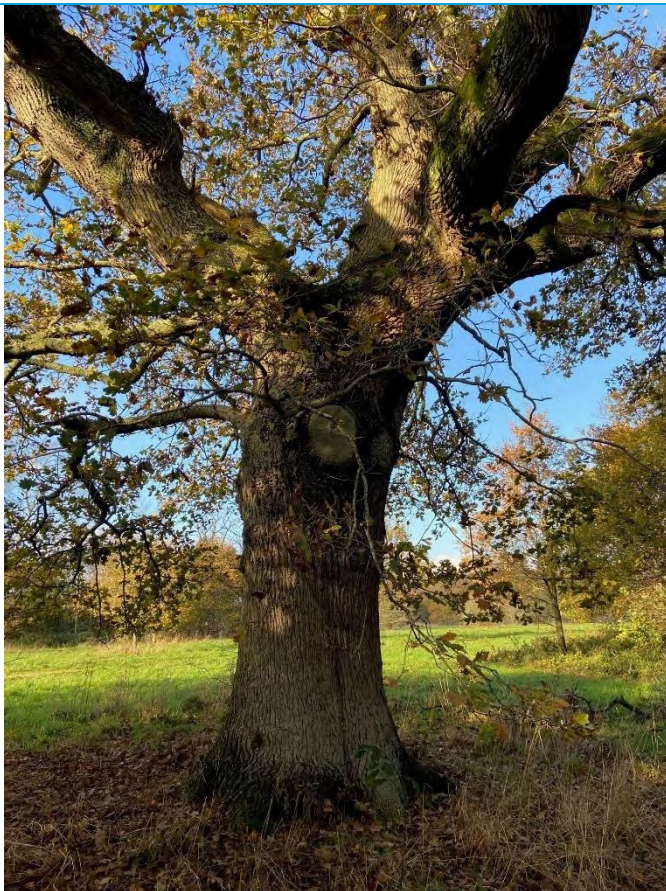
| Tree no. | Species | Location | Summary of value | Tree photographs |
|---|---|---|---|---|
| T023 | Common Oak | Staunton Country Park<br>Easting: 47170911<br>Northing: 10888163 | <p><b>Size:</b><br/>Large stem girth in comparison to other trees in locality.</p> <p><b>Condition:</b><br/>Crown break at approximately 5m into multi stems. Suggesting potential former pollard. Goblet shaped crown.<br/>Dead branches and old storm damage recorded in crown with desiccated white rot present.</p> <p><b>Biodiversity value:</b><br/>Potential heartwood rot and white rot providing habitat for saproxylic invertebrates.</p> <p><b>Cultural and heritage value:</b><br/>Tree within Sir George Staunton Conservation Area.</p> <p><b>Age:</b><br/>Its diameter of 1230mm means it has a girth of 3.86m and means it is included within the 'locally notable' criterion of girth in relation to age as shown in Figure 1.3 of 'Ancient and Other Veteran Trees: Further Guidance on Management' (Lonsdale, 2013).</p> | |

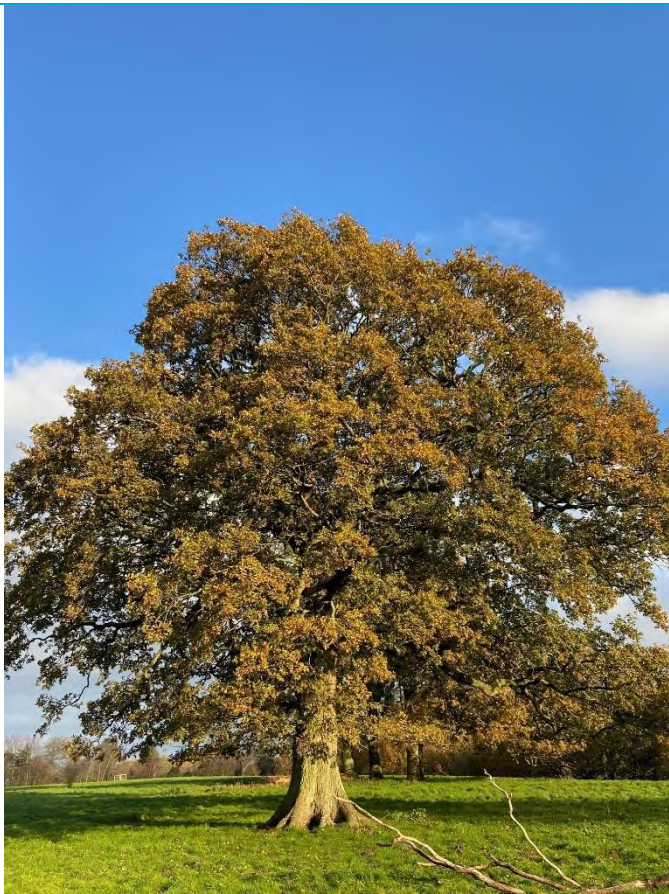
| Tree no. | Species | Location | Summary of value | Tree photographs |
|---|---|---|---|---|
| T027 | Common Oak | Staunton Country Park<br>Easting: 47185145<br>Northing: 10875061 | <p><b>Size:</b><br/>Large stem girth in comparison to other trees in locality.</p> <p><b>Condition:</b><br/>Decay features present including developing heartwood decay.<br/>Dead branches and old storm damage recorded in crown with desiccated white rot present.<br/>Pronounced buttress roots and basal flare. <i>Ganoderma</i> spp. Wood decay fungi brackets present in between buttress roots to South West, North East and West. Not significant at present. Historic brackets. Extensive reaction wood</p> <p><b>Biodiversity value:</b><br/>Decayed heartwood rot and white rot providing habitat for saproxylic invertebrates.</p> <p><b>Cultural and heritage value:</b><br/>Tree within Sir George Staunton Conservation Area.</p> <p><b>Age:</b><br/>Its diameter of 1330mm means it has a girth of 4.17m and means it is included within the 'veteran/notable' criterion of girth in relation to age as shown in Figure 1.3 of 'Ancient and Other Veteran Trees: Further Guidance on Management' (Lonsdale, 2013).</p> | |

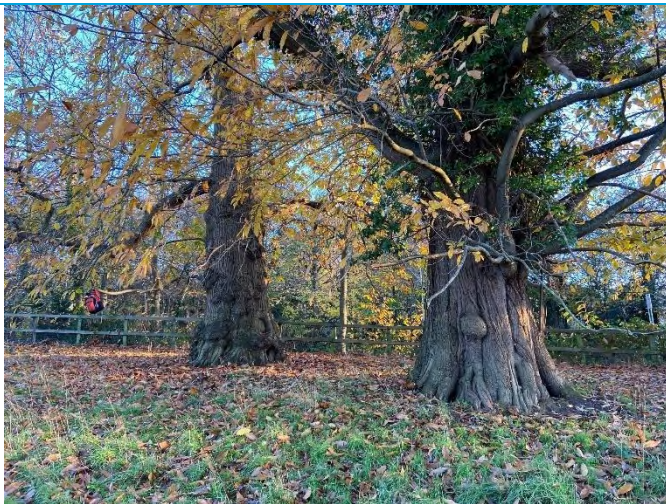
| Tree no. | Species | Location | Summary of value | Tree photographs |
|---|---|---|---|---|
| T036<br>T037 | Sweet Chestnut<br>Sweet Chestnut | Staunton Country Park<br>Easting: 47196497<br>Northing: 10870251 | <p><b>Size:</b><br/>Large stem girths in comparison to other trees in locality.</p> <p><b>Condition:</b><br/>Dead branches and old storm damage recorded in crowns with desiccated white rot present.<br/>Large diameter dead wood present. Crowns still full, no significant retrenchment recorded.<br/>Pronounced basal swelling.<br/>Dense ivy encroachment on T036.</p> <p><b>Biodiversity value:</b><br/>Decayed white rot providing habitat for saproxylic invertebrates.</p> <p><b>Cultural and heritage value:</b><br/>Trees within Sir George Staunton Conservation Area.</p> <p><b>Age:</b><br/>Their diameters of 1670mm &amp; 1680mm mean they have girths of 5.2m and that they are included within the 'veteran/notable' criterion of girth in relation to age as shown in Figure 1.3 of 'Ancient and Other Veteran Trees: Further Guidance on Management' (Lonsdale, 2013).</p> | |

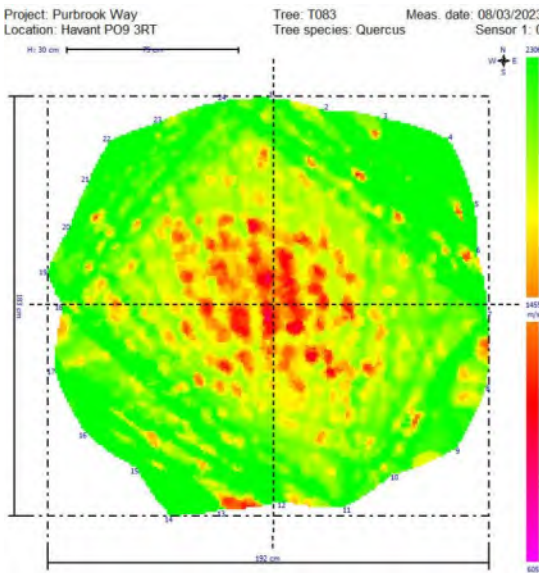
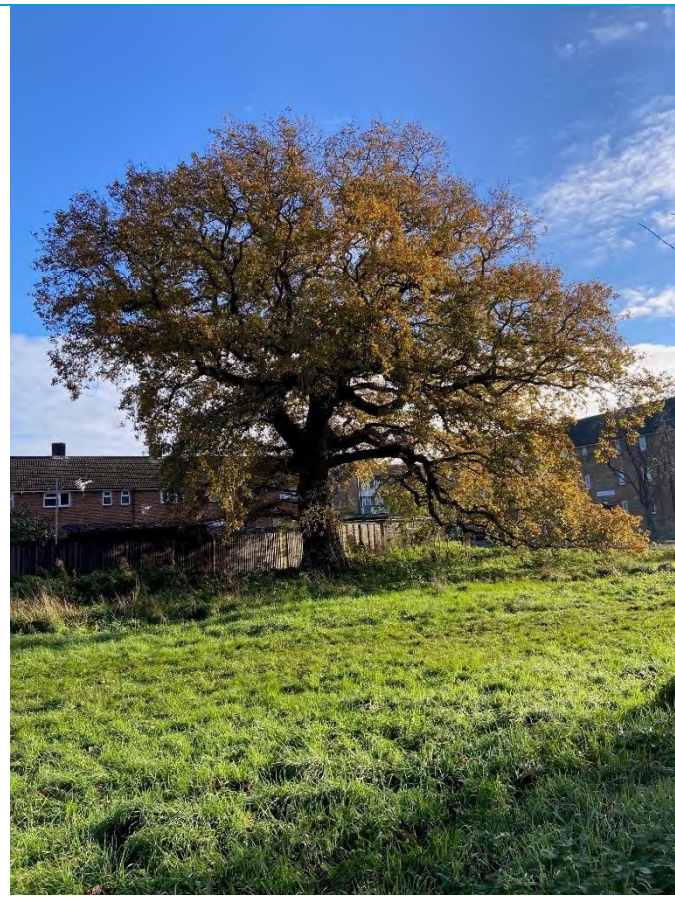
| Tree no. | Species | Location | Summary of value | Tree photographs |
|---|---|---|---|---|
| T083 | Common Oak | Purbrook Way<br>Easting: 47120760<br>Northing: 10780942 | <p><b>Size:</b><br/>Large stem girth in comparison to other trees in locality.</p> <p><b>Condition:</b><br/>Occasional moderate diameter deadwood in lower and middle crown. Not extensive.<br/>Arbotom sonic tomography testing revealed limited internal decay (red being decayed wood, green being sound)</p> <p>Project: Purbrook Way<br/>Location: Havant PO9 3RT</p> <p>Tree: T083<br/>Tree species: Quercus</p> <p>Meas. date: 08/03/2023<br/>Sensor 1: 0</p> <p><b>Biodiversity value:</b><br/>Occasional dead wood with white rot providing limited habitat for saproxylic invertebrates.</p> <p><b>Cultural and heritage value:</b></p> | |

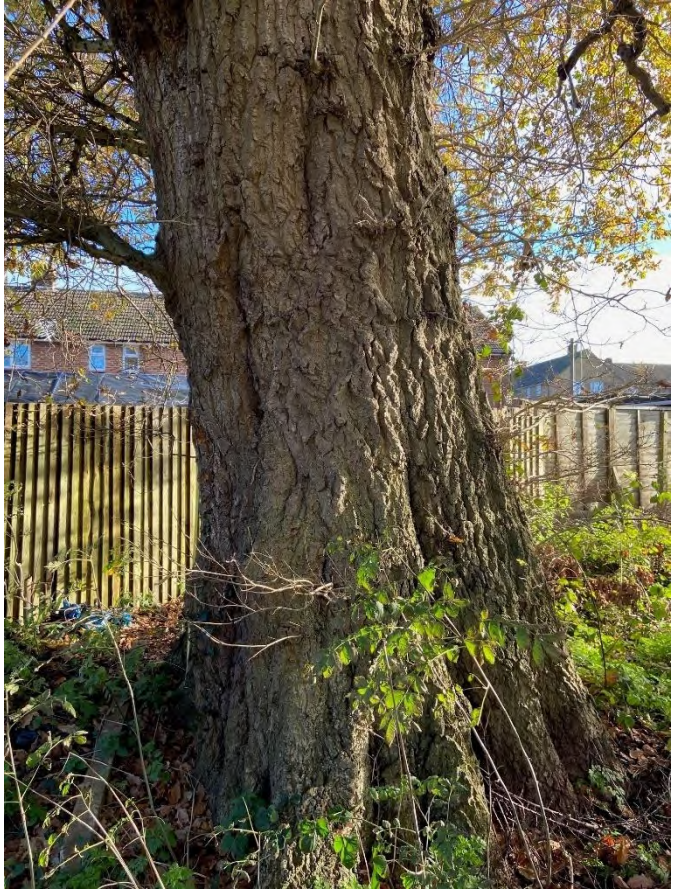
| Tree no. | Species | Location | Summary of value | Tree photographs |
|---|---|---|---|---|
| | | | <p>Tree is not subject to a TPO or set within a Conservation Area. Old relatively to other trees in the locality.</p> <p><b>Age:</b></p> <p>Its diameter of 1330mm means it has a girth of 4.17m and means it is included within the 'veteran/notable' criterion of girth in relation to age as shown in Figure 1.3 of 'Ancient and Other Veteran Trees: Further Guidance on Management' (Lonsdale, 2013).</p> | |

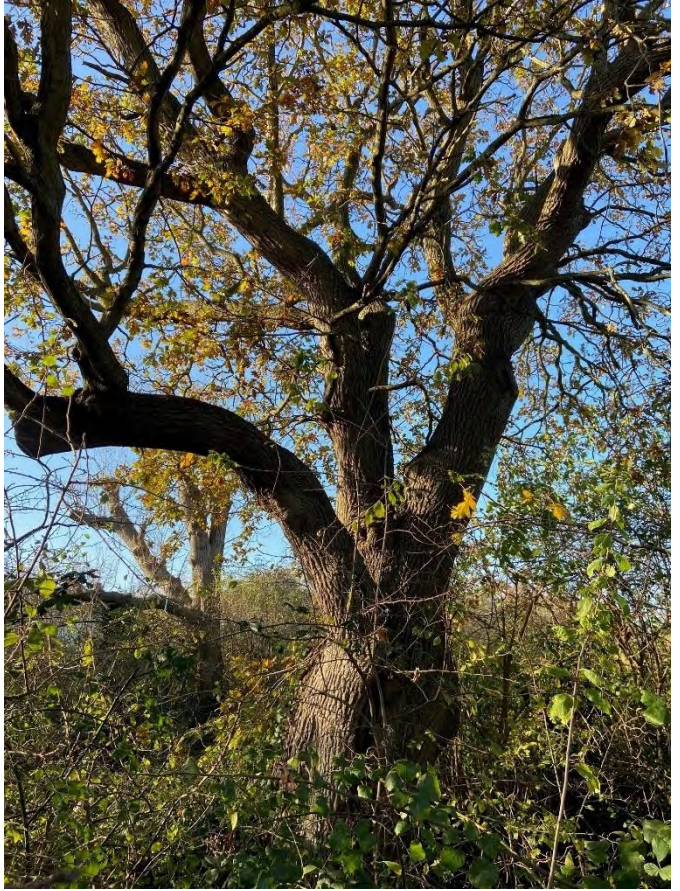
| Tree no. | Species | Location | Summary of value | Tree photographs |
|---|---|---|---|---|
| T128 | Common Oak | West of Stockheath lane, on bank of Hermitage Stream<br>Easting: 47121115<br>Northing: 10725990 | <p><b>Size:</b><br/>Large stem girth in comparison to other trees in locality.</p> <p><b>Condition:</b><br/>Decay features present including developing heartwood decay.<br/>Dead branches and old storm damage recorded in crown with desiccated white rot present.<br/>Pronounced basal swelling.</p> <p><b>Biodiversity value:</b><br/>Decayed heartwood rot and white rot providing habitat for saproxylic invertebrates.</p> <p><b>Cultural and heritage value:</b><br/>Tree is not subject to a TPO or set within a Conservation Area. Old relatively to other trees in the locality.</p> <p><b>Age:</b><br/>Its diameter of 1300mm means it has a girth of 4.08m and means it is included within the 'veteran/notable' criterion of girth in relation to age as shown in Figure 1.3 of 'Ancient and Other Veteran Trees: Further Guidance on Management' (Lonsdale, 2013).</p> | |

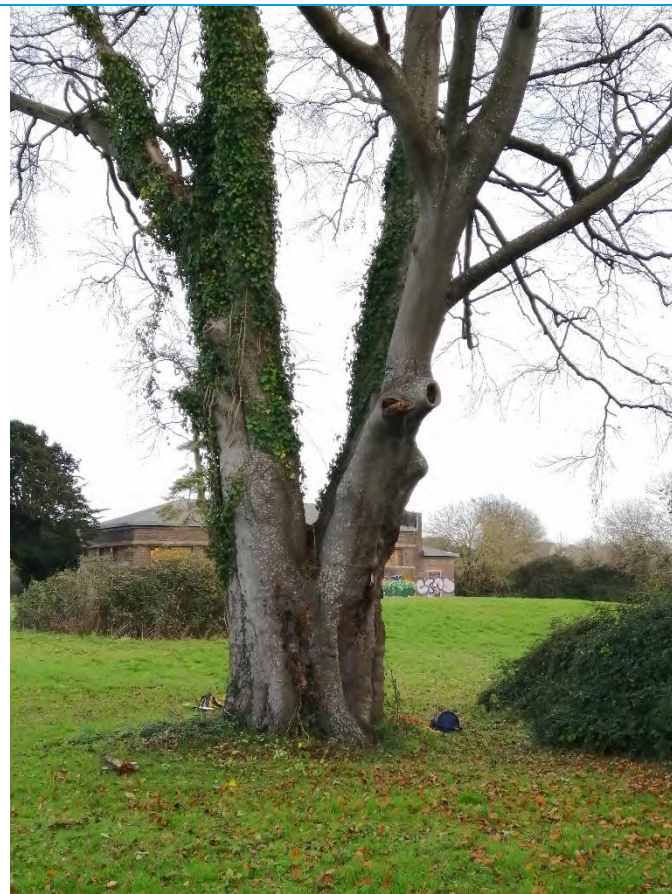
| Tree no. | Species | Location | Summary of value | Tree photographs |
|---|---|---|---|---|
| T189 | Common Beech | East of Hermitage Stream in Bedhampton Water Treatment works<br>Easting: 47042762<br>Northing: 10626212 | <p><b>Size:</b><br/>Large stem girth in comparison to other trees in locality.</p> <p><b>Condition:</b><br/>Decay features present including developing heartwood decay.<br/>Dead branches and old storm damage recorded in crown with desiccated white rot present.<br/>Three stems from 1.5m.</p> <p><b>Biodiversity value:</b><br/>Decayed heartwood rot and white rot providing habitat for saproxylic invertebrates.</p> <p><b>Cultural and heritage value:</b><br/>Tree is not subject to a TPO or set within a Conservation Area. Old relatively to other trees in the locality.</p> <p><b>Age:</b><br/>Its diameter of 1580mm means it has a girth of 4.96m and means it is included within the 'veteran/notable' criterion of girth in relation to age as shown in Figure 1.3 of 'Ancient and Other Veteran Trees: Further Guidance on Management' (Lonsdale, 2013).</p> | |
