11<sup>th</sup> January 2022

Our ref: GE20565/FG01/220111

**RE: Phase 2 Manor Farm, Lower Road, Bedhampton – Soakage Testing and Installation of Groundwater Monitoring Wells**

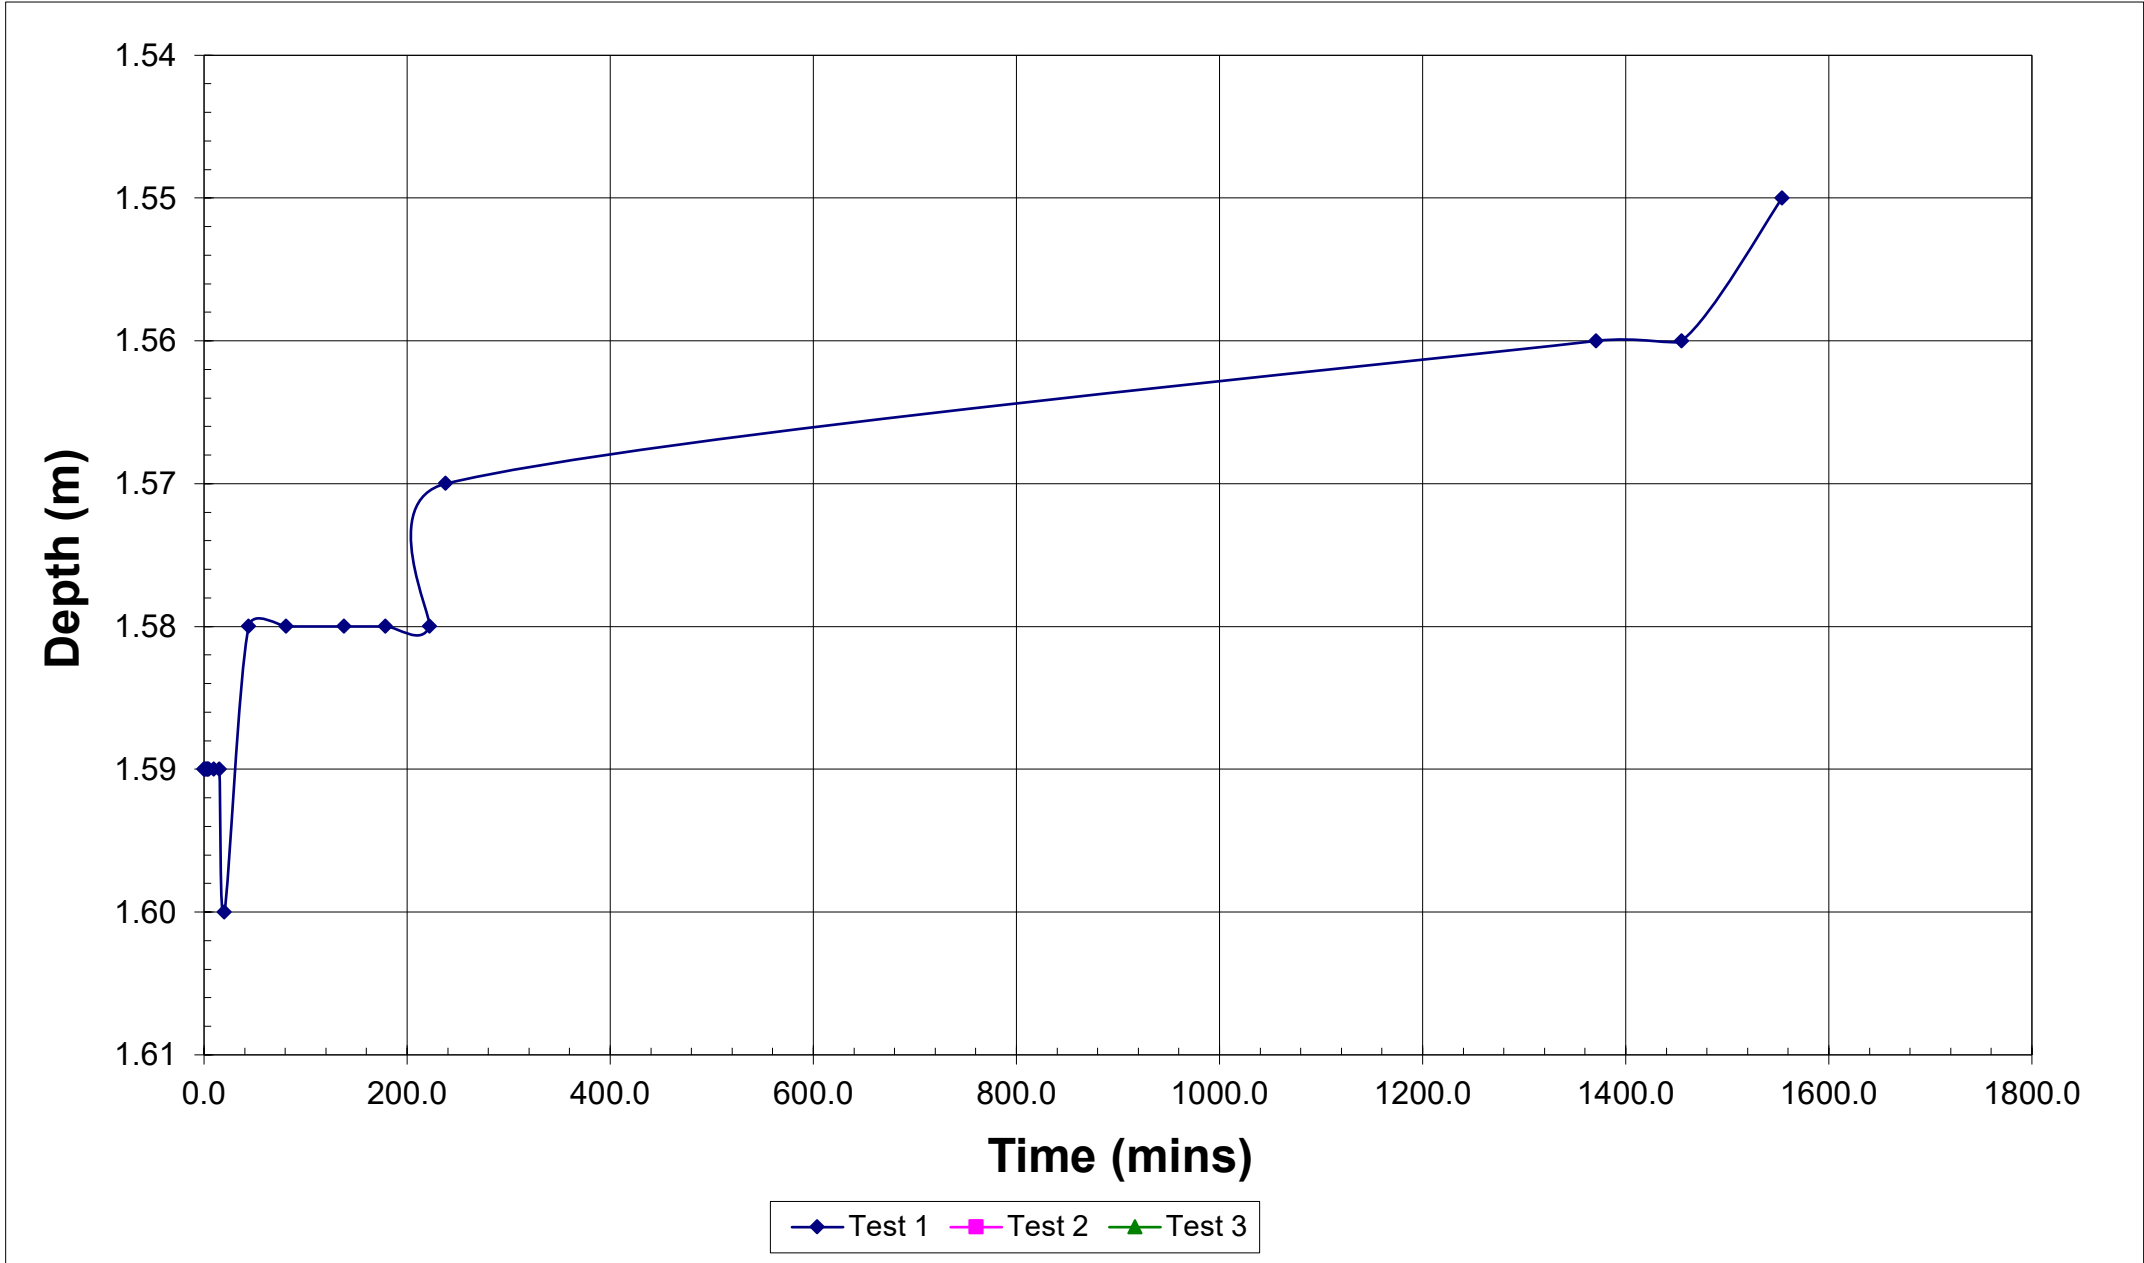
| <b>Pit reference</b> | <b>SA02</b> |

The testing was undertaken over two consecutive days. It was not possible to calculate an infiltration rate for SA02, as water levels within this trial pit increased during the testing period, therefore the test was deemed to have failed. There was an insufficient fall in head to calculate an infiltration rate for the tests undertaken within SA01, which were located within the cohesive River Terrace Deposits, and it is not considered suitable or reliable to estimate a permeability based on the actual measured range as this would be likely to derive an overly optimistic permeability. The soakage testing results are presented within Appendix B.

| Soil infiltration rate (m/s) | Insufficient fall in water to complete test | |

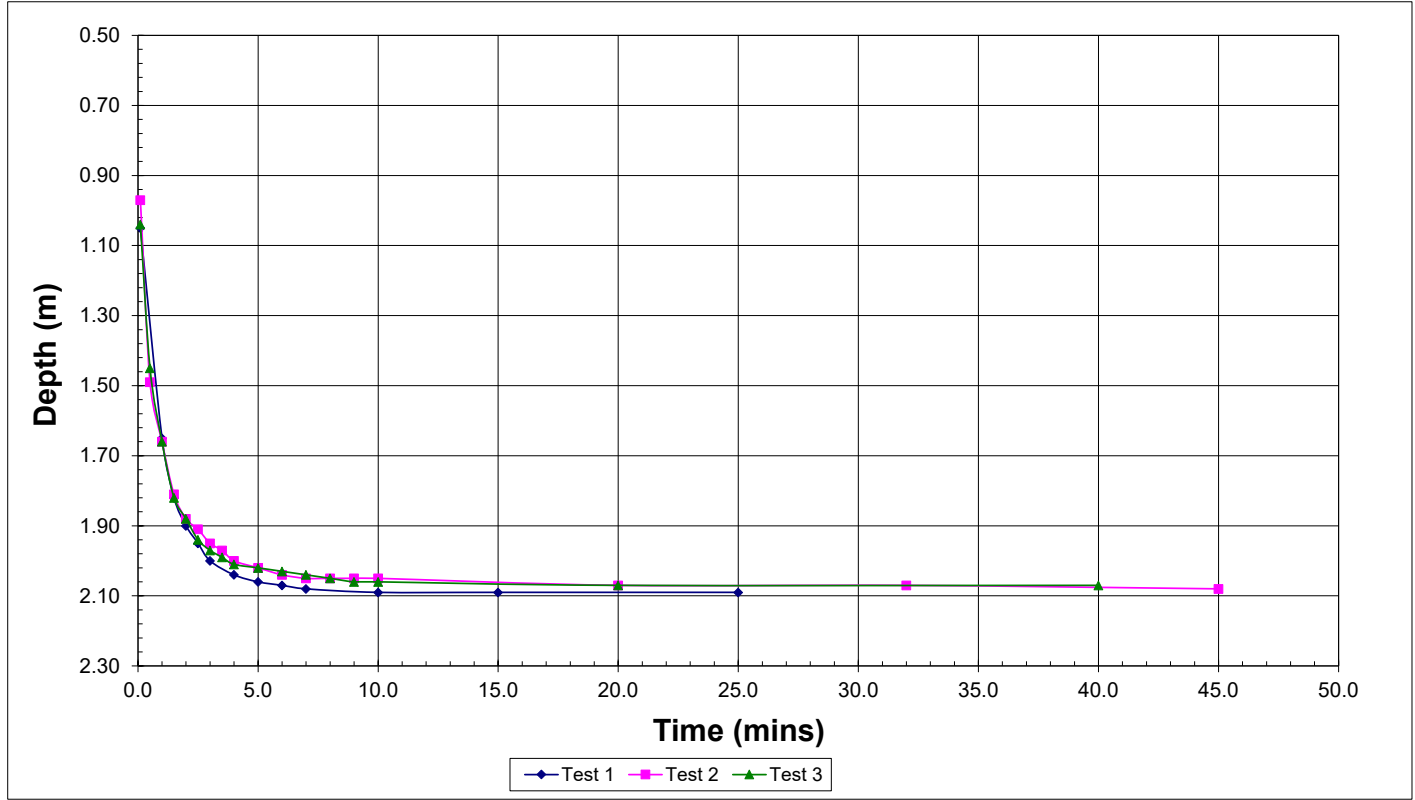
| <b>BH Reference:</b> | <b>BH01</b> |

Groundwater was present within the borehole during testing and was recorded at a depth of 2.09m bgl prior to commencing testing. The estimated preliminary infiltrations rates for each test undertaken within BH01 are summarised within Table 3 below with the results presented in a graphical format in Appendix C.

| Trial Pit | Stratum tested | Estimated infiltration rates (m/s) | | |
|---|---|---|---|---|
| BH01 | Chalk | $2.29 \times 10^{-7}$ | $1.41 \times 10^{-7}$ | $1.43 \times 10^{-7}$ |

Given the presence of highly weathered Chalk strata at relatively shallow depth, it is recommended that any infiltration devices are located at least 20m from any structures.
