PROJECT NAME  
Staunton Farm, Gothic Library

SHEET NAME  
GA Roof Plan  
Condition Survey  
And Scope of Works

P13962-HCC-ZZ -115 ROOF

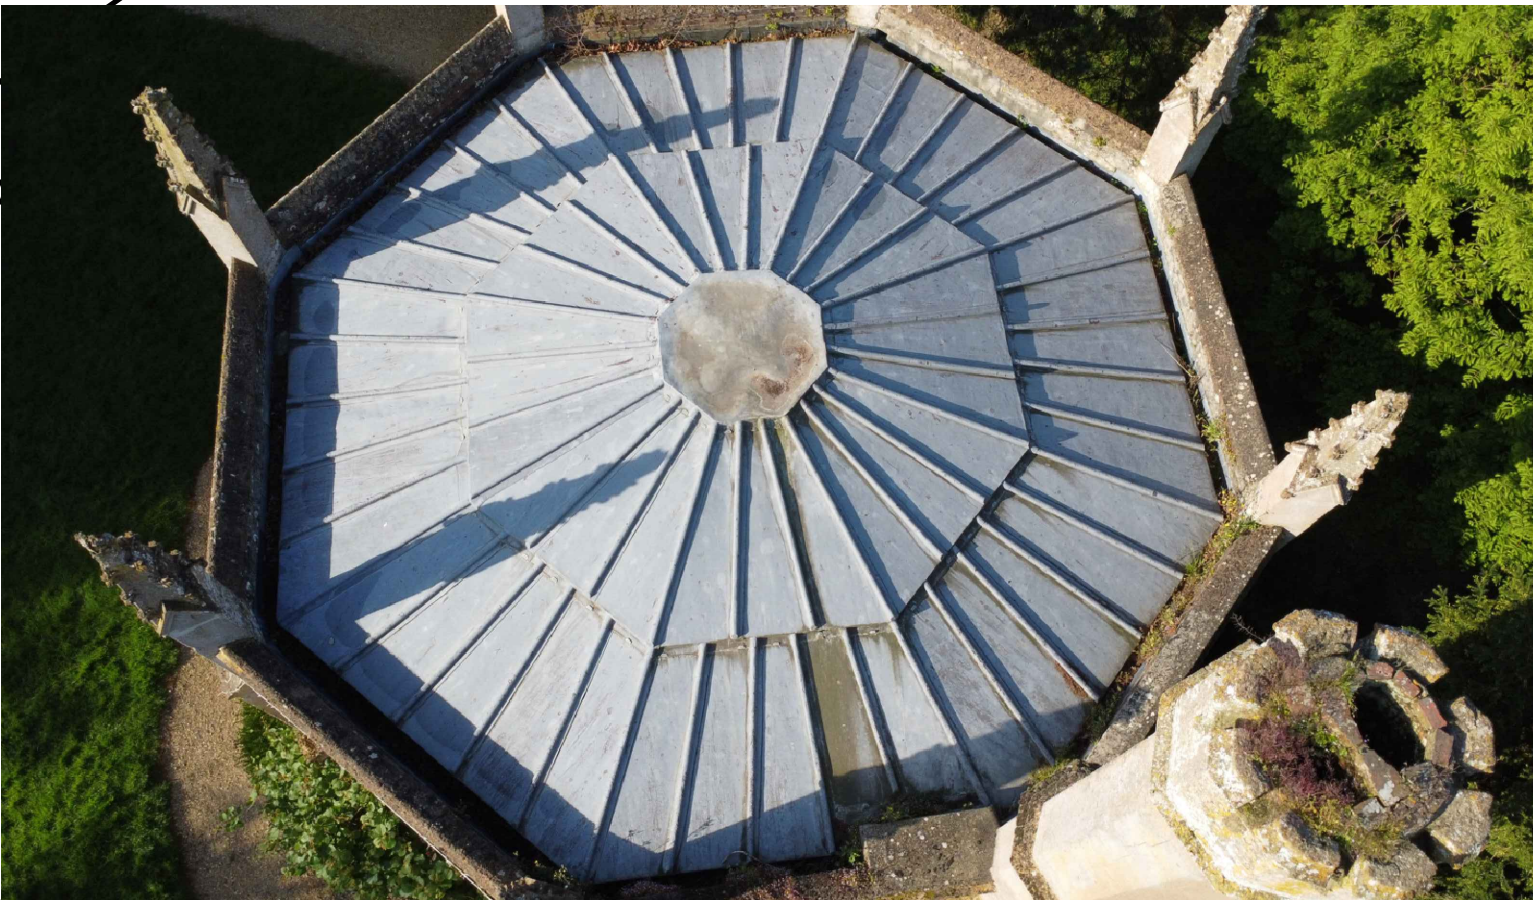
When high level access is available, invite the CA and structural engineer to undertake a roof condition survey, to include inspection of the roof covering, the gutter, the flashing, the condition of the parapet masonry and render finish inside and outside. Further high level access to the chimney is required to inspect the capping detail.

There are drone images of the roof covering. It is assumed that the lead sheet is in sound condition. However there is evidence of leaks to the gutter, which appears to be caused by vegetation and blockages. Allow for cleaning, the gutter and outlets through the parapet.

4.1 Green hatch indicates areas of high level internal damp masonry.  
Drone photograprs indicate vegetation in parapet gutter.  
Clear the gutter to the full perimeter and clear the 2 no. shoots through the parapet masonry..

2.1 Cracks above window arch in this location extends through the parapet.  
Provide high level access for structural inspection.

4.2 Top section stabilise loose render.

4.3 Check whether chimney is capped.  
If not cap with slate fixed over ventilated hit and miss masonry, to direct water through the battlements.

2.1 Structural inspection.  
2 no. 1m long Hilibar crack stitching.  
Outer face set into brickwork above arch window.  
Inner face set masonry parapet facing the roof
