## **Bat Survey Report**

**12 Nile Street**

**Emsworth  
Hampshire  
PO10 7EE**

**22-195  
August 2023**

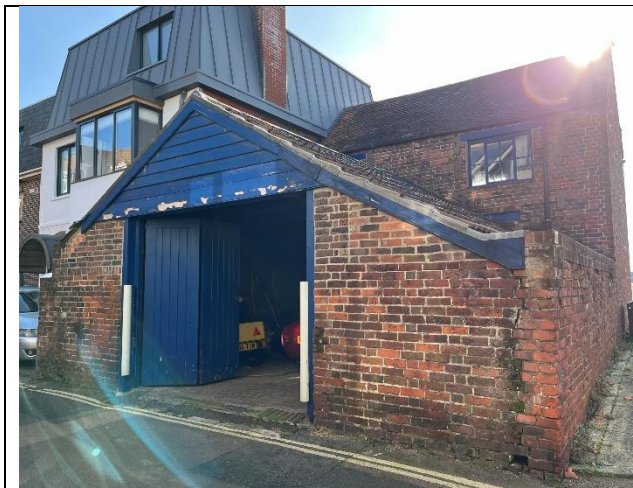
**Photograph 1:** The north and west elevations.

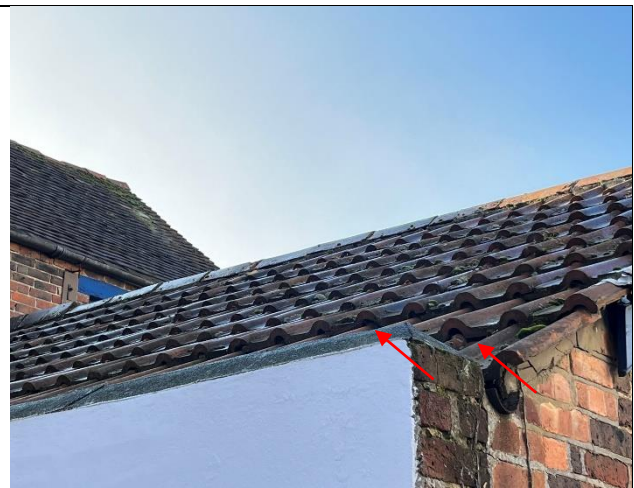
- 4.1 The building subject to survey is a brick-built structure with a two-storey southern section and single-storey northern section, both supporting gabled roofs. The northern single-storey roof supports interlocking clay roof tiles which were recorded to be largely tight fitting with a small number of gaps suitable for bat access recorded under raised tiles and where mortar was missing from the bottom row of tiles.

**Photograph 2:** Raised tiles on the single-storey roof.

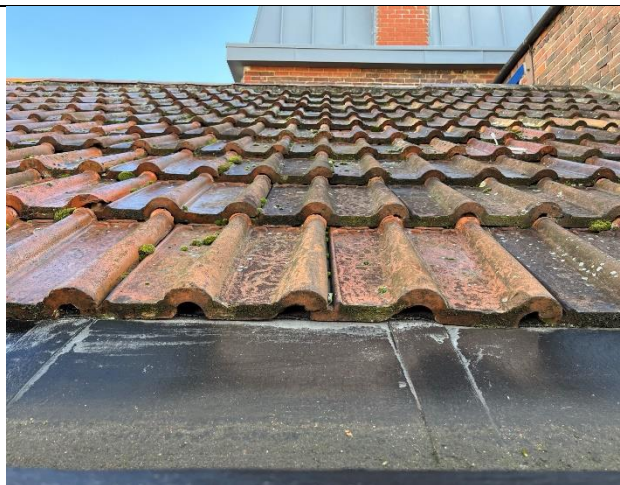
**Photograph 3:** Gaps within the bottom row of tiles on the single-storey roof.

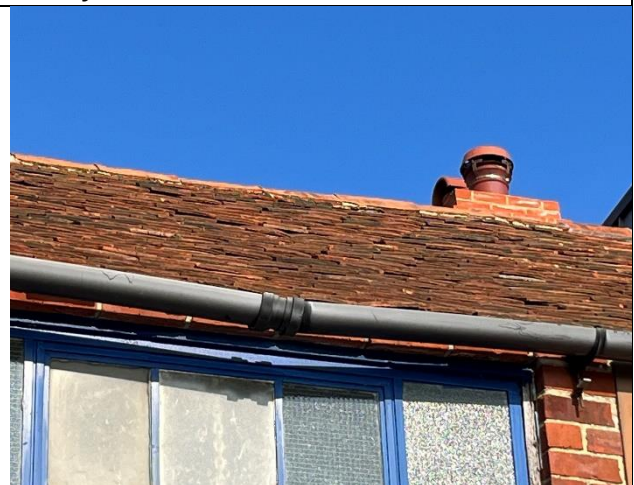
- 4.2 The two-storey southern roof supports clay roof tiles which were recorded to contain numerous gaps suitable for bat access under raised tiles. A gap which allows direct access into the workshop on the second floor is also present on the western elevation.

**Photograph 4:** Raised roof tiles on the two-storey roof.

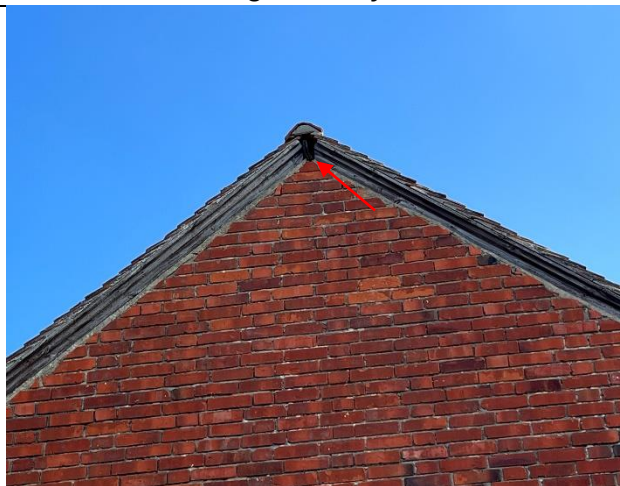
**Photograph 5:** Gap allowing direct access into the workshop.

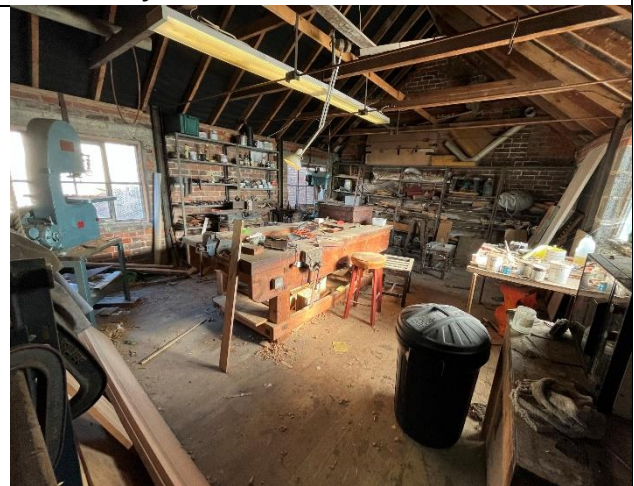
- 4.3 The building is open to the apex within all sections of the building and bitumen felt can be seen below the tiles. A section of bitumen felt has fallen away within the two-storey roof and modern non-bitumen-coated roofing membrane can be seen underneath. The internal space is bright due to the presence of windows which allow light into all rooms of the building. No evidence of bats was recorded internally.

**Photograph 6:** The first floor workshop.
