## **ARBORICULTURAL IMPLICATIONS ASSESSMENT.**

**For Mr James, 6 Netherfield Close Havant.**

**Produced by Andrew Skeet ONDipArb MW1980**

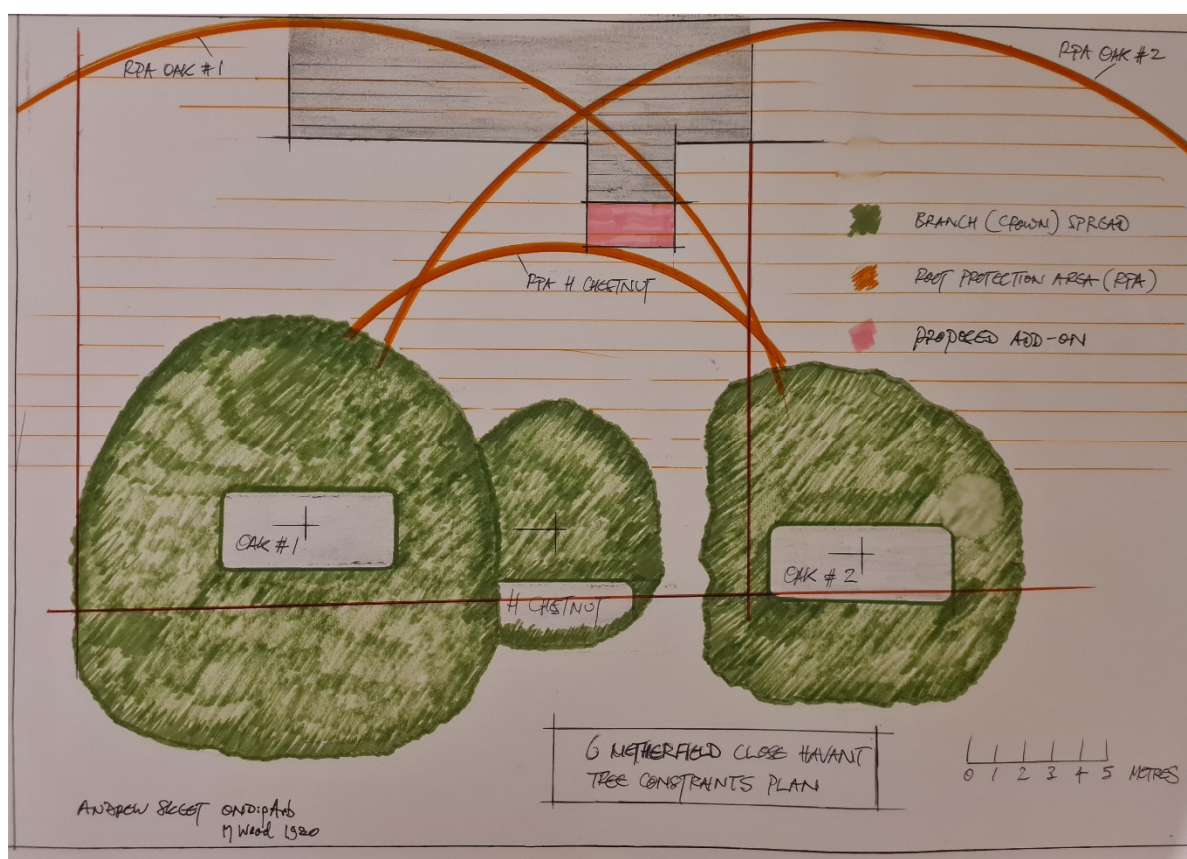
The proposed add-on falls wholly within the Root Protection Area (RPA) of both oaks but is right on the edge of oak #1 RPA and close to the edge of oak #2 RPA and is outside the Horse Chestnut RPA.

Oak #1 RPA is 798 square metres and oak #2 RPA is 693 square metres. Especially in the case of oak #2 some of the RPA is under existing buildings (not newly built) but the trees have had decades to adapt their root systems as required so it may be safe to say the RPAs are not compromised.

The proposed construction falls within the overlap of both these RPAs so any fine root loss could be from either oak (but more likely oak #2). The proposed construction will require excavating into a mere 6-7 square metres and is therefore not of any significance to either tree given their very large square metre area. By contrast an excavation of this size at the base of either tree could be seriously harmful to the tree.

I am advising that no special precautions are necessary when excavating and building.

So far as concerns the possibility of damage to the above-ground parts of the trees, the risk is almost non-existent because oak #1 is so far away and oak #2 is 4 metres into a neighbouring garden. I am recommending that BS5837 spec protective fencing is not necessary and so would be an unjustifiable requirement to place on the applicant. I would consider ground protection to be unnecessary.

I would though, recommend roping or taping off any parts of the garden that the builders will not need access to and requiring them to not use this roped off area for storage. This will minimise the risk of toxic materials seeping into the RPAs, for example from mortar, mortar additives, fuel or oil from any machines in use.
