## BS 5837:2012 Arboricultural Impact Assessment

**SITE: Bunting Gardens, Waterloooville. PO8 9UW.**

**Stuart Campbell FdSc Arb (MArborA)**

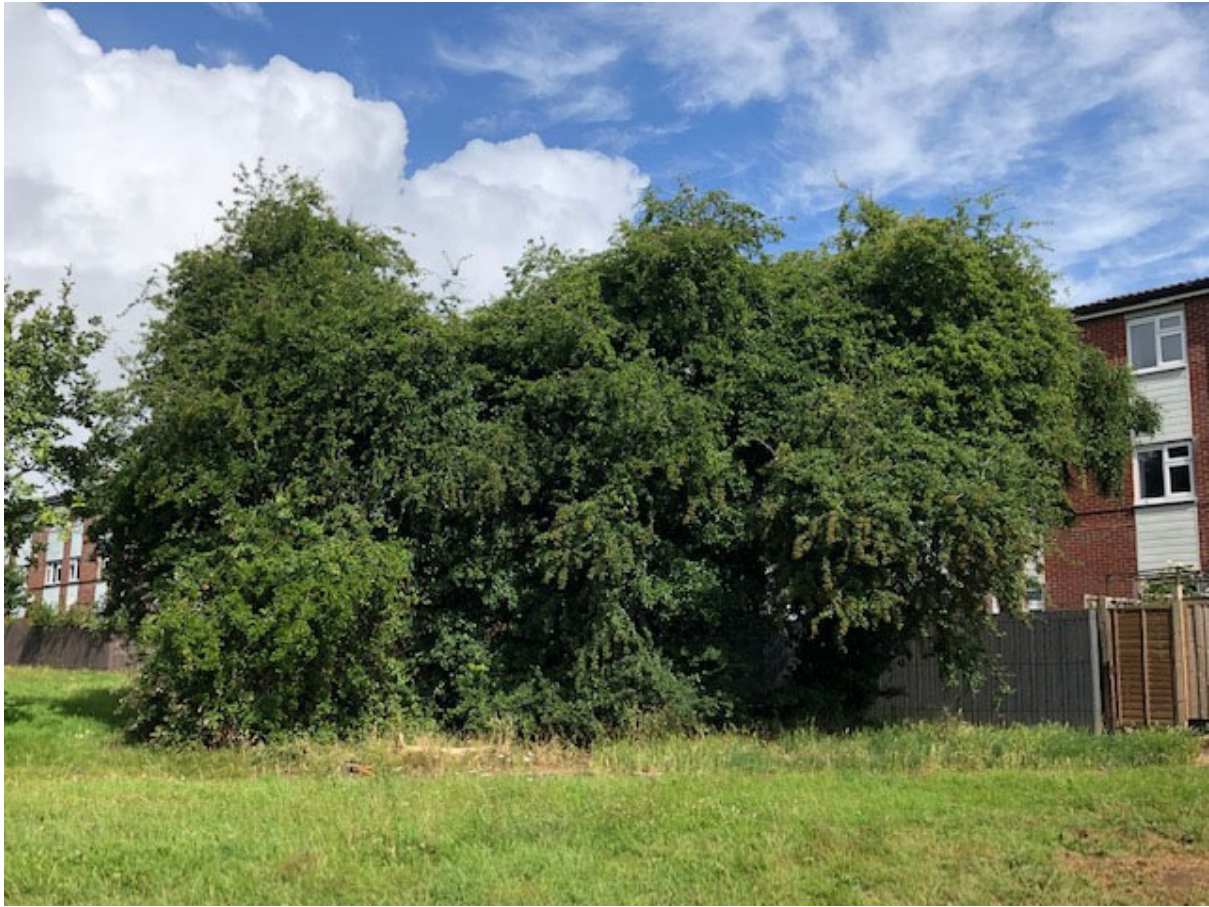
4.6 Trees on the schedule consisting of common hawthorn (*Crataegus monogyna*) forming a small group. All the trees have dense undergrowth of brambles and ivy to their lower stems extending into their crowns. All the trees are of poor condition and out of context with their surroundings.

Photo 2. Group of hawthorn trees (2,3,4,5) of poor quality and value.

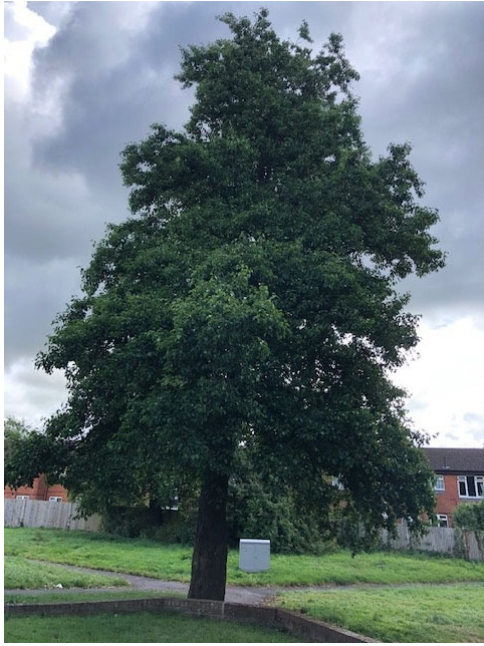
Photo 3. Mature Italian alder (11)( *Alnus cordata*).

4.9 The mature alder trees ( 1,7,11,12 & 13) as shown above in photographs 3,4 and 5, are all single standalone trees and good examples of there species type.

| Tree No. | Species | Recommended Tree Works |
|---|---|---|
| 11 | Italian alder | Crown lift to 5m above ground level |

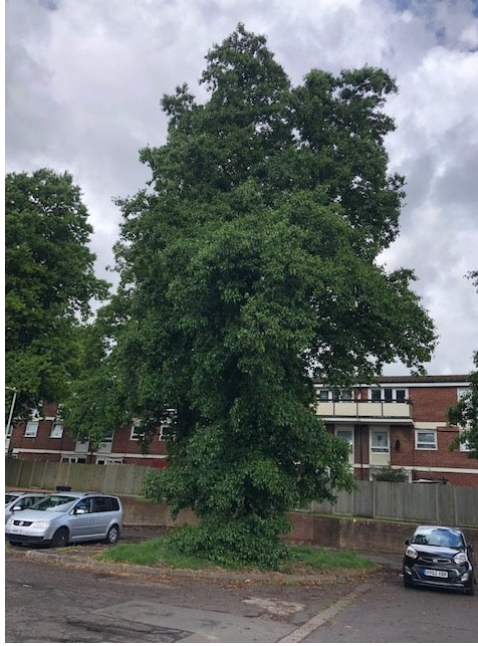
Photo 4. Mature Italian alder (12)( *Alnus cordata*)

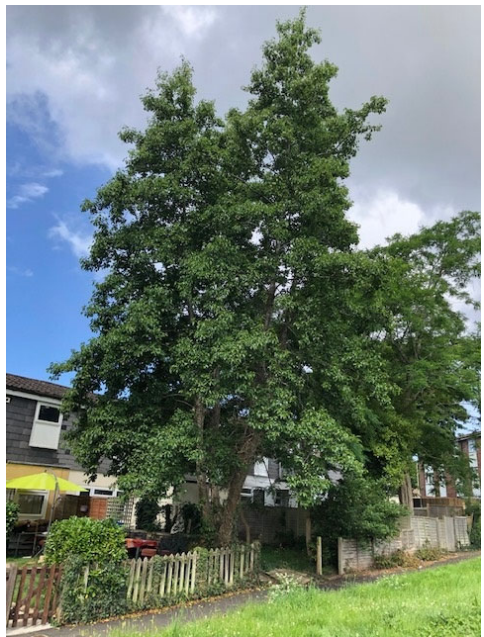
Photo 5. Mature Italian alder (7)( *Alnus cordata*)

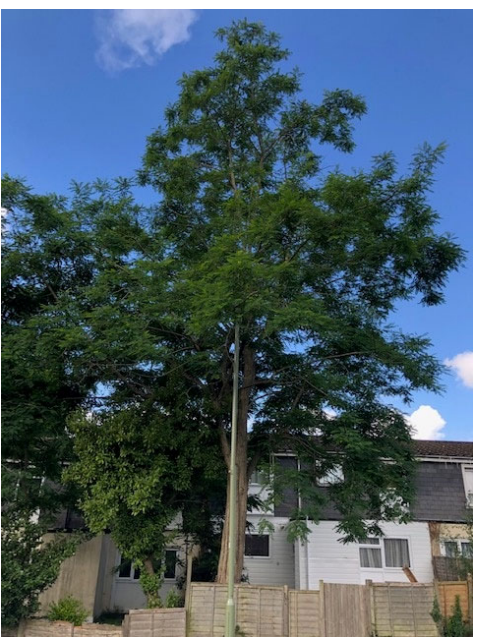
Photo 6. Mature False acacia (8) (*Robinia pseudoacacia*)

4.10 The mature robinia (8) *Robinia pseudoacacia* (photo no.6) located within a front garden of an adjacent property to the west of the developmental area displays good vitality and is growing true to form.

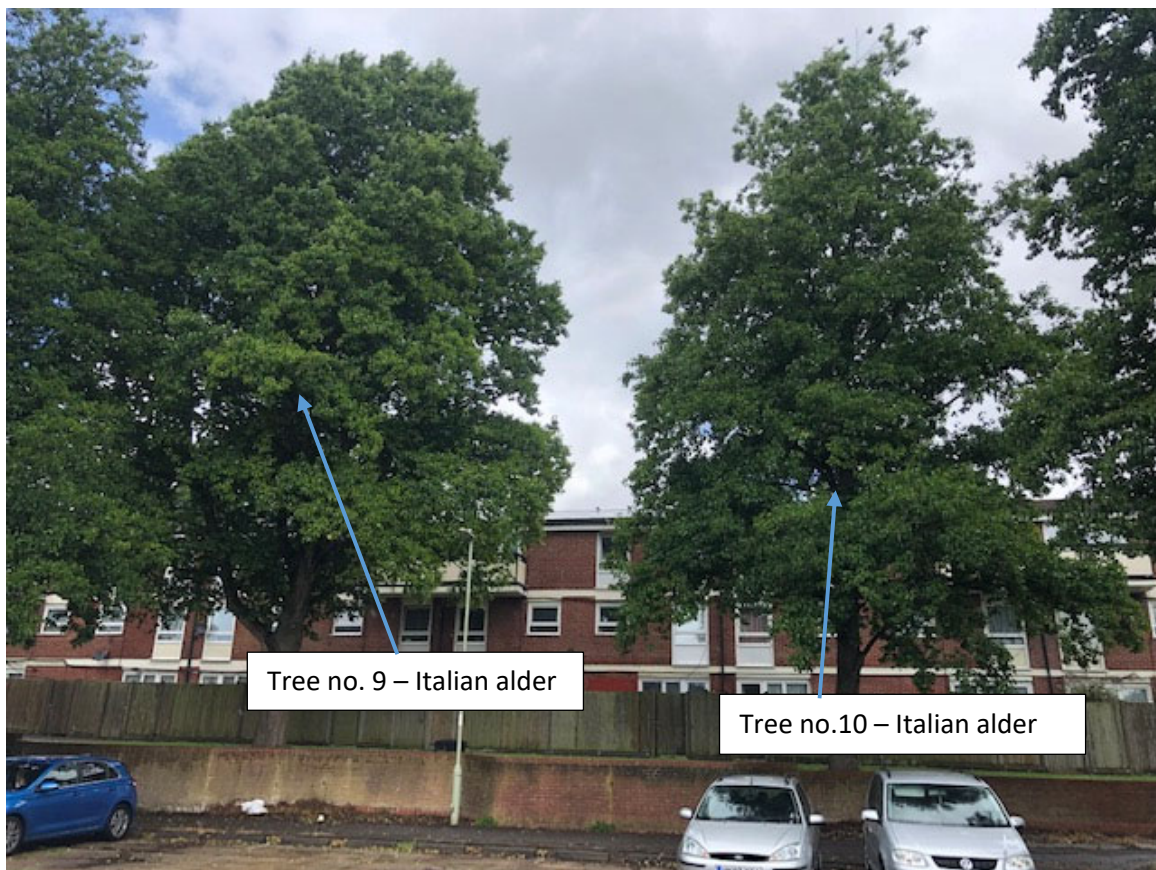
4.13 Tree 9 and 10, Italian alders ( *Alnus cordata* ) are of high quality and both growing true to form and a good example of their species.

Photo 7. Trees 9 and 10 mature Italian alders (*Alnus cordata*)

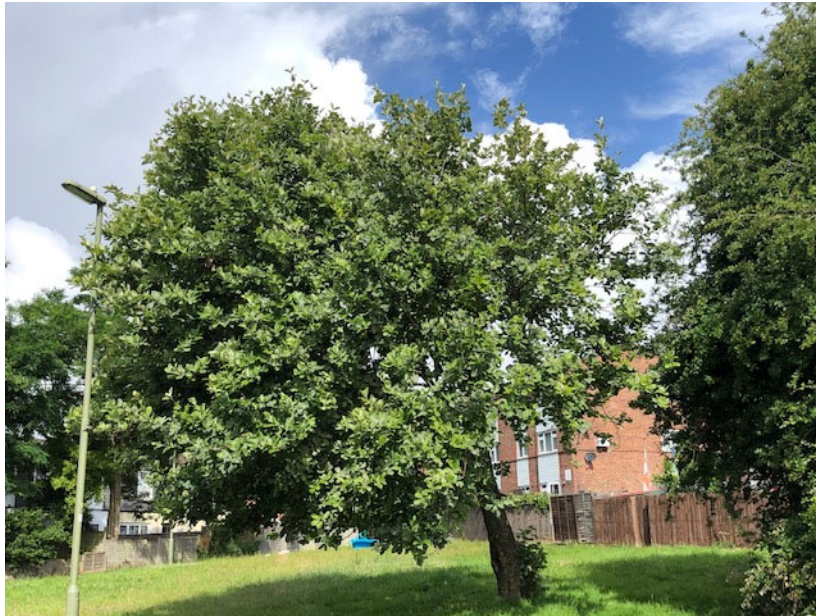
4.16 I have recommended that tree no.6 Swedish whitebeam (*Sorbus intermedia*) to be felled. On investigation the tree was found to have extensive basal and lower stem decay.

Photo 8. Heavily leaning tree no.6 Swedish whitebeam ( *Sorbus intermedia*)

| Tree and Tag No<br>Species | Hght<br>(m) | Stems | | Crown | | Age | RP<br>A (m²)<br>R (m) | Phys<br>Condition | Structural<br>Condition | Preliminary Recommendations | | | Cat<br>ERC |
|---|---|---|---|---|---|---|---|---|---|---|---|---|---|
| Swedish Whitebeam<br><i>Sorbus intermedia</i> | 6 | 1 | 340 | N | 3 | | M | A: 52.3<br>R: 4.08 | Poor | C: Fair<br>S: Poor<br>B: Poor | Fell :: Fell and treat stump(s)<br>Leaning, extensive basal and lower stem decay. | <b>U.1</b><br>n/a | |

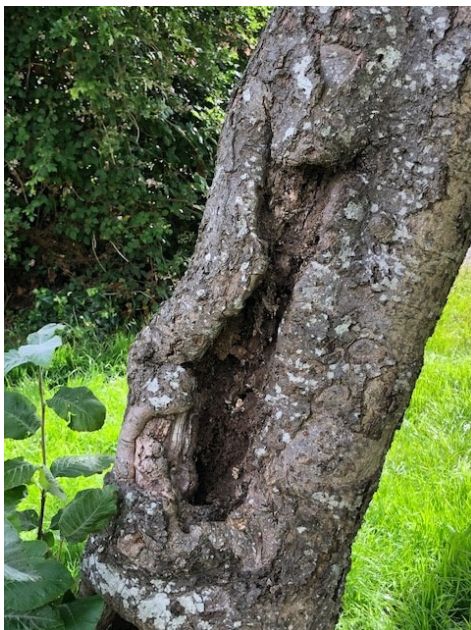
Photo 9. Stem decay evident to tree no.6

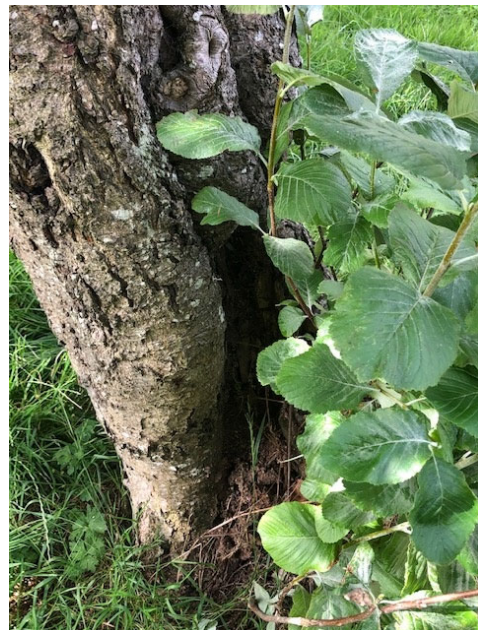
Photo 10. Basal decay at ground level to tree no.6
