## 25 Queen Street, Emsworth

Design & Access Statement  
Heritage Statement

## 25 Queen Street, Historic England

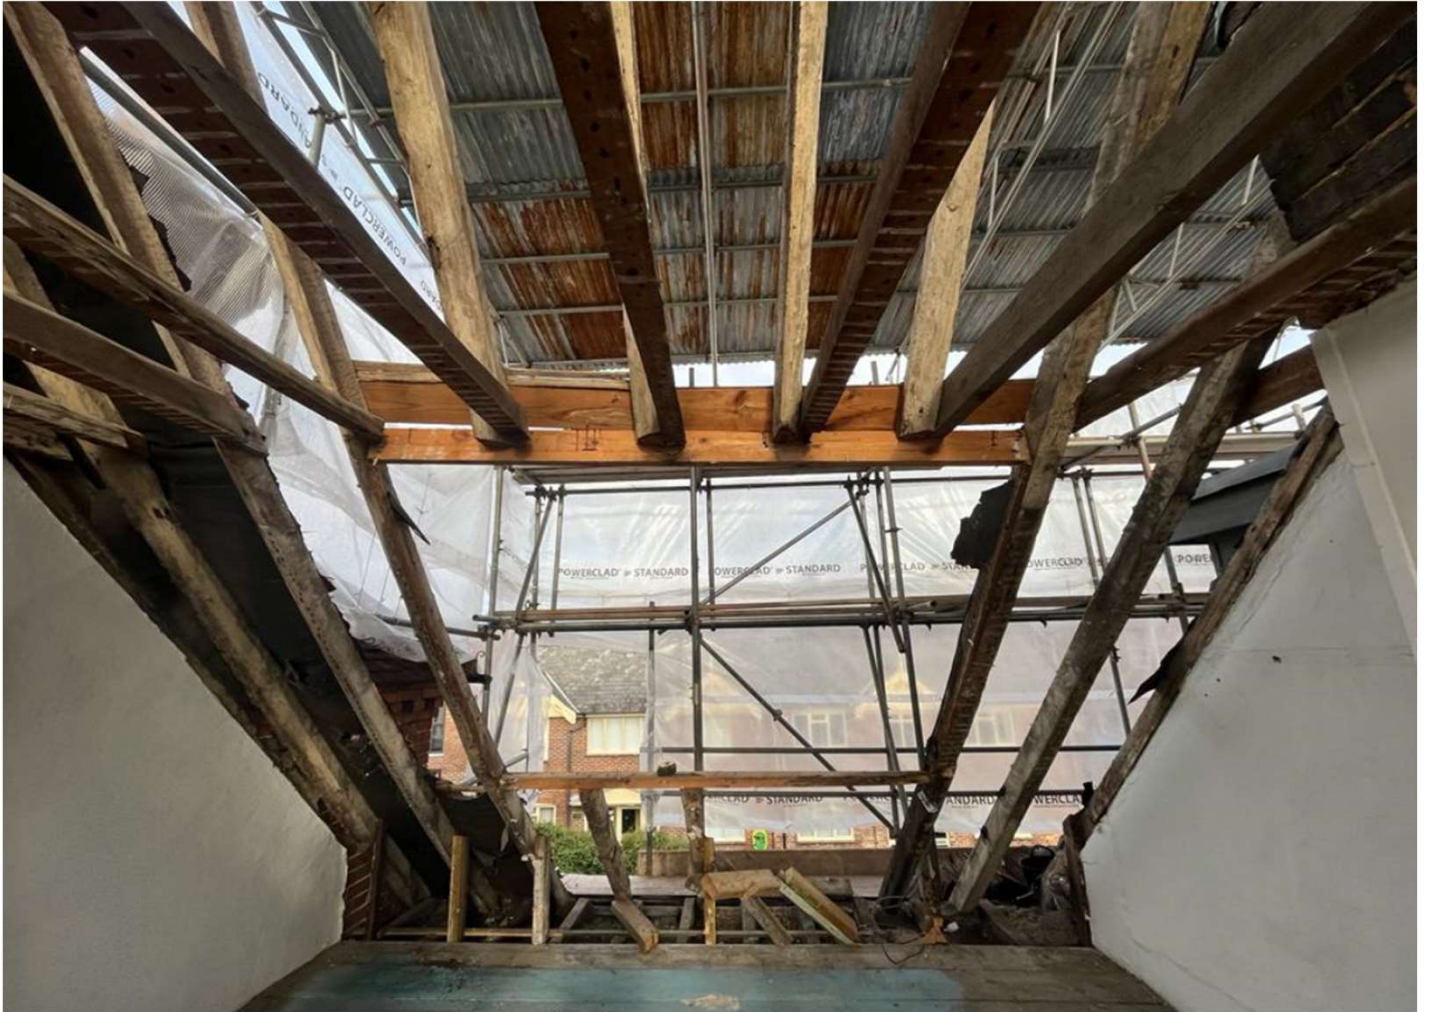
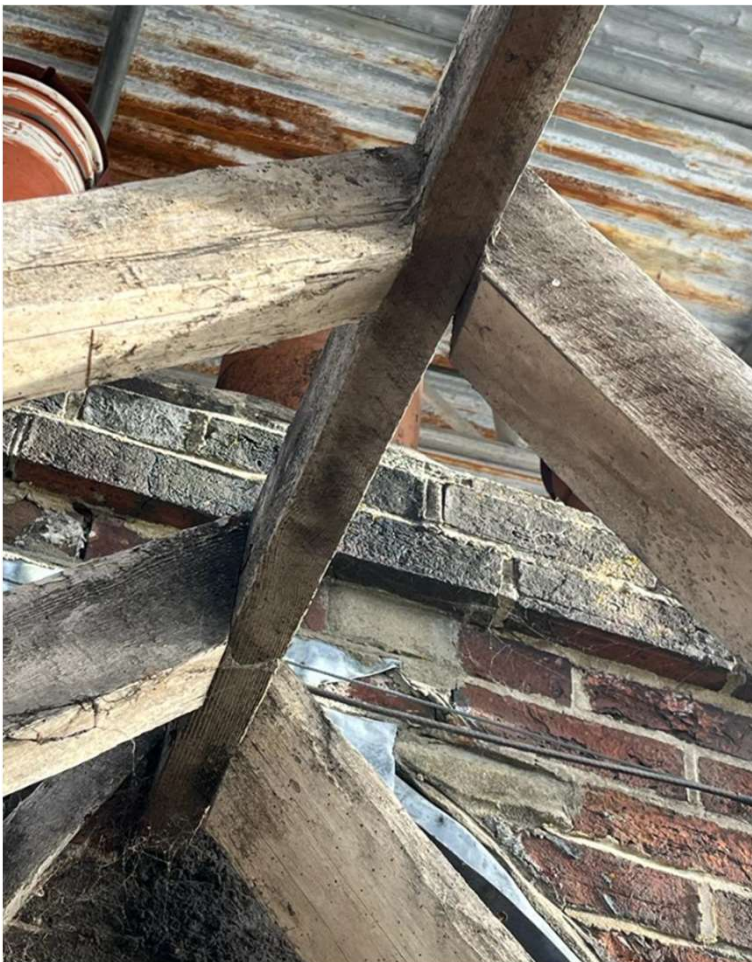
The original roof structure would appear to have been modified at some point in the past to install dormer windows.

This has cut several rafters in the centre of the roof and has resulted in the load from the dormers and the central part of the roof being carried by the two rafters either side of the dormer windows.

As a result these rafters have deflected excessively.

Inspection on Friday also showed that the rafters either side of the dormers were suffering from deterioration due to water ingress.

Failure of these rafters would result in a potential collapse of the central part of the roof structure.

The dormer window as previously modified has a thin section of timber at the head and either side it sits on single common rafters. This has caused the roof to sag and has overstressed the timbers. Furthermore, they have rotten at joints, and it would only be a matter of a few years before the roof collapsed under its own mass.

In other places bit of timber were no longer connected. This can of course be fixed.

The existing roof will be treated for rot and insect infestations and where necessary additional joists of the same [Pine] species will be positioned alongside. No existing timbers will be removed.

As we discussed on site, urgent remedial works are therefore required to strengthen the structure to prevent further deflection and a potential collapse.

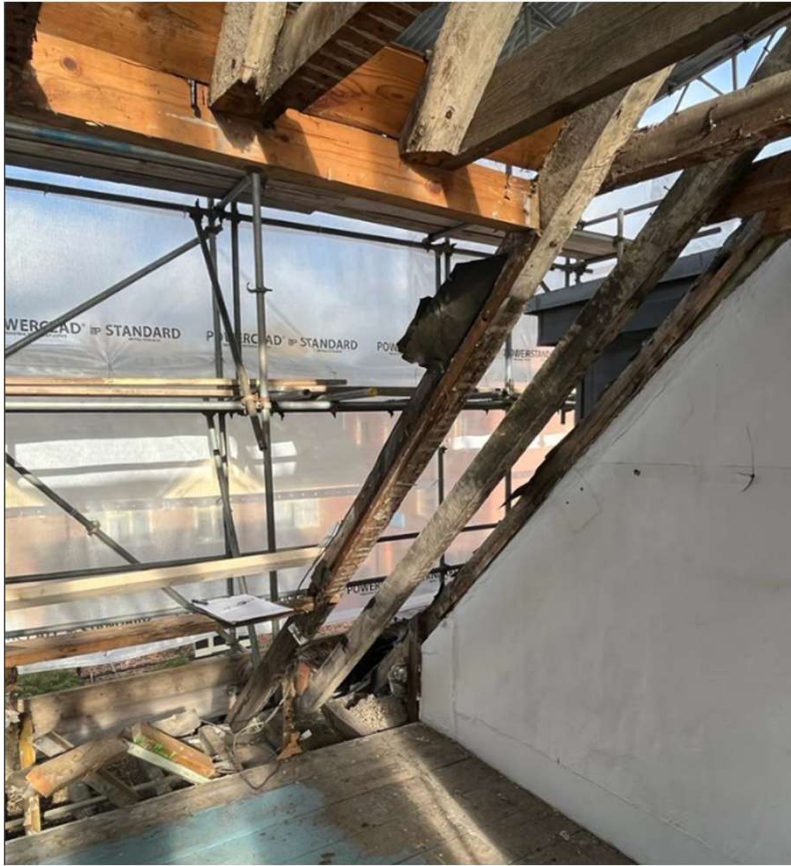
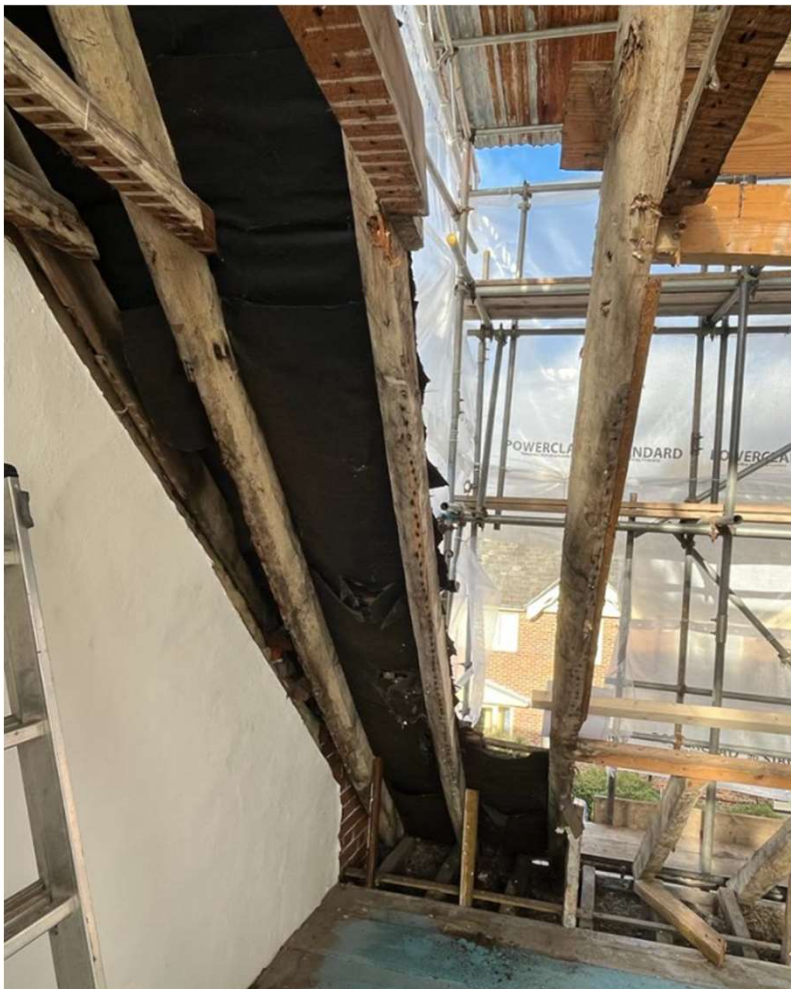
Additional photos showing lack of doubled rafters for existing timbers.

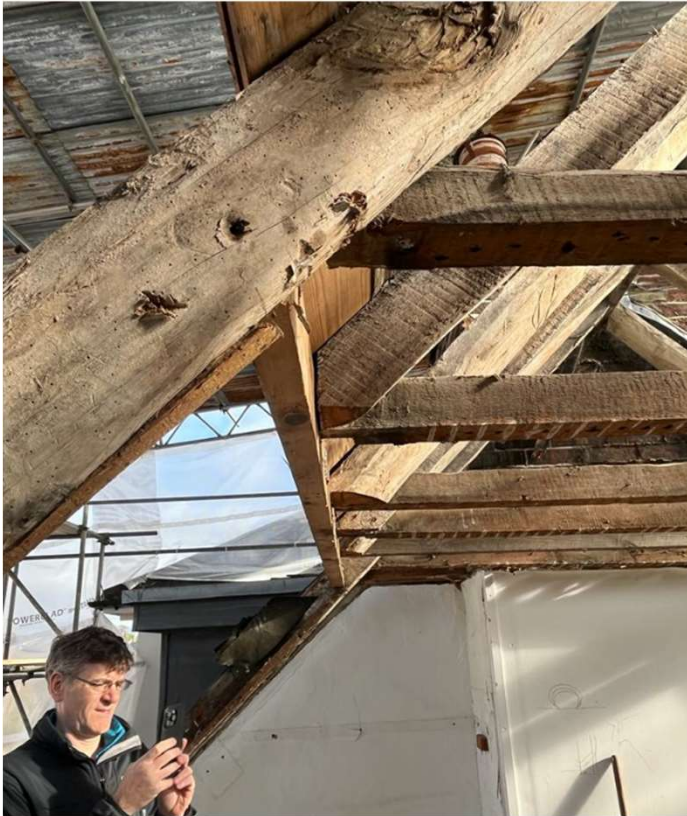
This photo shows how slender the head beam is to the existing dormer [which was a modern one] The rafters coming down on this had caused it to sag.

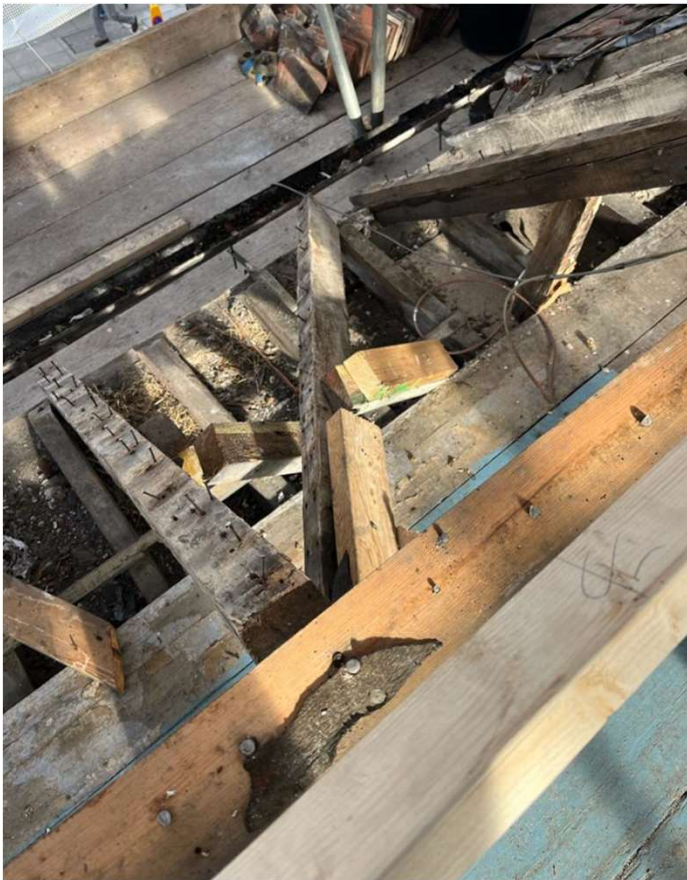
Joints to the wall below the rafter has rotten and the timbers were only supported by the battens.

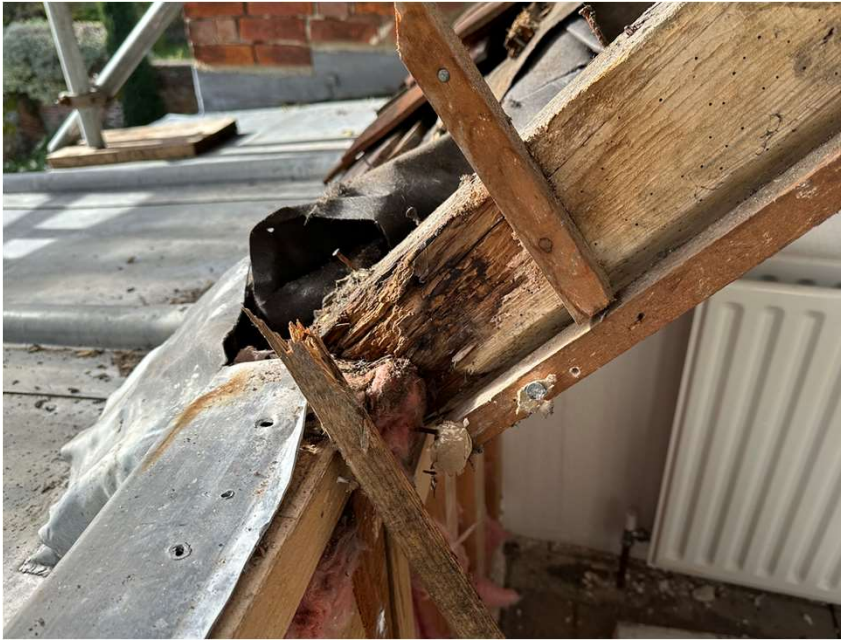
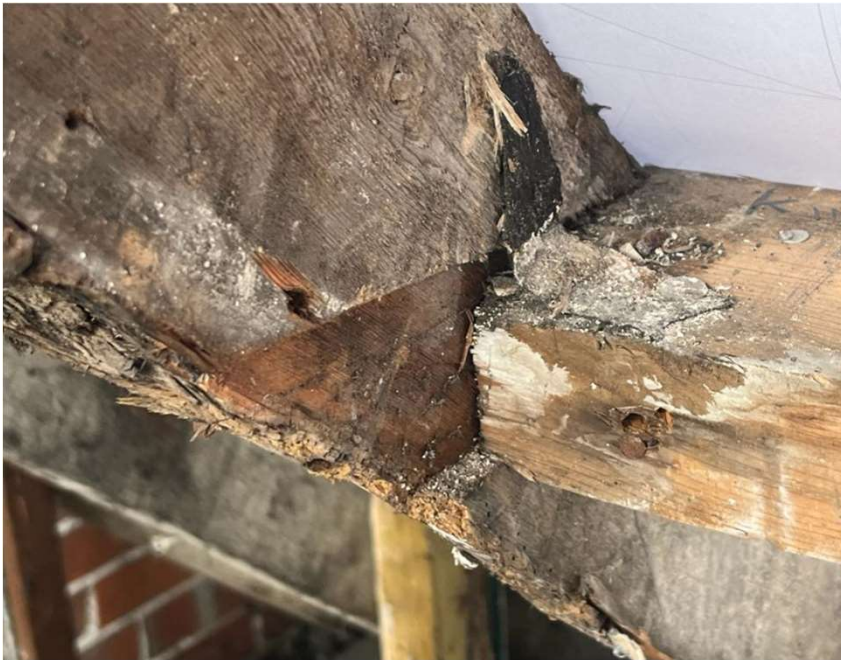
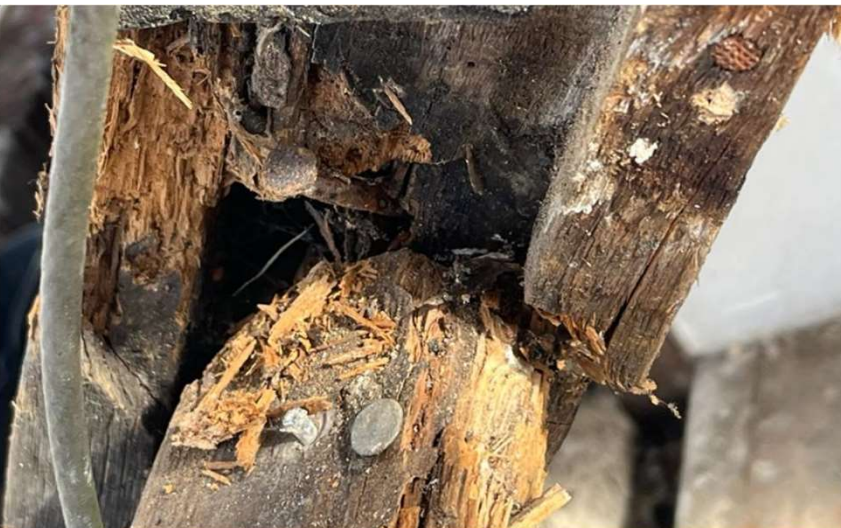
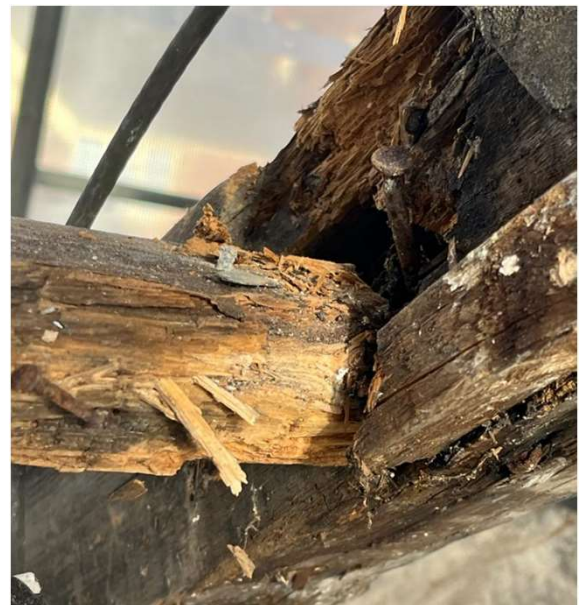
Photographs of various rotten or failed junctions / connections.

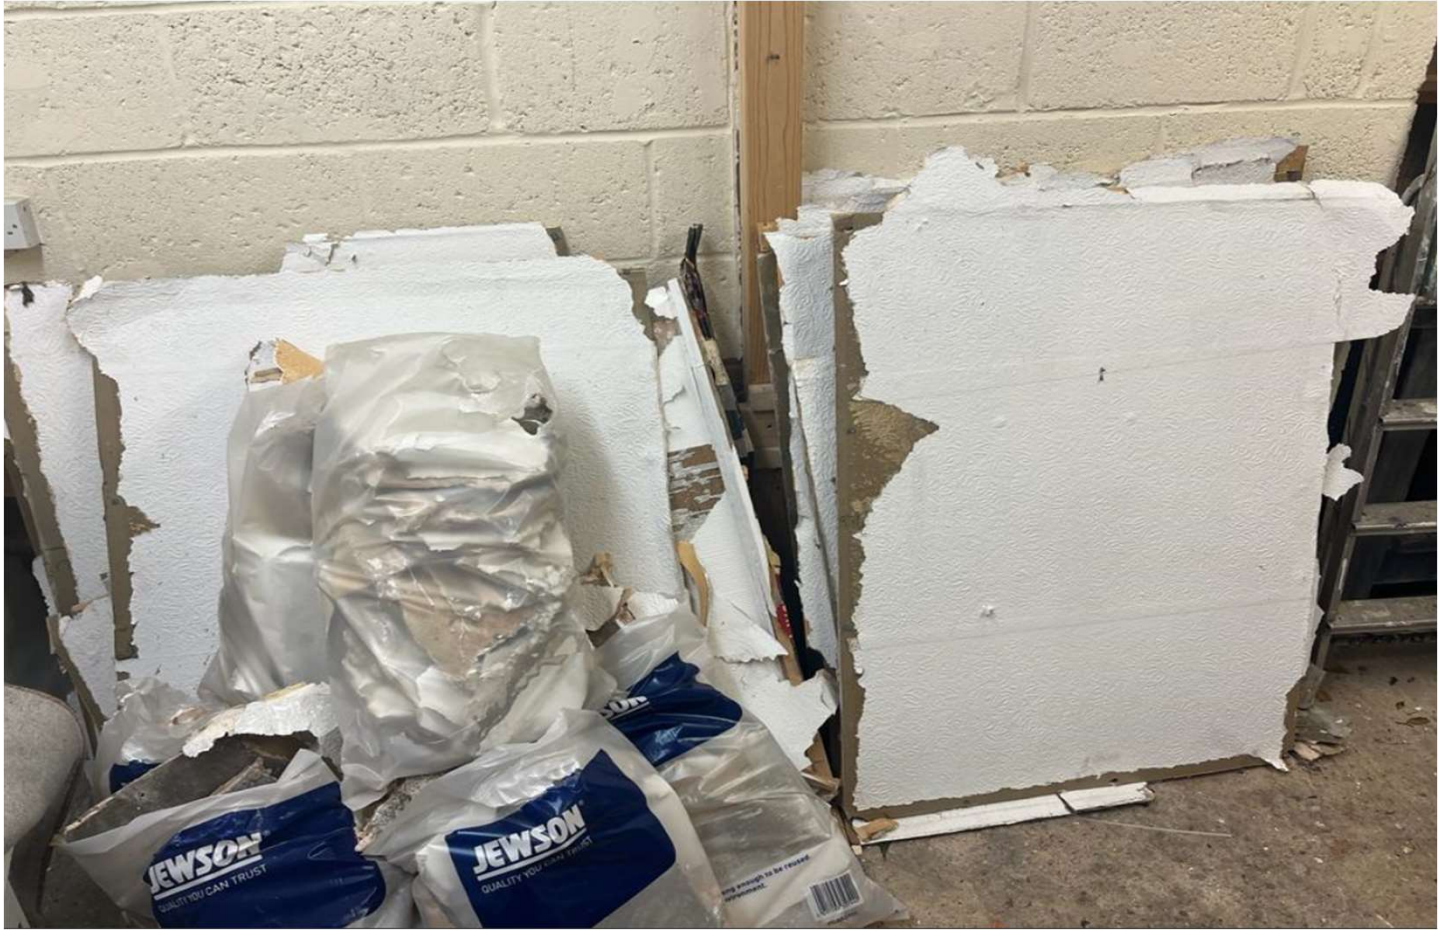
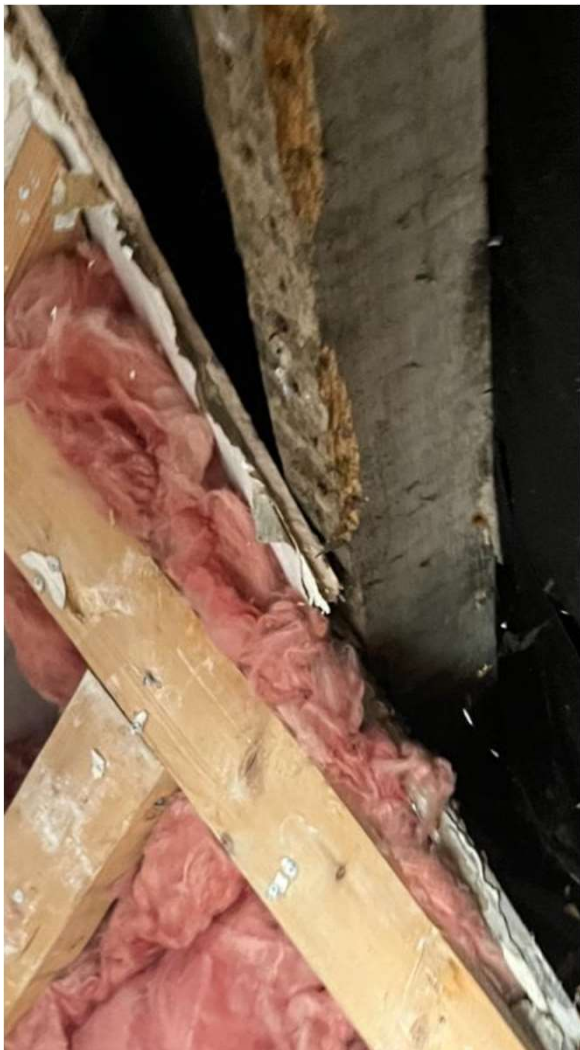
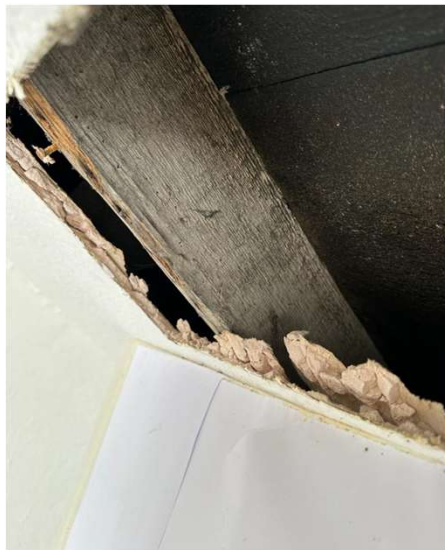
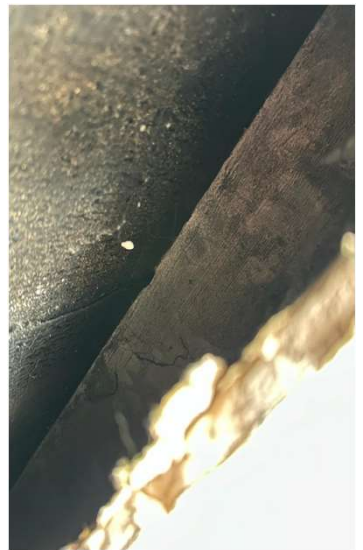
As predicted the existing ceiling linings were replaced when the modern dormer were built – presumably in the 20<sup>th</sup> Century. We plan to replace with the same plasterboard.

The ceilings were replaced in C20th century with plasterboard so we propose replacing with same. We will endeavour to get circa 50mm of insulation in the roof void allowing a 50mm ventilation gap beneath the tiles in line with best practice.

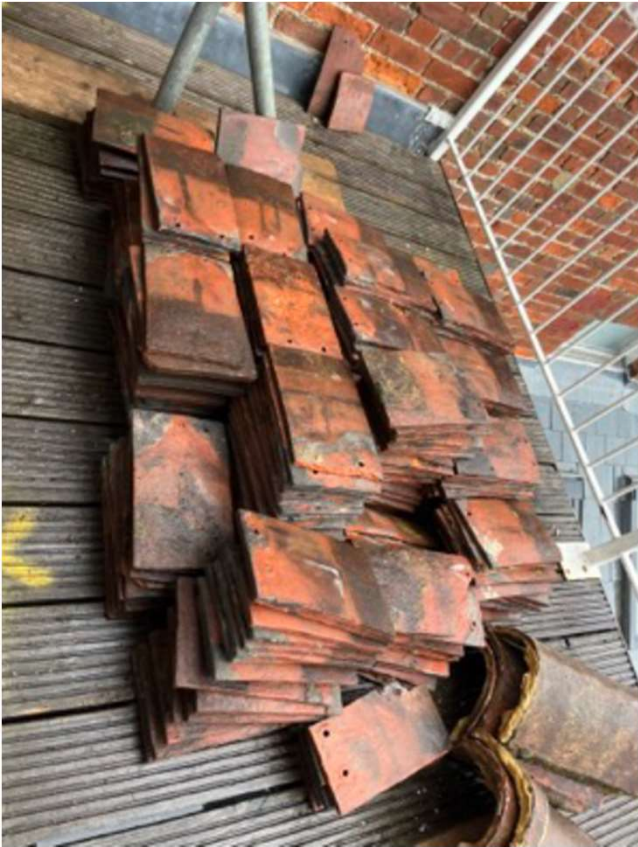
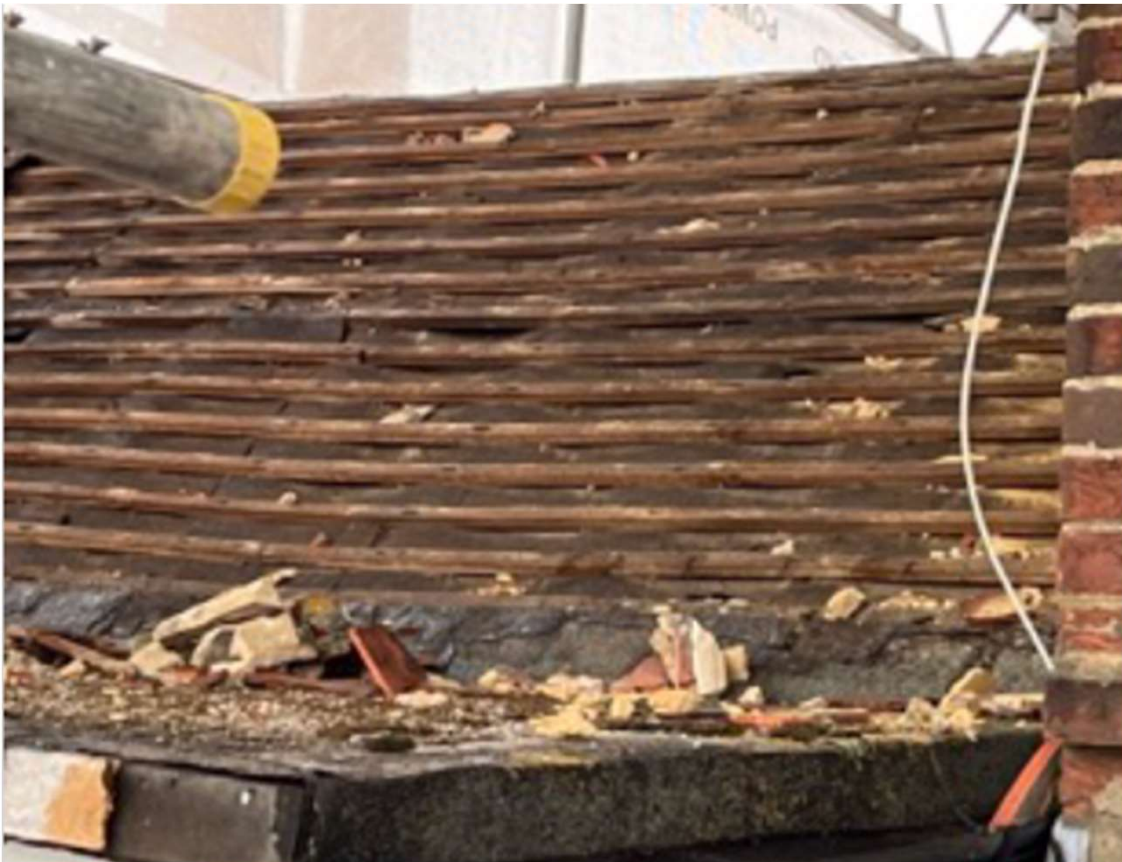
Battens were rotten and have been removed.  
Tiles have been saved for reuse.
