40, Horndean Road, Emsworth.

Tree location and constraints plan

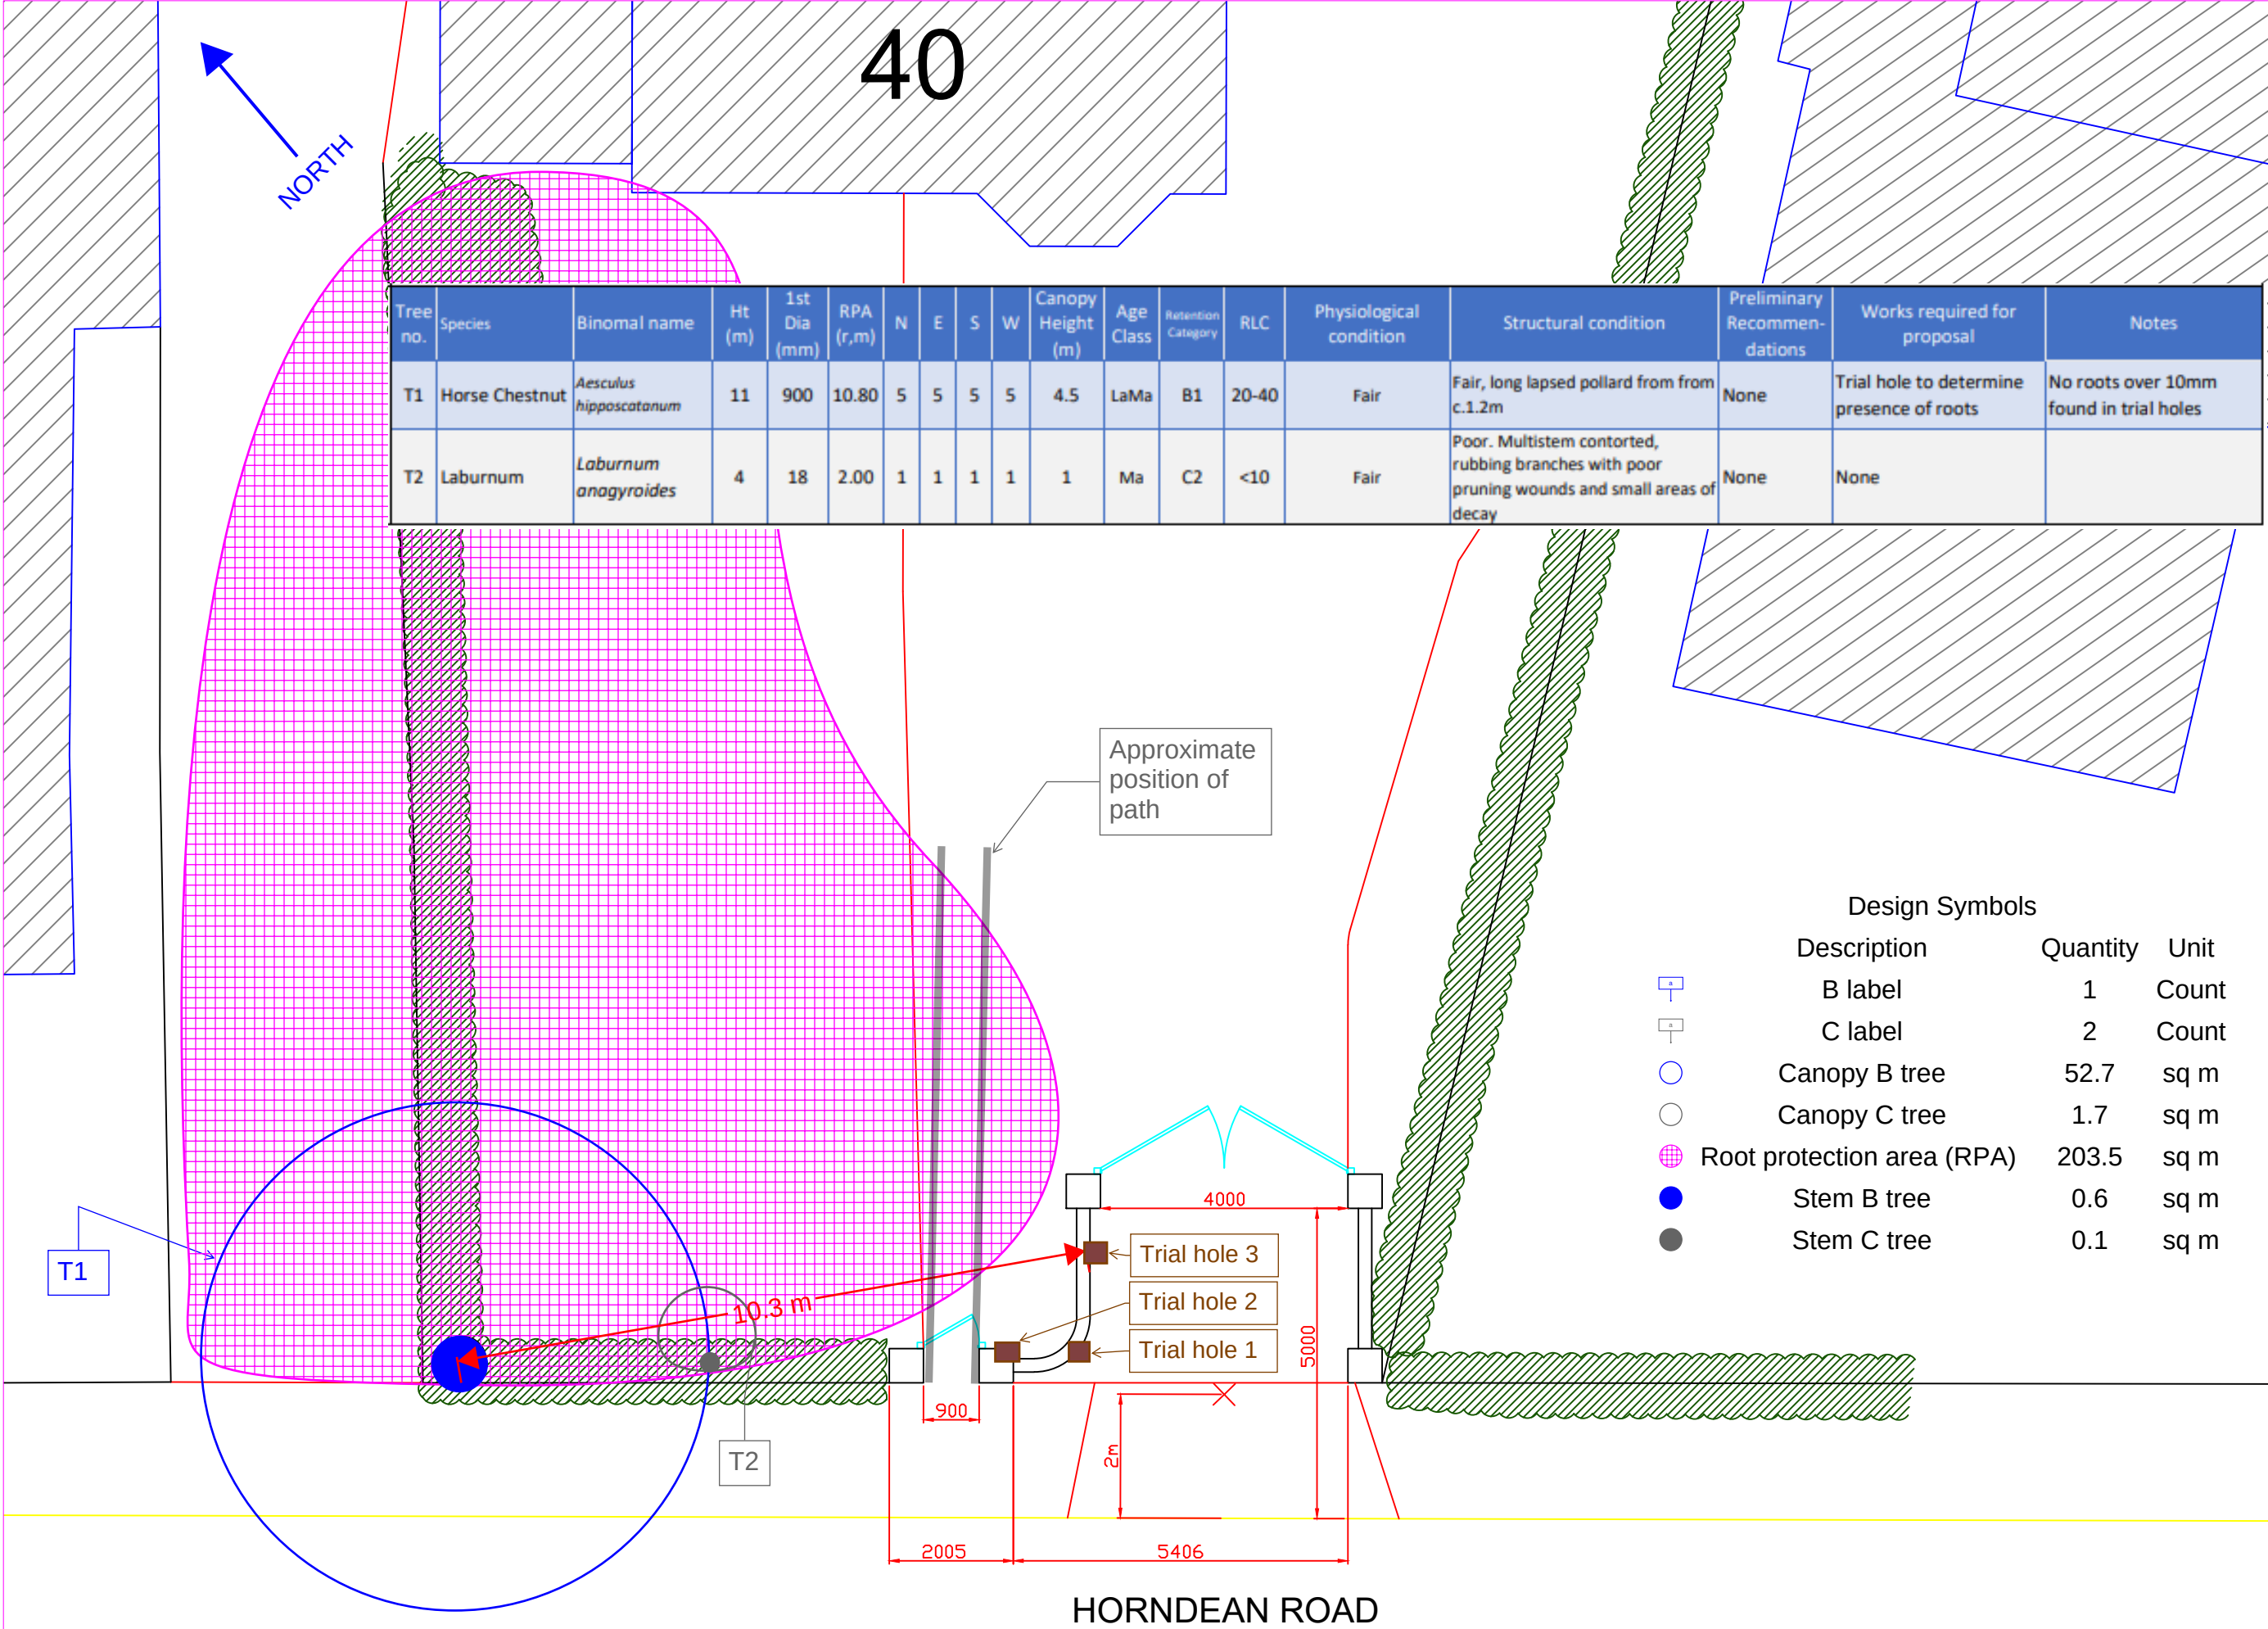
1. The RPA for T1 and T2 are adjusted for site constraints: it is assumed but not demonstrated that the roots for T1 extend under the adjacent tarmac access drive but not under the carriageway. It has been adjusted to take the existing historic driveway into account

2. Three trial holes have been dug approximately 1.5m cubed: roots of up to 10mm have been round but the colouration indicates these probably grew from a laburnum that has been removed from the frontage recently.

3. The RPA shown is larger than is suggested in BS5837 to reflect the constraints and the fact that we don't know which direction the roots will have grown.

4. T1 has been reduced at least twice in the past: it is likely that the root spread is lower than if the tree was full-canopy.
