**Tree Survey, Arboricultural Impact Assessment  
Preliminary Arboricultural Method Statement & Tree Protection Plan  
In Accordance with BS 5837:2012**

| Proj. No<br><b>8482</b> | <b>The Grange, Waterlooville, Hampshire, PO7 5PL</b> | | |
| Client: | | Walsh & Associated Ltd | |
| Date of Report: | 30/11/2020 | Revision: | Original |

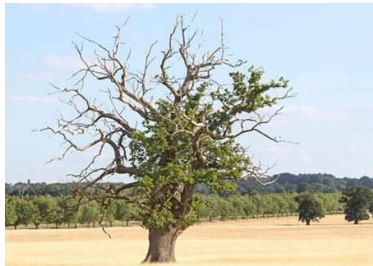
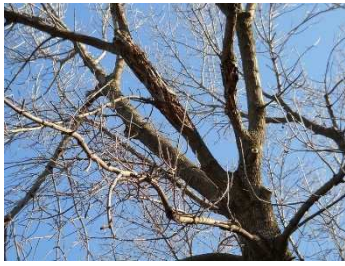
| <b>Name: Deadwood</b> | |
|---|---|
| <b>Symptoms/damage type and cause:</b> | This relates to dead branches in the crown of the tree. In the majority of cases, this is caused by the natural ageing process of the tree or shading due to its close proximity to neighbouring trees. However, in some situations, it may be related to fungal, bacterial or viral infection. |
| <b>Consequence:</b> | Depending upon the location and mass of dead wood removal of the affected tissue may be necessary to prevent harm to persons or property as the wood will become unstable as it decays and in some circumstances is likely to fall from the tree with little or no warning. |

| <b>Name: Deadwood</b> | |
|---|---|
| <b>Control:</b> | Detailed monitoring should be undertaken on those trees showing signs of excessive deadwood production to identify the underlying cause. |

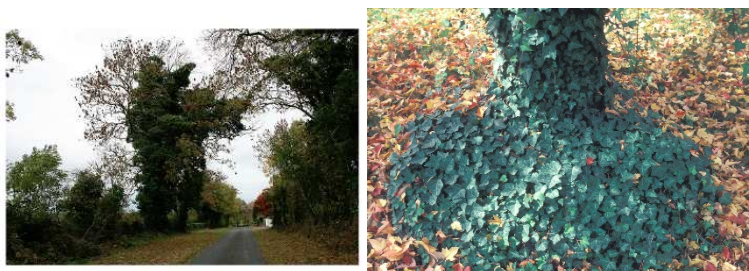
| <b>Symptoms/damage type and cause:</b> | Ivy may grow to varying degrees on all areas of a tree from the base to the upper crown. It is possible that in doing so it will out-compete the host tree for available light thereby suppressing the host. |

| <b>Control:</b> | Ivy should only be removed if absolutely necessary because it provides abundant cover to wildlife and then by severing twice close to the ground and removing a length of stem thereby causing the gradual dying away of the aerial parts of the plant providing extended benefit to wildlife whilst relieving the pressure on the tree. |
