# Havant Thicket Reservoir Project

## **Environmental Statement Volume 4 - Appendices**

#### **A9.14 Arboricultural Impact Assessment**

Portsmouth Water Ltd.

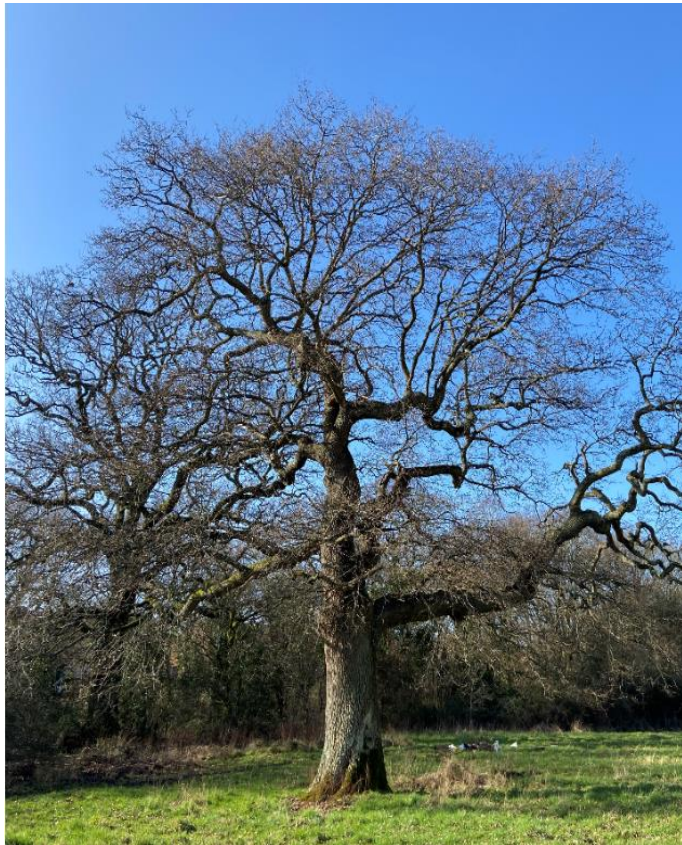
| Tree no. | Species | Location | Summary of value | Tree photographs |
|---|---|---|---|---|
| T075 | Common Oak | Staunton Country Park<br>Easting:47148487<br>Northing:10897386 | <p><b>Size:</b><br/>Large stem girth in comparison to other trees in locality.</p> <p><b>Condition:</b><br/>Decay features present including developing heartwood decay.<br/>Dead branches and old storm damage recorded in crown with desiccated white rot present.<br/>Crown break at approximately 3m.<br/>Pronounced northern scaffold branch</p> <p><b>Biodiversity value:</b><br/>Decayed heartwood rot and white rot providing habitat for saproxylic invertebrates.</p> <p><b>Cultural and heritage value:</b><br/>Tree within Sir George Staunton Conservation Area.</p> <p><b>Age:</b><br/>Its diameter of 1300mm means it has a girth of 4.08m and means it is included within the 'veteran/notable' criterion of girth in relation to age as shown in Figure 1.3 of 'Ancient and Other Veteran Trees: Further Guidance on Management' (Lonsdale, 2013).</p> | |

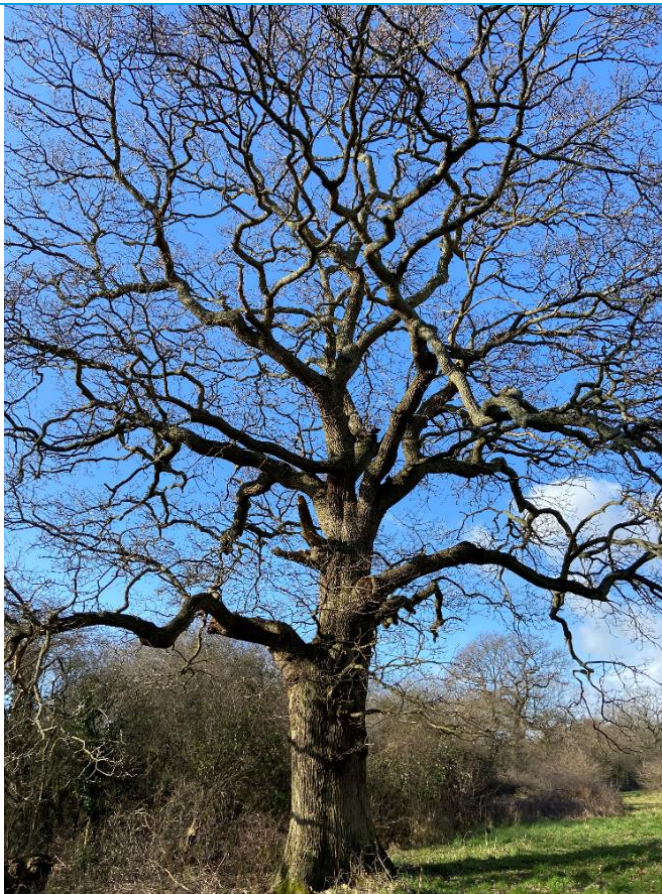
| Tree no. | Species | Location | Summary of value | Tree photographs |
|---|---|---|---|---|
| T077 | Common Oak | Staunton Country Park<br>Easting:47160754<br>Northing:10885194 | <p><b>Size:</b><br/>Large stem girth in comparison to other trees in locality.</p> <p><b>Condition:</b><br/>Decay features present including developing heartwood decay.<br/>Dead branches and old storm damage recorded in crown with desiccated white rot present.</p> <p><b>Biodiversity value:</b><br/>Decayed heartwood rot and white rot providing habitat for saproxylic invertebrates.</p> <p><b>Cultural and heritage value:</b><br/>Tree within Sir George Staunton Conservation Area.</p> <p><b>Age:</b><br/>Its diameter of 1300mm means it has a girth of 4.08m and means it is included within the 'veteran/notable' criterion of girth in relation to age as shown in Figure 1.3 of 'Ancient and Other Veteran Trees: Further Guidance on Management' (Lonsdale, 2013).</p> | |

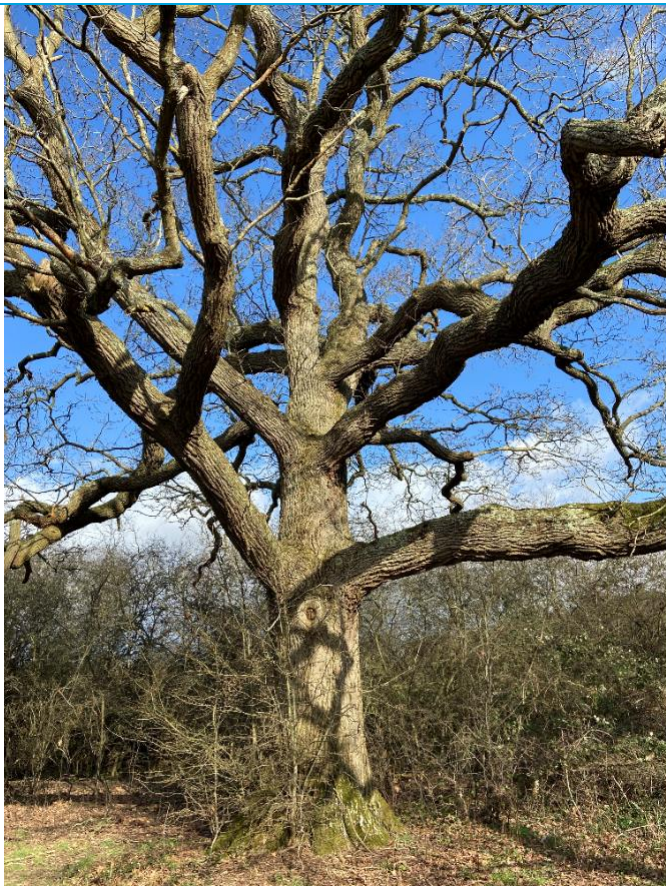
| Tree no. | Species | Location | Summary of value | Tree photographs |
|---|---|---|---|---|
| T082 | Common Oak | Staunton Country Park<br>Easting:47172114<br>Northing:10883285 | <p><b>Size:</b><br/>Large stem girth in comparison to other trees in locality.</p> <p><b>Condition:</b><br/>Decay features present including developing heartwood decay.<br/>Dead branches and old storm damage recorded in crown with desiccated white rot present.<br/>Vast crown, dominant to west with pronounced scaffold branch.<br/>Pronounced buttress roots.</p> <p><b>Biodiversity value:</b><br/>Decayed heartwood rot and white rot providing habitat for saproxylic invertebrates.</p> <p><b>Cultural and heritage value:</b><br/>Tree within Sir George Staunton Conservation Area.</p> <p><b>Age:</b><br/>It's diameter of 1400mm means it has a girth of 4.40m and means it is included within the 'veteran/notable' criterion of girth in relation to age as shown in Figure 1.3 of 'Ancient and Other Veteran Trees: Further Guidance on Management' (Lonsdale, 2013).</p> | |

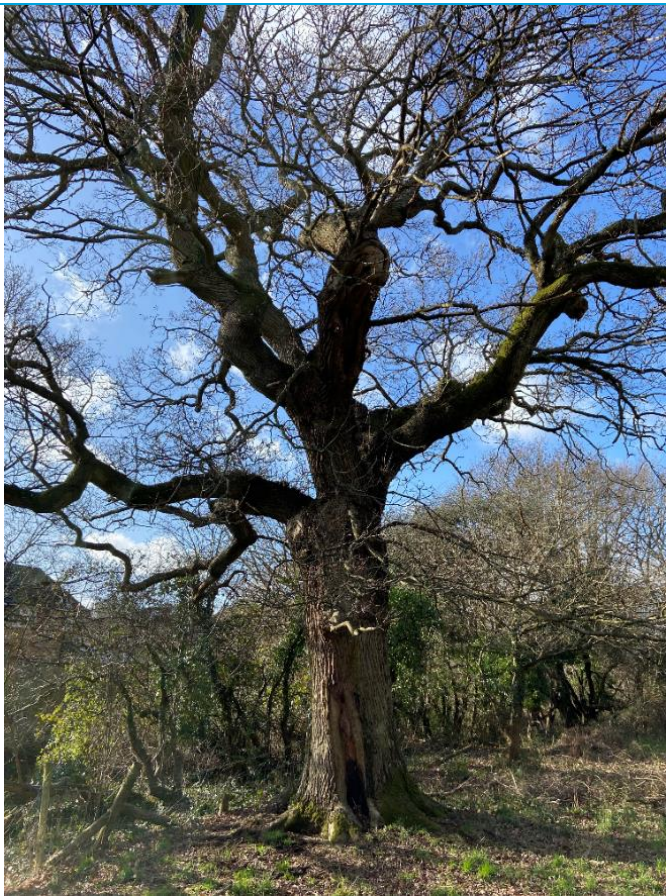
| Tree no. | Species | Location | Summary of value | Tree photographs |
|---|---|---|---|---|
| T083 | Common Oak | Staunton Country Park<br>Easting:47171565<br>Northing:10879370 | <p><b>Size:</b><br/>Large stem girth in comparison to other trees in locality.</p> <p><b>Condition:</b><br/>Decay features present including basal cavity on south side of main stem revealing desiccated white rot and developing heartwood decay.<br/>Dead branches and old storm damage recorded in crown with desiccated white rot present.<br/>Crown break at approximately 4m into multi stems suggesting historic pollard.</p> <p><b>Biodiversity value:</b><br/>Decayed heartwood rot and white rot providing habitat for saproxylic invertebrates.</p> <p><b>Cultural and heritage value:</b><br/>Tree within Sir George Staunton Conservation Area.</p> <p><b>Age:</b><br/>Its diameter of 1250mm means it has a girth of 3.92m and means it is included within the 'locally notable' criterion of girth in relation to age as shown in Figure 1.3 of 'Ancient and Other Veteran Trees: Further Guidance on Management' (Lonsdale, 2013).</p> | |

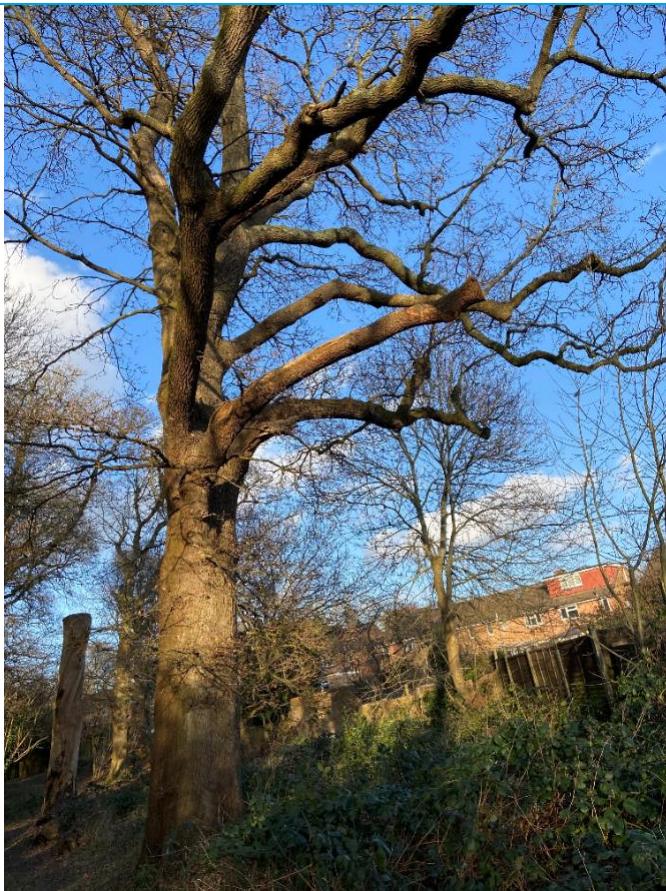
| Tree no. | Species | Location | Summary of value | Tree photographs |
|---|---|---|---|---|
| T107 | Common Oak | Great Copse<br>Easting:47185401<br>Northing:10845605 | <p><b>Size:</b><br/>Large stem girth in comparison to other trees in locality.</p> <p><b>Condition:</b><br/>Decay features present including desiccated white rot and developing heartwood decay<br/>Dead branches and old storm damage recorded in crown.<br/>Crown previously reduced in height and lateral spread. Regrowth in places.<br/>Abrupt angles on retained branches.</p> <p><b>Biodiversity value:</b><br/>Decayed heartwood rot and white rot providing habitat for saproxylic invertebrates.</p> <p><b>Cultural and heritage value:</b><br/>Tree within Sir George Staunton Conservation Area.</p> <p><b>Age:</b><br/>It's diameter of 1280mm means it has a girth of 4.02m and means it is included within the 'locally notable' criterion of girth in relation to age as shown in Figure 1.3 of 'Ancient and Other Veteran Trees: Further Guidance on Management' (Lonsdale, 2013).</p> | |

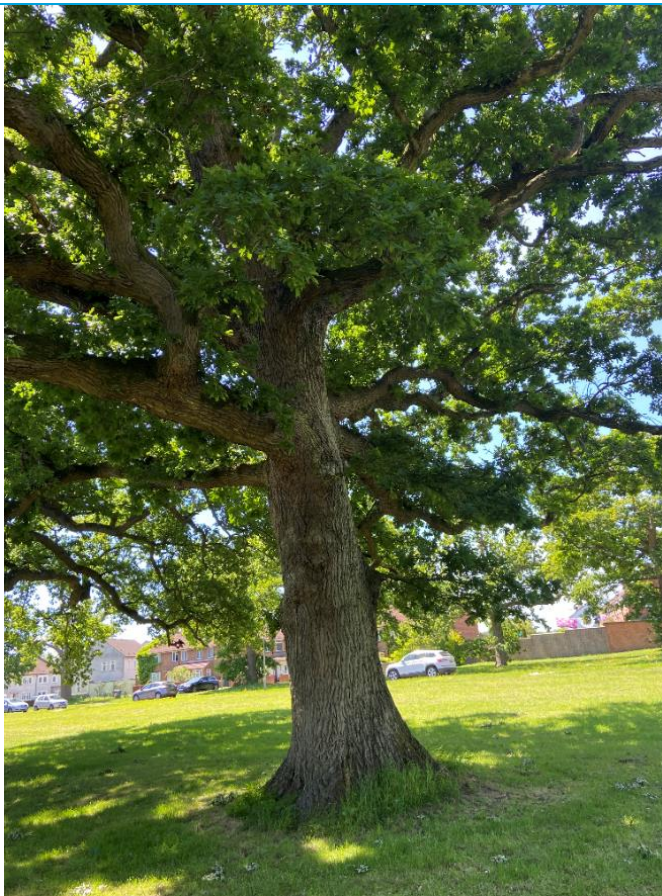
| Tree no. | Species | Location | Summary of value | Tree photographs |
|---|---|---|---|---|
| T154 | Common Oak | Leigh Park<br>Easting:47118238<br>Northing:10795388 | <p><b>Size:</b><br/>Large stem girth in comparison to other trees in locality.</p> <p><b>Condition:</b><br/>Decay features present including basal cavity to east revealing hollowing main stem and decayed heartwood.<br/>Remnants of wood decay fungal bracket around cavity. Potential <i>Ganoderma spp</i> or <i>Fistulina. spp</i>.<br/>Dead branches and old storm damage recorded in crown with desiccated white rot present and saprophytic wood decay fungi visible.</p> <p><b>Biodiversity value:</b><br/>Decayed heartwood rot and white rot providing habitat for saproxylic invertebrates.</p> <p><b>Cultural and heritage value:</b><br/>Tree growing within open green space within Leigh Park.</p> <p><b>Age:</b><br/>Its diameter of 1250mm means it has a girth of 3.92m and means it is included within the 'locally notable' criterion of girth in relation to age as shown in Figure 1.3 of 'Ancient and Other Veteran Trees: Further Guidance on Management' (Lonsdale, 2013).</p> | |

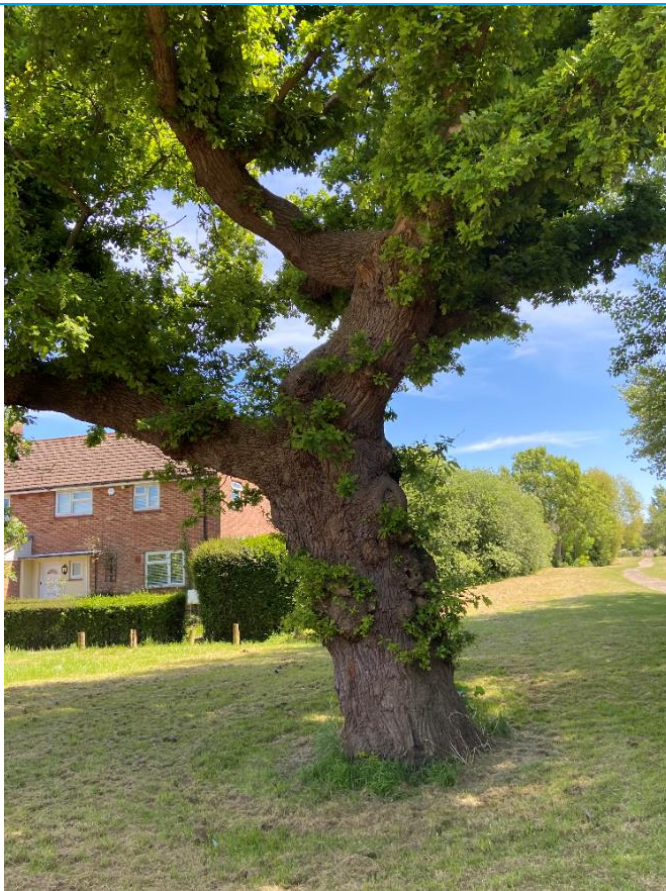
| Tree no. | Species | Location | Summary of value | Tree photographs |
|---|---|---|---|---|
| T157 | Common Oak | Leigh Park<br>Easting:47078899<br>Northing:10783208 | <p><b>Size:</b><br/>Large stem girth in comparison to other trees in locality.</p> <p><b>Condition:</b><br/>Decay features present including hollowing main stem and decayed heartwood.<br/>Remnants of wood decay fungal bracket around cavity. Potential <i>Ganoderma spp.</i><br/>Crown extensively reduced. Dense epicormic growths regenerated.<br/>Potential former pollard given crown break at 3m into multi stems.</p> <p><b>Biodiversity value:</b><br/>Decayed heartwood rot and white rot providing habitat for saproxylic invertebrates.</p> <p><b>Cultural and heritage value:</b><br/>Tree growing within open green space within Leigh Park.</p> <p><b>Age:</b><br/>Its diameter of 1300mm means it has a girth of 4.08m and means it is included within the 'veteran/notable' criterion of girth in relation to age as shown in Figure 1.3 of 'Ancient and Other Veteran Trees: Further Guidance on Management' (Lonsdale, 2013).</p> | |

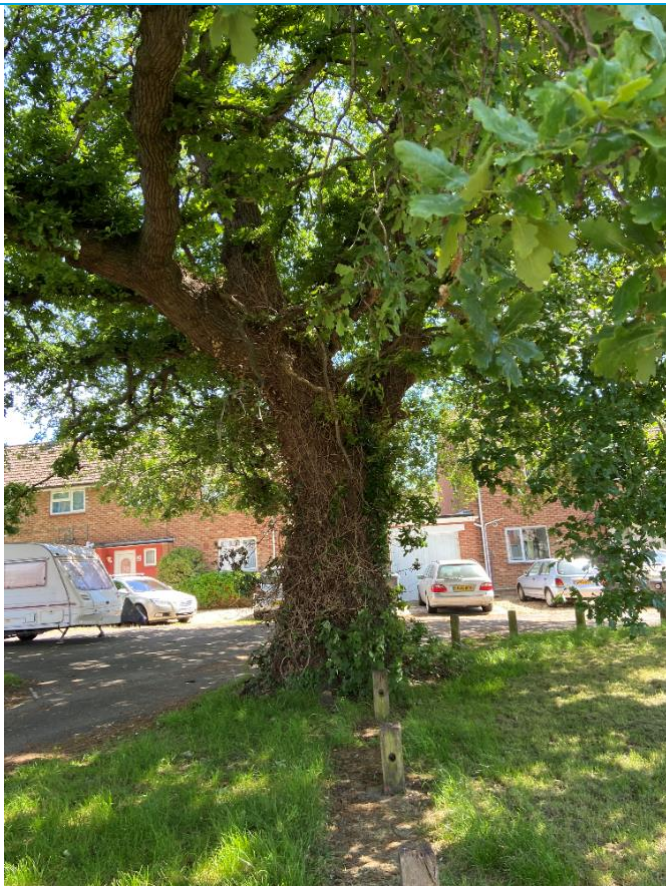
| Tree no. | Species | Location | Summary of value | Tree photographs |
|---|---|---|---|---|
| T160 | Common Oak | Leigh Park<br>Easting:47082477<br>Northing:10787400 | <p><b>Size:</b><br/>Large stem girth in comparison to other trees in locality.</p> <p><b>Condition:</b><br/>Dense ivy encroachment on main stem and into crown hindering full assessment of condition.</p> <p><b>Biodiversity value:</b><br/>White rot providing habitat for saproxylic invertebrates.</p> <p><b>Cultural and heritage value:</b><br/>Tree growing within open green space within Leigh Park.</p> <p><b>Age:</b><br/>It's diameter of 1300mm means it has a girth of 4.08m and means it is included within the 'veteran/notable' criterion of girth in relation to age as shown in Figure 1.3 of 'Ancient and Other Veteran Trees: Further Guidance on Management' (Lonsdale, 2013).</p> | |
