# 128 Victoria Road | P004

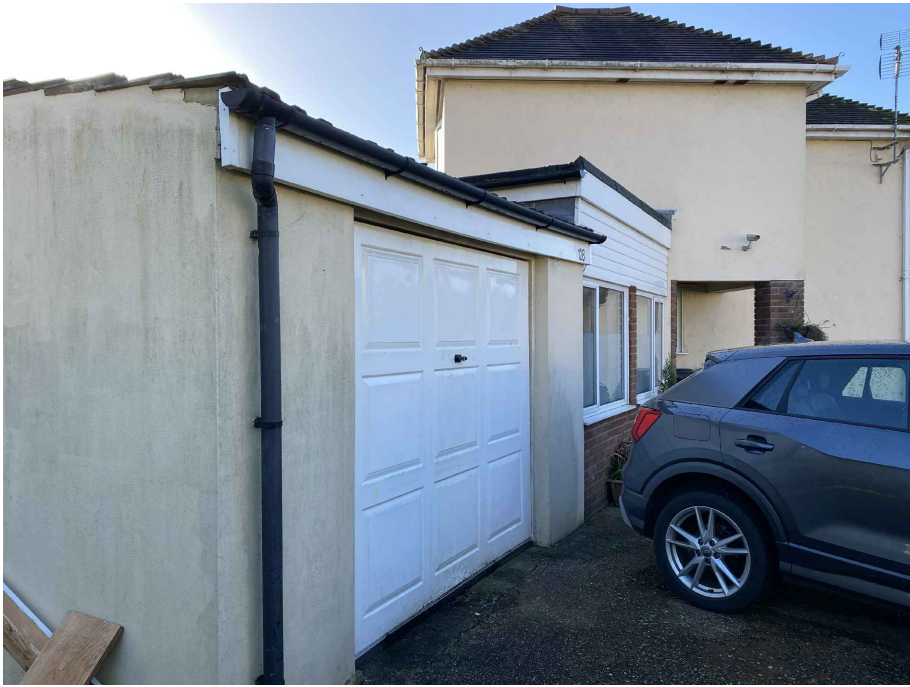
**01 |**  
View towards existing 'back door' showing various historic 'add-on' extensions and materials.

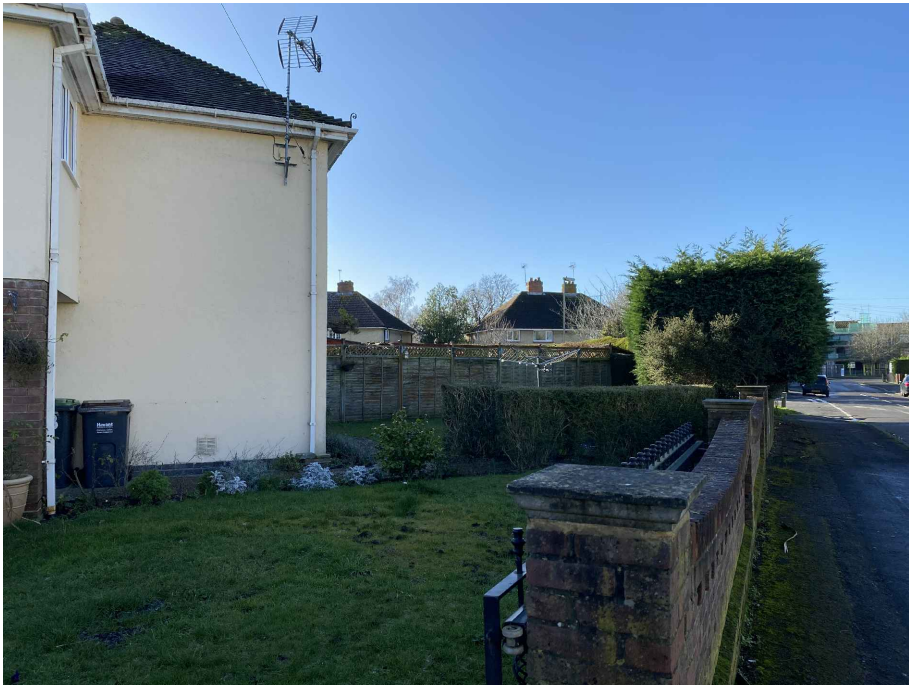
**02 |**  
View from driveway/road looking into 'back garden' - identifying existing lack of privacy and defensible space.

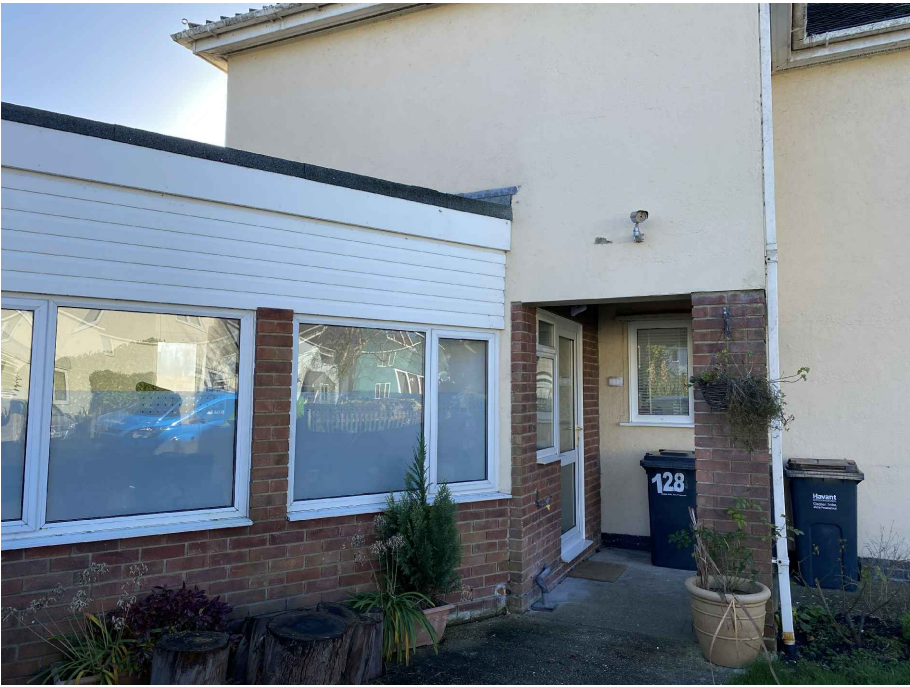
**03 |**  
View from driveway to 'back door' (below undercroft, adjacent to bins) now used as main door due to location upon 'arrival'.

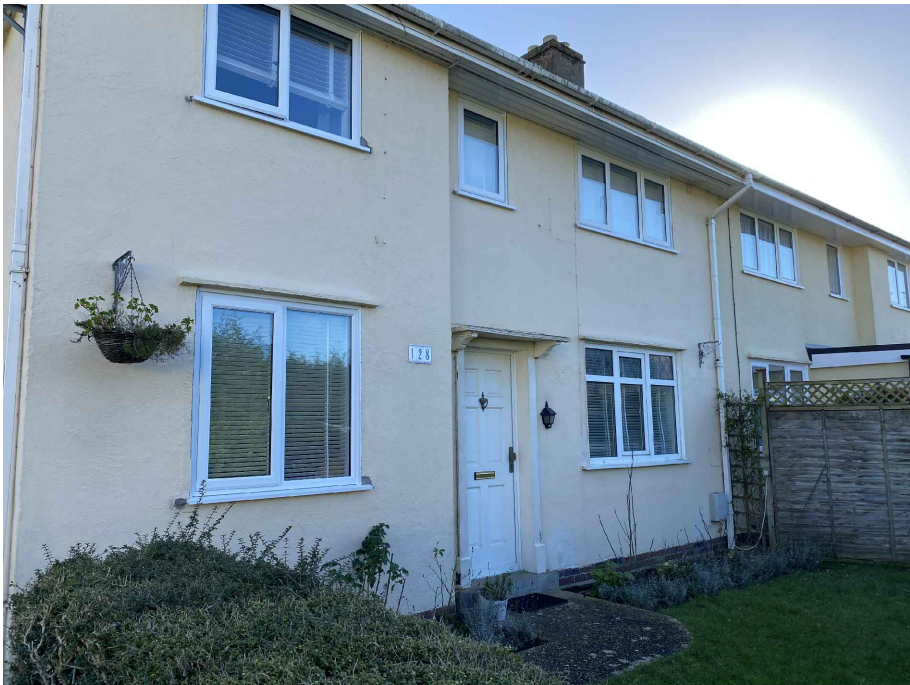
**04 |**  
Original 'front door' within 'back garden' - no privacy to garden, nor visibility of door upon arrival.

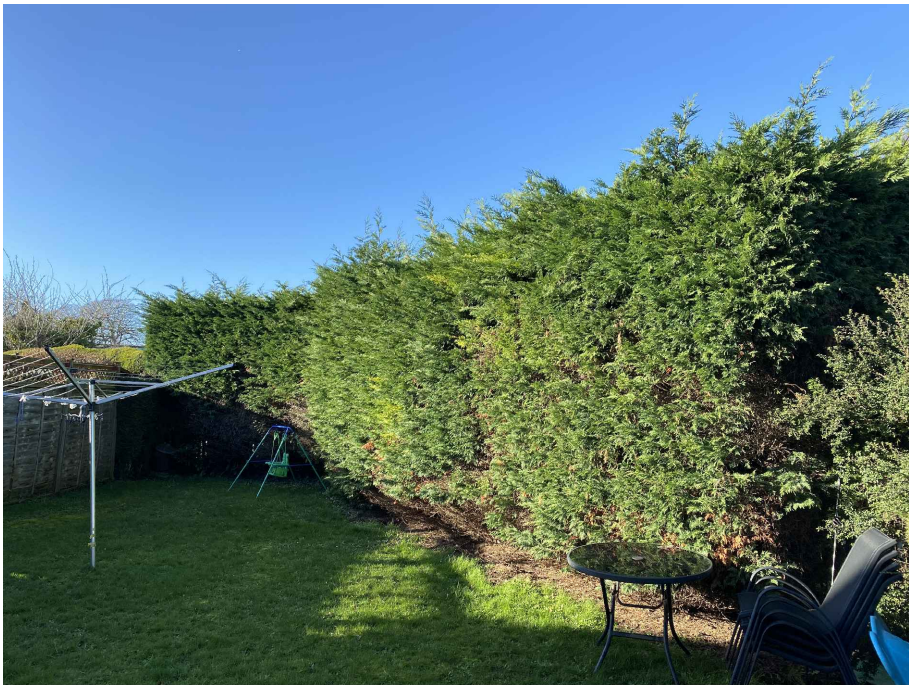
**05 |**  
Existing boundary of (approx) 12ft leylandii hedgerow with severe 'Conifer dieback' due to historic lack of maintenance and age. Imposing scale to both garden and Victoria Road footpath on opposite side.

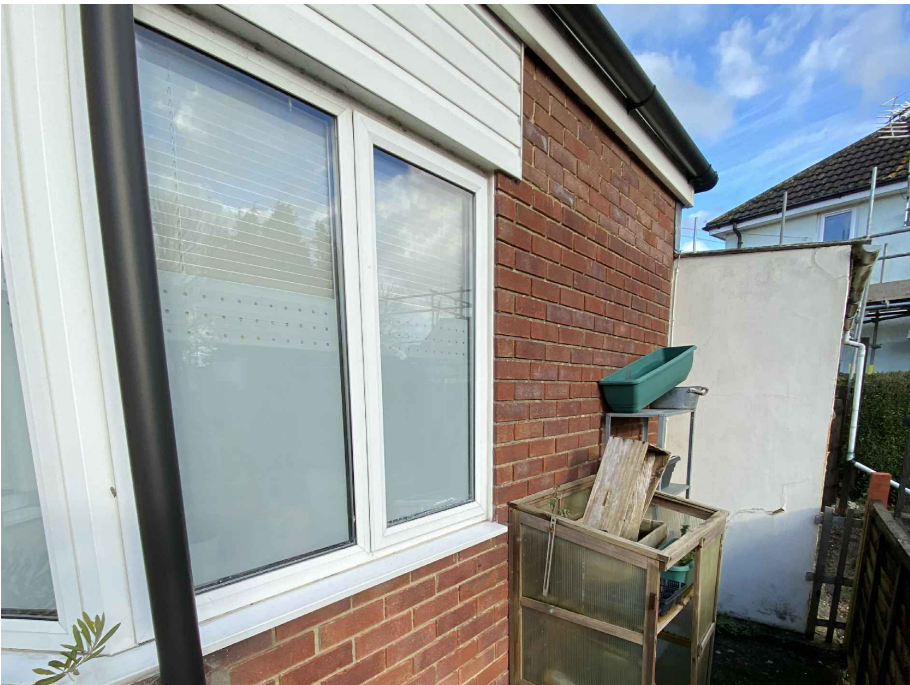
**06 |**  
Poor historic massing and space planning prevents access around property (front rear to 'front')
