# **ARBORICULTURAL IMPACT ASSESSMENT AND METHOD STATEMENT**

**The White House, 2 Langstone Road,  
Langstone, PO9 1RE**

**Add additional floor space to the existing guest room above  
the garage by adding a new dormer to the east side of the  
roof**

**Date – 10<sup>th</sup> August 2019**

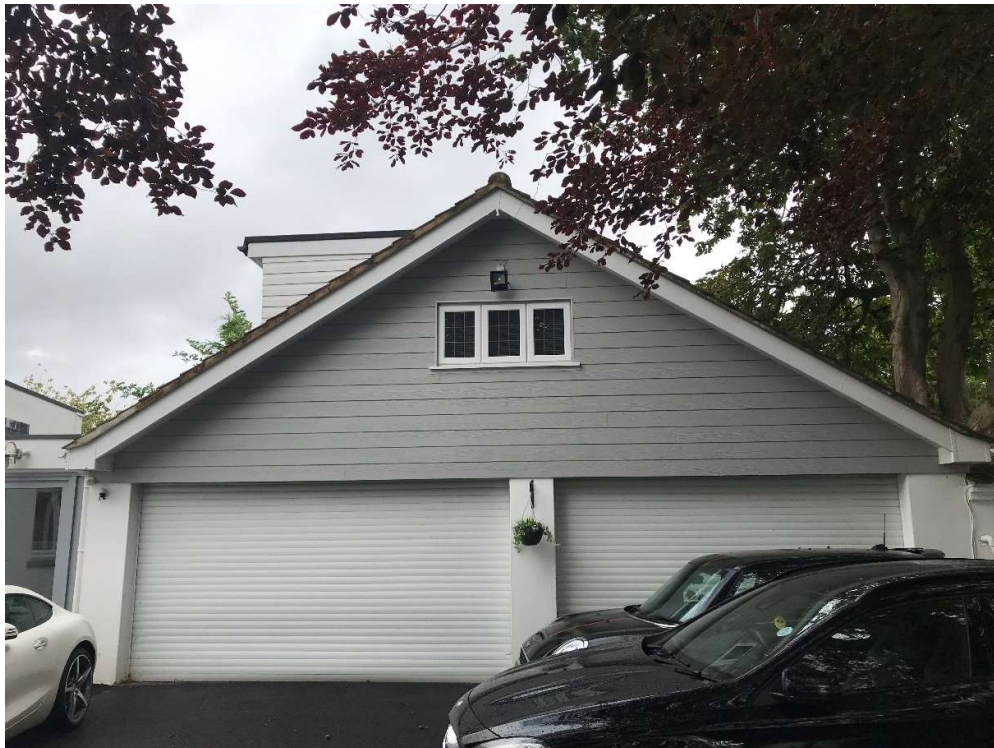
**Photograph 1:** Showing the existing garage, dormer window and T2 to the east with the crown of T1 in the foreground

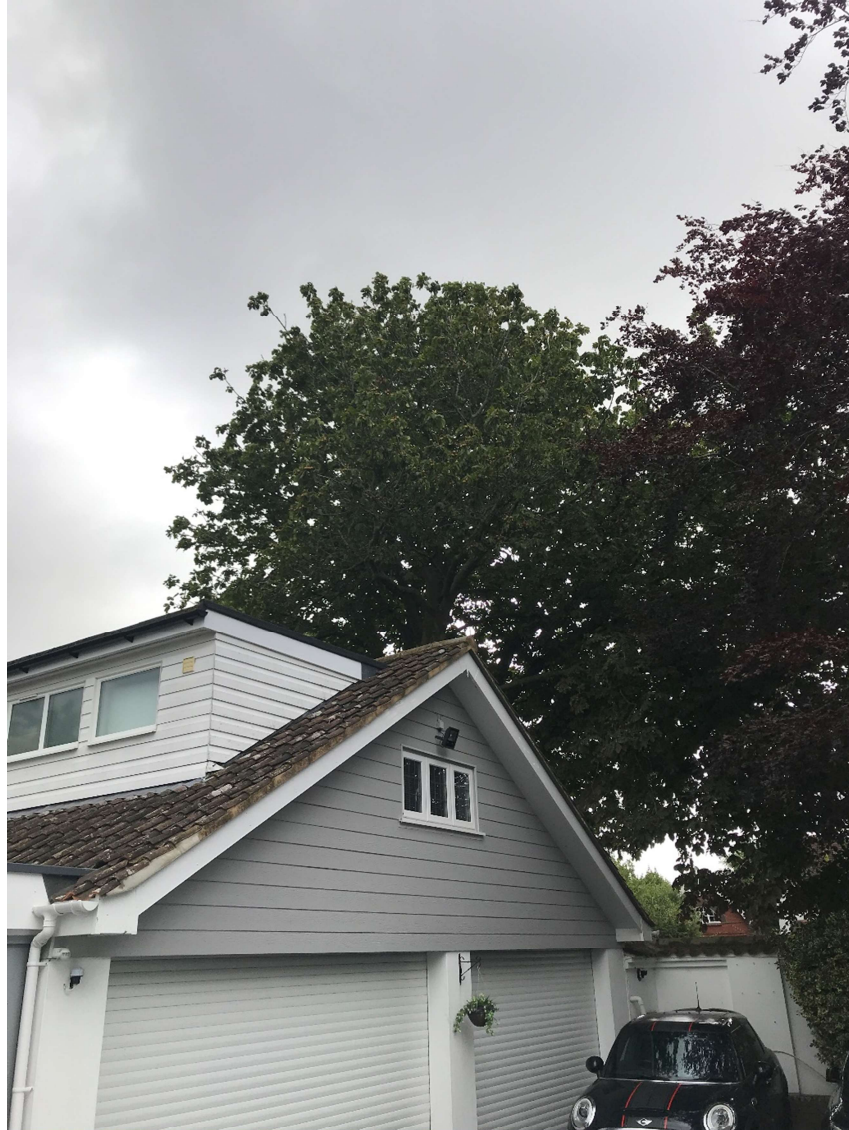
4.3 Tree 2 is an offsite Horse Chestnut, with the majority of tree roots covered by built form. Due to the tree being offsite, the boundary brick wall and the existing garage mean the tree does not require any additional protection as the trunk stands offsite by some 1.5m.

4.4 The crown of this tree on the west side has been historically lifted with the remaining significant branches clear of the garage. There is one area of branches in close proximity to the garage roof and the location of the proposed dormer window on the north west of the crown. These grow at approximately 4m above ground level overhanging the garage roof. Removing the branches with a

diameter of <75mm or less will provide sufficient clearance for the dormer window with little if any impact to the health or visual appearance of the tree.

**Photograph 2:** Showing the existing garage, dormer window and T2 with the crown of T1 in the foreground

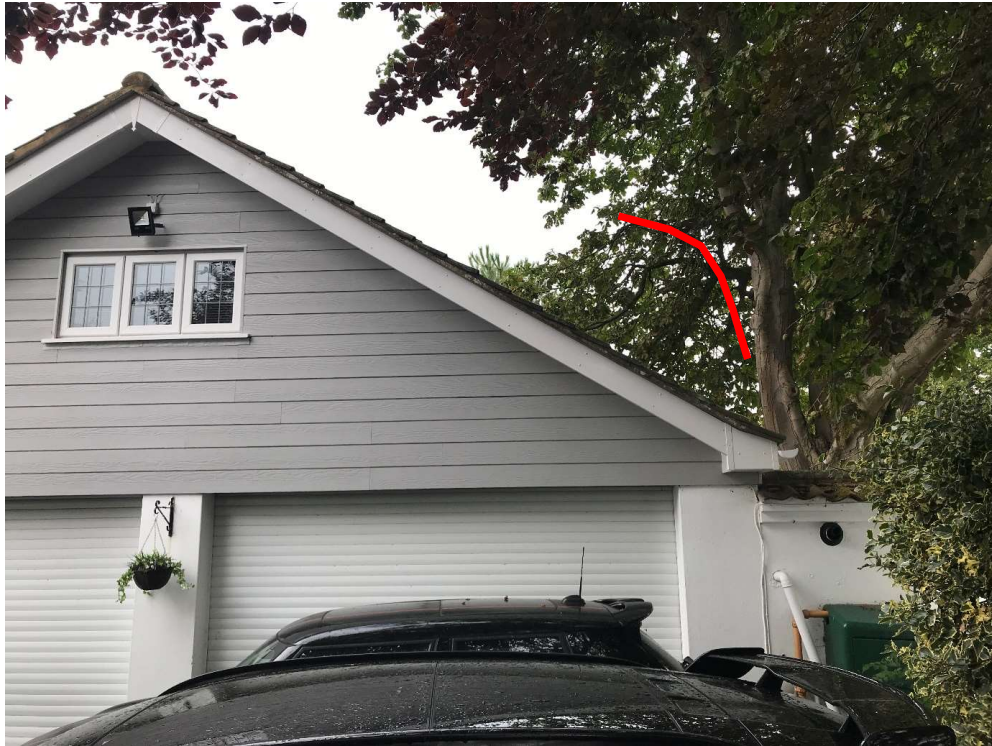
**Photograph 3:** Showing crown overhang from T2 and the area of crown pruning

14.3 The proposal will retain all identified trees within the survey and report. The development proposal will require the pruning of small diameter (<75mm) branches from T2 (Horse Chestnut) that will not be detrimental to the tree's health or visual amenity. Therefore, it is our opinion that as a direct result of the planning proposal, the trees closest to the garage and the dormer window work will not be significantly affected.

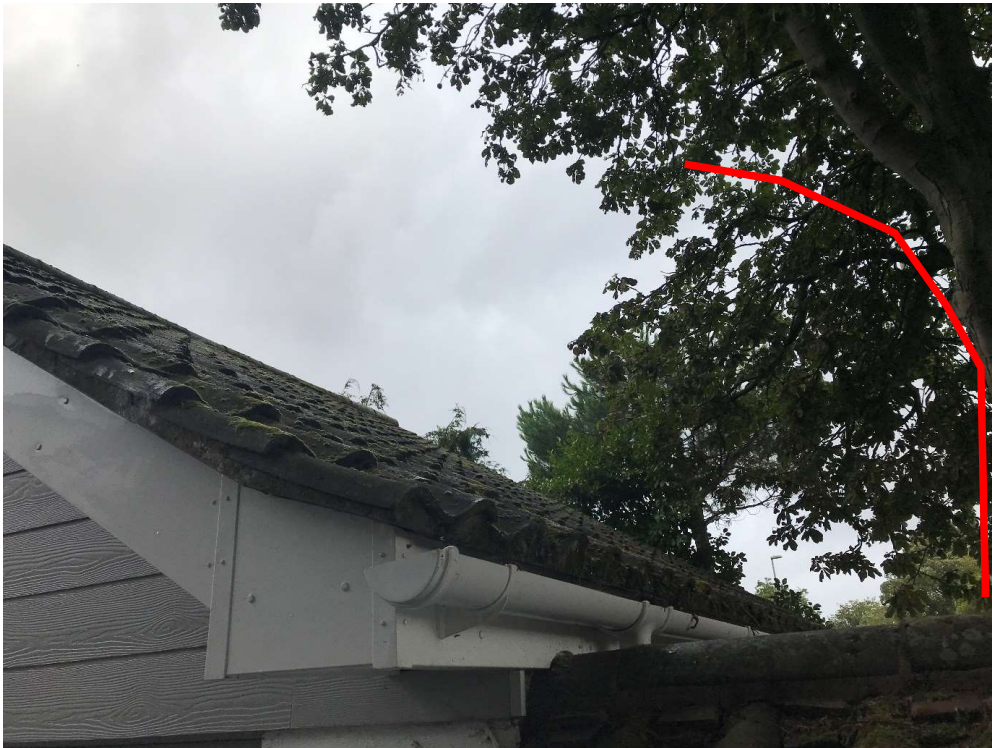
**Photograph 4:** Showing the area of the small diameter <75mm branches to be pruned

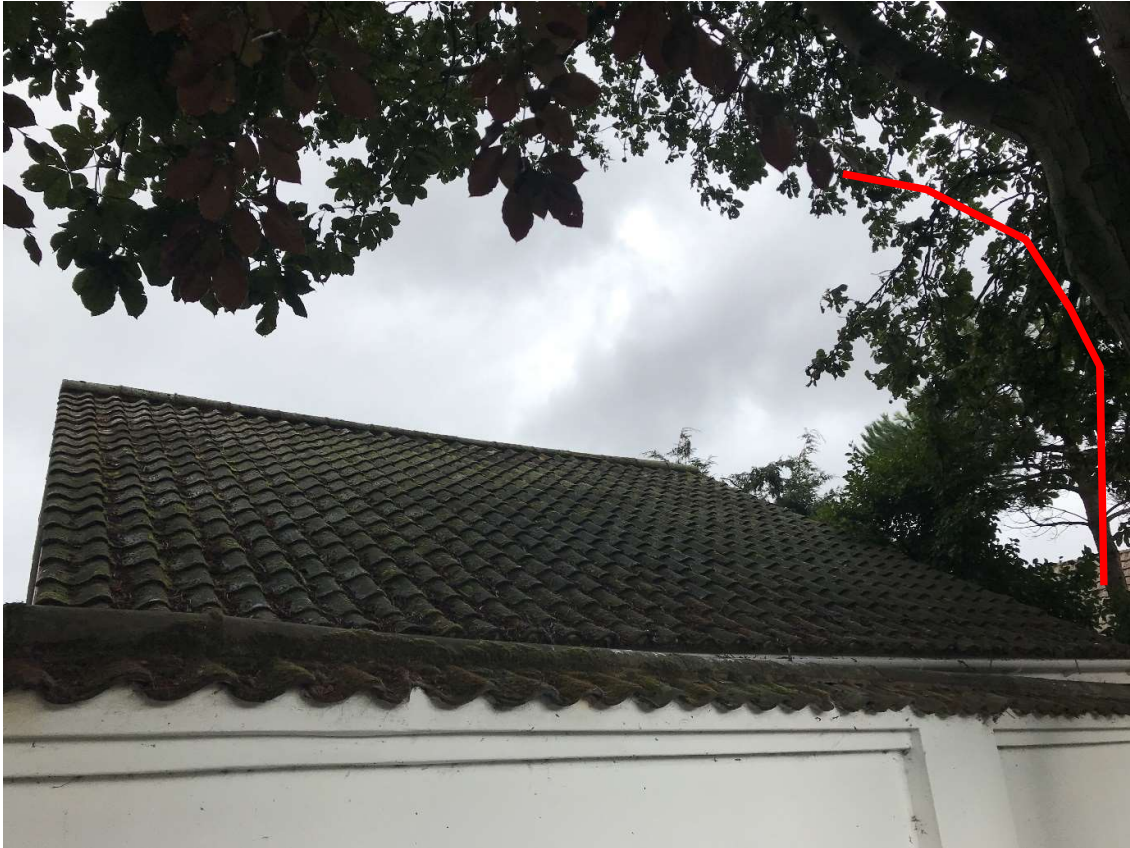
**Photograph 5:** Showing the clear existing garage roof and the area of the small diameter <75mm branches to be pruned
