## **Arboricultural assessment & method statement**

Land East of Castle Avenue, Havant, Hampshire

13<sup>th</sup> February 2019 18295-AA2-AN

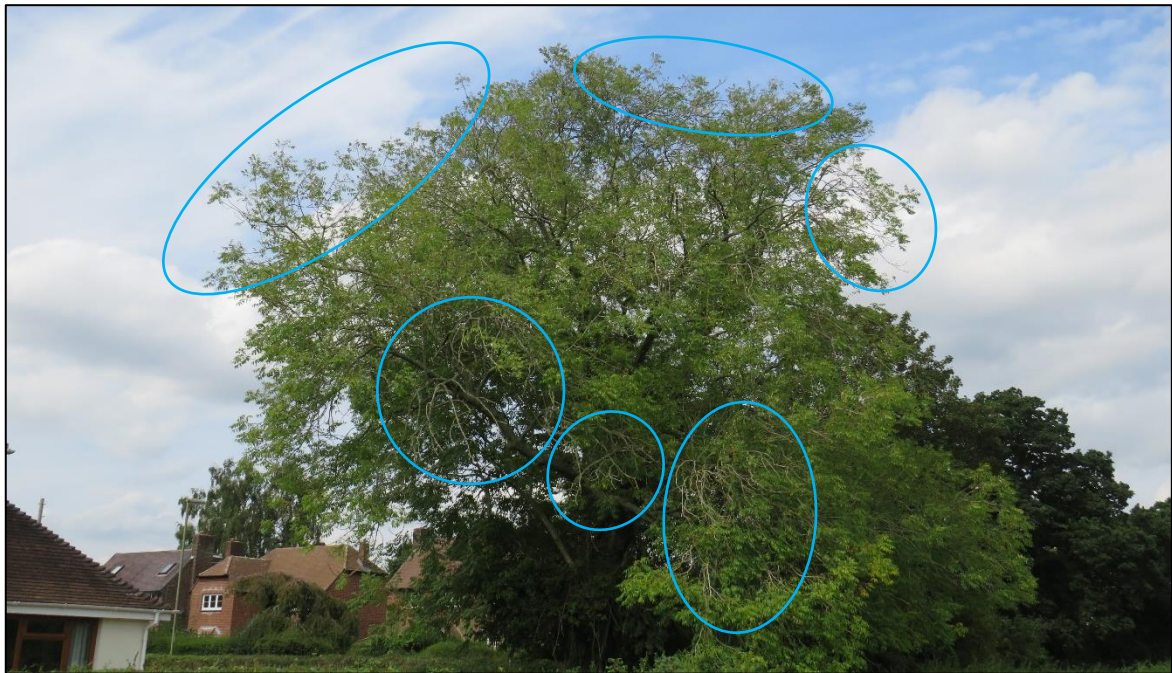
**T1:** This C category tree is visible from St George's Avenue where it forms a modest landscape feature. (Photo 1). It is located at the end of the avenue within a quiet cul-de-sac serving five private houses. The tree offers some public visual amenity along the avenue, but it is not prominent beyond the immediate landscape.

The tree is showing signs of dieback in the crown which is very likely to be early symptoms of the highly pathogenic ash dieback disease (*Hymenoscyphus fraxineus*) (Photos 2 and 3). This disease is now epidemic within the south east of England and there is no known treatment. It causes the death of infected trees over a short period. As such, the anticipated life expectancy of this tree is no more than 3–5 years. I also note that it is located at the edge of the public highway within the footpath where any replacement may be impractical.

**Photo 1:** Showing T1 with areas of dieback and sparse leaf coverage at crown extremities.

In my opinion the loss of T1 is inevitable regardless of development, and this loss will affect the local landscape in the short-term only. The proposed development will offer the opportunity to secure the replacement of this tree elsewhere within the new landscape, through enforceable planning conditions.

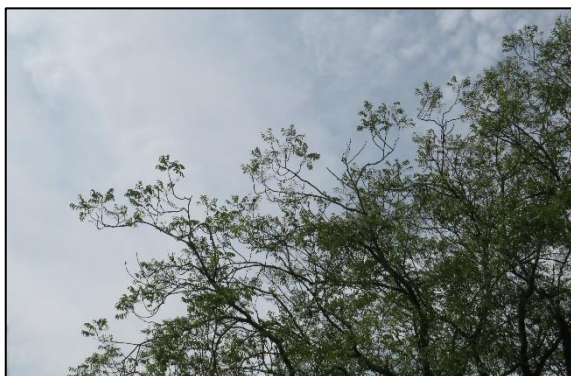
**Photo 2:** Showing T1 crown dieback and leaf coverage.

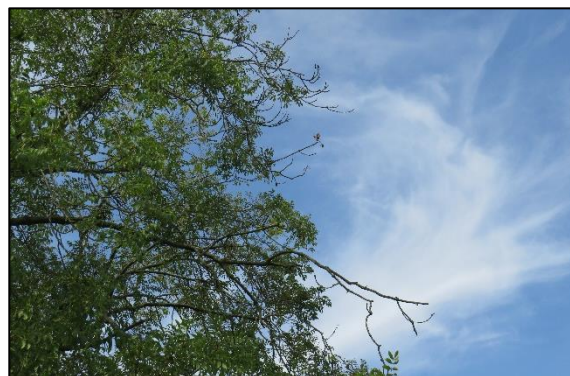
**Photo 3:** Showing T1 crown dieback.

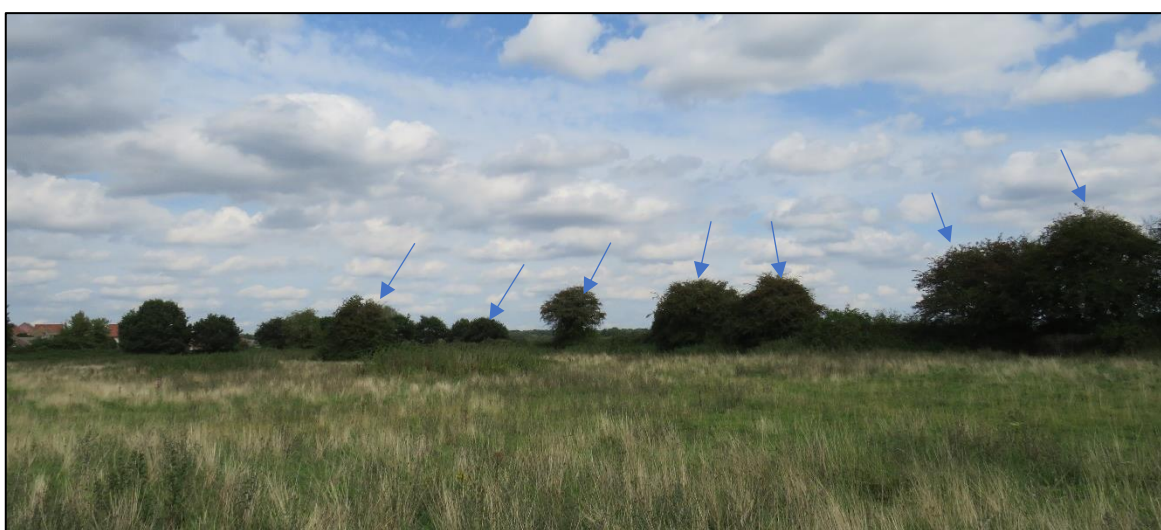
**T13, T14, G15 (part), T22, and T23:** These C category trees are growing within an unmanaged, field-boundary hedgerow and are noticeable only by virtue of a lack of larger landscape features within the adjacent fields (Photo 4). They are not prominent as skyline features from outside the site and their loss will not have a long-term impact on local character. Management of the hedgerow by the owner would reasonably seek to significantly reduce the height and spread of these trees regardless of the proposal, and as such I do not consider them a sustainable long-term landscape feature.

**Photo 4:** Showing the unmanaged field boundary hedgerow trees within G15 situated in the wider landscape.
