## **TREE SURVEY, ARBORICULTURAL IMPACT ASSESSMENT AND TREE PROTECTION PLAN**

Report to accompany a planning application for the demolition of a single-storey side extension, creation of an access drive and construction of a new three-bedroom bungalow on land to the rear garden of 198 London Road, Waterloooville, PO7 7AN.

*13<sup>th</sup> August 2018*

MDA reference K18

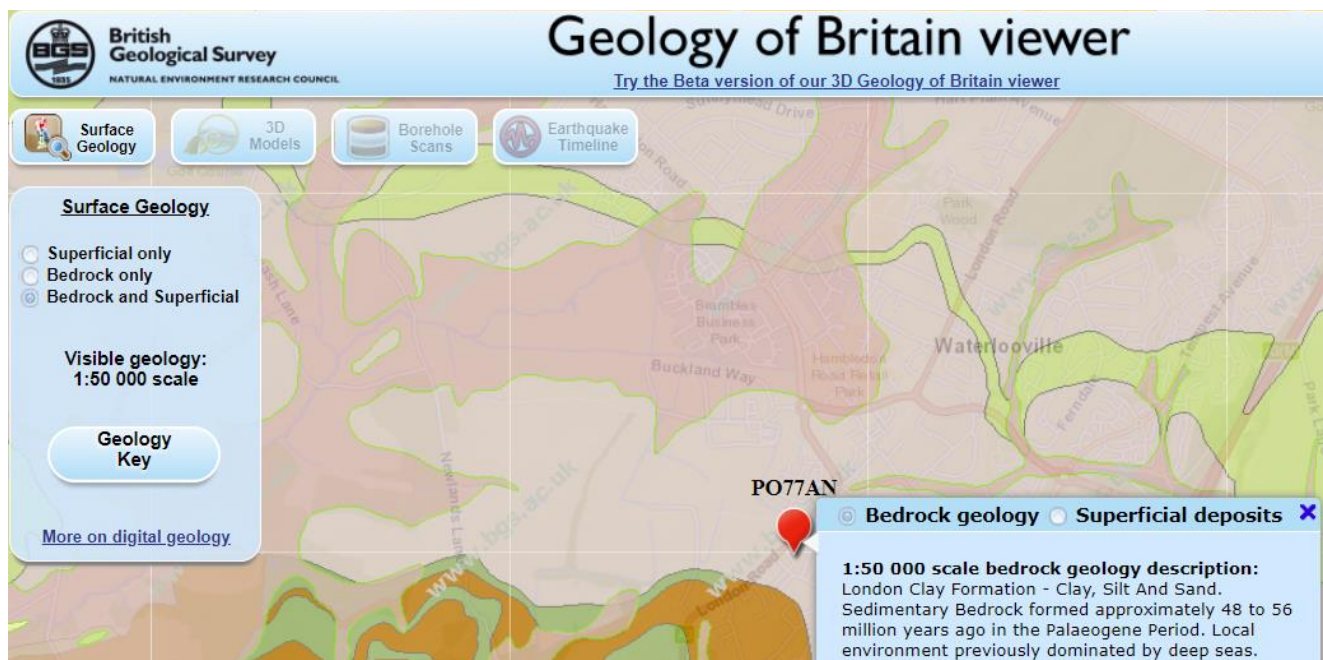
- 3.2 The British Geological Survey 1: 50,000 scale map indicates that the underlying geology of the site is shrinkable London Clay Formation – Clay, Silt and Sand (Figure 1). Thus, foundations will need to be deepened beyond the minimum of 1 m to take account of trees. Oak is regarded as being a high water demand species and the National House Building Council's Standards Chapter 4.2 *Building near trees* suggests that foundations closest to the oak tree should be a minimum of 2.2 m deep. It is recommended therefore that foundations should be designed by a suitably qualified engineer under the guidance of NHBC Chapter 4.2 taking account of all trees within influencing distance of the proposed new dwelling.

**Figure 1.** British Geological Survey 1: 50,000 scale map showing that the site is underlain by the London Clay Formation – Clay, Silt and Sand

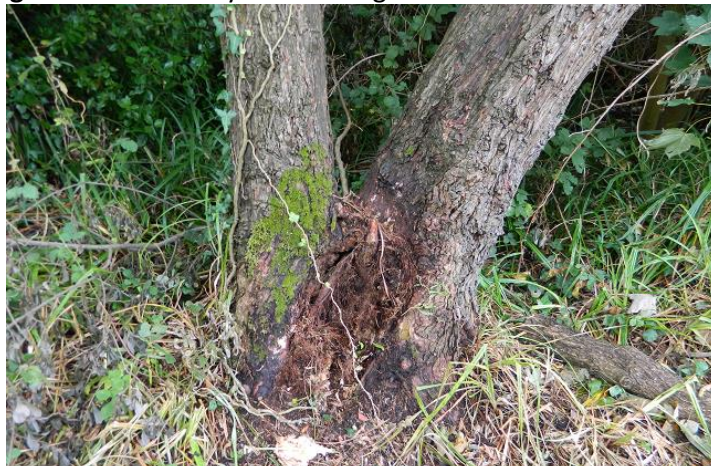
- 4.5 It is unclear whether T1 contorted willow is on land at 198 London Road or in the neighbouring garden as it is close to the unmarked boundary. It has been categorised U as it has basal decay and infection with honey fungus (Figure 2). One stem out of three original stems which divide at ground level has collapsed, and been removed, but the remaining two stems (440 mm and 360 mm diameter) cannot be considered safe. Whilst the tree does not create a conflict with the development proposals it should be removed on safety grounds.

**Figure 2.** Basal decay and missing stem of contorted willow T1.

| Tree No. | Species | Height (m) | Trunk diameter (mm) | N (m) | S (m) | E (m) | W (m) | Height of crown clearance (m) | Age class | Physiological condition | Structural condition | Useful life | BS5867 Grade | Comments |
|---|---|---|---|---|---|---|---|---|---|---|---|---|---|---|
| T1 | Contorted willow | 14 | 569 | 7 | 5 | 5 | 4 | 3 | OM | Poor | Poor | <10 | U | Decay at base of trunk. One stem fallen. Honey fungus infection. Remove. |

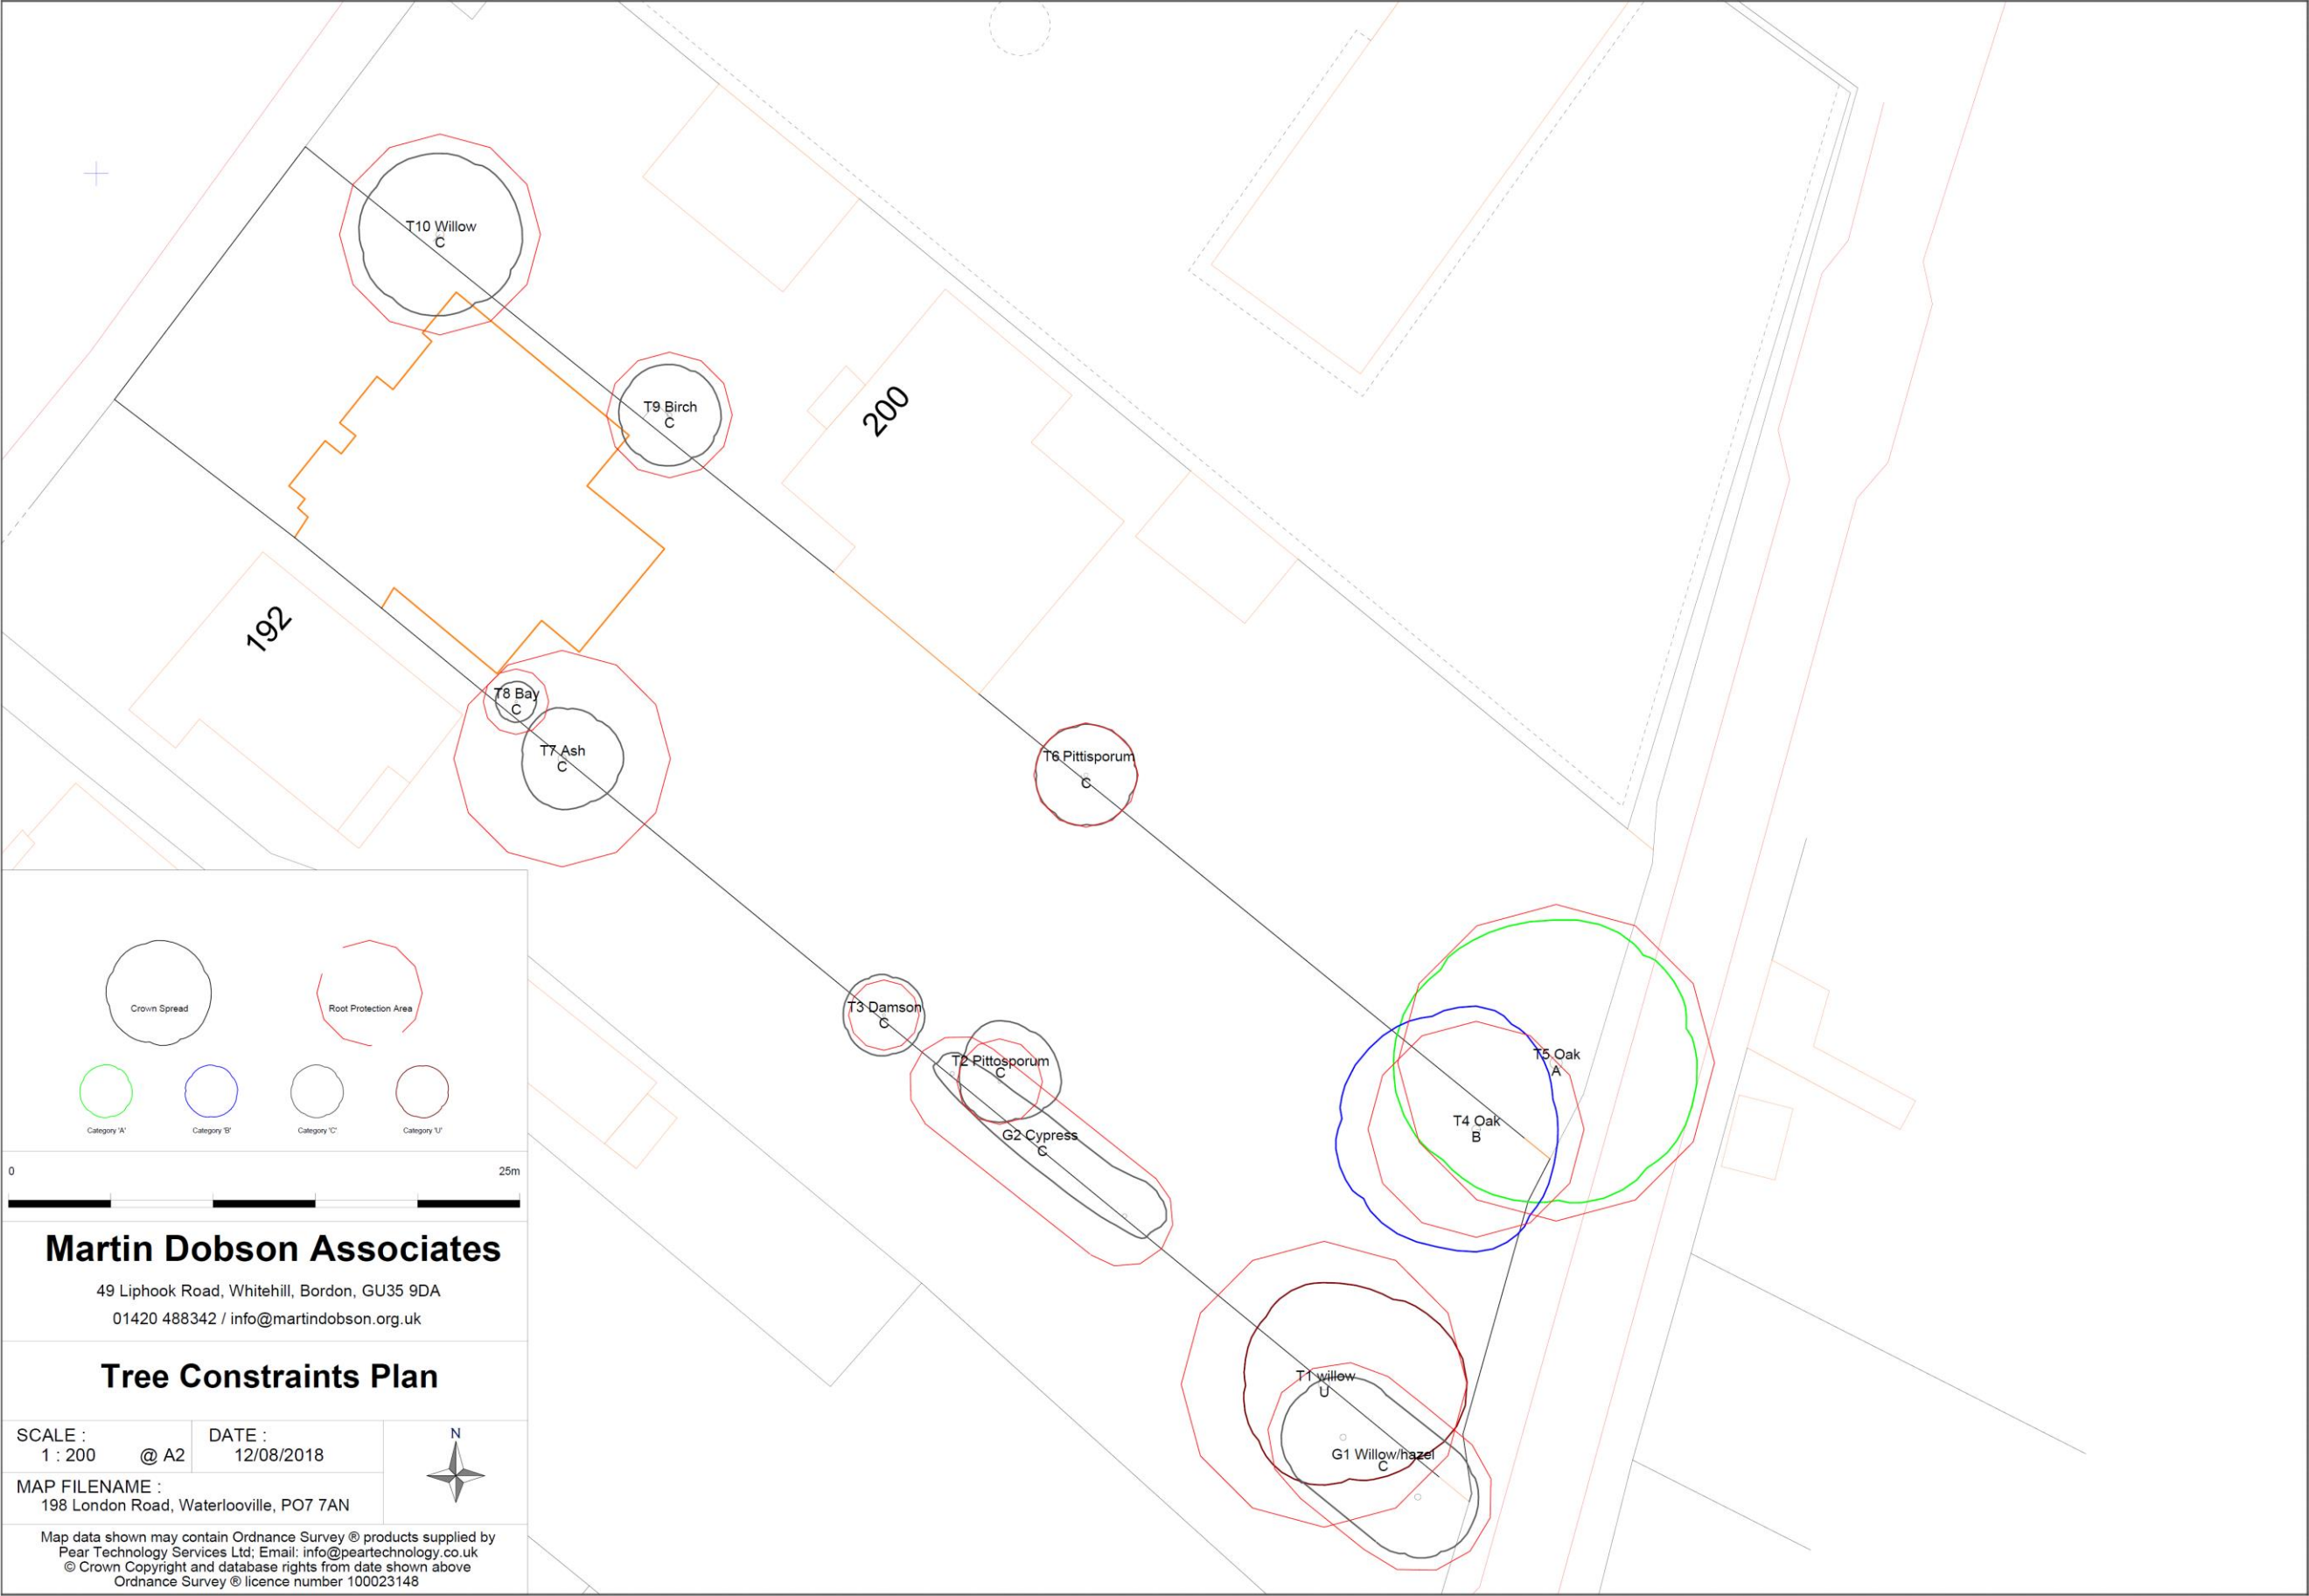
APPENDIX MD2

Tree constraints plan (TCP) showing existing plot layout with tree numbers, BS5837: 2012 colour codes (A – Green, B – Blue, C – Grey, U - Red) and root protection areas (red circles). The plan has been provided separately as a PDF at a scale of 1: 200 @ A2.

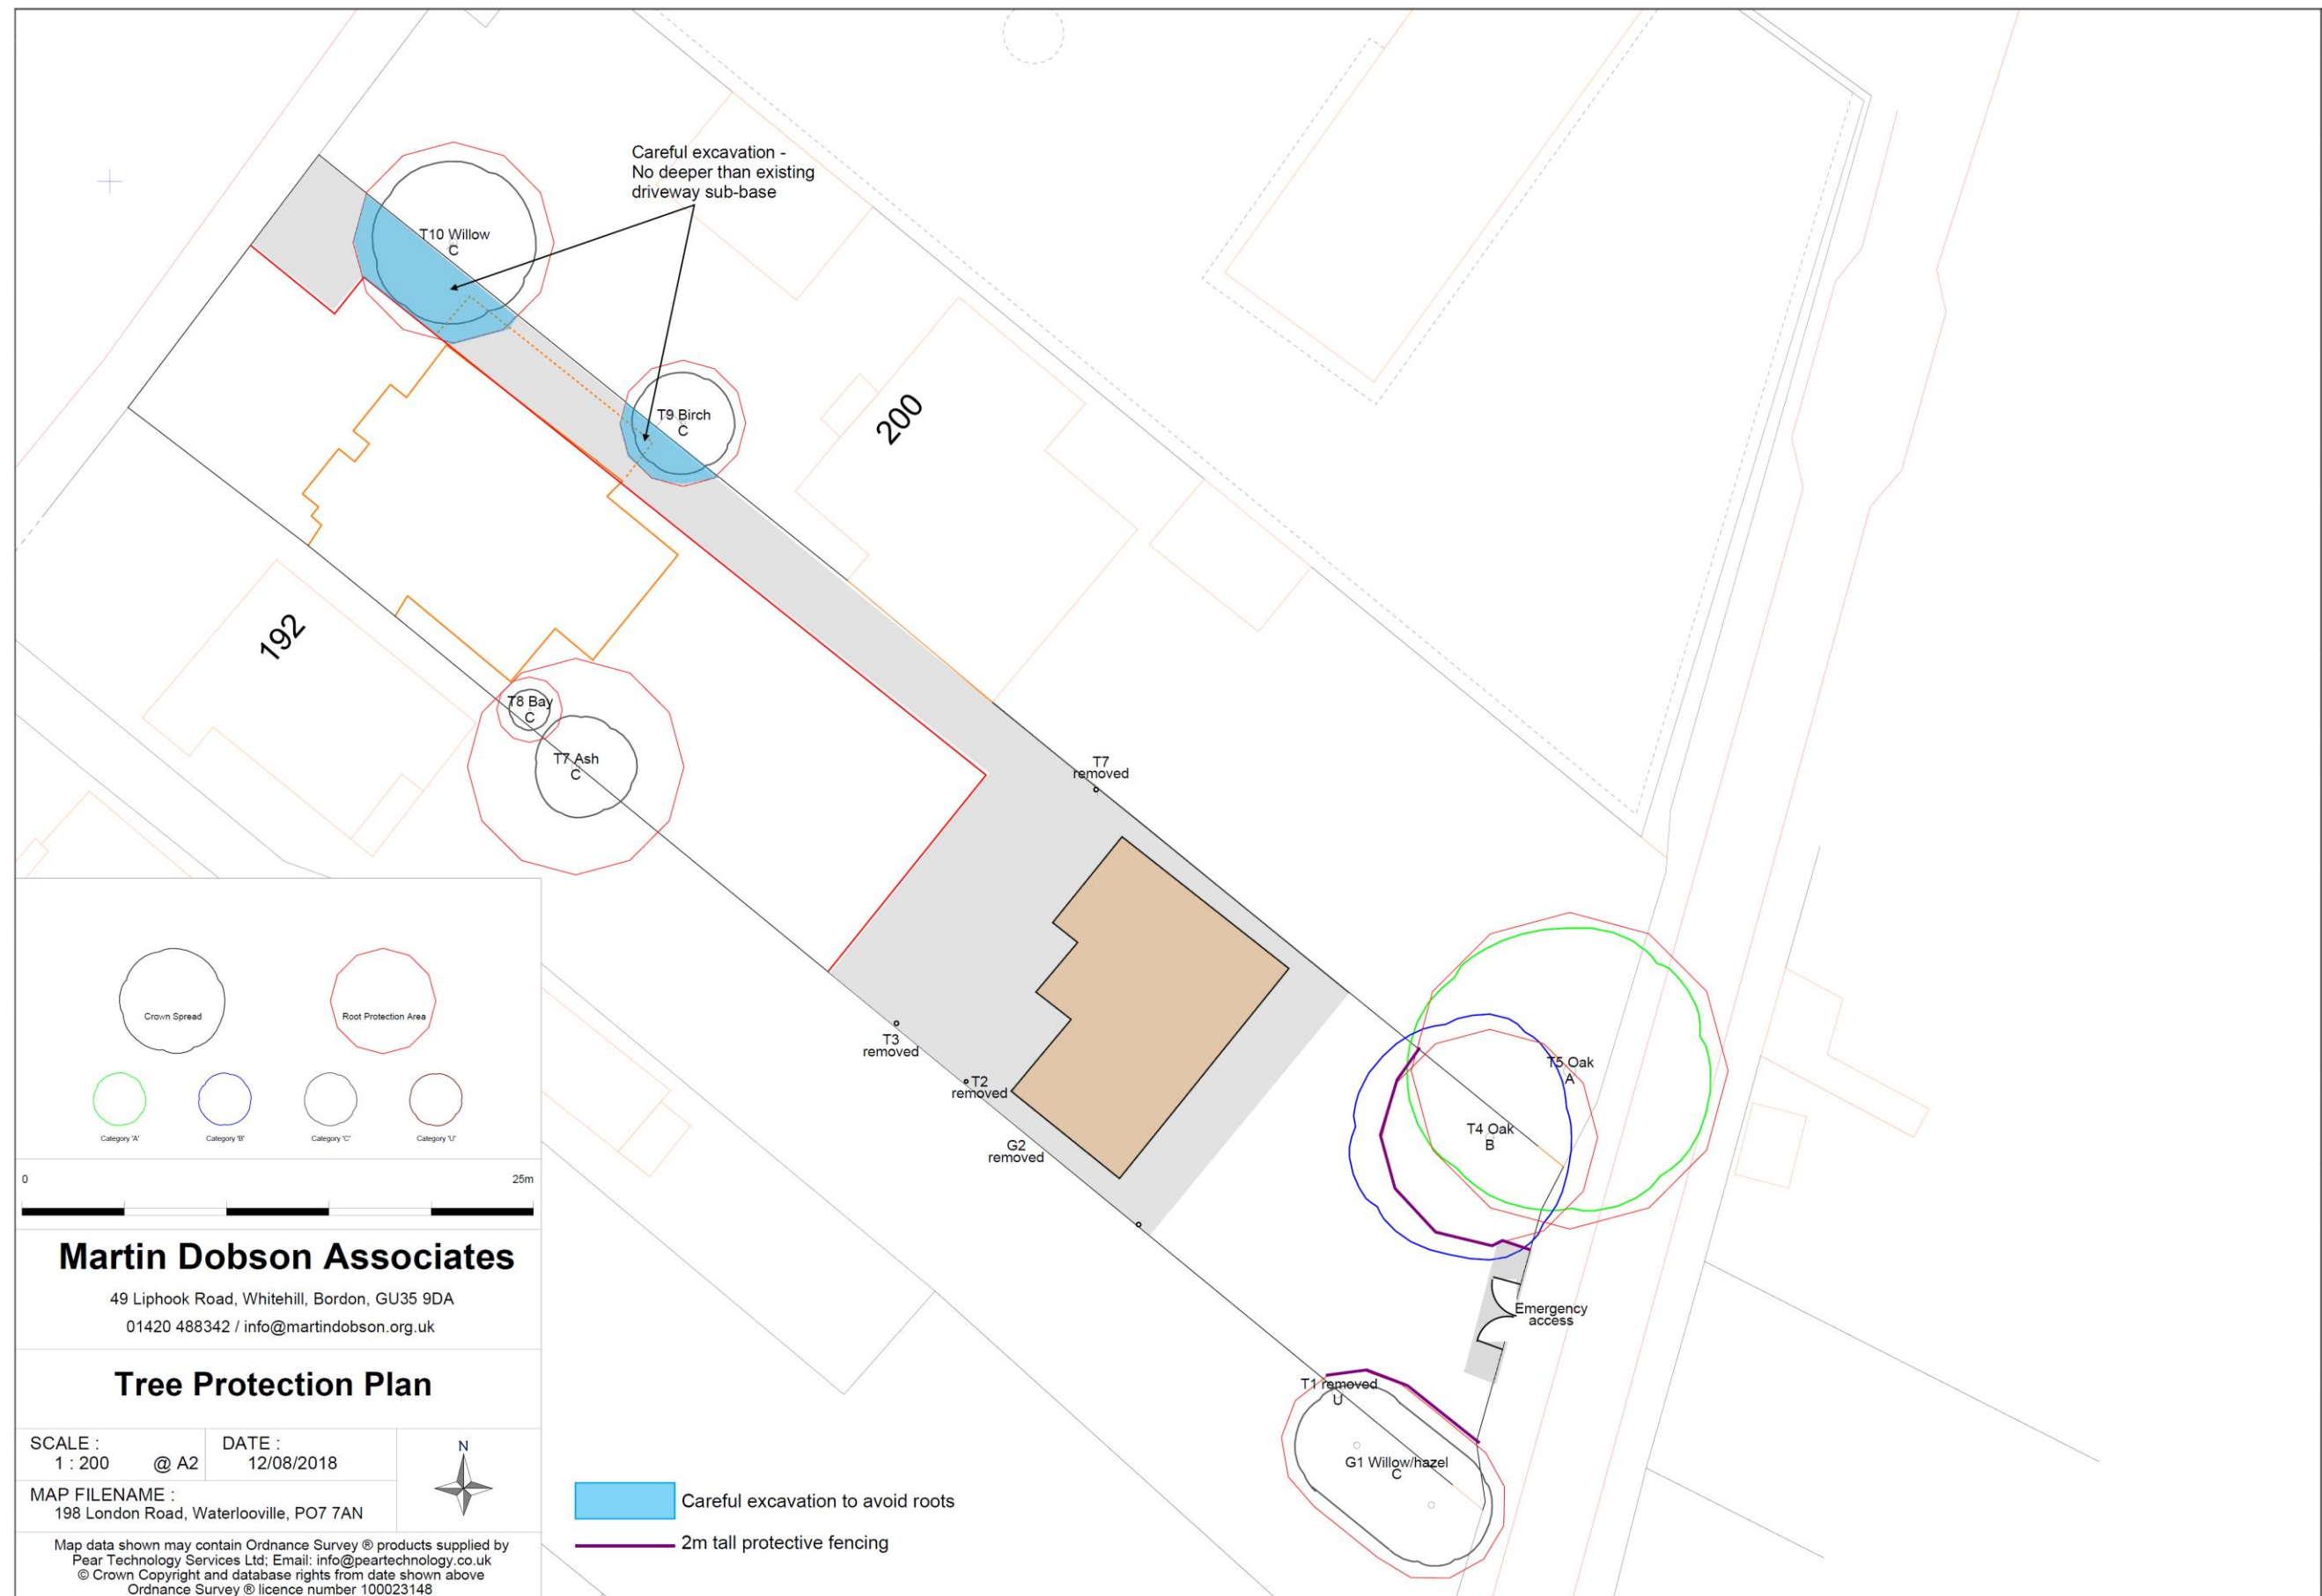
## APPENDIX MD4

Tree protection plan (TPP) showing retained trees, tree numbers and root protection areas (red circles). The location of protective fencing is shown as purple lines and area for careful excavation of driveway as blue shading. The plan has been provided separately as a PDF at a scale of 1: 200 @ A2

- 5.3 Tree protection will comprise of 2 m tall fencing installed in the positions shown at **MD4** before demolition takes place or materials are delivered to site or construction commences. The fencing will consist of a scaffold framework, well braced to resist impacts, with vertical tubes spaced at a maximum interval of 3 m (Figure 3). Onto this, weld mesh panels or 2 m high shuttering board will be securely fixed with wire or scaffold clamps. Un-braced weld mesh panels on unsecured rubber or concrete feet will not be used as these are not resistant to impact and are too easily removed by site operatives. An alternative system of bracing which does not require a scaffold framework is shown in Figure 4.
