| Hayling Billy Pub, 117 Elm Grove, Hayling Island, Hampshire, PO11 9ED<br>Schedule of works | | | | | | | | | | |

Project  
HAYLING BILLY, ELM GROVE,  
HAYLING ISLAND

Title  
TREE MAINTENANCE PLAN

Drawing Number  
9030-KC-XX-YTREE-TMP01Rev0

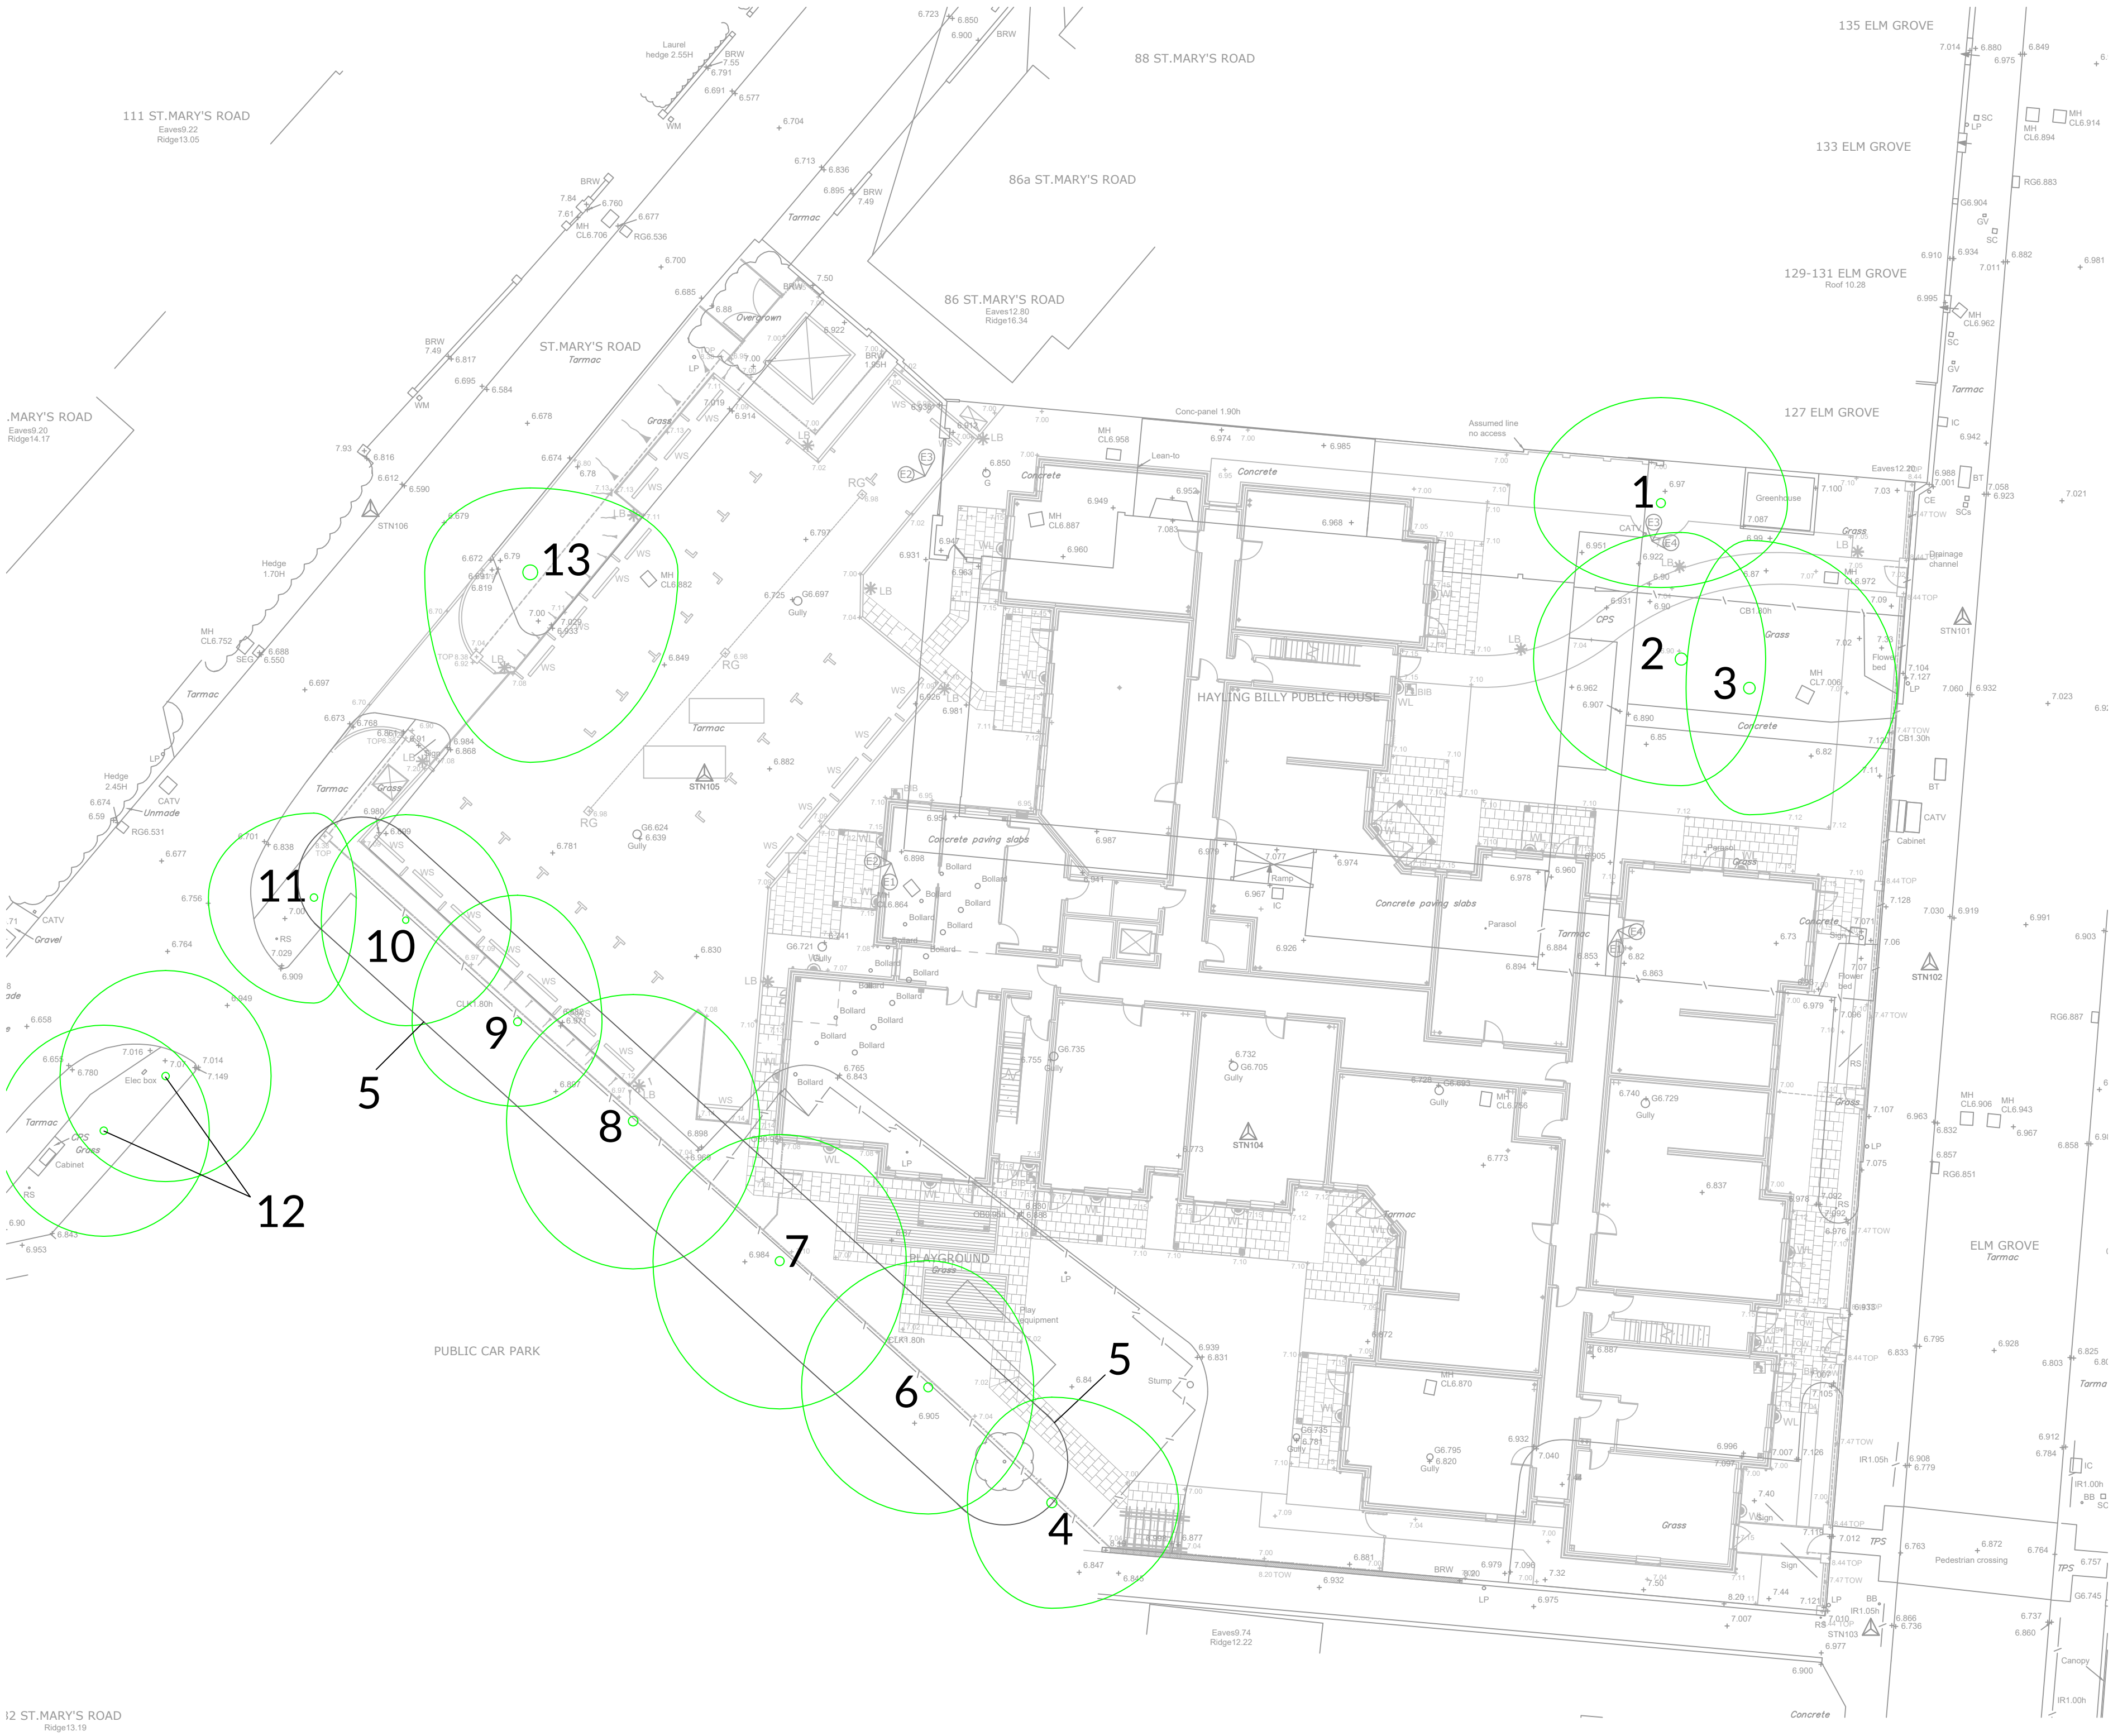
| Hayling Billy Pub, 117 Elm Grove, Hayling Island, Hampshire, PO11 9ED<br>Schedule of works | | | | | | | | | | |
|---|---|---|---|---|---|---|---|---|---|---|
| 1 | English oak | Remove dead and broken branches throughout the crown.<br><br>Remove all deadwood in excess of 25mm in diameter and cut back to maintain minimum 3m clearance from buildings. | • | | | | | • | | • |
| 2 | Lime | Crown lift to 4 metres above ground level.<br><br>Remove all deadwood in excess of 25mm in diameter. | | • | | | • | | • | |
| 3 | Lime | Currently (September 2018) interfering with sales boards at front but these boards will be removed and it is therefore not worth compromising the tree form for these boards.<br><br>Crown lift to 4 metres above ground level.<br><br>Remove all deadwood in excess of 25mm in diameter. | | • | | | | • | | • |
| 4 | Lime | Remove all deadwood in excess of 25mm in diameter.<br><br>Reduce overhang to 3 metres over the garden space. | • | | | | • | | | • |
| 5 | Row of hawthorn | Cut back to the boundary | | • | • | | • | • | • | • |
| 6 | Lime | Remove all deadwood in excess of 25mm in diameter.<br><br>Reduce overhang to 3 metres over the garden. | | | • | | | | • | |
| 7 | Lime | Cut back to provide 2 metres clearance from building.<br><br>Crown lift to 5 metres above ground level where it overhangs the garden. | | • | | | | • | | • |
| 8 | Lime | No works required at present (2018).<br><br>Crown lift to 5 metres over the parking bays.<br><br>Prune back to provide 2 metres clearance from the buildings. | | | | | | • | | • |
| 9 | Lime | Crown lift to 5 metres over the parking bays. | | | | | | • | | • |
| 10 | Lime | Crown lift to 5 metres over the parking bays. | | | | | | • | | • |
| 13 | Maritime Pine | Remove deadwood in excess of 25mm in diameter throughout the crown.<br><br>Remove arborist's ropes, one green and one white, that are located coiled within the crown. | • | | | | • | | | • |
