# Christopher Hoare Tree Services Ltd

## Arboricultural Report

- Pre-development Arboricultural Tree Survey
- Arboricultural Impact Assessment
- Arboricultural Method Statement

Havant Road  
Emsworth  
Hampshire  
PO10 7JD

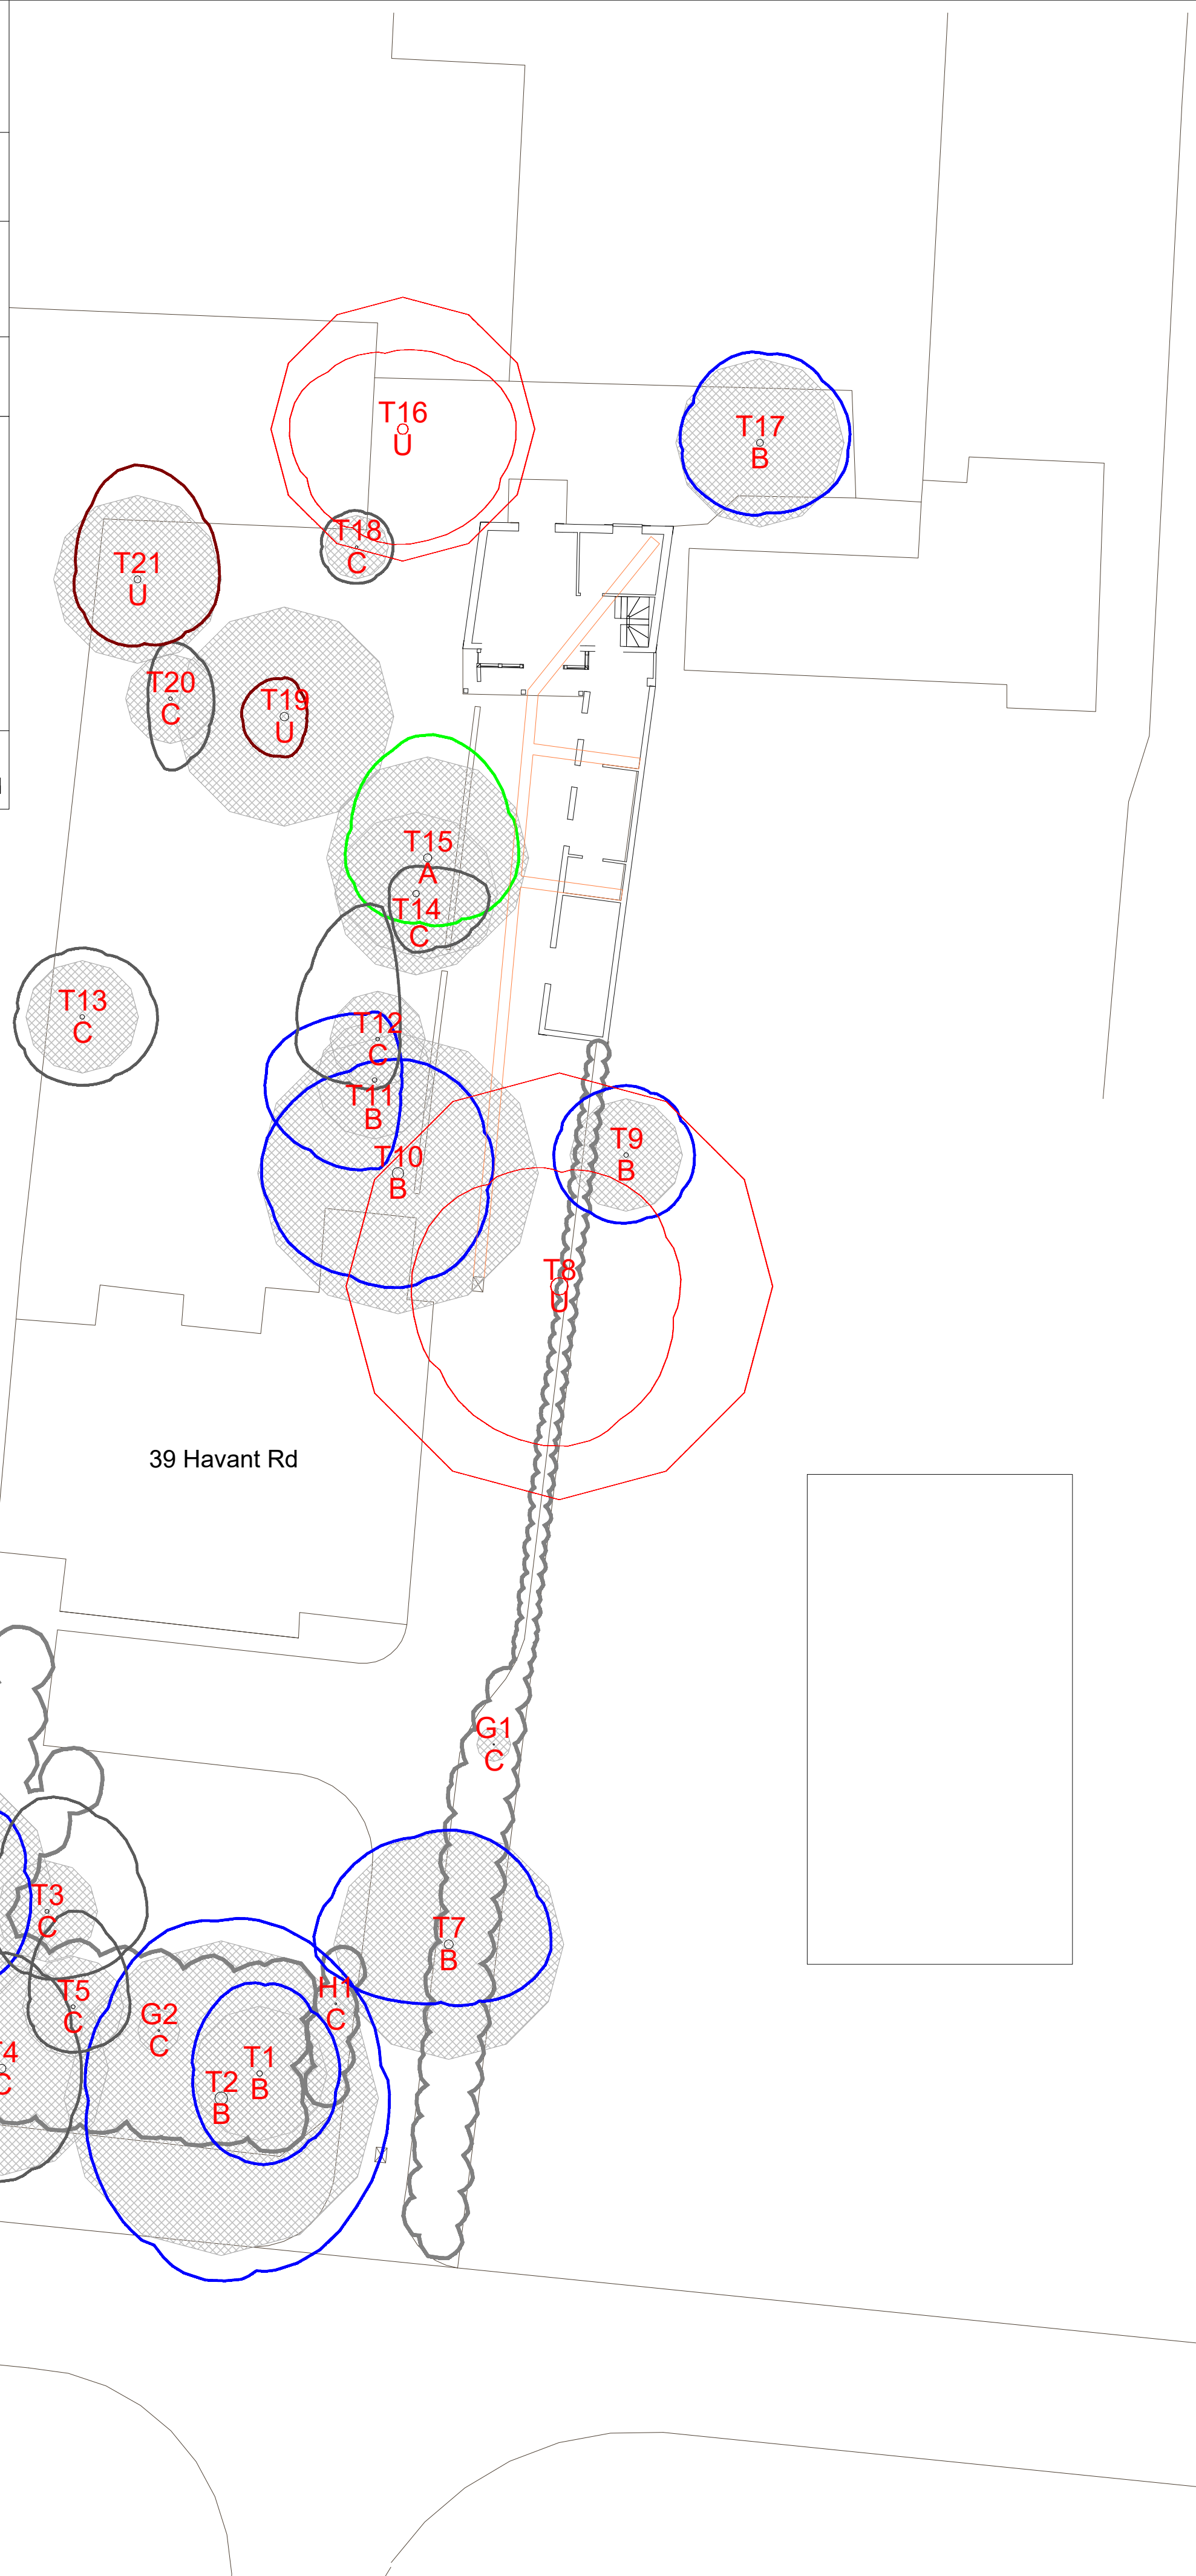
## Tree Retention/Removal Plan

4.3.1. Two category **U** trees have been identified for removal. **T8** and **T16** have irremediable defects which predispose them or component parts of their structure to failure. The loss of these trees may be mitigated through supplementary planting elsewhere at the site if appropriate.

4.4.1. Some minor pruning works are required to the eastern canopy of **T15**. This work has been recommended in order to safeguard the canopy of the tree from potential mechanical injury.

4.4.2. The reshaping and pruning of the canopy of **T18** has been recommended to ensure that it is maintained at its current size. This has been specified in light of the installation of the arched window on the western elevation of the Coach House.

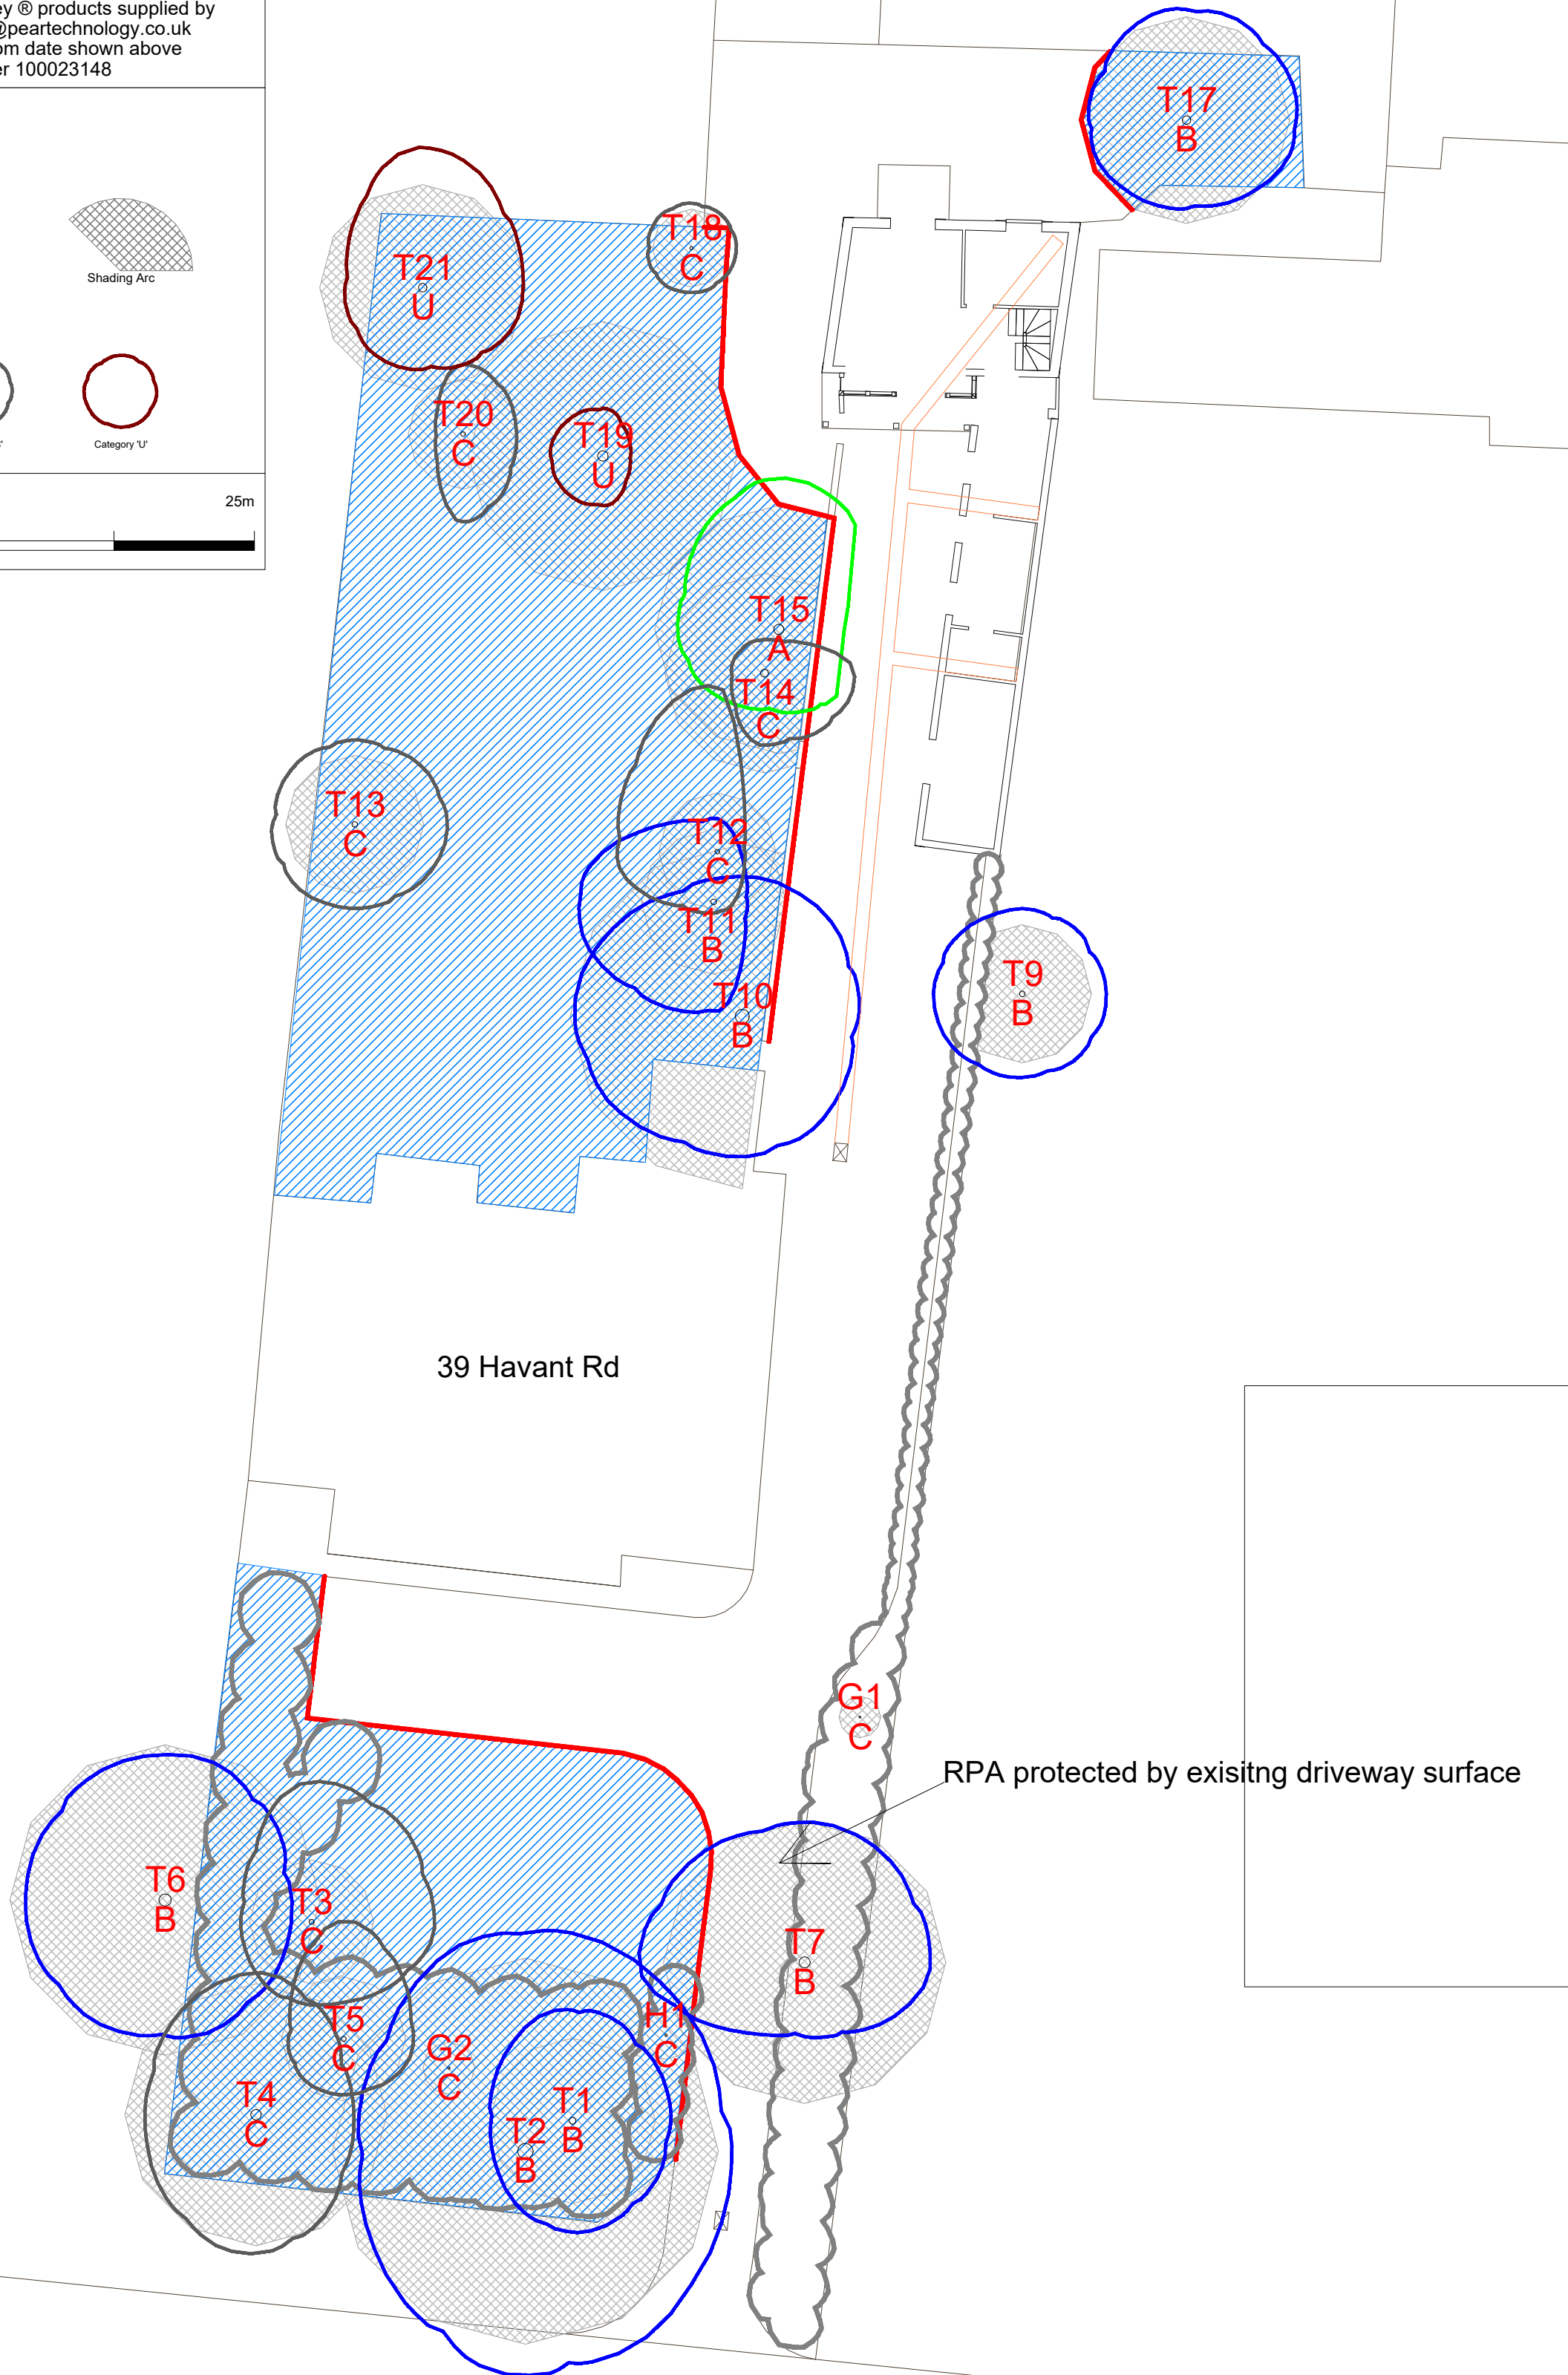
## Tree Protection Plan

- 4.8.3.2. The service run highlighted in orange on the accompanying plans is displayed as passing through the theoretical root protection areas of retained tree numbers **T10** and **T15**. However, there is a brick wall located to the west of the existing service trench<sup>17</sup>. The brick wall appears to be the same age as the main house and Coach House. The purpose of the brick wall is to define the garden and driveway boundary. I inspected the wall and found it to comprise of five courses of above-ground brickwork and one course of foundation brickwork laid below ground level. The brick wall retains a significant amount of garden soil and measures a height of 400mm above ground level. When combined with the subterranean brick course, this gives the wall a total height as 480mm.

- 4.8.3.3. The subject wall predates the trees growing on the raised ground to the west of the subject wall by a considerable amount. Subsequently, I believe the position of the wall to have acted as a barrier to roots which would otherwise proliferate into the area around the existing service trench. I noted a number of other factors regarding the driveway and existing service trench which I would also consider as being inhibiting to root growth.

- Construction in any form.
  - The installation of services or drainage.
  - Landscaping works.
- 3.3.2. Tree protection barriers are to be erected in the locations specified in the **Tree Protection Plan (Q12978/TPP/15-9-17\_V1)** provided in **Appendix B** of this document. The protection barriers will conform to the guidance set in **BS 5837:2012 “Trees in relation to design, demolition and construction – Recommendations.**
