**HAVANT RFU SITE, BEDHAMPTON,  
HAVANT**

**PRE-DEVELOPMENT  
ARBORICULTURAL SURVEY AND  
IMPACT ASSESSMENT**

A Report to: CBRE Ltd

Report No: RT-MME-126985

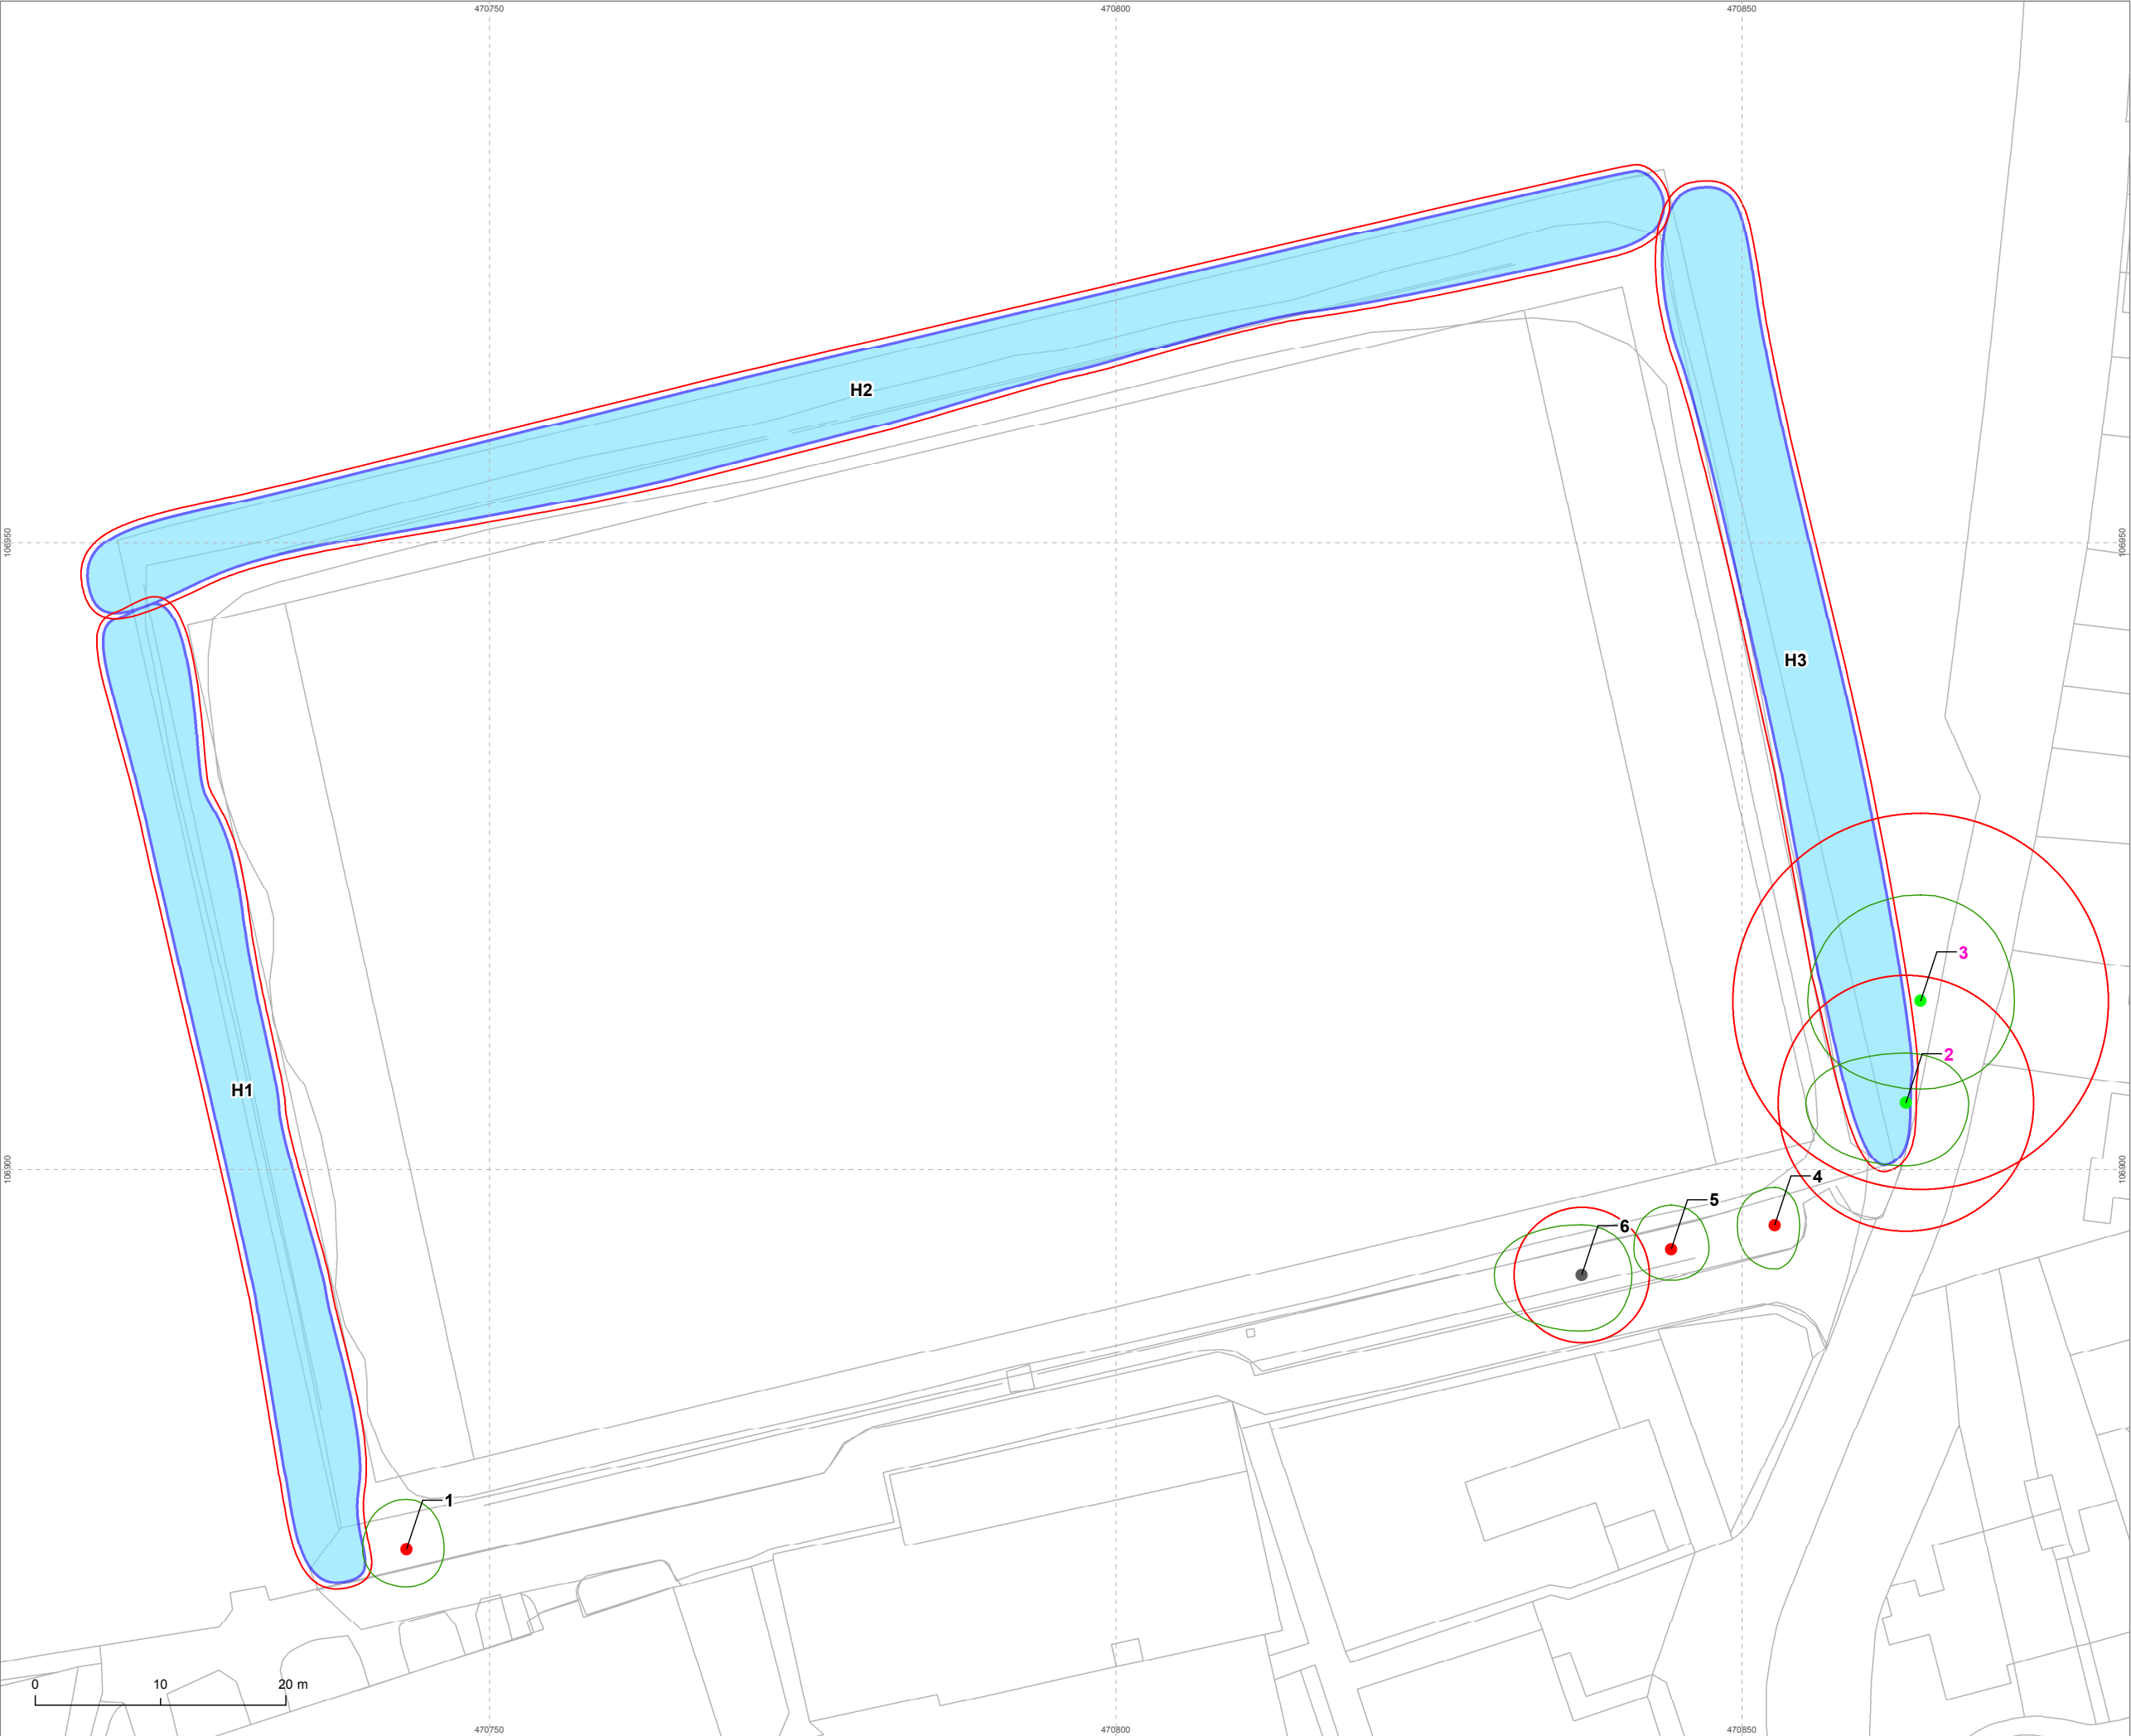
C126985-01

| Tree No. | Species | No. Stems | Diam (mm) | H't (m) | H't 1st Branch (m) | Branch Spread (m) | | | | Crown Clearance (m) | | | | Age | Phys Cond | Struc Cond | Est. Remain Contrib (Years) | Cat | Comments | Preliminary Management - Recommendations |
|---|---|---|---|---|---|---|---|---|---|---|---|---|---|---|---|---|---|---|---|---|
| 3 | Monterey cypress | - | 1270 | 17.0 | 4.0 W | 8.5 | 7.5 | 7.0 | 9.0 | 4.0 | 3.0 | 3.0 | 3.0 | M | G | G | 40+ | A1 | <ul style="list-style-type: none"> <li>Hardstanding within RPA of tree.</li> <li>Located off-site but does overhang.</li> <li>Minor deadwood present.</li> <li>Small branches hanging in crown.</li> <li>Stem damage present.</li> <li>Previous work – crown reduced.</li> </ul> | - |

| Tree No. | Species | No. Stems | Diam (mm) | H't (m) | H't 1st Branch (m) | Branch Spread (m) | | | | Crown Clearance (m) | | | | Age | Phys Cond | Struc Cond | Est. Remain Contrib (Years) | Cat | Comments | Preliminary Management - Recommendations |
|---|---|---|---|---|---|---|---|---|---|---|---|---|---|---|---|---|---|---|---|---|
| 5 | Flowering cherry | - | 320 | 6.0 | 2.0 E | 3.5 | 3.0 | 2.5 | 3.0 | 3.0 | 2.5 | 2.5 | 2.5 | Y | F | P | <10 | U | <ul style="list-style-type: none"> <li>Major breakout, decay present.</li> <li>Large quantity of deadwood present.</li> <li>Dieback present on apical and lateral branches.</li> <li>Generally a poor specimen with a limited contribution to the local landscape.</li> </ul> | - |
| 6 | English oak | - | 440 | 8.0 | 3.0 S | 4.0 | 4.0 | 4.5 | 7.0 | 2.5 | 2.5 | 2.5 | 2.5 | Y | F | F | 20+ | C1 | <ul style="list-style-type: none"> <li>Dieback present in northern section of crown.</li> <li>Minor deadwood present.</li> <li>Tree appears to be in decline.</li> <li>Wound present on northern section of main stem between 0.0 and 1.0 m above ground level, decay present.</li> </ul> | - |

| Tree Number | Species | BS5837 Category | Reason for Removal |
|---|---|---|---|
| 1 | Flowering Cherry | U | Removal required due to poor structural condition. |
| 4 | Apple | U | Removal required due to poor structural condition. |
| 5 | Flowering Cherry | U | Removal required due to poor structural condition. |

In this respect it is recommended that the tree numbers 2, 3 and 6 are lifted to an adequate height (i.e. 3.5 m above ground level) to provide clearance for proposed construction works.

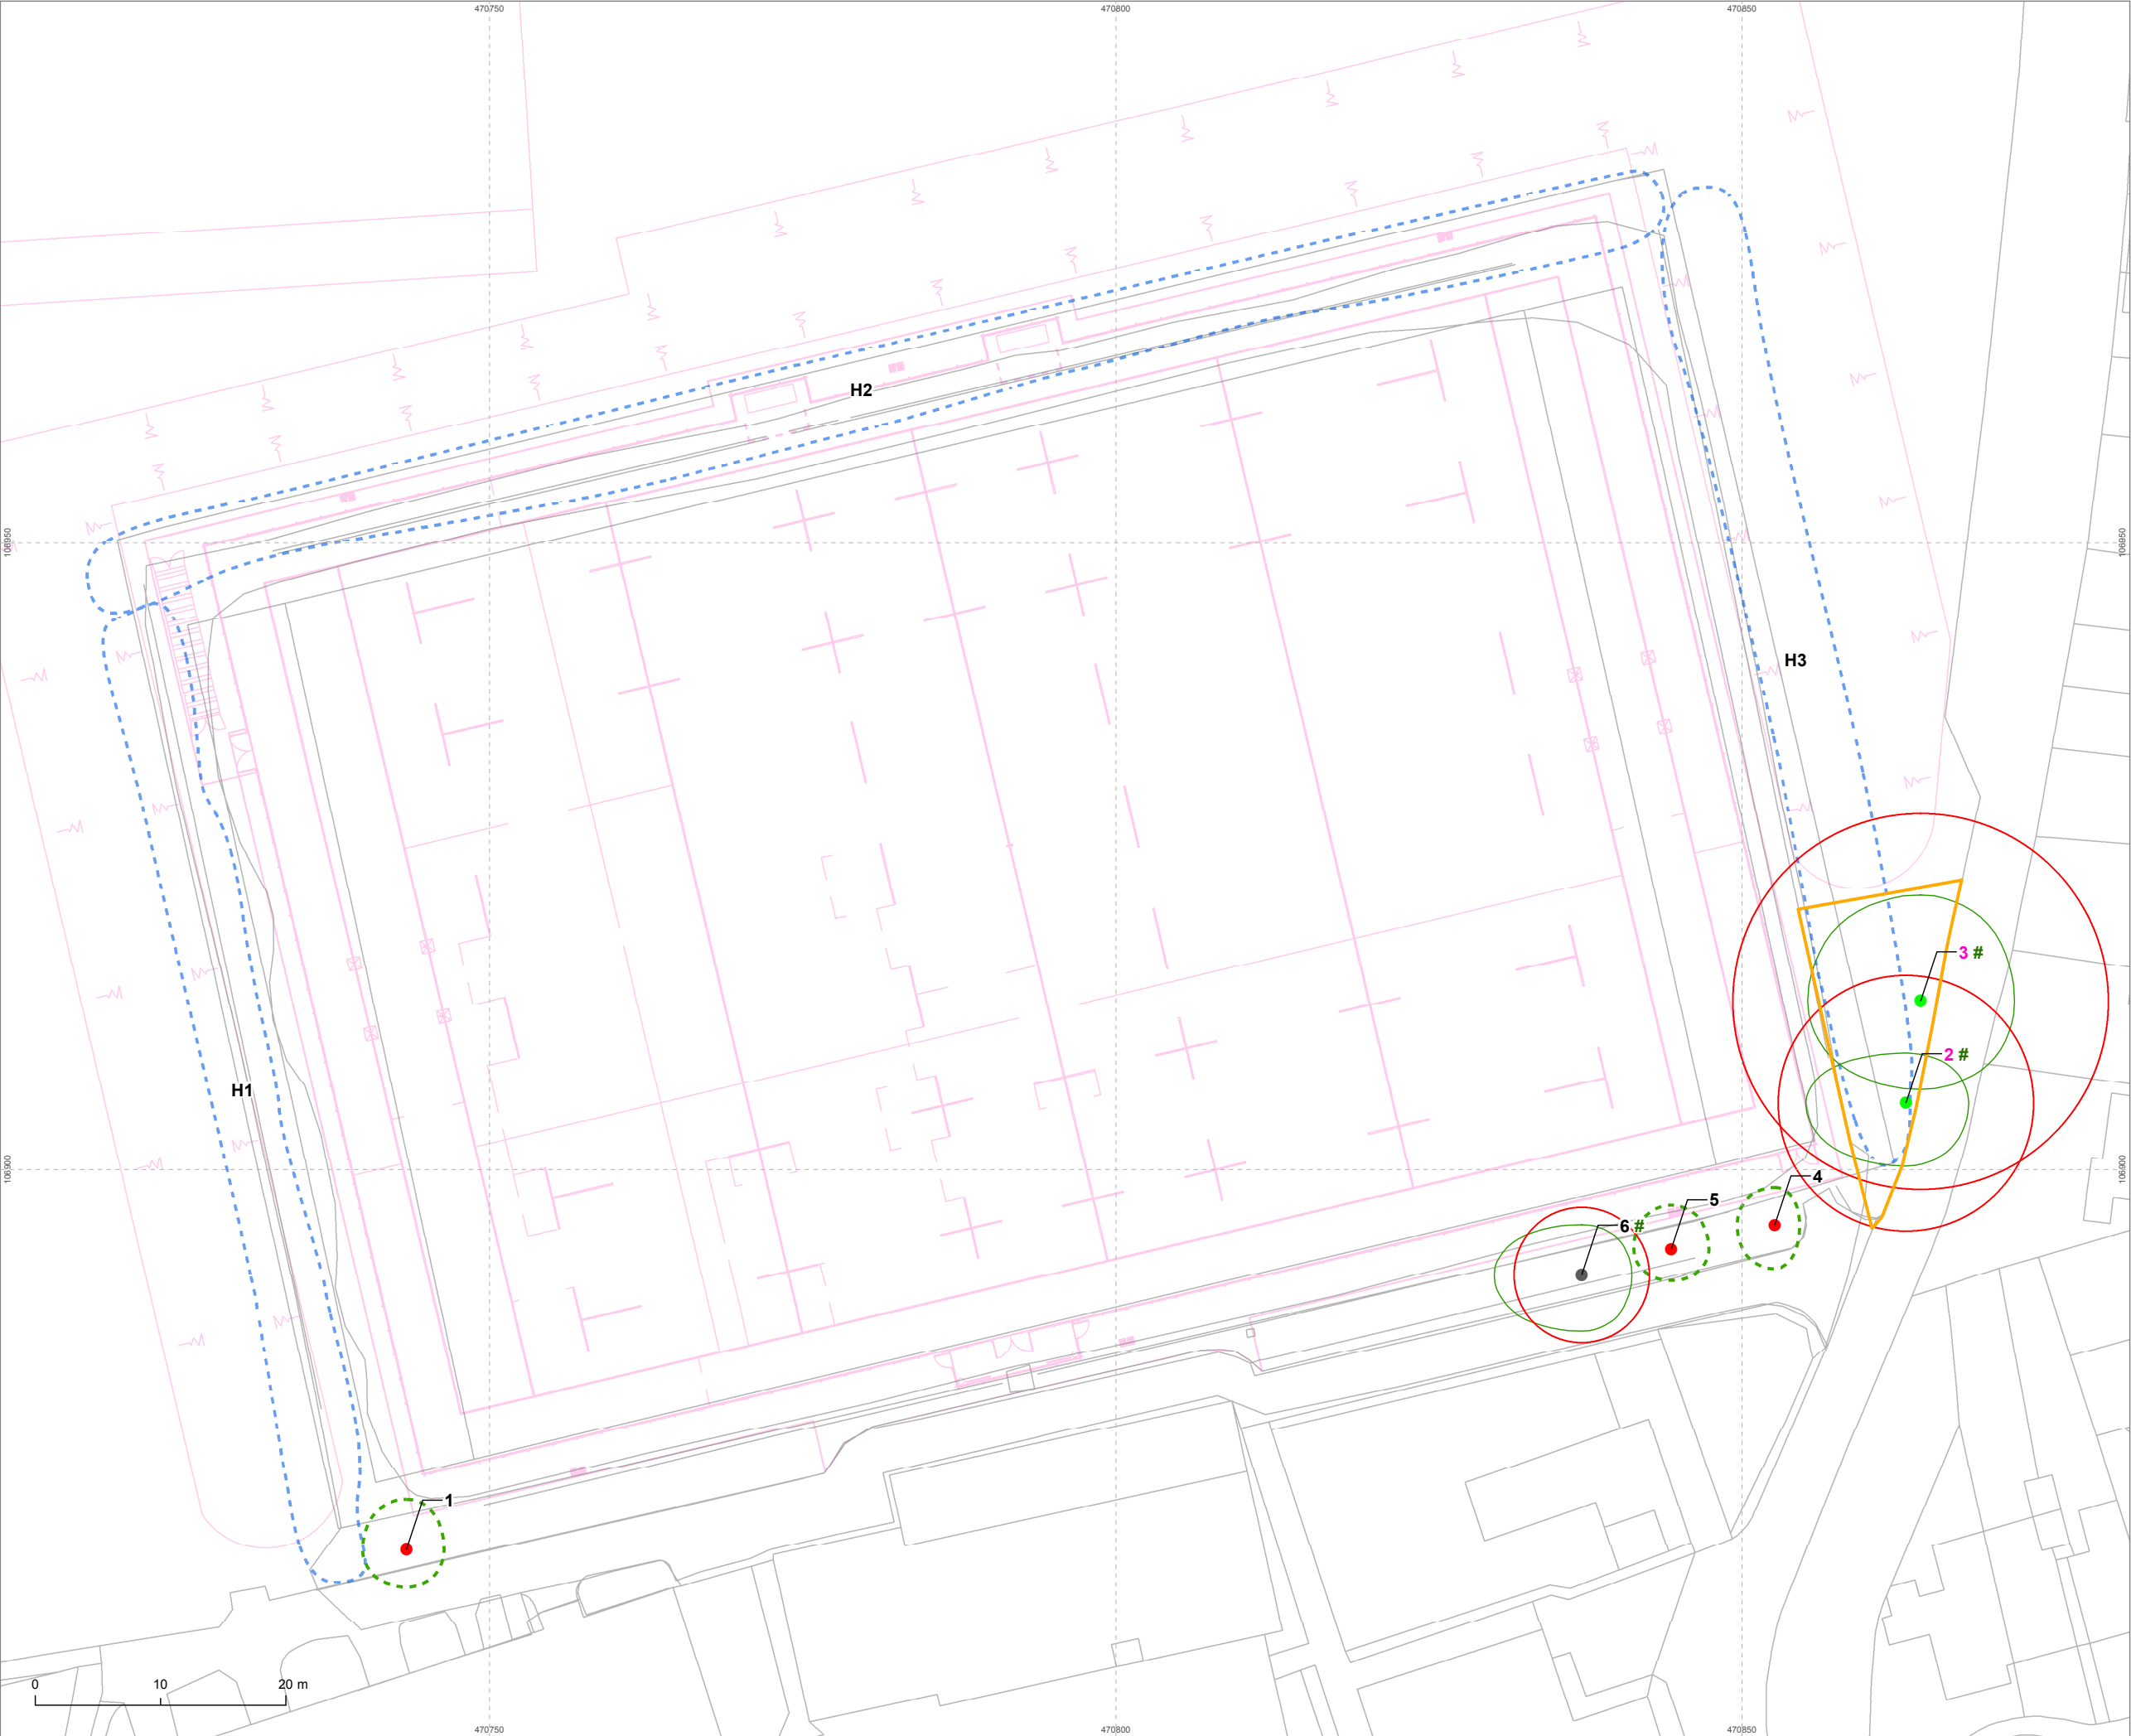
C126985-02

Proposed works to resurface the rugby pitch itself are expected to fall partially within the RPAs of tree numbers 2, 3 and 6. These works will involve excavation of existing topsoil to facilitate installation of new hardstanding for foundations and perimeter footpaths within the footprint of the pitch. It is noted that the extent of encroachment within the RPAs of tree numbers 2, 3 and 6 is relatively minor and as such significant root activity is not expected to be present.

However, in order to minimise any potential impacts upon tree health, it is recommended that excavation works proceed according to an appropriate working methodology (as detailed in Section 6.3.2) and under supervision of a suitably qualified and experienced arboriculturist.

It is recommended that the exclusion zones are afforded protection at all times through the use of tree protection barriers and/or ground protection (specified in accordance with BS5837:2012). No works that cause compaction of the soil or severance of tree roots, except where undertaken in accordance with the guidance provided within this document, will be undertaken within any exclusion zone.
