- Existing garage (corner of the site)

- Proposed Plan (Filletted building corner)

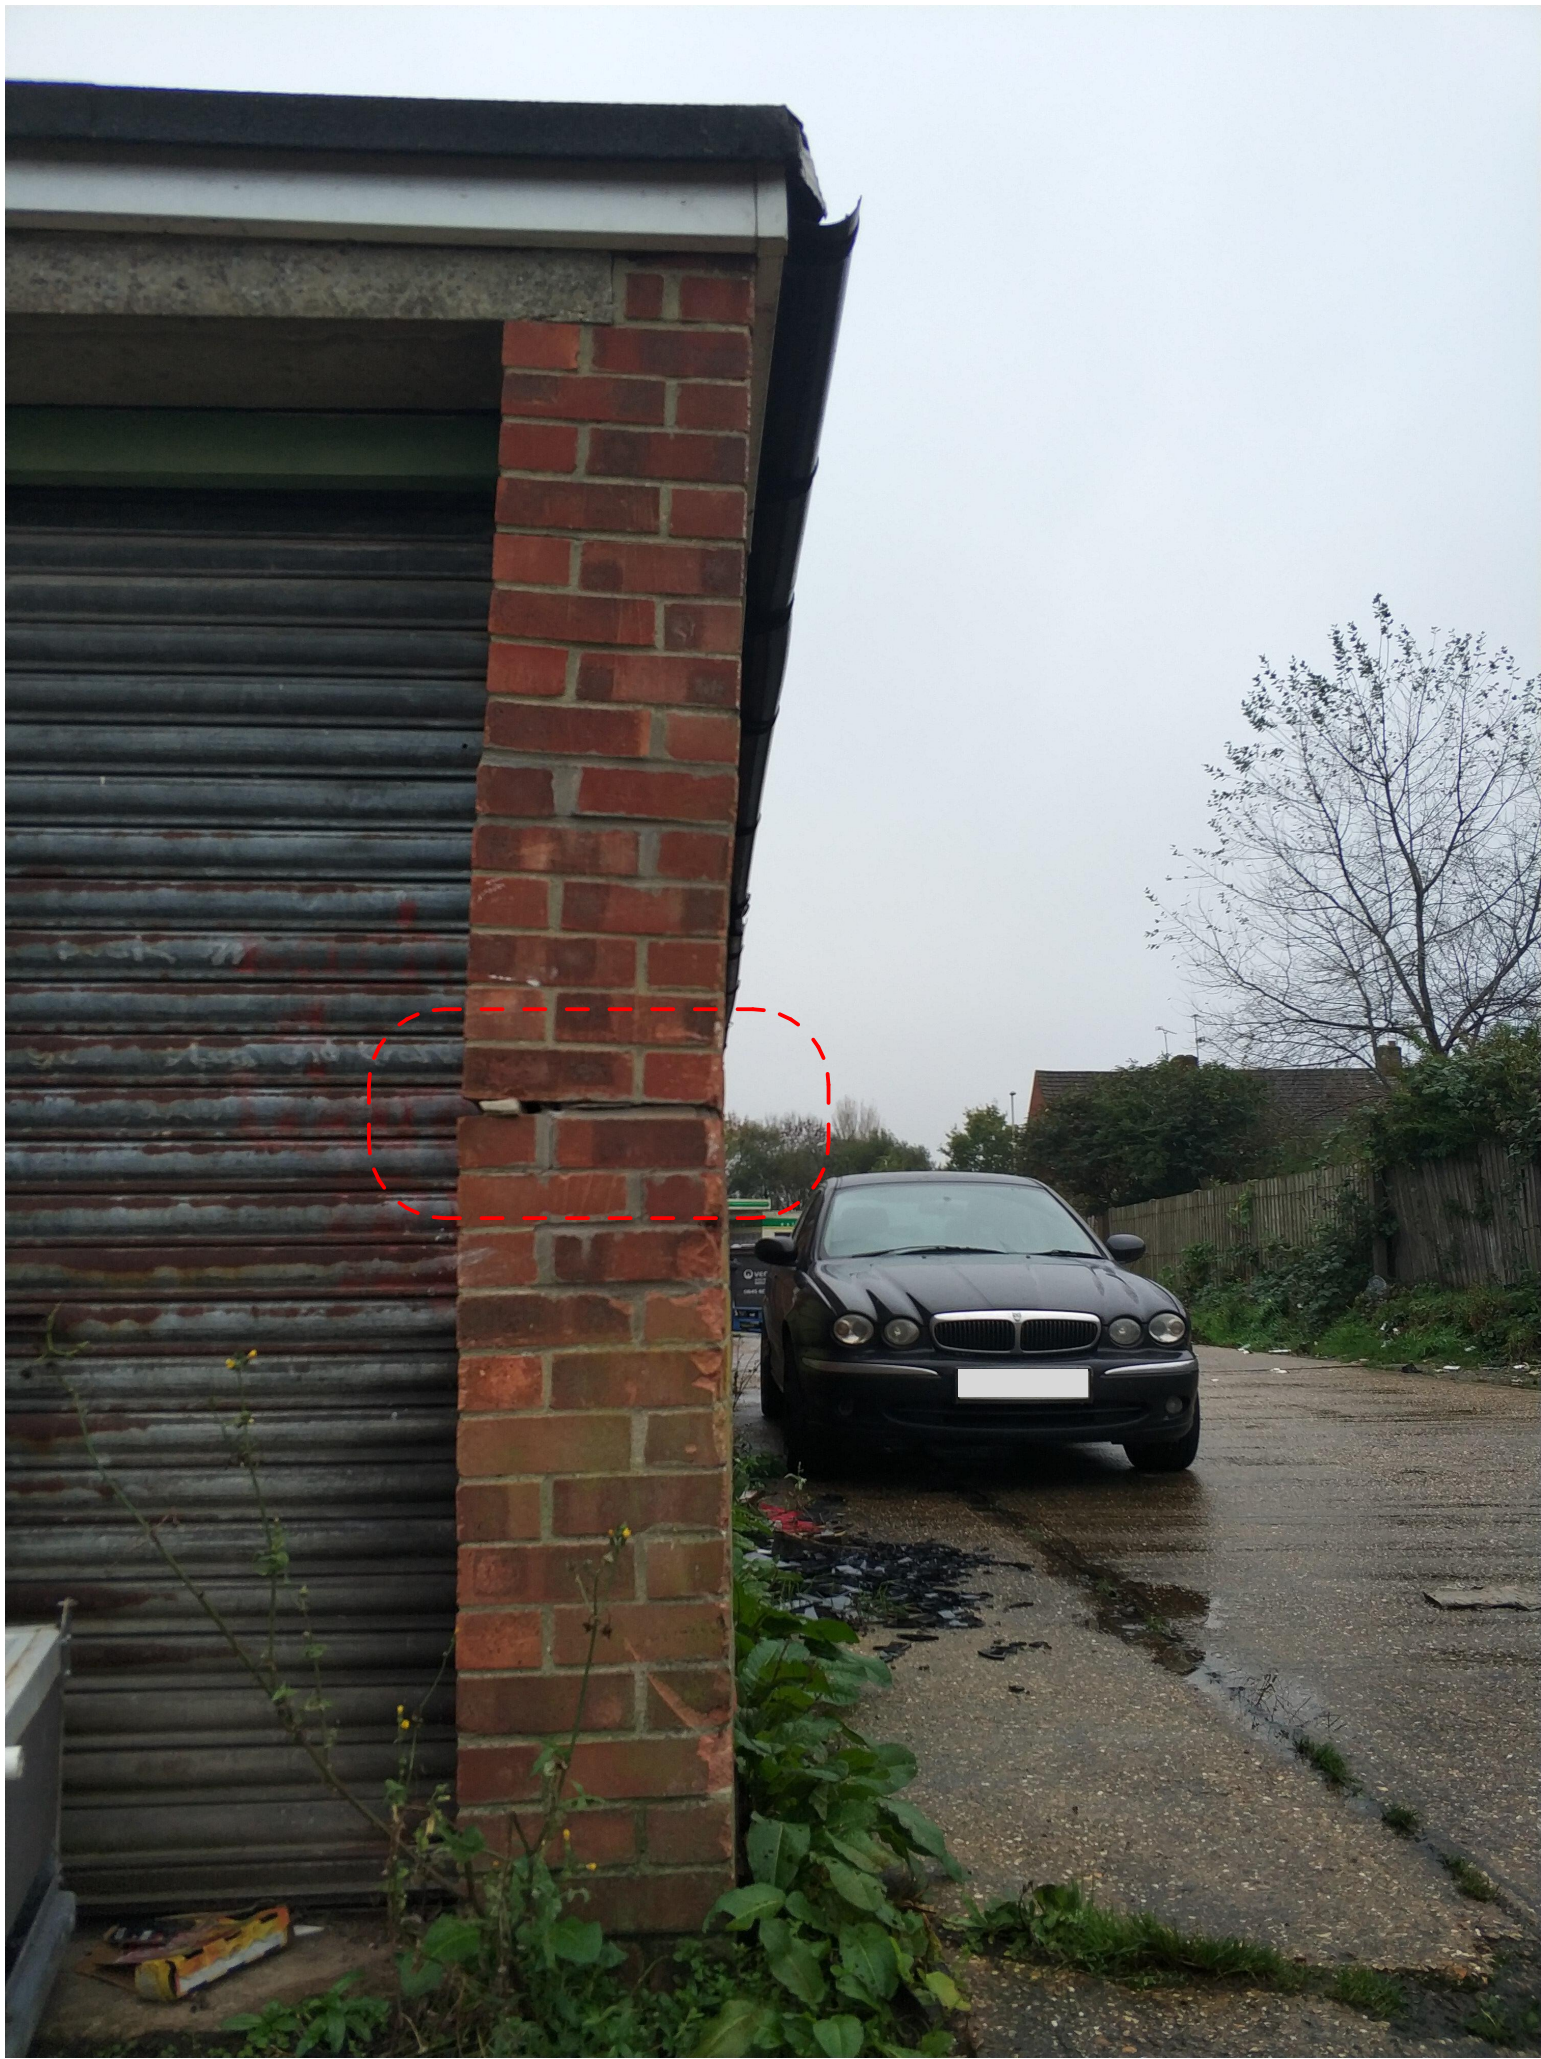
The photo is showing the damages caused by vehicle bashing to the corner of the existing garage from vehicle turning.
