## **TREE SURVEY, ARBORICULTURAL IMPACT ASSESSMENT AND TREE PROTECTION PLAN**

Report to accompany a planning application for the demolition of a single-storey side extension, creation of an access drive and construction of a new three-bedroom bungalow on land to the rear garden of 198 London Road, Waterloooville, PO7 7AN.

*13<sup>th</sup> August 2018*

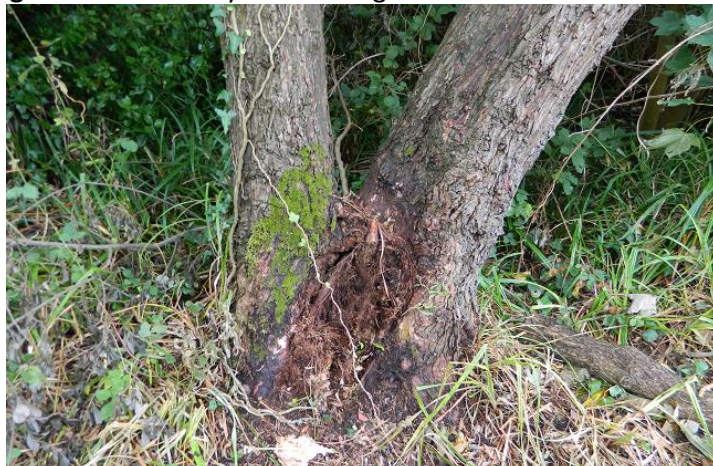
- 4.5 It is unclear whether T1 contorted willow is on land at 198 London Road or in the neighbouring garden as it is close to the unmarked boundary. It has been categorised U as it has basal decay and infection with honey fungus (Figure 2). One stem out of three original stems which divide at ground level has collapsed, and been removed, but the remaining two stems (440 mm and 360 mm diameter) cannot be considered safe. Whilst the tree does not create a conflict with the development proposals it should be removed on safety grounds.

**Figure 2.** Basal decay and missing stem of contorted willow T1.

| Tree No. | Species | Height (m) | Trunk diameter (mm) | N (m) | S (m) | E (m) | W (m) | Height of crown clearance (m) | Age class | Physiological condition | Structural condition | Useful life | BS5867 Grade | Comments |
|---|---|---|---|---|---|---|---|---|---|---|---|---|---|---|
| T1 | Contorted willow | 14 | 569 | 7 | 5 | 5 | 4 | 3 | OM | Poor | Poor | <10 | U | Decay at base of trunk. One stem fallen. Honey fungus infection. Remove. |
