## Arboricultural Report

**BS 5837:2012 Tree Survey, Arboricultural Impact Assessment,  
Method Statement & Tree Protection Plan**

**22 Manor Close, Havant PO9 1BD**

**Ref:** AS/PH/1117 (Rev. A)

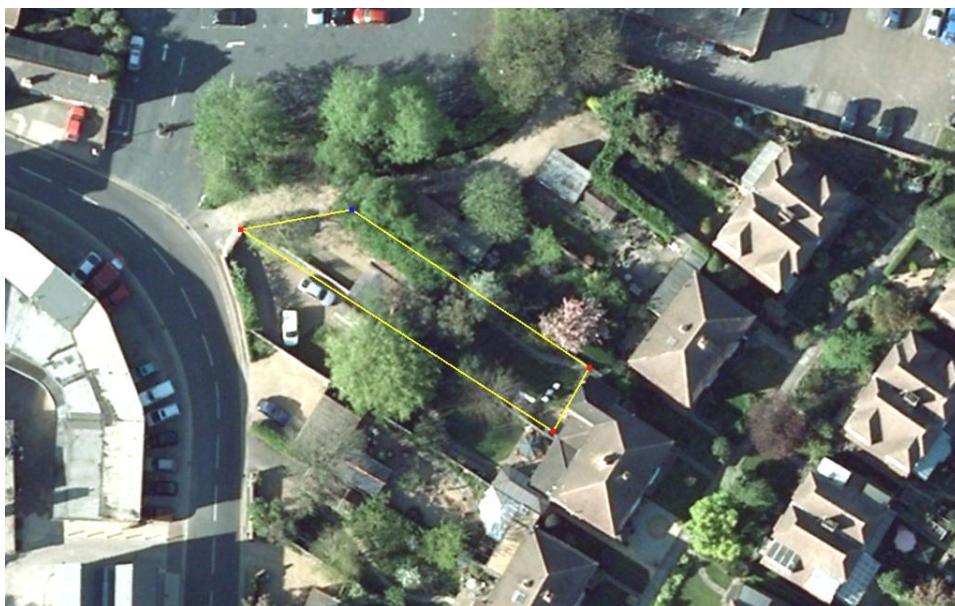
Figure 1. Aerial view showing the rear garden at 22 Manor Close (Google 2017)

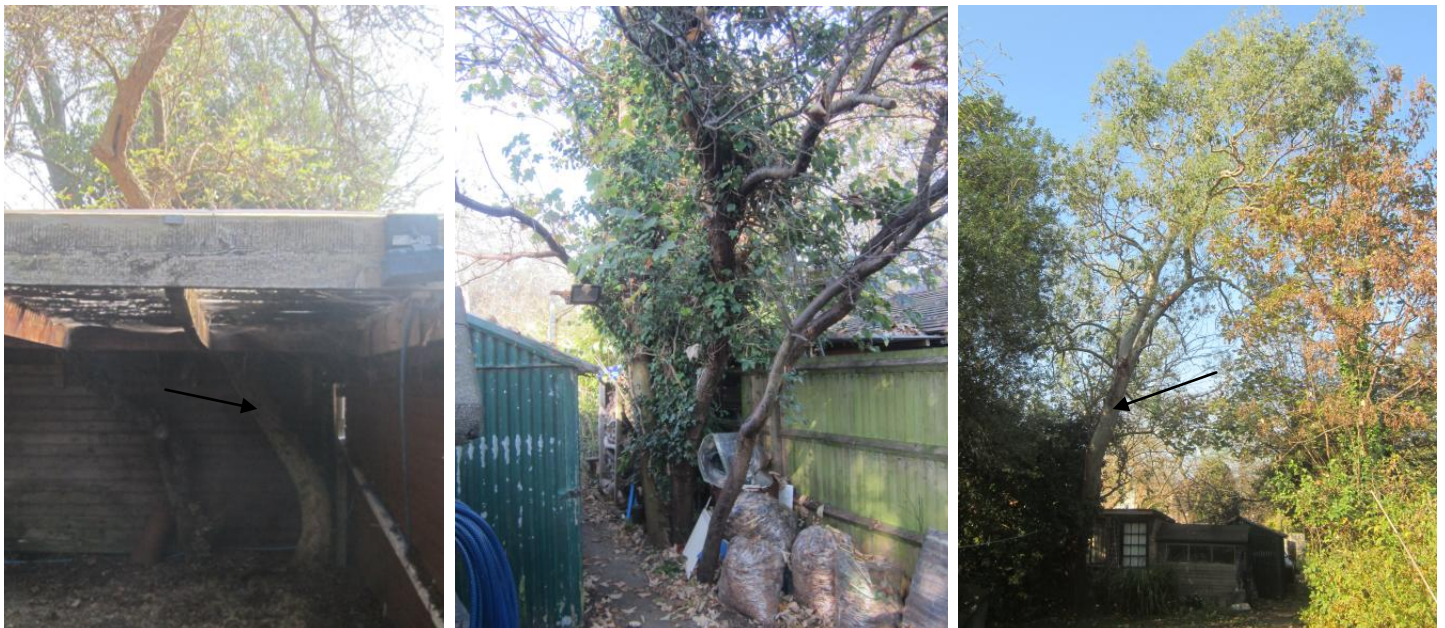
- 3.6 **Tree removal:** T3, T5 and G1 will require removal in order to facilitate this proposal; please see Figure 2 for views of these trees. T3 is a very poor specimen growing from within the current car port structure and due to its structurally and visually weak condition is recommended for removal regardless of any development (a BS5837 category U tree). T5 and G1 are all low quality category C trees. T5 has a leaning and unbalanced growth habit, and being a Eucalyptus is of typically vigorous growth and has quickly outgrown its garden location. G1 consists of a cluster of small diameter stems growing close to the boundary fence, with weak growth habit and poor form. None of the trees to be removed are of any significant public amenity or landscape value, and could comfortably be replaced with better quality specimens in more suitable positions to result in a net enhancement of amenity value in the longer term.

Figure 2. Trees to be removed (L-R): T3 growing through car port, G1 adjacent to boundary fence, and T5 leaning Eucalyptus further back within the rear garden
