**MILL RYTHE HOLIDAY VILLAGE,  
HAYLING ISLAND, HAMPSHIRE**

**PRELIMINARY ROOST ASSESSMENT**

Report No: RT-MME-123420-02

Date: September 2016

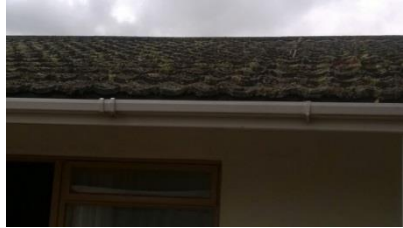
**Plate 4.2: Roof tiles and walls in good condition**

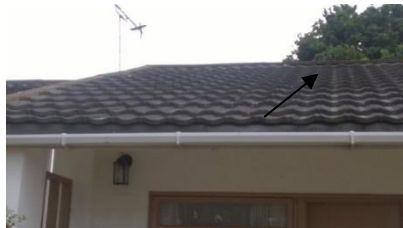
Buildings 2, 3 and 4 had small gaps under the ridge tiles (Plate 4.3). It was not possible to inspect these areas due to the height at which they were located and therefore their roosting potential could not be determined at the time of survey.

**Plate 4.3: Gaps under ridge tiles**

The only features recorded at Buildings 2, 3 and 4 which could be utilised by bats to gain entry into the buildings and potential roost locations included gaps under ridge tiles (Plate 4.3).

It was not possible to inspect these features due to the height at which they were located and as such it was not possible to establish if bats had used these features to enter a roost location at the time of surveying. No evidence of roosting bats, e.g. droppings, urine staining, feeding remains or scratch marks, was recorded within the features that could be fully inspected during the survey.

Buildings 1, 2, 3, 4, 5, 10, 29 & 41 at Mill Rythe Holiday Village have been identified as having low potential to support roosting bats. Bat Surveys: Good Practice Guidelines, published by the Bat Conservation Trust (Collins, 2016), recommends for structures with low bat roosting potential that at least one survey (consisting of either a nocturnal emergence survey or a dawn re-entry survey) be undertaken during the bat activity season to determine the presence/absence of roosting bats within the structures. The bat activity season extends from May to September, with mid-May to August being the optimum survey period.

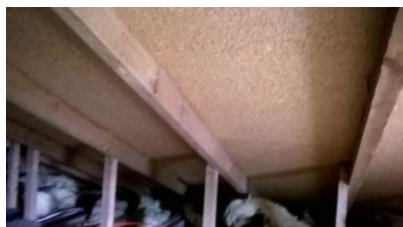
**Plate 4.5: Boarding was present between the rafters and the roof tiles**

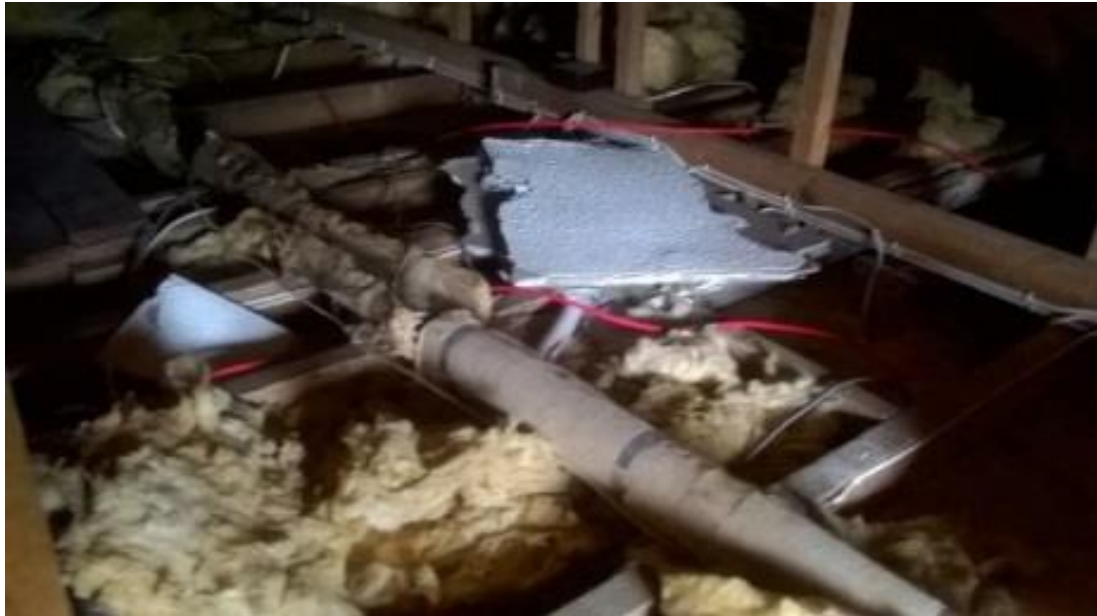
It was not possible to fully inspect all features within the loft spaces, due to advice by onsite maintenance that cables running along the floor were unsafe. (Plate 4.6). Furthermore, the space between the boards and the roof tiles, potentially providing a suitable feature for crevice dwelling bats, could not be inspected. As such the bat roosting potential of the majority of the loft spaces could not be determined during the survey.

**Plate 4.6: A large number of exposed cables were present preventing safe access**

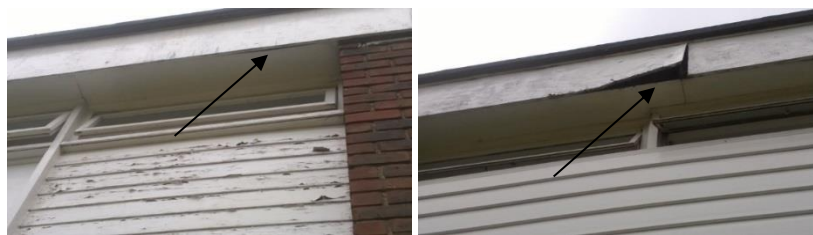
Buildings 5 and 29 had gaps within the timber soffit boxes, providing potential access points into the building for bats (Plate 4.8). It was not possible to inspect these areas due to the height at which they were located and therefore their roosting potential could not be determined.

**Plate 4.8: Gaps within the timber soffit boxes (Buildings 5 & 29)**

The only features recorded around Buildings 5 and 29 which could be utilised by bats to gain entry into the buildings and potential roost locations included gaps within the timber soffit boxes (Plate 4.8).

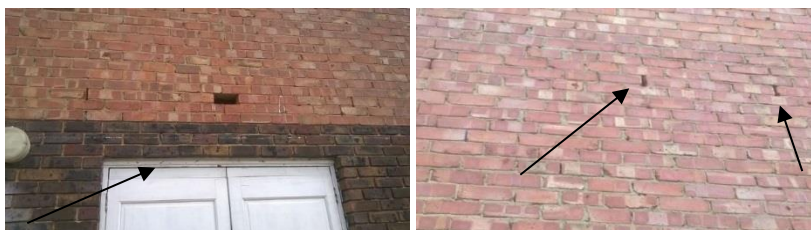
Building 41 had a number of weep holes and missing bricks within the chimney breast (Plate 4.10). It was not possible to inspect these features due to the height at which they were located and therefore their roosting potential could not be determined.

**Plate 4.10: Weep holes and missing bricks within the chimney breast of Building 41**

The only features recorded around Building 41 which could be utilised by bats to gain entry into the buildings and potential roost locations included the weep holes and missing bricks in the chimney breast (Plate 4.10). It was not possible to inspect these features due to the height at which they were located and as such it was not possible to establish if bats had used these features to enter a roost location at the time of surveying.

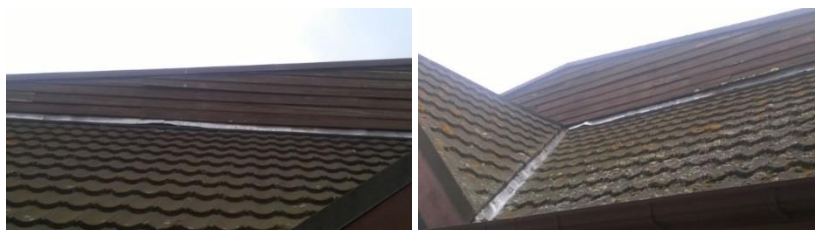
Building 10 had lifted lead flashing and lifted wooden cladding in the western gable end which could be of value to roosting bats (Plate 4.15). It was not possible to inspect these areas due to the height at which they were located and therefore their roosting potential could not be determined.

**Plate 4.15: The western gable end of Building 10 had lifted lead flashing and lifted cladding**

A small number of features were recorded around Building 10 which could be utilised by bats to gain entry into the buildings and potential roost locations and lifted lead flashing and wooden cladding (Plate 4.15). It was not possible to inspect these features due to the height at which they were located and as such it was not possible to establish if bats had used these features to enter a roost location at the time of surveying.

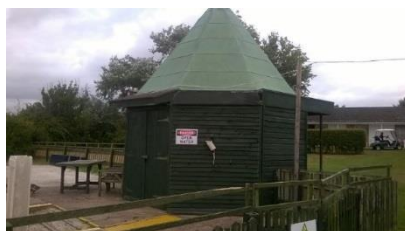
**Plate 4.22: View of Building 1**

Building 1 was a small wooden structure adjacent to the lake in the north-western corner of the site (Plate 4.22). The building had a large hole in the soffit which could be utilised by bats to gain entry into the building and potential roost locations. This feature was inspected thoroughly and no evidence of bats e.g. droppings was recorded.
