## Tree Survey Report (BS5837:2012)

Proposed Gap Plant Hire, Hermitage Park, Harts Farm Way, Havant,  
Hampshire, PO9 1JN

July 2017

Report Reference: A3355

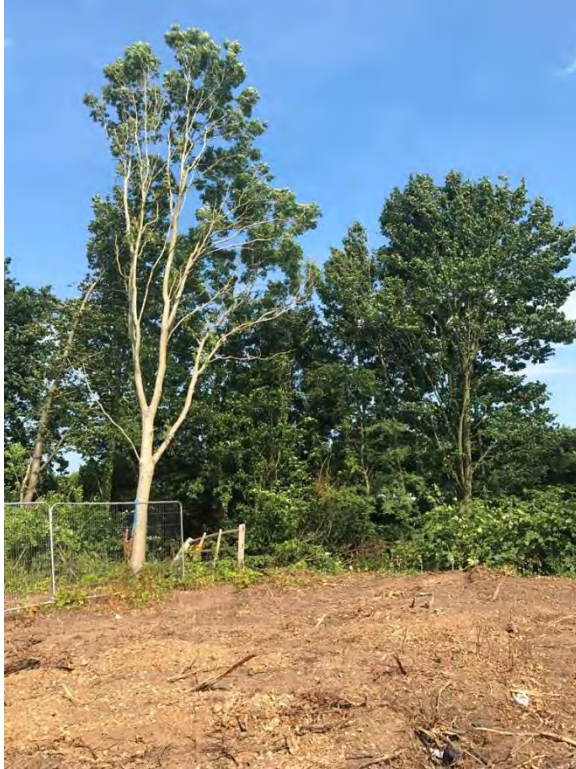
| Ref | Species | Height (m) | Stem Diameter (mm) | Branch spread (m) | | | | Height crown clearance (m) | Age class | Condition & Comments | Years left | Category grading | RPA (m²) | RPA radius |
|---|---|---|---|---|---|---|---|---|---|---|---|---|---|---|
| T1 | Fraxinus (Ash) | 15 | 300 | 6 | 1 | 0 | 2 | 7 | M | Poor. Located off site beyond the western boundary on adjacent site. | <20 | C2 | 41 | 3.60 |
| G1 | Acer campestre (Field Maple) | 10 | 200 | 2 | 2 | 2 | 2 | 2 | M | Fair. Group of field maple with hawthorn and hazel understory | 20+ | C2 | 18 | 2.40 |

**Photo 1** – View of the ash tree (T1) with group of field maple (G1) located off site

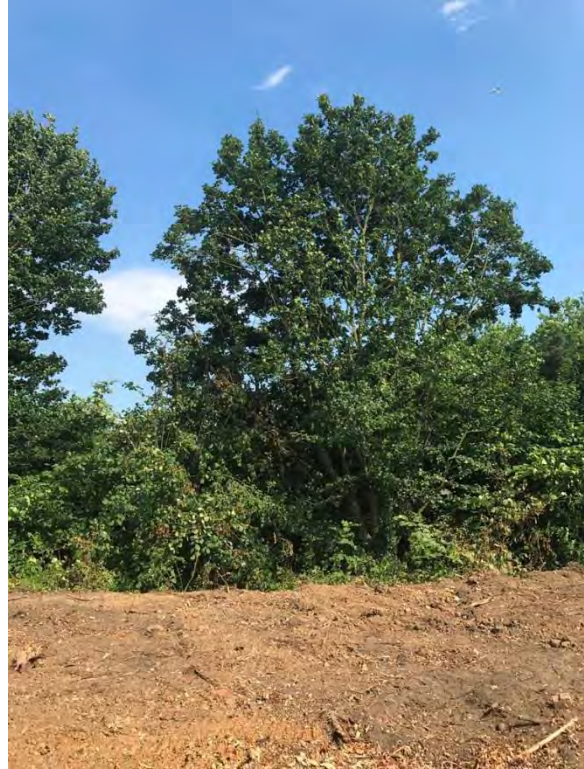
| Ref | Species | Height (m) | Stem Diameter (mm) | Branch spread (m) | | | | Height crown clearance (m) | Age class | Condition & Comments | Years left | Category grading | RPA (m²) | RPA radius |
|---|---|---|---|---|---|---|---|---|---|---|---|---|---|---|
| T2 | Acer campestre (Field Maple) | 11 | 350 | 4 | 4 | 4 | 4 | 5 | M | Fair. Located beyond ditch adjacent to the A27 road. | 20+ | C2 | 55 | 4.20 |

**Photo 2** - View of field maple (T2) beyond the northern boundary adjacent to the A27 motorway

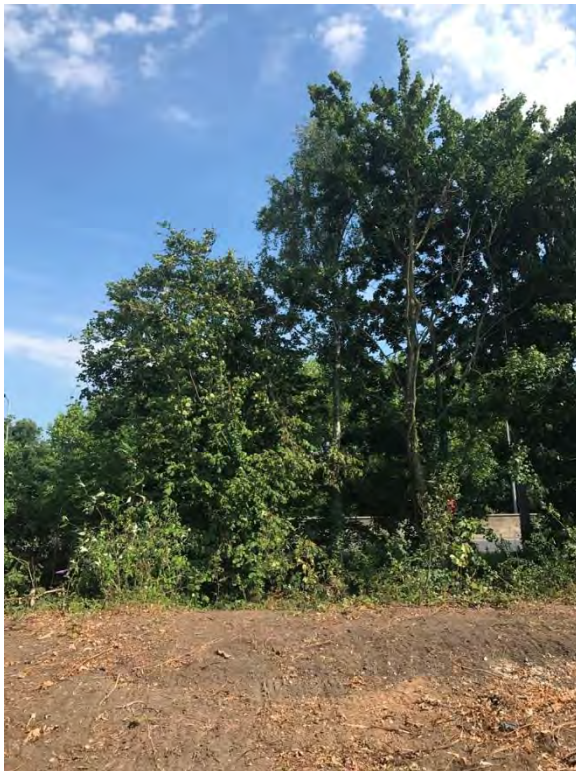
| Ref | Species | Height (m) | Stem Diameter (mm) | Branch spread (m) | | | | Height crown clearance (m) | Age class | Condition & Comments | Years left | Category grading | RPA (m²) | RPA radius |
|---|---|---|---|---|---|---|---|---|---|---|---|---|---|---|
| T5 | Betula (Birch) | 10 | 200 | 2 | 2 | 2 | 2 | 6 | M | Fair. Tall, thin tree. | 20 | C2 | 18 | 2.40 |
| T6 | Acer campestre (Field Maple) | 12 | 300 | 5 | 5 | 4 | 5 | 3 | M | Fair. Ivy growth. | 20 | C2 | 41 | 3.60 |

**Photo 3** - View of the birch (T5) and field maple (T6) beyond the northern boundary adjacent to the A27 motorway

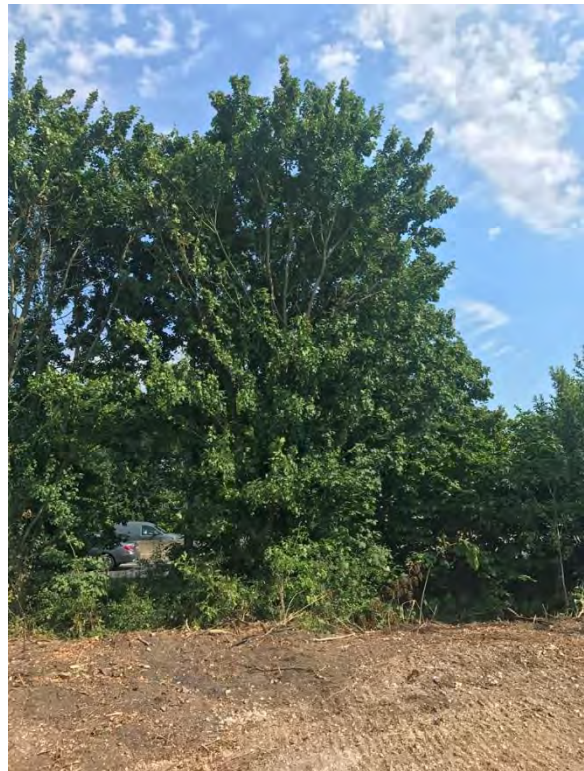
| Ref | Species | Height (m) | Stem Diameter (mm) | Branch spread (m) | | | | Height crown clearance (m) | Age class | Condition & Comments | Years left | Category grading | RPA (m²) | RPA radius |
|---|---|---|---|---|---|---|---|---|---|---|---|---|---|---|
| T7 | Acer campestre (Field Maple) | 12 | 300 | 5 | 5 | 4 | 5 | 3 | M | Fair. Ivy growth. | 20 | C2 | 41 | 3.60 |

**Photo 4** - View of the field maple (T7) and ash (T8) beyond the northern boundary adjacent to the A27 motorway

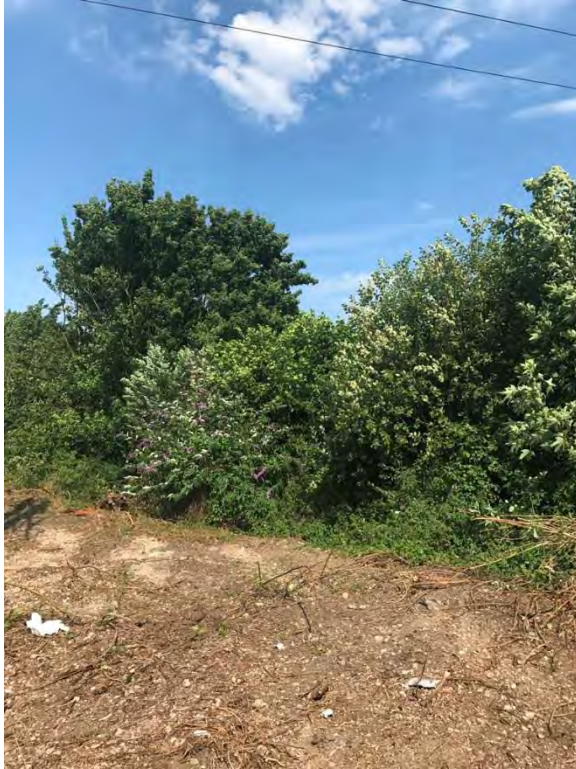
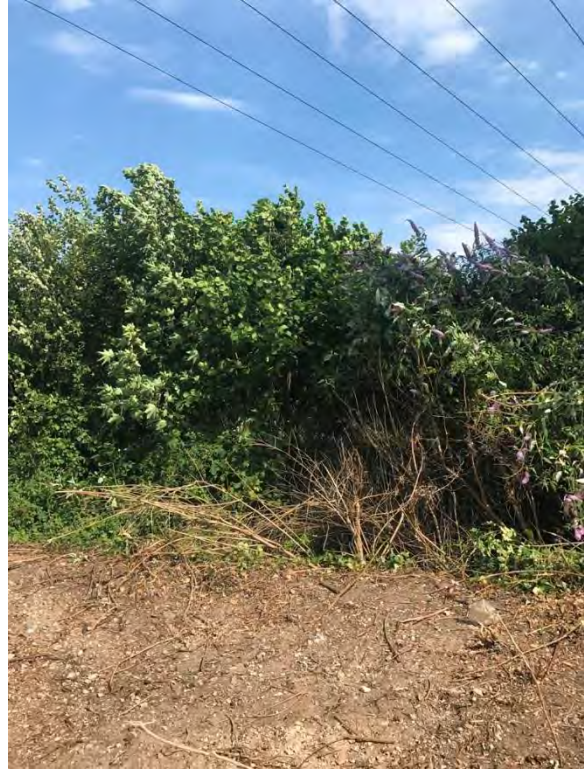
| Ref | Species | Height (m) | Stem Diameter (mm) | Branch spread (m) | | | | Height crown clearance (m) | Age class | Condition & Comments | Years left | Category grading | RPA (m²) | RPA radius |
|---|---|---|---|---|---|---|---|---|---|---|---|---|---|---|
| G2 | Buddleia, Hazel, Sycamore & Willow | 5 | 75 | 3 | 3 | 3 | 3 | 0 | YNG | Fair. Group of mixed shrubs and young regenerating tree species. | 20+ | C2 | 3 | 0.90 |

**Photo 5** – View of the buddleia, hazel, sycamore and willow shrubs and young trees (G2) under the overhead cables

**Photo 6** - View of the buddleia, hazel, sycamore and willow shrubs and young trees (G2) under the overhead cables

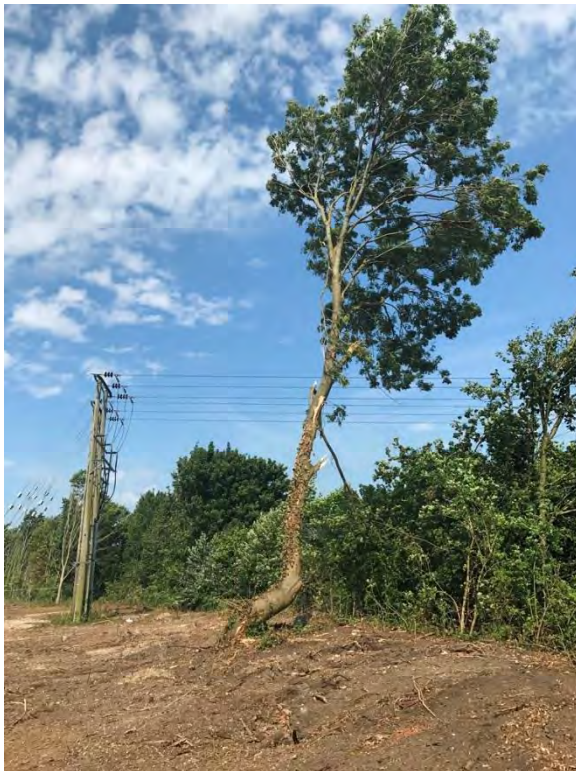
- 3.5 The exception is T8, an Ash tree in serious decline which would be inappropriate to be retained in its current condition and should be considered for removal before works commence on site.

| Ref | Species | Height (m) | Stem Diameter (mm) | Branch spread (m) | | | | Height crown clearance (m) | Age class | Condition & Comments | Years left | Category grading | RPA (m²) | RPA radius |
|---|---|---|---|---|---|---|---|---|---|---|---|---|---|---|
| T8 | Fraxinus (Ash) | 13 | 500 | 5 | 4 | 0 | 5 | 8 | M | Poor. Severly leaning to the north. Bend in trunk at 800m above ground. Snapped branches and deadwood in crown. In serious decline. | <10 | U | 204 | 8.05 |

**Photo 7** - View of the poor ash (T8) with deformed lower trunk and leaning to the north which should be removed

- 7.1 No trees are proposed for removal and therefore no replacement trees are required.
- 7.2 There is one very poor tree (T8) which is in such decline and whilst its removal is not required to facilitate the development, it's removal is recommended that it should be removed.
- 7.3 It is recommended that any new tree planting proposed should be of a sufficient size and maturity to provide instant impact and recommended to be no less than "Heavy Standards", 3.5-4.25m high, 12-14cm girth with a 1.75-2.0m clear stem, located in strategic positions.

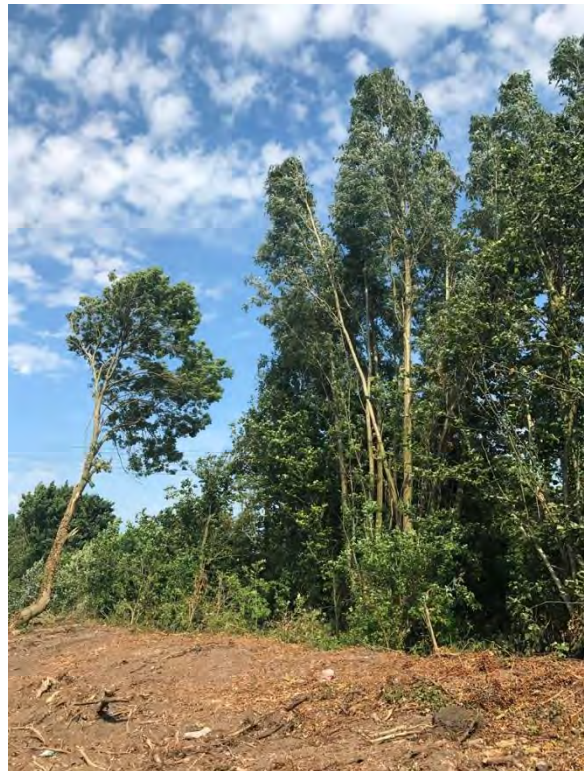
| Ref | Species | Height (m) | Stem Diameter (mm) | Branch spread (m) | | | | Height crown clearance (m) | Age class | Condition & Comments | Years left | Category grading | RPA (m²) | RPA radius |
|---|---|---|---|---|---|---|---|---|---|---|---|---|---|---|
| G3 | Birch, Hazel & Field Maple | 10 | 200 | 2 | 2 | 2 | 2 | 2 | M | Fair. Group of mixed deciduous trees. | 20 | C2 | 18 | 2.40 |
| G4 | Salix (Willow) | 12 | 350 | 2 | 2 | 2 | 2 | 8 | SM | Fair. Pair of large tall, thin Willows with small canopies. | 20 | C2 | 55 | 4.20 |

**Photo 8** - View of the birch, hazel and field maple (G3) and the tall willow trees (G4) beyond the northern boundary adjacent to the A27 motorway
