Global Tree Care

## Arboricultural assessment and Method statements.

Surveyed by Ian Lansley 21/05/2017

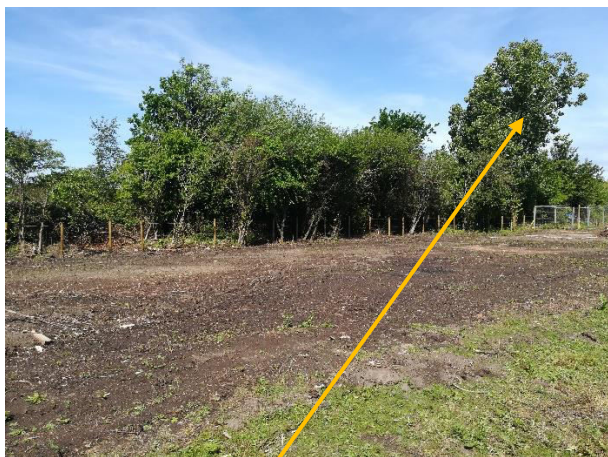
Species *Populus balsamifera*, commonly called balsam poplar. Tree Number 02133

Height 15.9m

DBH @ 1.5m 33cm

Tree in Question.

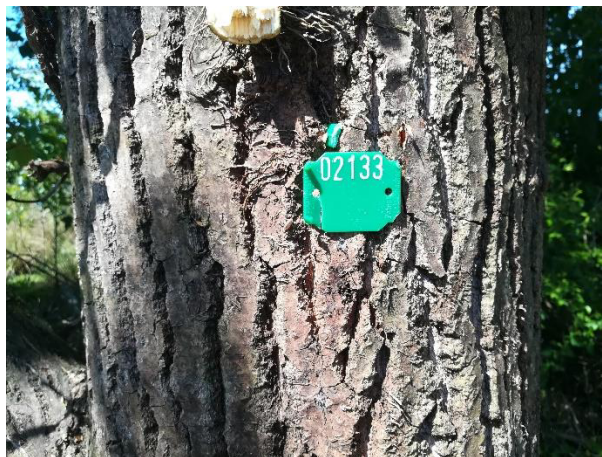
Showing tree number.

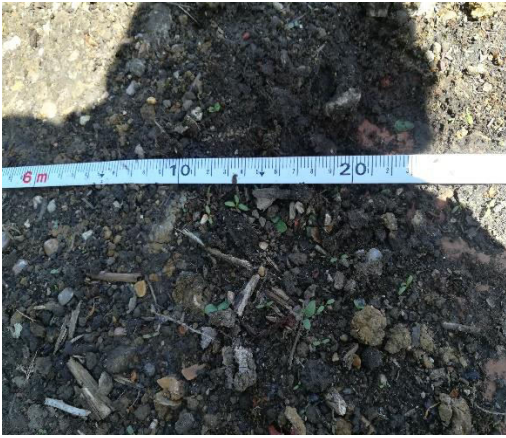
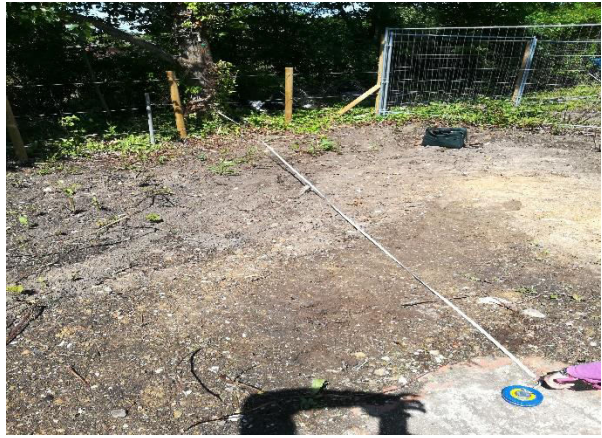
Close by there is an area of hard standing concrete. During surveys this has been used as a fixed point in the previous production of topographical survey. The closest point to this tree has been measured at 6.2 metres. This is well outside the calculated Root Protection area for tree no. 02133. See below.

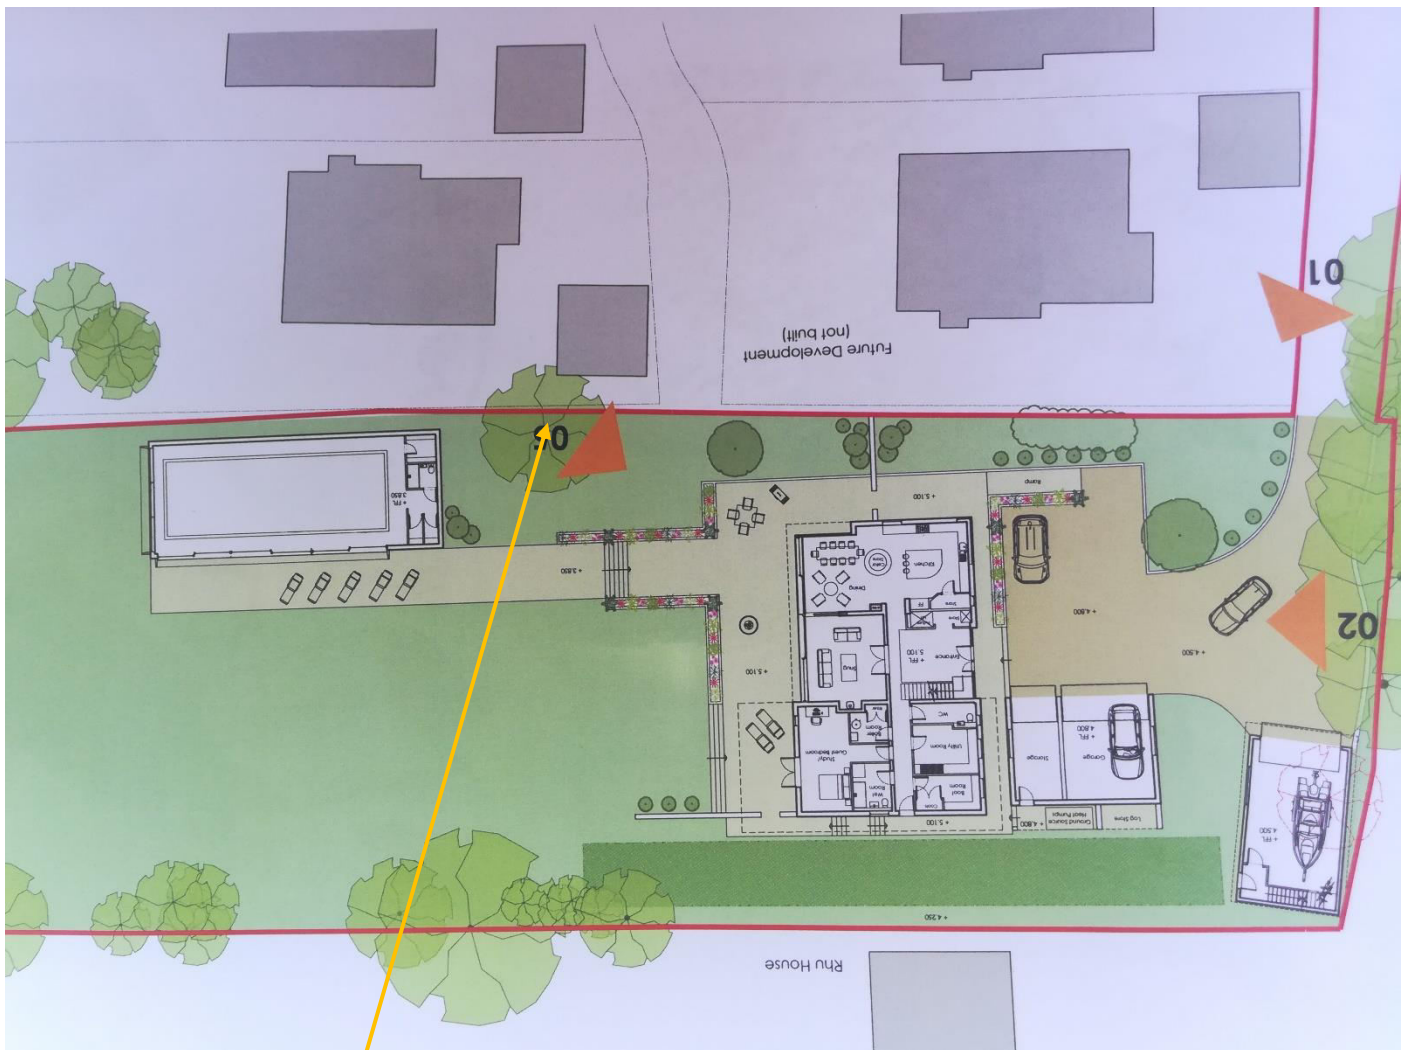
Tree No. 02133 as shown.

As can be also seen from the plans supplied the pool house is also well outside this designated area.

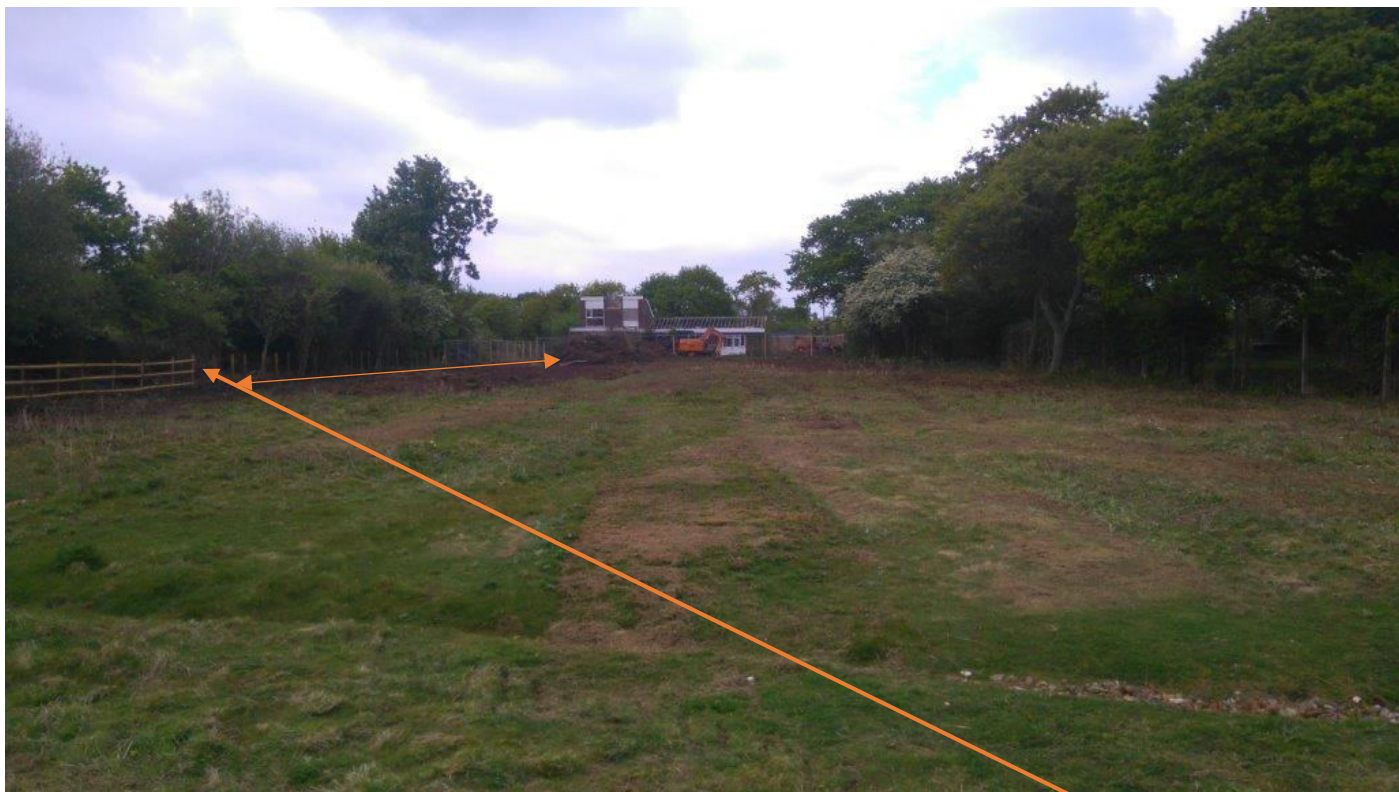
The owners of the site have also been advised that along the adjoining boundary, they must erect a fence measuring 1.8m in height. This has already been taken into account as is shown by the type of fencing already erected. See below.

High level fence to be erected from this point running along the boundary toward the house.

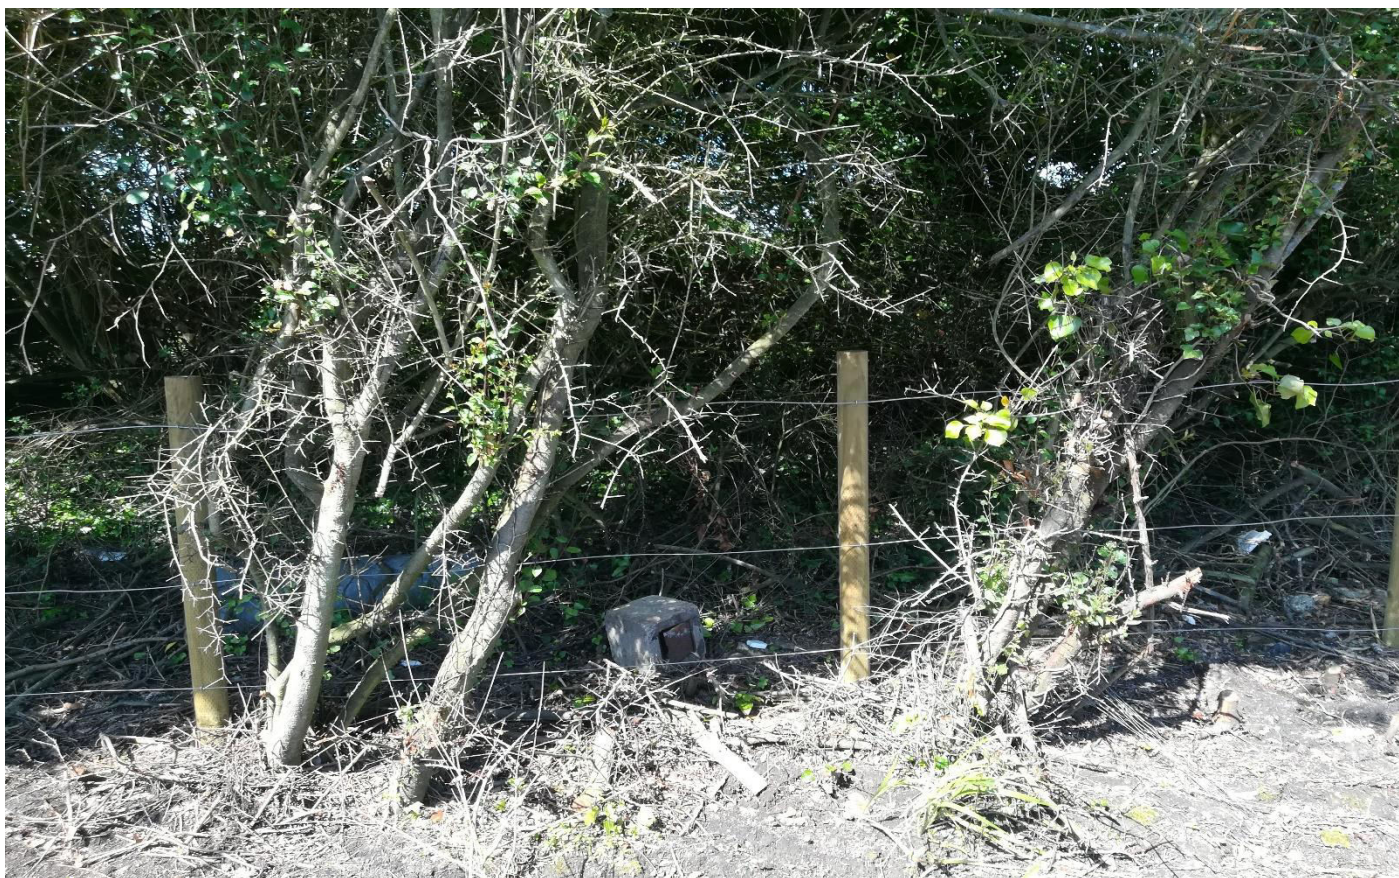
In order to erect this fence several scrub Hawthorn will require removal. All of these are multi stemmed and are of very little aesthetic value. See below.

None of these scrub "trees" have legal restriction for their removal. With their removal, I can see no problems with the pool house being placed as proposed. Given the requested height of the fence, there would also be very little impact visually from the finished level of the pool house roof. The largest of these

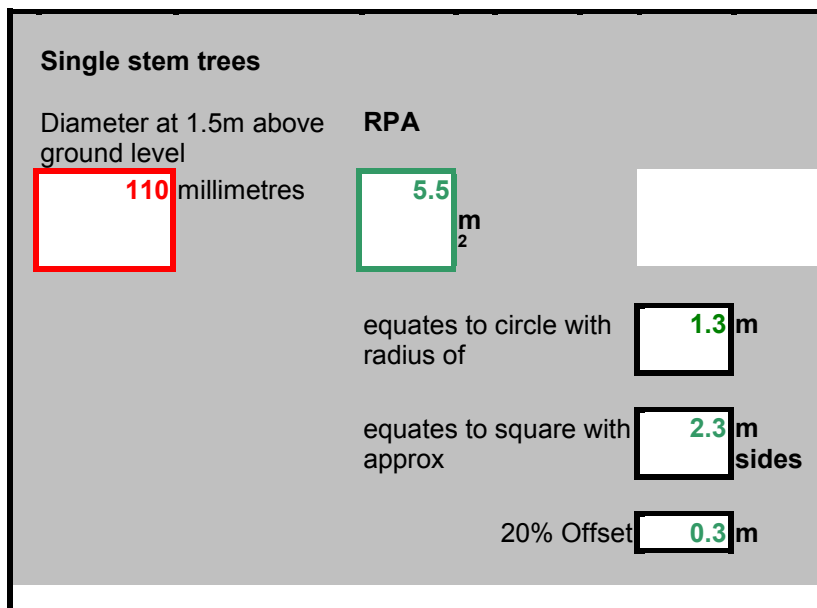
scrub trees has a DBH of 11cm @1.5m. this calculates to a root protection area of 1.3 meter radius. See below.

In order to erect the fence as required by the Planning conditions, this rootzone will be impacted. As can be seen by the last photograph these scrub trees are growing directly along the boundary line and will have to be removed in order to comply with the Council request for the installation of a 1.8m fenceline.

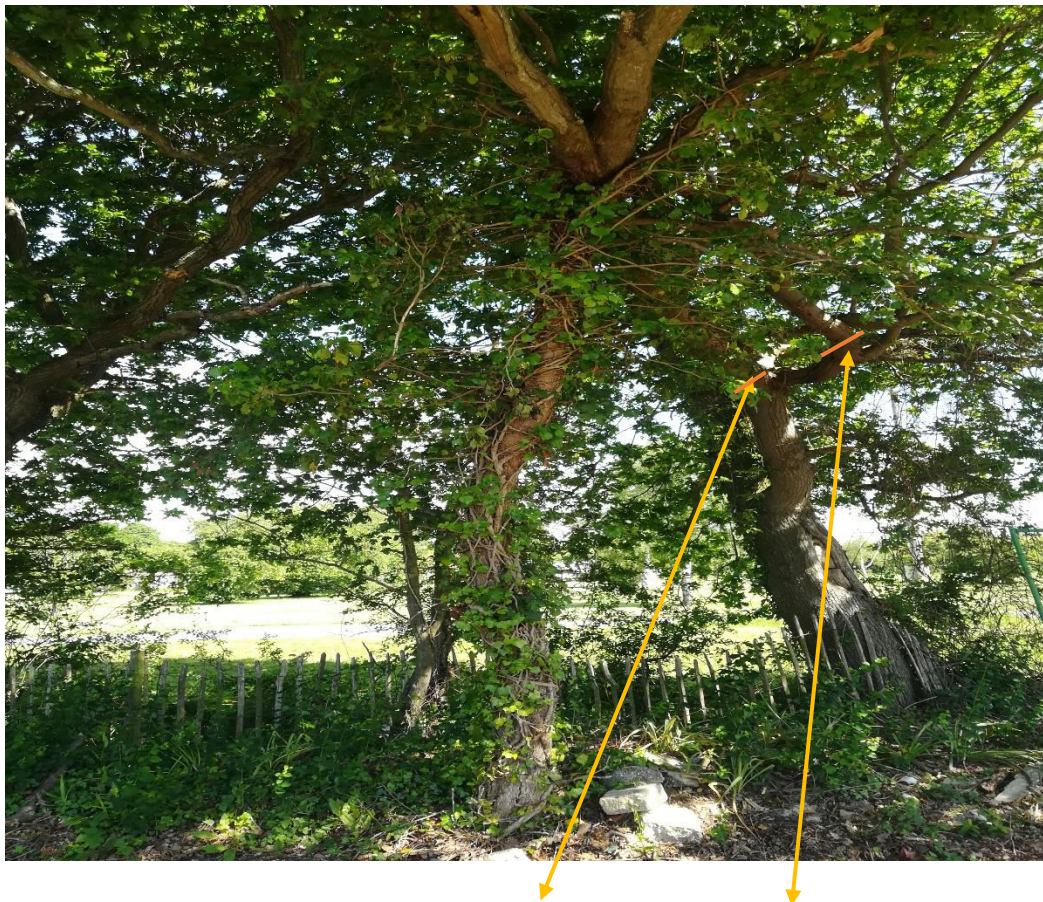
T6 *Acer campestre* (Field Maple). As can be seen from the below photograph T7 has a large and friction bearing branch growing through the fork of T6. Due to this problematic growth, I would recommend the removal of T6 as it is now misshapen, well over shaded and now has growth problems due to the large oak branch. Over time this will continue to weaken the fork and result in failure at the fork point for T6.

These points are ground assessed and should be used as a guide only, until the tree is climbed and the final pruning points ascertained.

I would also recommend that this branch on T7 be pruned back, as its growth has been supported and may well fracture with the removal of T6. T7 has been pruned in the past, shows good health and recovery." All pruning and felling works should be carried out by a qualified arborist.

1. Works should begin with the removal of T8, (T8 *Quercus robur* (Oak) Height 9.8m Girth 29cm)
2. The supported branch in T7, (T7 *Quercus robur* (Oak) Height 9.6m Girth 38cm) should then be removed. This branch must be worked on by a qualified arborist, and pruned back to a suitable point. From looking at the tree from ground level I would suggest that the branch be pruned to the marked points as seen below. This is to prevent splitting when the supporting tree is removed.

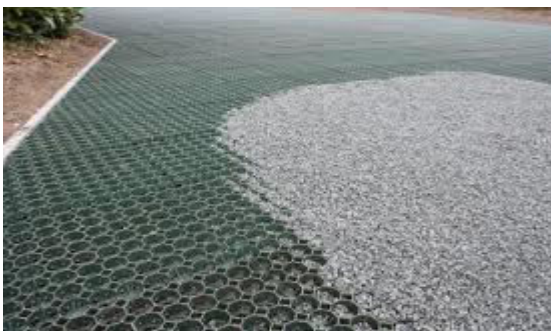
This system is Terram Bodpave 40.

As suggested I concur that a load dispersal system would be of benefit along the main access to the site. There are several systems on the market which will achieve the required result. An example is shown below.

The added bonus of using a “tile weight dispersal structure”, is that it can have any tiles damaged by construction replaced and left in situ. Leaving this system in situ would allow the driveway to be built up to the required finished level, and it will continue to provide weight dispersal over years to come.

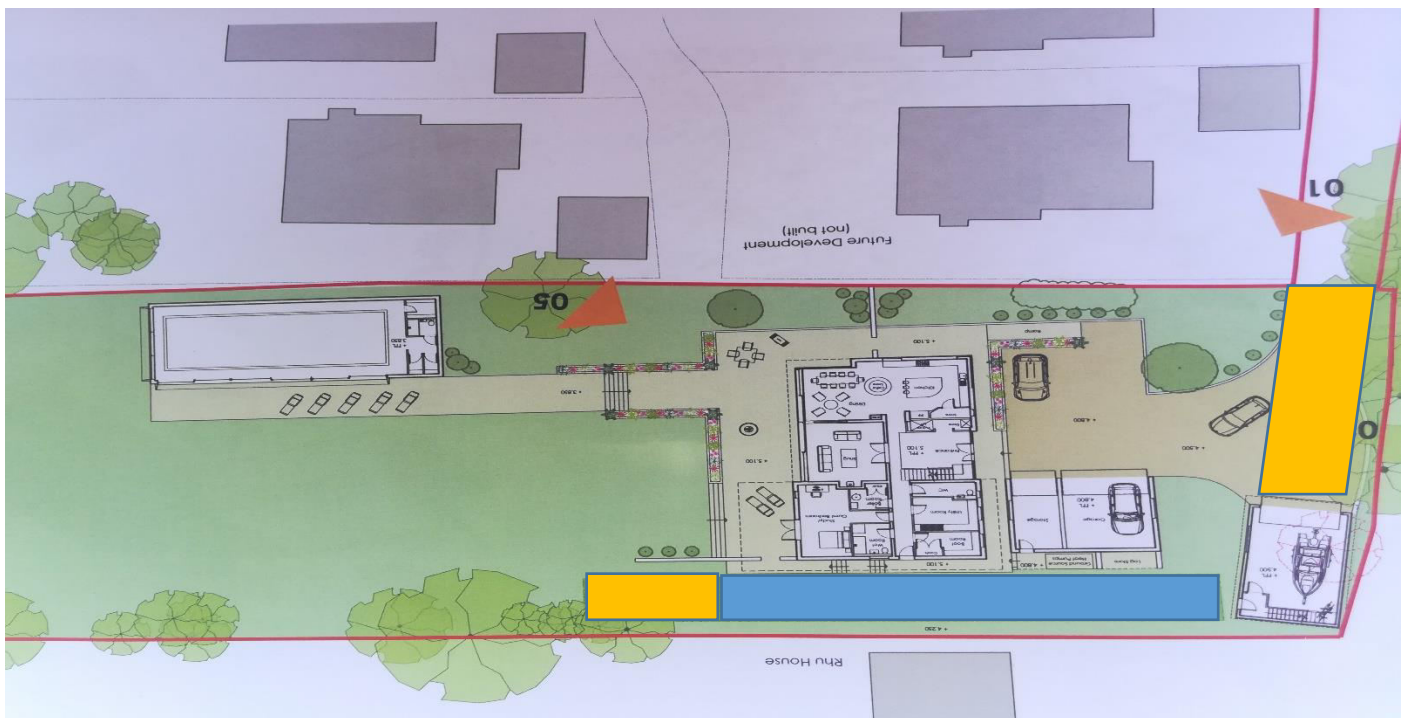
Denotes areas for weight distribution tiles to be deployed.

Denotes area where there is no requirement for root protection.

This system can also be deployed along the proposed “hard access” along the far side of the property. This will not be required along the wall, but would be useful if extension to access is required along the tree line as shown below.

1. Prepare the ground levels, building up rather than lowering the present surface using Type 1 aggregate.
2. Install weight distribution tiles to the manufacturers specifications. The tile system should be installed along the planned line of the driveway, and extend out southward from the northern driveway edge by 5 meters. This will ensure all of the fibrous root area of the protected trees is well covered.
