## Method statement for the conversion of stables into a residential dwelling for Manor Farm, Hayling Island.

**PROJECT:** Conversion of stables into a residential dwelling for Manor Farm, Hayling Island.

**LOCATION:** Osier Dell Manor Farm, Manor Rd., Hayling Island, Hants, PO110QW

**DATE:** June 2017

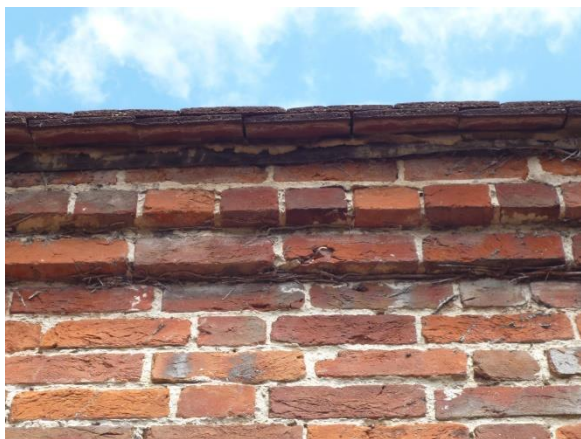
Figure 1 – Cornice detail

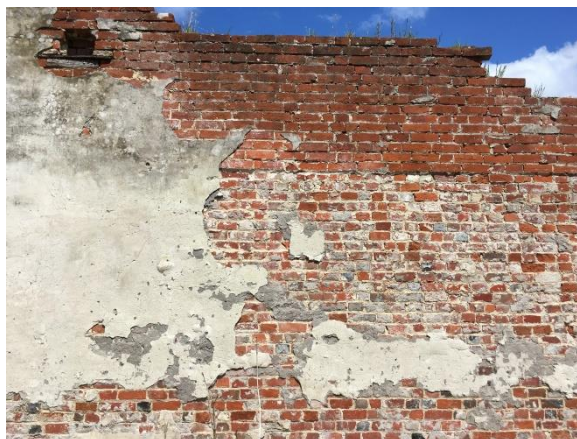
Figure 2 – Roofless wall to be retained on North elevation.

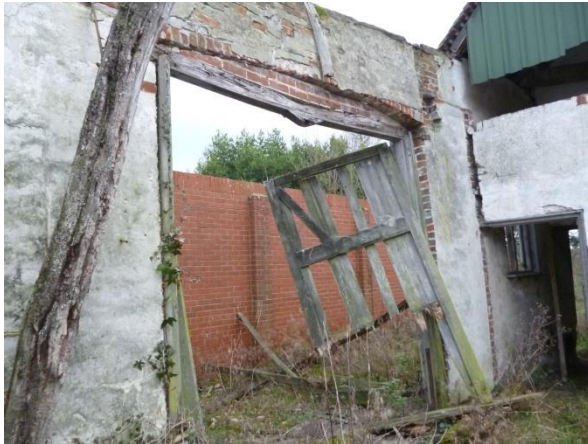
Figure 3 – Semi derelict archway with loosely hanging doors panels

- 1) Photographic survey to be taken prior to works.
- 2) For health and safety reasons the arch needs to be broken after the ground is covered with soft materials to avoid further damage to bricks.
- 3) Clean the bricks of previous mortar. Carefully stack for re-use.
- 4) Broken bricks to be replaced with reclaimed equivalent that match the existing in pattern, size, and colour.
- 5) Remove and dispose of loosely hanging cart door panels.
- 6) The composition of the cornice (figure 1) will need to be carefully re-created. It features 3 rows of brickwork. The lower row advances by half a brick's width from the plane of the wall, and is a running bond. The second row advances by another half a brick and is composed of header bonds. The third row is in the same plane reverts back to the running bond.

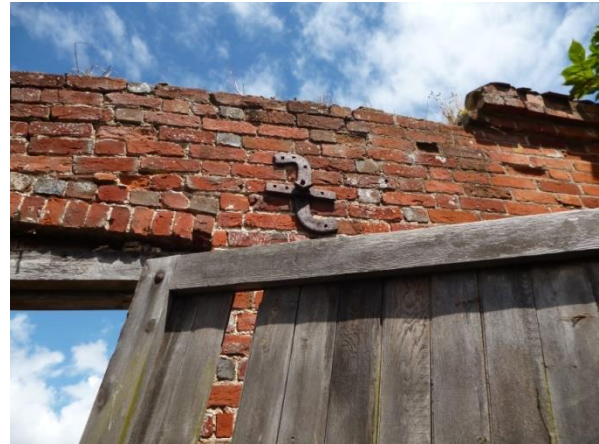
Figure 4 – redundant reinforcing S shaped tie rods to be stored and re-used

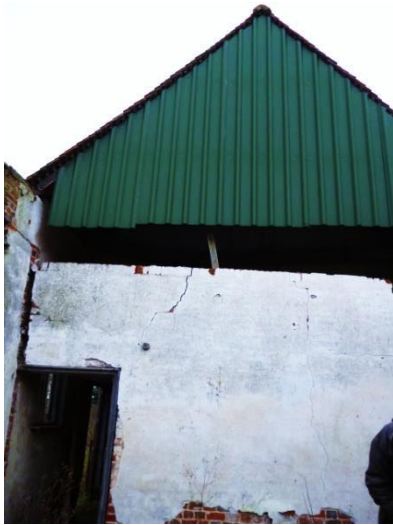
- 1) The original stable is currently sub divided in 3 bays due to good quality full height internal brick gable walls. These will be retained.
- 2) However, the gable wall at the extremity of the property is in poor condition and only encloses the building with the help of a metal corrugated sheet on the upper part of the wall (figure 5).

Figure 5 – Corrugated metal sheet

- 3) This unstable sub division will be removed and disposed of to welcome the chimney as part of the new lounge. Its original brickwork will be recycled.

- 4) For health and safety reasons this gable wall needs to be broken after the ground is covered with soft materials to avoid further damage to bricks.

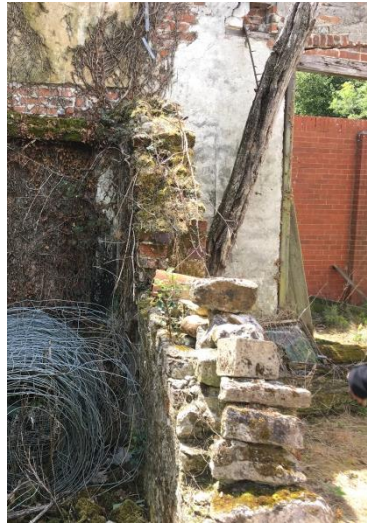
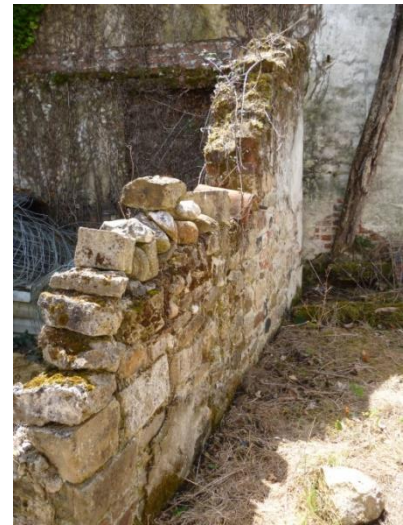
Figure 6 & 7 – Proposed East gable wall (chicken wire to be disposed of).

- 7) The existing stone wall (figure 6 & 7) will be used as a base to the new gable end. All rubble will be disposed of and the wall levelled. This level will be established once a more thorough assessment is made.

- 8) This new gable end will be built above the existing wall in the same style as the rest of the stables, paying particular attention to the existing Sussex bond and occasional grey header pattern.

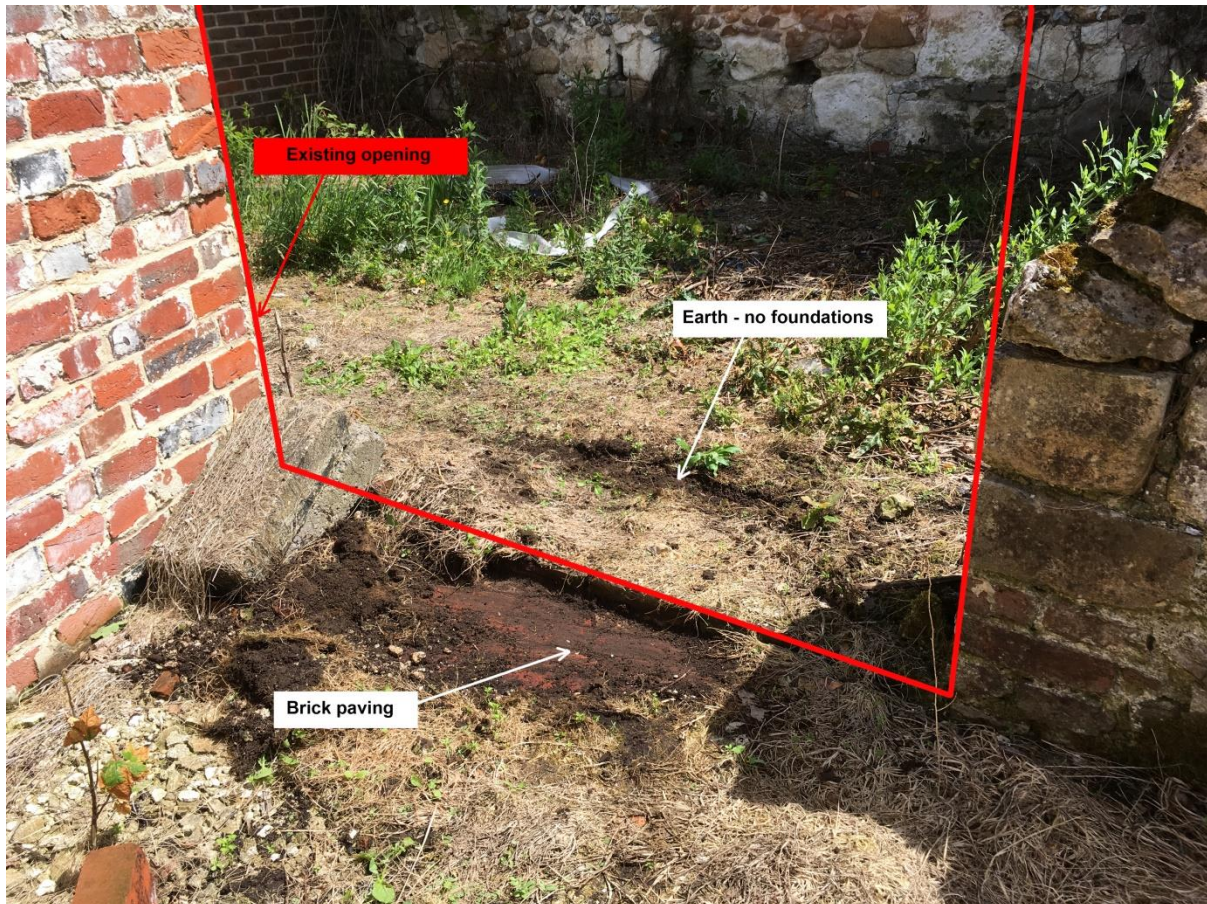
Figure 8 – Original footprint of build denoted by change in surface. Evidence of original opening.

- 9) The existing opening will be retained with a new doorway following the same outline as the previous opening (figure 8).

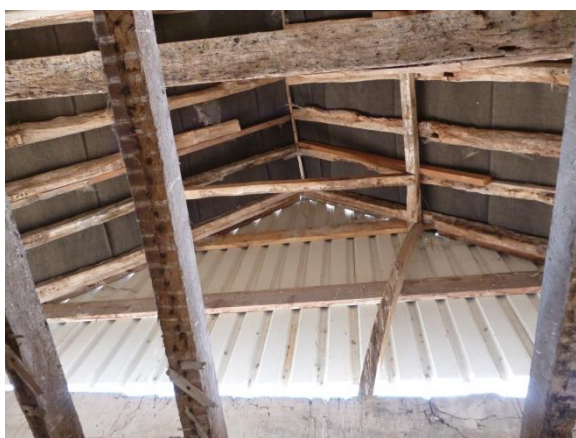
- 4) There are 5 existing timber roof trusses in the roof which include tie beams/lower chords, straining beams and (on some) angled strutted queen posts.

- 5) A structural frame solution has been looked at and we have consulted with a structural engineer to see if an amendment to the truss is possible.
- 6) Currently the bottom part of the truss' tie beam is 1.4 – 1.5 m above FFL (Finish Floor Level). We need this to be increased by minimum 0.5m to 4 out of the 5 trusses.

Figure 9 - Roof structure to be re-built

- 1) Check the integrity of all the trusses. Add a ridgepiece.
- 2) Beams that have snapped to be removed and re-used in another part of the building.
- 3) Tiles on the east end of the roof (in the bay featuring the chimney) will be removed. The removed weight from the roof will allow structural amendments to the existing timber roof trusses (figure 9).

- 7) The solution proposed would be to place another tie beam/lower chord, at a comfortable head height from FFL, before cutting the bottom cord and re-using it as tie beam for the following truss.

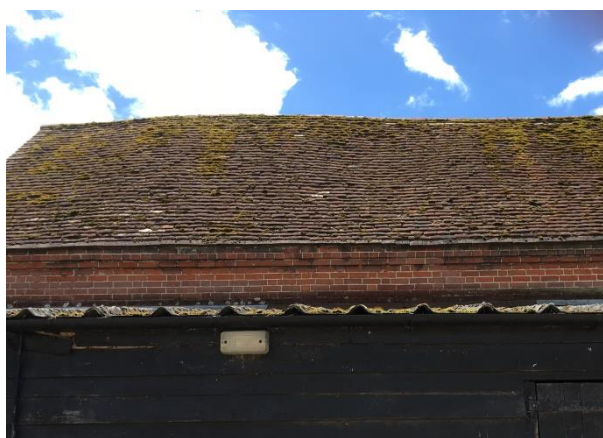
Figure 10 – Existing roof covering to be retained in part.

- 1) Existing clay tiles and bitumen felt under existing clay tiles was laid 30 years ago and are in adequate condition. Missing or broken tiles can be replaced with reclaimed equivalent.
- 2) Cover the re-constructed East end with reclaimed equivalent.

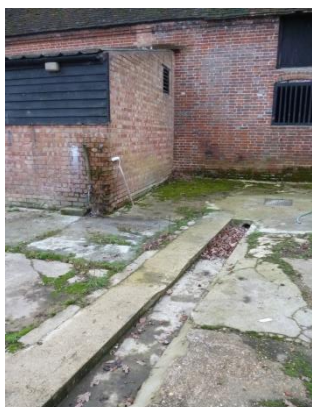
Figure 11 – 1970's lean to

- 1) This 1970's lean-to has no historical significance and is of poor quality. Its demolition will be replaced by a superior, modern, more spacious extension.
- 2) After some examination it has been established that the demolition will not affect the stability of the northern stables walls on which it is leaning on.
- 3) Care will need to be taken to not damage the brickwork of the original stables when demolition takes place.
- 4) London brick and asbestos corrugated roof to be disposed of carefully, following health and safety regulations.
- 5) Existing foundations to be grubbed out and disposed of.
- 6) Remove the white paint of the newly exposed stables wall to reveal the original brickwork.

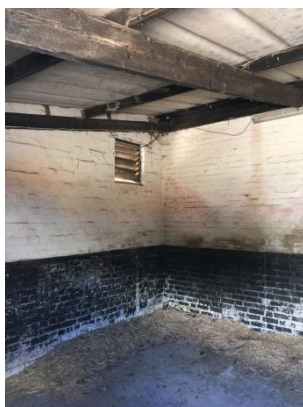
Figure 12 – Interior

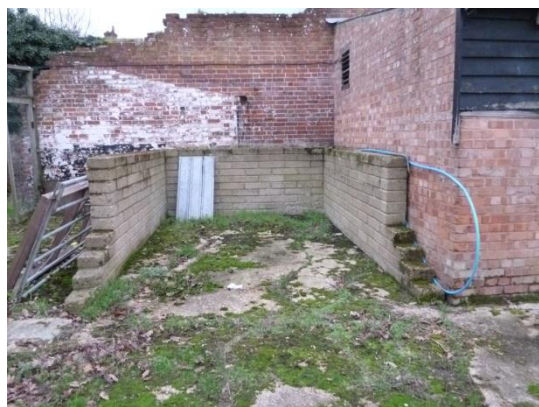
Figure 13 – Blockwork to be removed

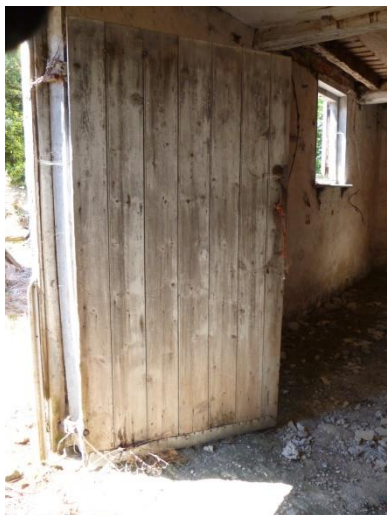
Figure 14 – Door for re-use

- 4) The cart door panels loosely hanging from archway will be removed, but evoked through the frame shape of the window and French doors that are to be installed.
- 5) Retain and re-use original door (figure 14) in the new East gable end, where there is evidence of an existing door opening.
- 6) Salvage and re-use window boards (figure 16).

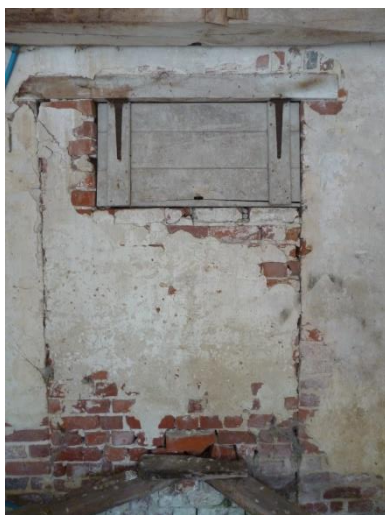
Figure 15 – Doorway to be re-opened

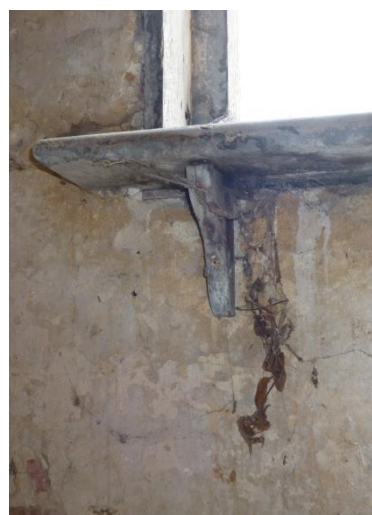
Figure 16 – window boards for re-use

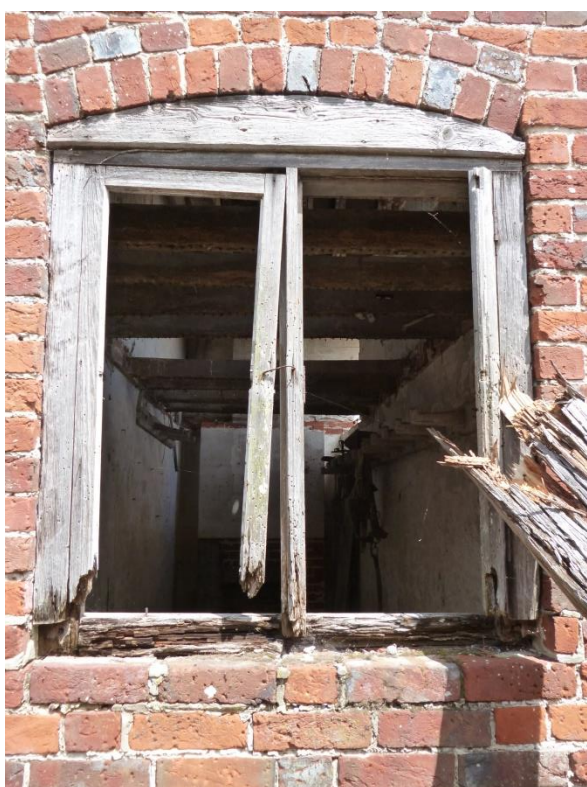
Figure 20 – derelict casement window

- 1) Photographic survey to be carried out to show size and shape before work progresses.
- 2) For the insertion of new openings in retained walls, ensure that the bricks removed are recycled. Steel support will ensure the stability of the wall opening prior to any of these works.
- 3) Remove and dispose of original derelict window frames. Replace with matching equivalent. Natural oak finish. See window details.

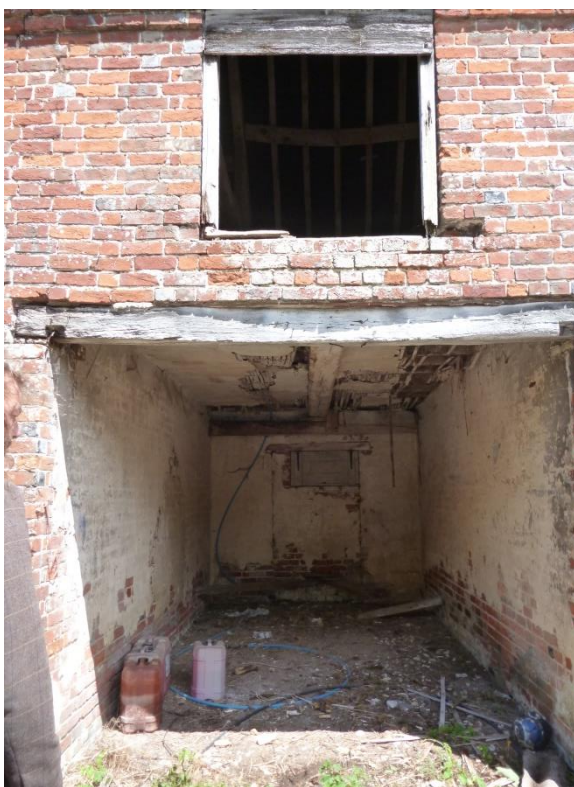
Figure 21 – Wide opening and hayloft opening above.

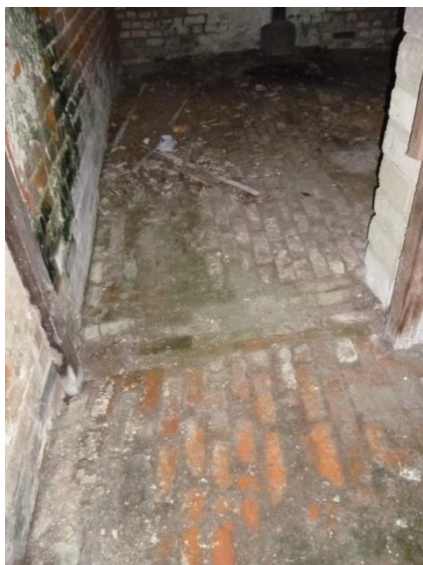
- 1) It is proposed to keep the foundations of the existing stables.
- 2) The floor currently inclines towards the troths creating a difference of 130mm in head height.
- 3) The single layer of uneven brick paving will have to be removed and recycled for the entrance, kitchen/dining area, and garden patio.
- 4) Rammed earth beneath will be levelled, covered with a DPM layer, insulated, and have 100 mm of concrete poured over. Lap up the DPM to the wall to avoid damp.
- 5) Strip foundations to the structural engineer's design for rear extension.

Figure 22 – Internal original brick paving

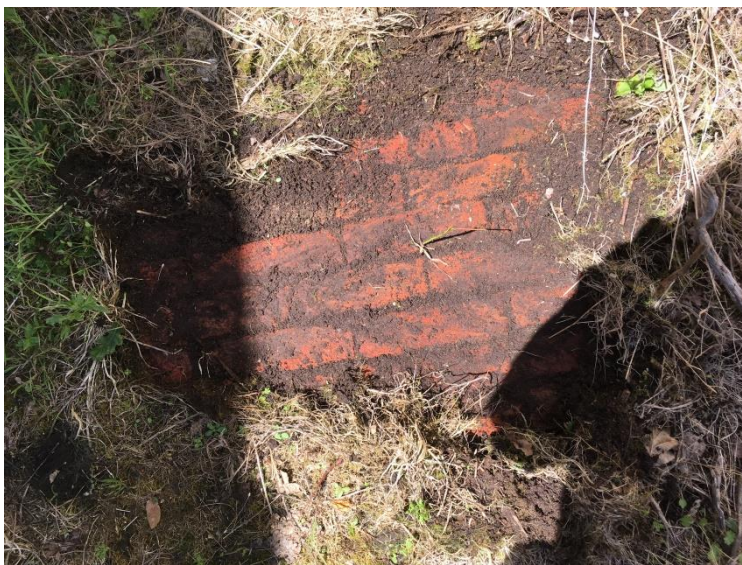
Figure 23 – Paving found in derelict East end of build.

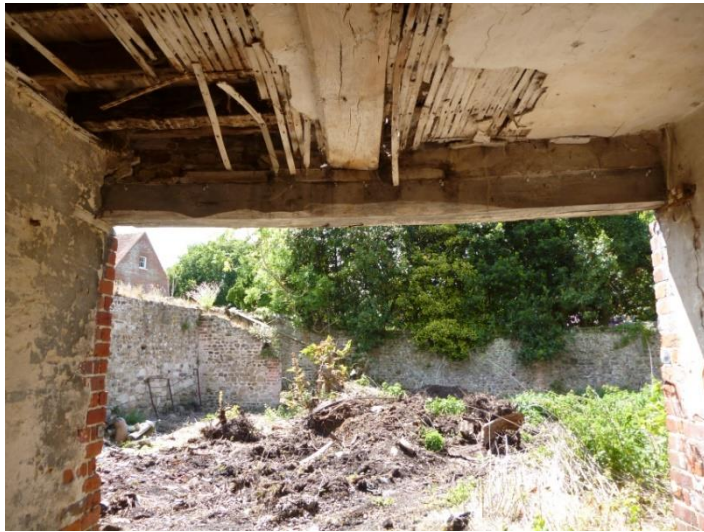
Figure 24 – Lintel that needs structural assessment

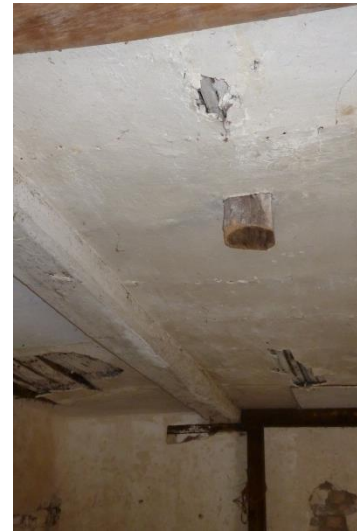
Figure 25 – Post in need of removal

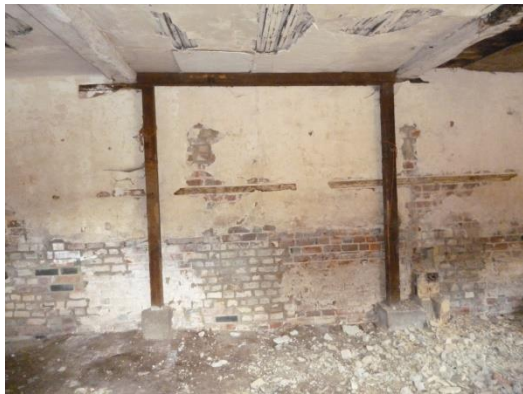
Figure 26 – Reinforcing wooden structure with concrete footing to be removed

- 1) Check the integrity of all the beams and floor joists.
- 2) Inject dry rot treatment. Treat for woodworms (figure 28).
- 3) Remove nails. Rub down and clean.
- 4) Dilapidated lath and plaster finish to be removed.
- 5) Floor joists and beam to be removed in proposed double height entrance space, and (if structurally sound) re-used in the rest of the build.
- 6) Ensure that the whole structure is stable before removing reinforcing wooden posts, beams and concrete footing (figure 26).
- 7) Add structural members in between existing beams and joists for further rigidity.

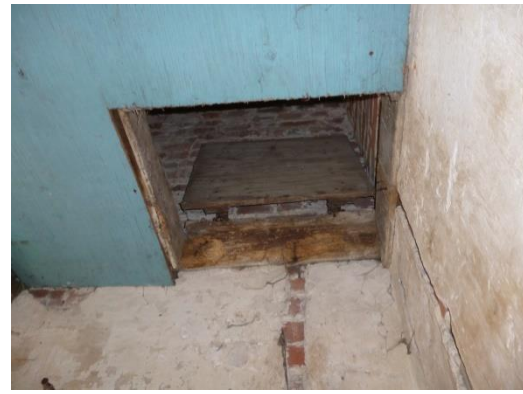
Figure 27 – Hatch to attic to be covered

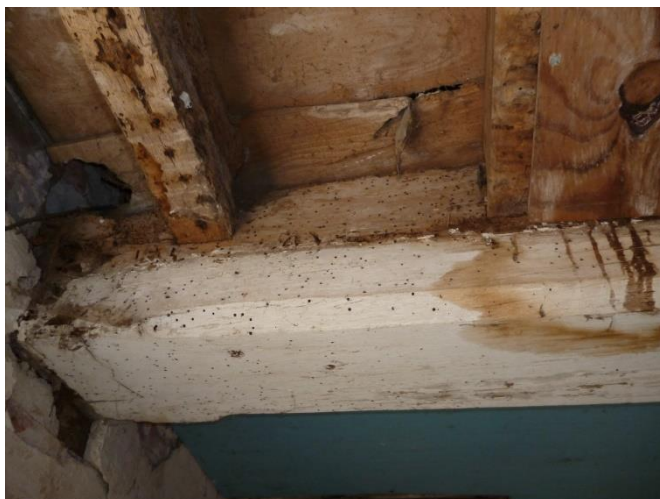
Figure 28 – Woodworm infected beam to be treated

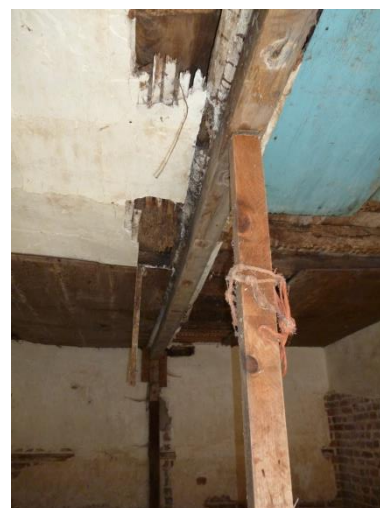
Figure 29 – Reinforcing wooden posts to be removed

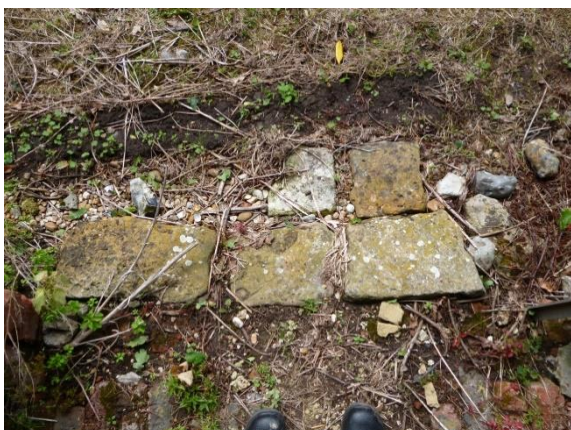
Figure 30 - Original stonework at doorway

- 4) Stone paving at doorways (figure 30) to be removed and located elsewhere on site.
- 5) Structure leaning against flint boundary wall in southern part of garden to be retained.

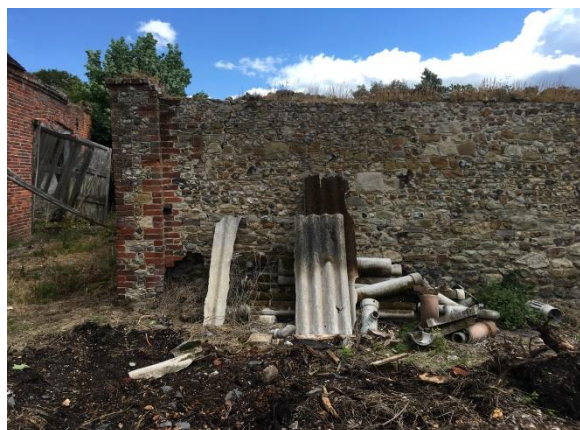
Figure 31 - Debris to be removed.

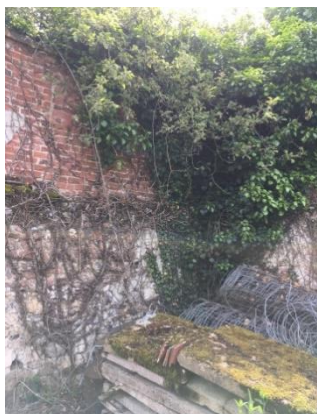
Figure 32 –East boundary wall. Chicken wire to be removed.

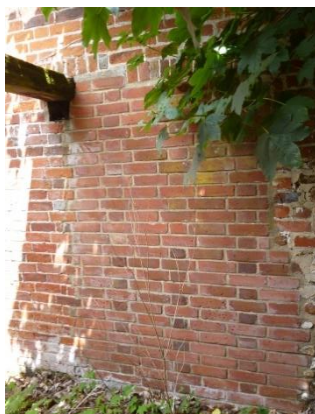
Figure 33 – Remove brick work to re-introduce opening.

- 6) Assessment about the paving to the north of the garden (at the entrance on site) will be made on site once works commence.
- 7) The wall that extends from the archway to form an enclosed garden (at the East of the plot) should be reduced in height by removing part of the unstable, non-original, upper brickwork. A triangular formation leaning towards the intersecting wall (belonging to Manor house) should be retained to create a reinforcing corner and increase rigidity to that part of the wall. This wall also has an opening (figure 33) that is blocked with brickwork which should be re-introduced to create a path into the enclosed garden. The extruding beam will be removed and disposed of.

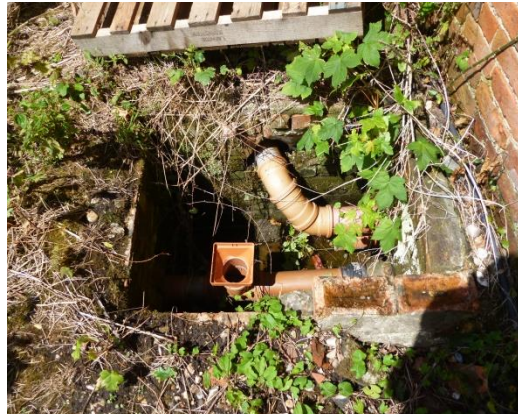
Figure 34 – Drainage hole to be covered

- 8) Ensure that the drainage holes are safely covered.

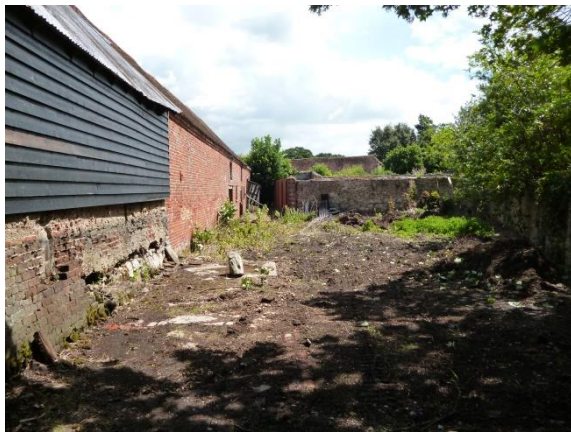
Figure 35 – Entrance to site with paving running the length of the barn to be relayed for level patio.

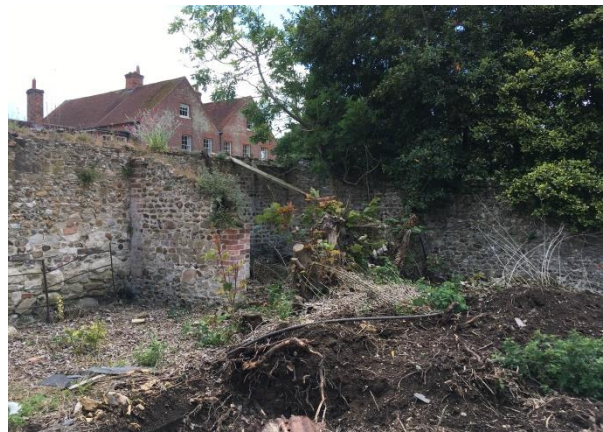
Figure 36 – Original remains of structure south of the garden to be retained

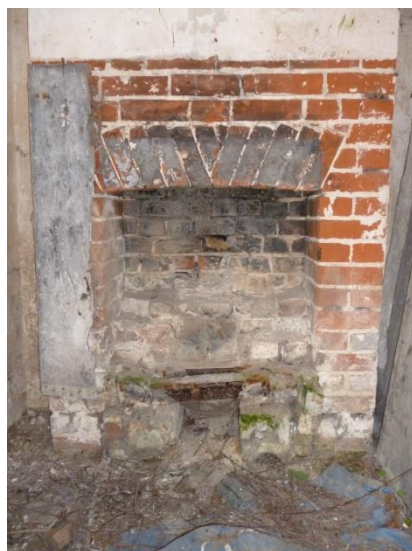
Figure 37 – Original chimney

- 1) Chimney to be retained and cleaned. Base to be reconstructed as original with reclaimed brickwork. Lime and mortar plaster to be carefully removed to reveal original brickwork. Same treatment to chimney flue. A traditional cast iron stove will be integrated inside so the roof will have to accommodate this.
- 2) Dispose of the low level triangular wooden structure (figure 38). Fill void in wall with reclaimed brickwork.
- 3) Salvage the harness hanger (figure 39) for re-use.

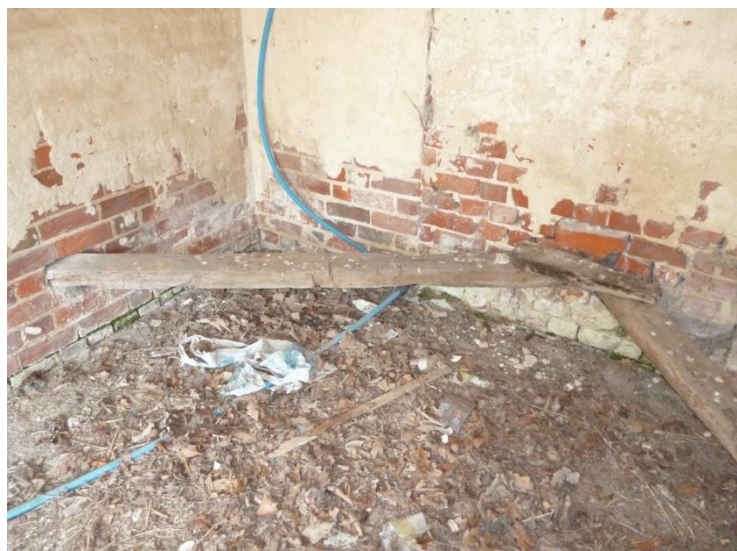
Figure 38 – Wooden structure inset in brick walls to be removed.

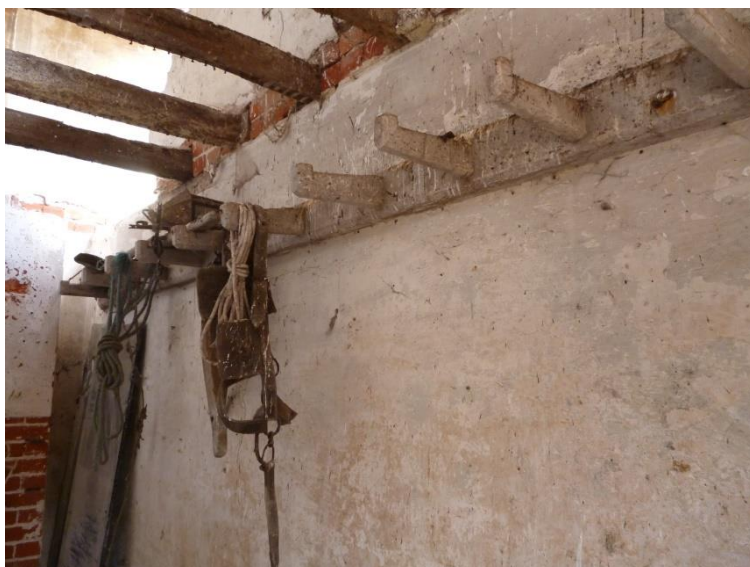
Figure 39 – Hanger to be salvaged and re-used

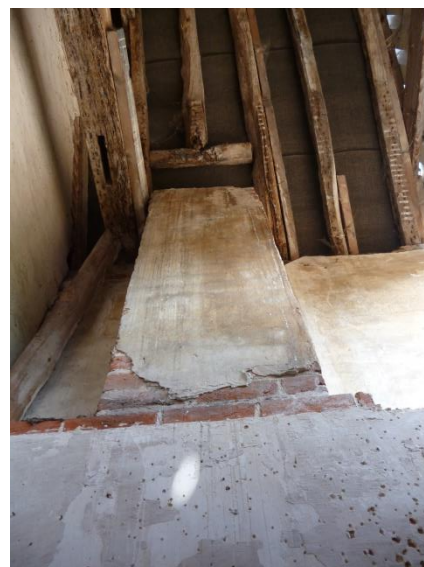
Figure 40 – Chimney flue. Lime mortar plaster to be removed
