30<sup>th</sup> March 2017

Our Ref: RT-MME-124714-Rev A

### **Endoscope Bat Survey at Mill Rythe Holiday Village, Havant Road, Hayling Island**

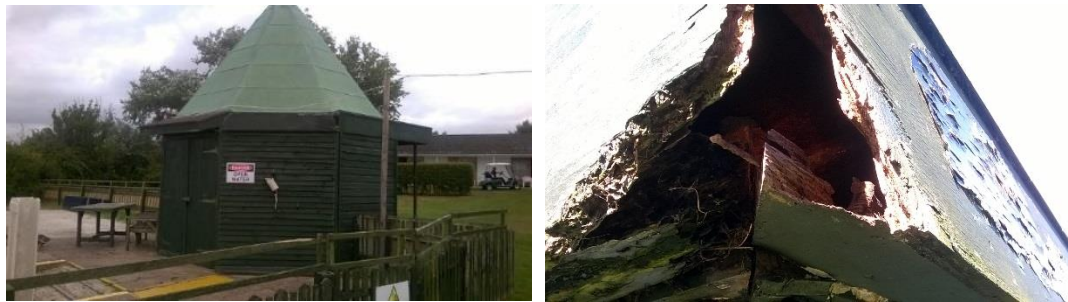
Building 1 was a small wooden structure adjacent to the lake in the north-western corner of the site. The building had a large hole in the soffit which could be utilised by bats to gain entry into the building and potential roost locations. This feature was fully inspected and did not lead to a suitable roosting cavity and the gap was exposed to the elements. Furthermore no evidence of bats such as droppings or staining were identified (Plate 1).

**Plate 1: Gap in Soffit of Building 1**

Building 1 is not considered to require any further survey effort at this stage.

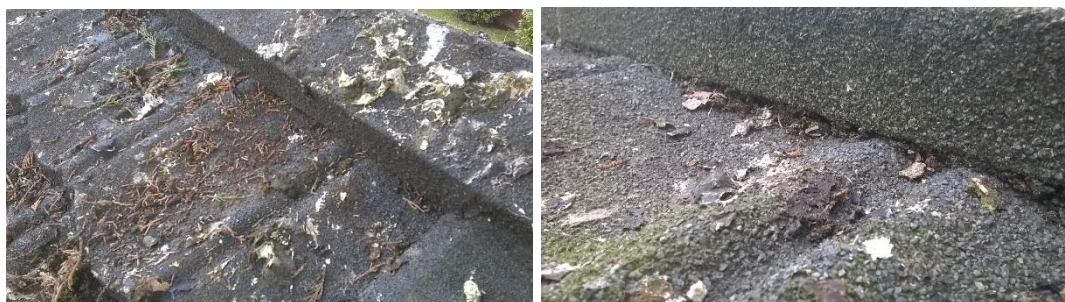
Building 2, 3 and 4 were single storey brick buildings with rendered walls. These buildings had pitched roofs with interlocking concrete tiles and uPVC soffits. Buildings 2, 3 and 4 had small gaps under the ridge tiles and it was not possible to inspect these areas during the initial survey due to the height at which they were located. The gaps under the ridge tiles were fully inspected and found to be fully blocked up with moss and dirt and therefore not suitable for use by roosting bats (Plate 2).

**Plate 2: Gaps Under the Ridge Tiles Were Blocked With Dirt and Moss**

Buildings 2, 3 and 4 are not considered to require any further survey effort at this stage.

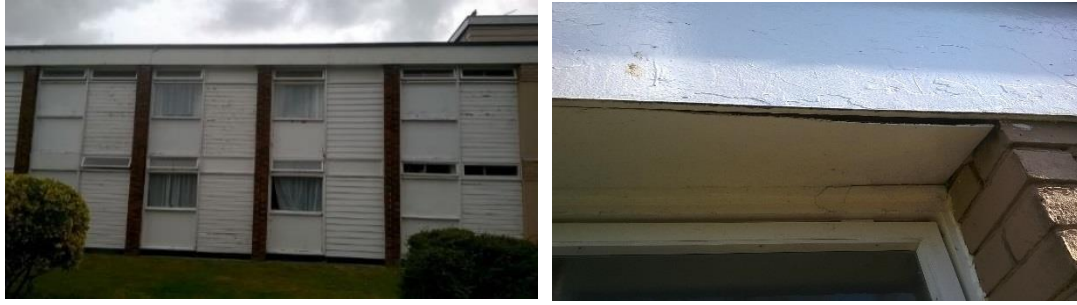
Building 5 was a two storey brick building with some elevations covered by timber and uPVC cladding. The buildings supported flat felted roofs, with timber soffit boxes. Gaps were identified within the timber soffit boxes, providing potential access points into the building for bats. The majority of the gaps were found to be too narrow to allow bats access into the soffit cavities. The largest gap was found to be an inch wide, however the gap was filled with cobwebs suggesting no recent activity. Furthermore, no evidence of bats such as droppings or staining was identified within and around the feature (Plate 3).

**Plate 3: Gap in Soffit of Building 5**

As a precautionary approach, it is recommended that the soffits of Building 5 are removed by hand under the supervision of a suitably qualified and licenced ecologist

- R1** As a precautionary approach, it is recommended that the soffits on Building 5 and the wooden cladding and lead flashing of Building 10 is removed by hand under the supervision of a suitably qualified and licenced ecologist. Should any evidence of bats be found, work will cease and the need for a Natural England development licence will be determined.

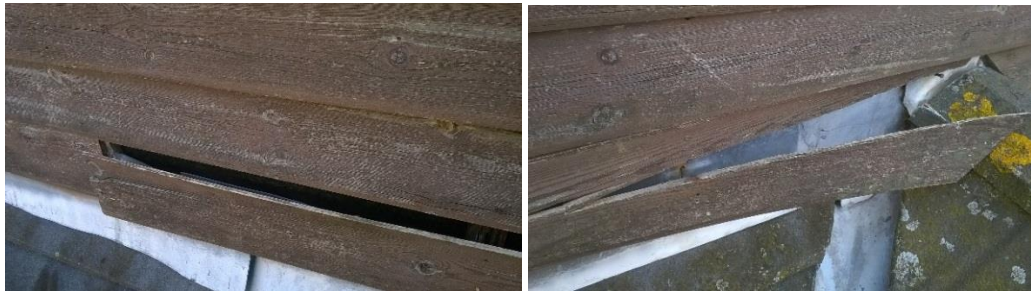
The building had lifted lead flashing and lifted wooden cladding in the western gable end which could be of value to roosting bats. All areas of lifted lead flashing and wooden cladding was fully inspected. Roofing felt was identified behind the wooden cladding, none of which were broken to allow bats into the roof void. No evidence of bats such as droppings or staining was identified within and around the features, and the majority of the features were heavily cobwebbed suggesting no recent use by bats (Plate 4).

**Plate 4: Example of Features On Building 10**

As a precautionary approach, it is recommended that the wooden cladding and lead flashing of Building 10 is removed by hand under the supervision of a suitably qualified and licenced ecologist

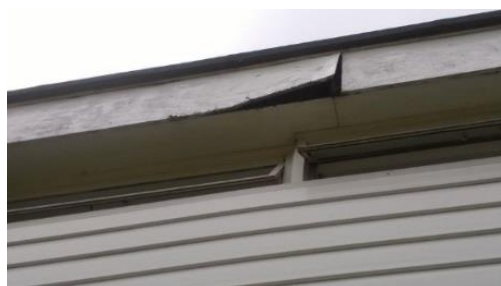
Building 29 was of an identical design to Building 5. A gap was identified within the timber soffit box, providing potential access points into the building for bats. The gap was found to be filled with cobwebs suggesting no recent activity. The wood was also found to be damp and rotten suggesting it is unsuitable for roosting bats. Furthermore, no evidence of bats such as droppings or staining was identified within and around the feature (Plate 5).

**Plate 5: Gap in Soffit of Building 29**

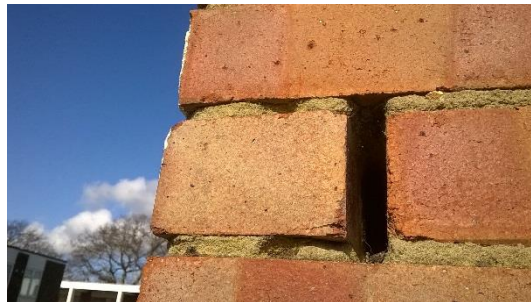
Building 46 was a single storey brick building with flat felted roofs and a brick chimney breast. A number of weep holes and missing bricks were identified within the chimney breast. All the weep holes were found to be approximately 30 cm deep, however they became too narrow for bats after the first 10 cm. All of the weep holes contained cobwebs suggesting no recent activity and no evidence of bats such as droppings or staining were identified within or around the features (Plate 6). The chimney breast also contained a number of areas with missing bricks. Three of the gaps left by the missing bricks contained old bird nests. Further inspection of the gaps with the endoscope found that there was a large cavity between two layers of bricks which could be accessed by bats through the gaps left by the missing bricks. This feature was inspected with a torch and endoscope and no evidence of the current or past presence of bats was found (Plate 7).

**Plate 6: Weep Hole in Building 46**

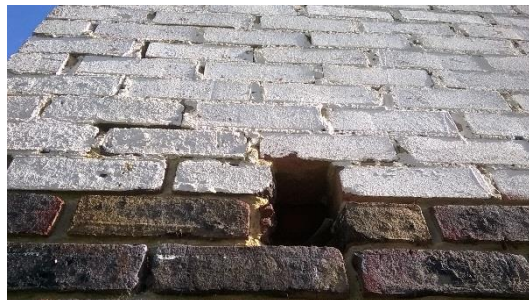
**Plate 7: Gaps in Brick Chimney of Building 46 Left by Missing Bricks**
