**Arboricultural Assessment & Method Statement**  
Woodcroft Farm, Woodcroft Lane, Waterloooville

21<sup>st</sup> December 2016  
16381-AMS-AN

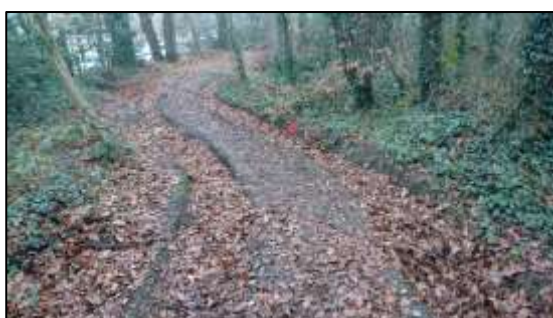
The existing byway is used recreationally by 4x4 vehicles and is heavily rutted and uneven. There is evidence of significant ground compaction in places. The construction of a new no-dig bridleway offers an opportunity to improve the soil structure and prevent further damage. This will greatly improve the long-term prospects for the retained trees. Some minor pruning of low hanging branches both in the paddock and the woodland is required to allow free passage below the trees. However, this is not considered to impact the character of the local area or the long-term health of the trees.

**Site photo 1:** Showing deep rutting on existing byway.

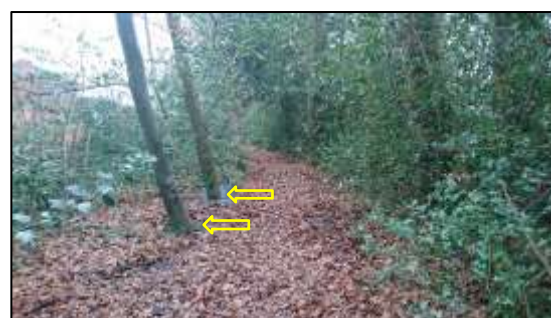
**Site photo 2:** Showing typically small, low quality trees to be removed to allow bridgeway construction.

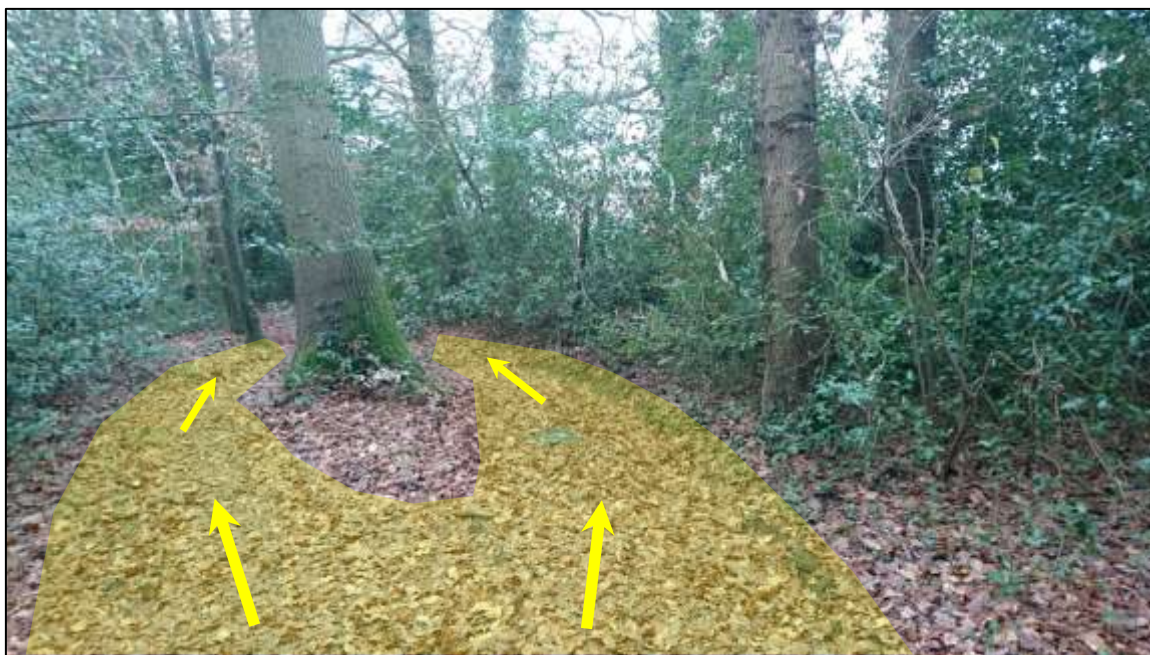
**Site photo 3:** Showing T23 and potential for routing the bridleway either side (leaf litter is covering byway rutting).
