## Preliminary Ecological Appraisal and Roost Assessment

18 Sea View Road, Hayling Island, Hampshire, PO11 9PE

4<sup>th</sup> July 2024

The demolition of the existing building and construction of a new replacement building.

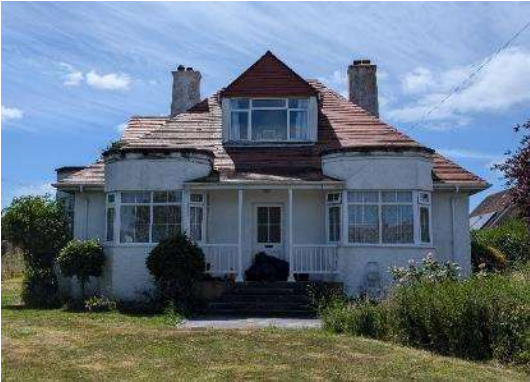
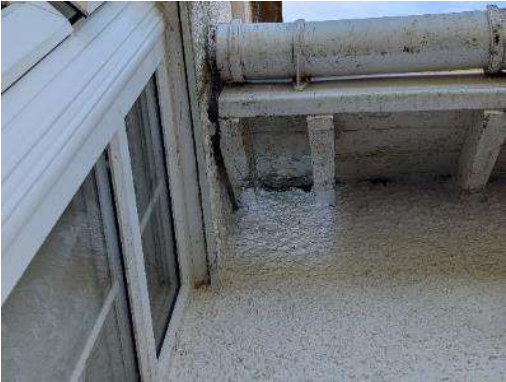
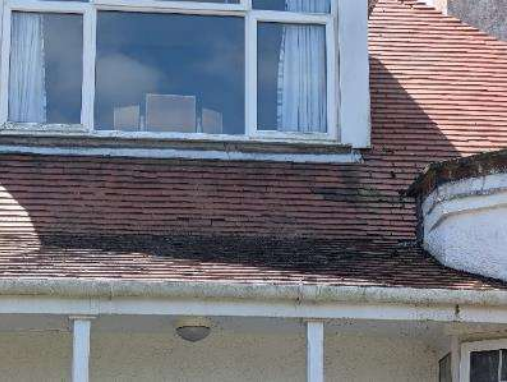
| B1 – northern elevation | <p>All windows and doors on the northern elevation appear to be tightly fitted (Fig 2). There is a gap in the eaves next to the western bay window (Fig 3) which could provide a suitable roosting feature for crevice dwelling bat species. There is no internal void in this area, so it is unlikely this provides any additional internal access. The roof tiles do not appear to be in good condition, with a number of missing and lifted tiles (Fig 4) providing a potential roosting feature for crevice dwelling bat species.</p> <div style="display: flex; justify-content: space-around; align-items: flex-end;"> <div style="text-align: center;"> <p><i>Fig 2</i></p> </div> <div style="text-align: center;"> <p><i>Fig 3</i></p> </div> <div style="text-align: center;"> <p><i>Fig 4</i></p> </div> </div> <p>There are gaps between the hip tiles (Fig 5) and some of the hip tiles appear to be missing, providing a potential roosting feature for crevice dwelling bat species. Around the dormer window on this elevation, the mortar is missing between the end roof tiles (Fig 6) leaving a large number of gaps. In addition, the hanging tiles are lifted in places (Fig 7) providing additional features for crevice dwelling bat species.</p> |

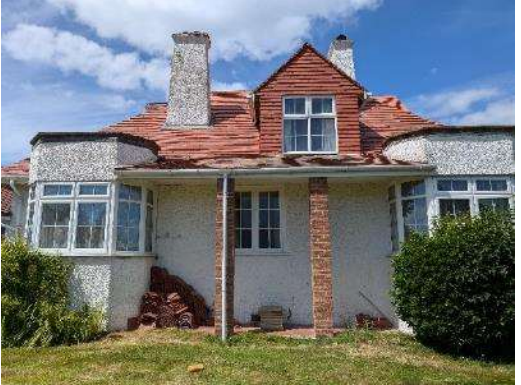
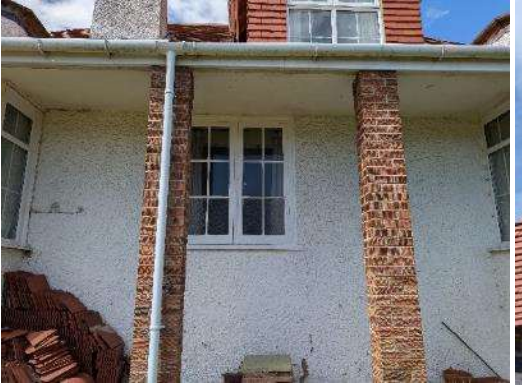
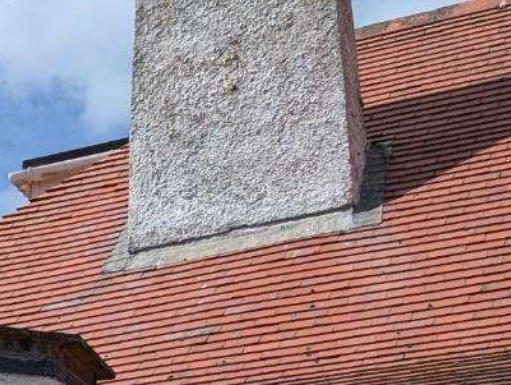
| B1 – eastern elevation | <p>As with the northern elevation, all windows appear to be tightly fitted (Fig 8) leaving no gaps, and the underside of the porch roof appears to be in good condition (Fig 9), with no damage or obvious gaps. The lead flashing around the chimney on this elevation appears to be flush to the roof (Fig 10), leaving no gaps.</p> <p style="text-align: center;"><i>Fig 8</i> <span style="margin-left: 100px;"><i>Fig 9</i></span> <span style="margin-left: 100px;"><i>Fig 10</i></span></p> <p>The dormer window on this elevation has a large number of lifted hanging tiles (Fig 11) which provide suitable roosting features for crevice dwelling bat species. While the mortar between the end roof tiles here appear to be in better condition than the northern elevation (Fig 12), there are still a small number of tiles with missing mortar, in particular the ridge tile which could potentially provide access to a larger space. There is a high number of lifted roof tiles on this elevation, particularly around the bay window to the north of this elevation (Fig 13) and the roof tiles near this area.</p> |

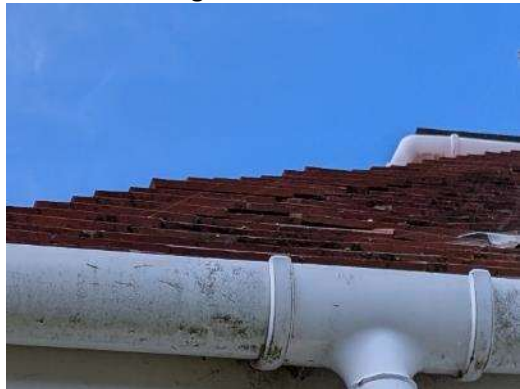
Fig 14

There are a high number of lifted roof tiles along the southern hip on this elevation in addition to a small section of lead flashing around the southern dormer window which is also lifted (Fig 14). There appears to be a small gap between the fascia board and the wall (Fig 15), however this could be inspected with a torch from ground level and the gap along here is not deep enough to provide a suitable roosting feature.

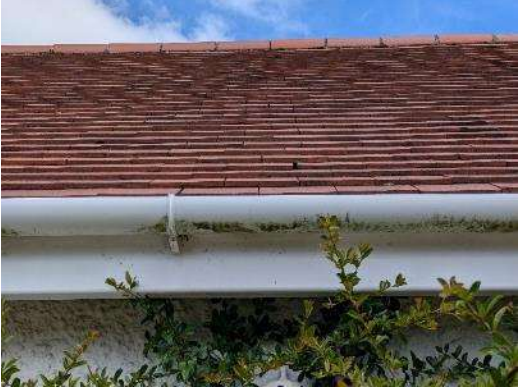
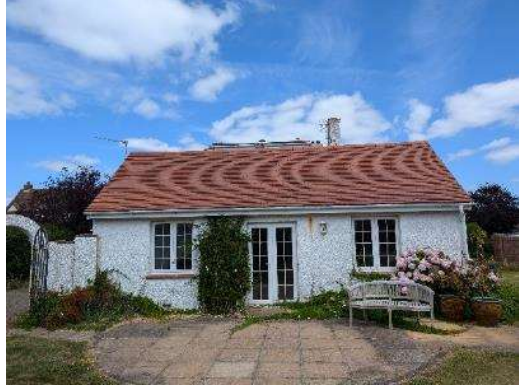
The roof tiles on this elevation appear to be in much better condition, with only two small gaps (Fig 16) which are big enough to provide a potential roosting feature for crevice dwelling bat species. The windows and doors appear to be tightly fitted leaving no gaps (Fig 17) and the remainder of this elevation appears to be in good condition.

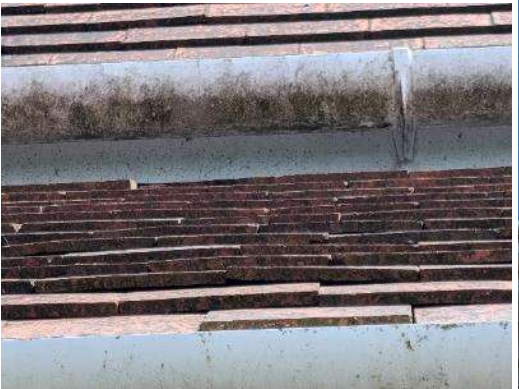
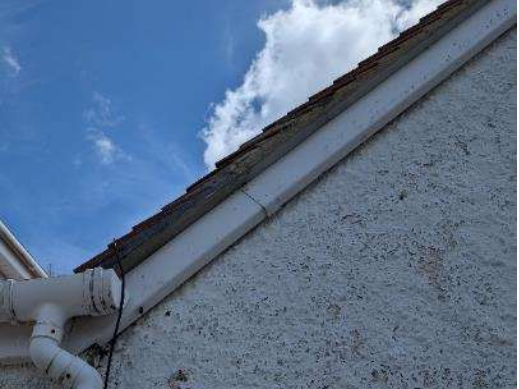
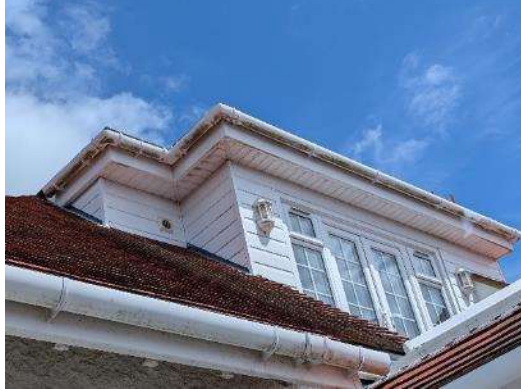
| B1 – western elevation | <p>The roof tiles on this elevation appear to be in poor condition, with a high number of missing or lifted tiles (Fig 18) in addition to missing mortar along the end roof tiles (Fig 19). The soffit box on the upper elevation here appears to be in good condition (Fig 20), with no obvious damage or gaps.</p> <p><i>Fig 18</i></p> <p><i>Fig 19</i></p> <p><i>Fig 20</i></p> <p>The skylight on this elevation does not appear to be tightly fitted (Fig 21), leaving a suitable gap in the bottom corners for crevice dwelling bat species. The eaves on this elevation appear to be in relatively poor condition (Fig 22), as there are two holes under the eaves, one of which is currently being used by a nesting bird. This suggests that the holes likely provide access to a reasonable sized space, which could provide a suitable roosting feature for crevice dwelling bat species.</p> |

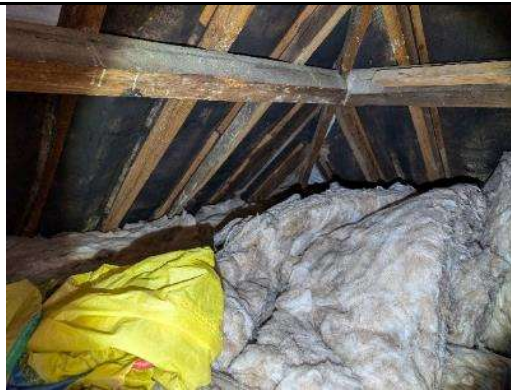
Fig 23

| B1 – interior | <p>There are four voids within B1, of which it was only possible to access two.</p> <p>Void 1 (V1) is a crawl space between the first and second floor to the south west of B1. Due to the entrance not being close enough to the wall to safely open this while on the ladder and the depth of the insulation leaving no place to move the loft hatch to, it was not possible to access this void. However, as the void is only ~60cm in height and there was no visible access to this from the exterior of the building, it is considered unlikely that void dwelling bat species would utilise this space.</p> <p>Void 2 (V2) is a loft void above the first floor to the south of B1. As with the first void, it was not possible to access this space safely due there being nowhere to safely lean the ladder. While there were no obvious access points externally, it is possible that there may be bats within this void.</p> <p>Void 3 (V3) is a loft void which is accessed via a small door within the second story of B1. It is constructed of wooden beams (Fig 23), which provide a potential roosting feature for void dwelling bat species. It stretches along the east of the building, and is insulated with mineral wool insulation and lined with bitumen felt. The bitumen felt is heavily damaged in places (Fig 24), leaving large gaps and entirely missing in places. A small amount of daylight could be seen from within the loft void (Fig 25), suggesting there is access to the loft void. This access point was not seen externally. No bat evidence was identified within the loft void.</p> |

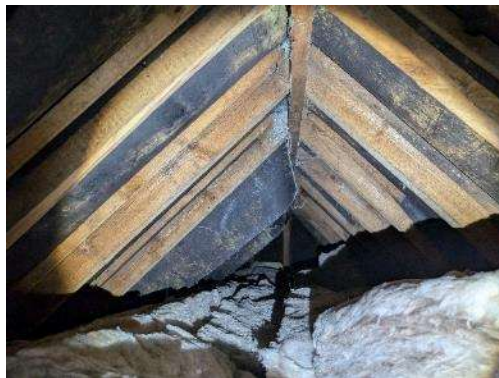
Fig 26

Void 4 (V4) is a loft void above the centre of the second story. It is long, but narrow with a low ceiling, approximately 1 meter in height at its peak. It is constructed with wooden beams, insulated with mineral wool insulation and lined with bitumen felt (Fig 26). As with void 3, the bitumen felt is heavily damaged, with sections falling away from the wall (Fig 27). In one section, the clay roof tiles can be seen (Fig 28), suggesting this could be a potential access point for crevice dwelling bat species should there be access underneath the tiles externally.

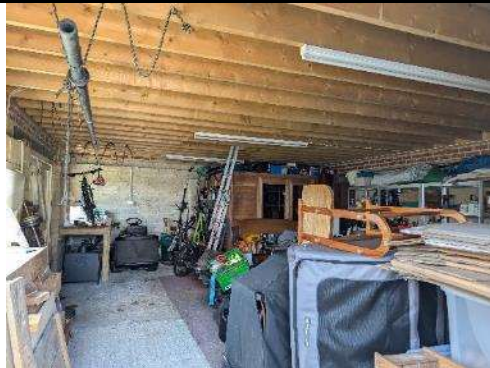
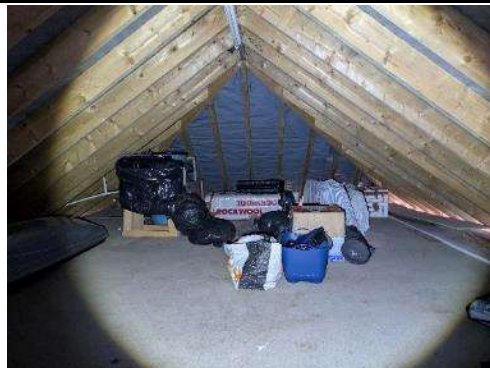
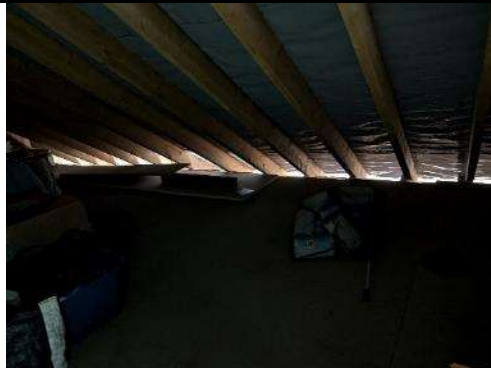
| B2 - interior | <p>B2 is currently being used as a storage space. It is a large, open space which is well lit (Fig 35) due to the windows to the east of B2. In the loft void within B2 is constructed of timber beams with a ridge beam through the centre (Fig 36), providing a potential roosting feature for void dwelling bat species. Daylight can clearly be seen internally around the entirety of the building by the eaves (Fig 37), suggesting there is access into the loft void. This is confirmed by an inspection of the eaves, which shows there is a gap between the eaves and the wall on all elevations of B2.</p> |
