Ref: LAS\_641\_A  
Date: 21.05.2024

**Site: Brookfield Hotel, Emsworth**

## **Arboricultural Statement**

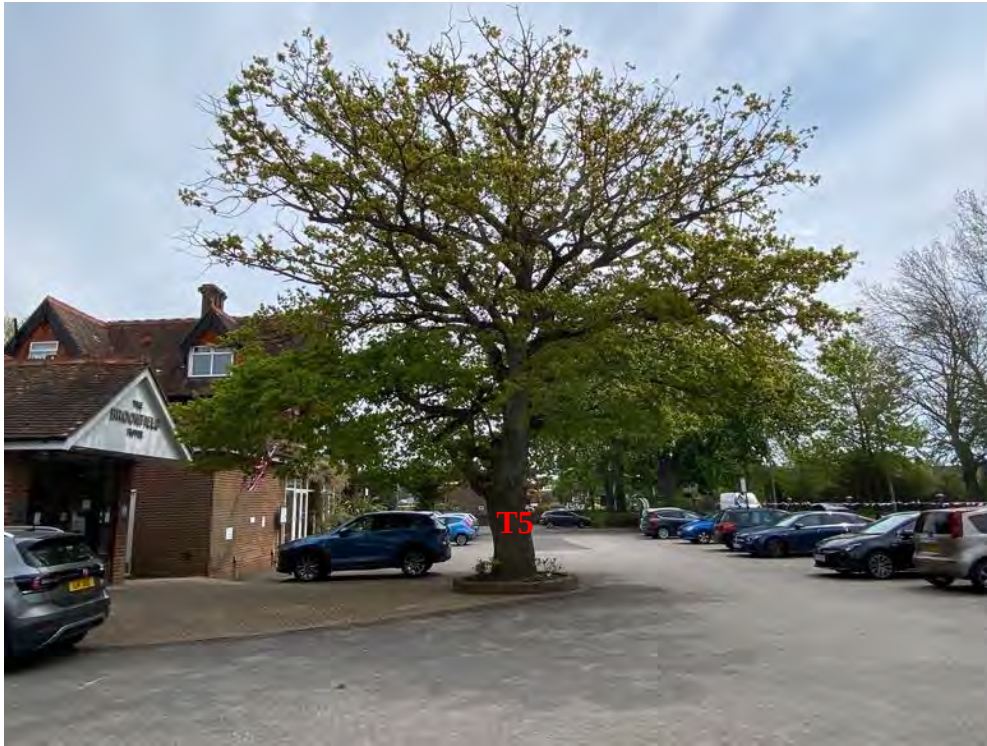
| Ref no. | Species | Ht. (m) | Stem | | | | Category Grading | Crown Spread (m) | | | | | | | | Life stage | ULE | Physiological Condition | Structural Condition | General Observations and Notes |
|---|---|---|---|---|---|---|---|---|---|---|---|---|---|---|---|---|---|---|---|---|
| T5 | Oak | 11.0 | 1 | 760 | 9.1 | 261 | C1 | 6.0 | 6.0 | 5.0 | 5.0 | N/A | - | N/A | 2.0 | M | 10+ | Fair | Fair | Set in small planting bed, hard surfacing and car park all around stem. Lighting fixed to the stem and hanging in the crown. Pruning wounds north west and south side with decay, crossing branches north east side, upper crown is thinning and there is minor to moderate deadwood and areas of dieback, lower leaves darker green upper canopy leaves yellowing. |

Photoview 1: View east towards T5.

6.3 In relation to T5 it would not be possible to fence of the RPA as works will occur within the RPA. As such the stem of T5 should be enclosed with a plywood box / hoarding to prevent direct contact.

- 6.11 Where removing the existing hard surfacing beneath the proposed timber decking the following methods should be followed:
- The existing hard surfacing is to be broken up and lifted out using hand tools or lightweight plant with care not to excavate into the existing sub soil/base.

- Once hard surfacing has been removed, no machinery or equipment is to enter or be stored in the exposed RPA.
- 6.12 The timber decking to be installed in the RPA of T5, following hard surface removal, must avoid strip foundations and instead adopt a lower impact methods such as small excavated concrete pads to support timber posts or screw/mini piles, or use an above ground foundation block / adjustable pedestal laid at ground level.

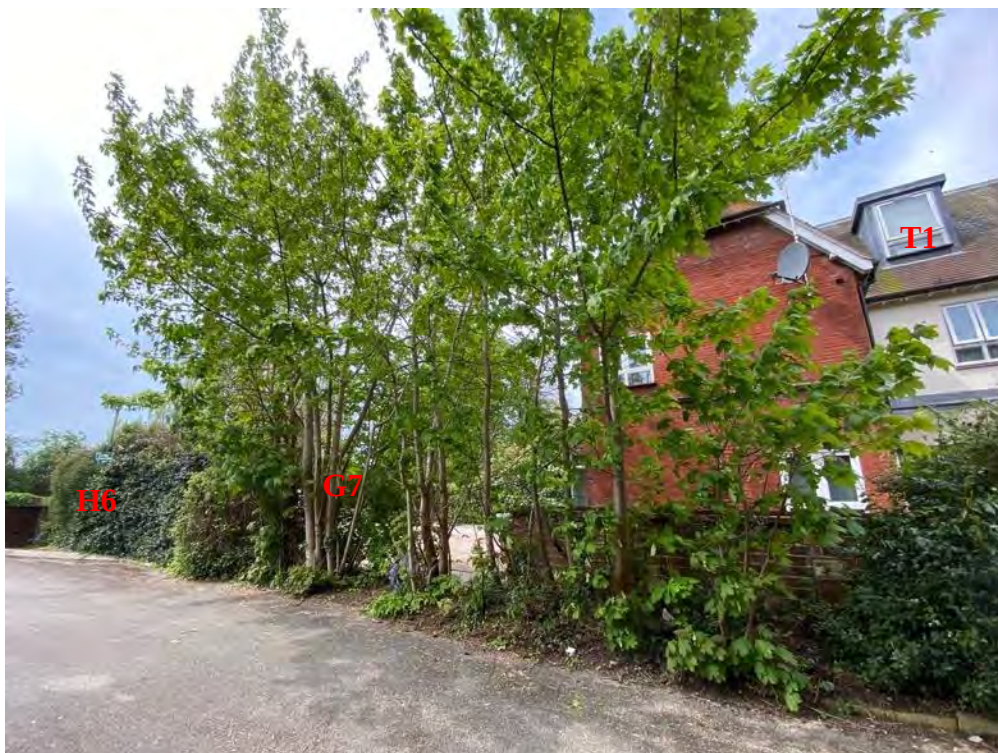
| Ref no. | Species | Ht. (m) | Stem | | | | Category Grading | Crown Spread (m) | | | | | | | | Life stage | ULE | Physiological Condition | Structural Condition | General Observations and Notes |
|---|---|---|---|---|---|---|---|---|---|---|---|---|---|---|---|---|---|---|---|---|
| G7 | Sycamore | 7.0 | 5+ | 80 | 1.0 | 3 | C2 | As on plan | | | | N/A | - | N/A | 0.0 | SM | 10+ | Fair | Poor | Self set semi mature sycamore, multiple stems, drawn up, poor quality. |

Photoview 2: View south west along G7.

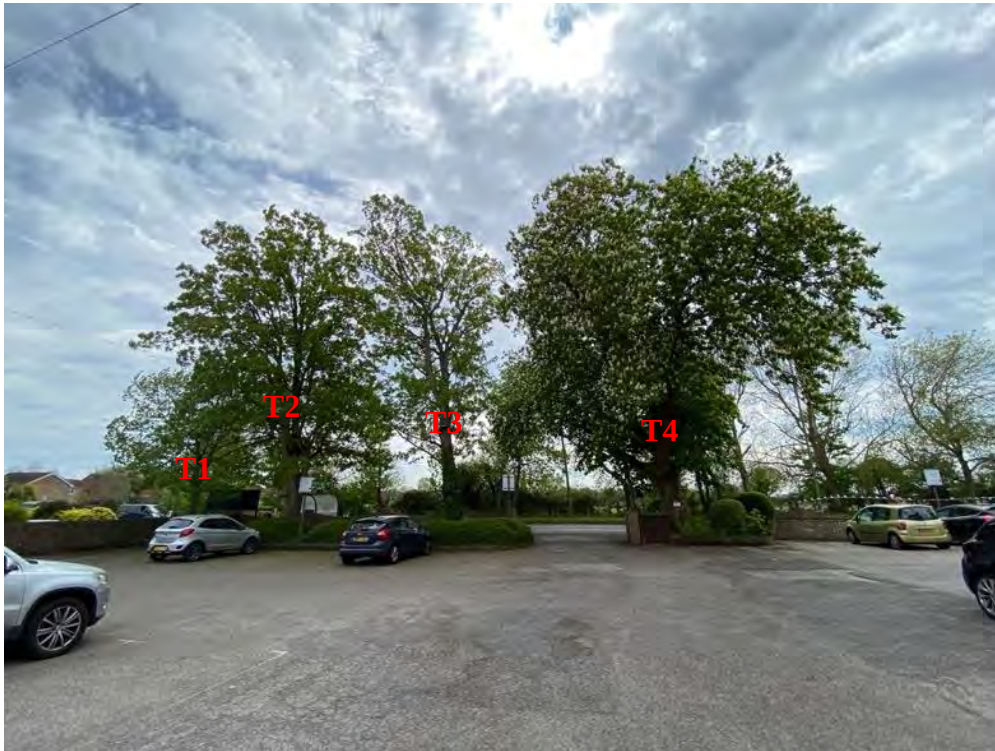
| Ref no. | Species | Ht. (m) | Stem | | | | Category Grading | Crown Spread (m) | | | | | | | | Life stage | ULE | Physiological Condition | Structural Condition | General Observations and Notes |
|---|---|---|---|---|---|---|---|---|---|---|---|---|---|---|---|---|---|---|---|---|
| T2 | Sycamore | 15.0 | 1 | 620 | 7.4 | 174 | B1 | 6.0 | 5.0 | 5.0 | 4.0 | N/A | - | N/A | 2.0 | M | 10+ | Good | Fair | Dense crown, union from 3m, crossing branches northeast side, set in planting bed, electrical point and metal embedded in stem south side. |
| T3 | Sycamore | 15.0 | 1 | 680 | 8.2 | 209 | B1 | 3.0 | 4.0 | 6.0 | 3.0 | N/A | - | N/A | 4.0 | M | 10+ | Fair | Fair | Southern branch with wounds and decay, canopy favours south and east side, flood lighting attached to stem, pruned in the past. |
| T4 | Horse chestnut | 15.0 | 1 | 1090 | 13.1 | 538 | B1 | 9.0 | 7.0 | 7.0 | 4.0 | N/A | - | N/A | 3.0 | M | 20+ | Good | Fair | Large horse chestnut with seven stems from 2.5m, deadwood and canopy thinning in upper crown, pruned in the past and multiple cavities in old pruning wounds, low retaining wall to north, wall to south and east. |

Photoview 3: View south towards T1-T4.

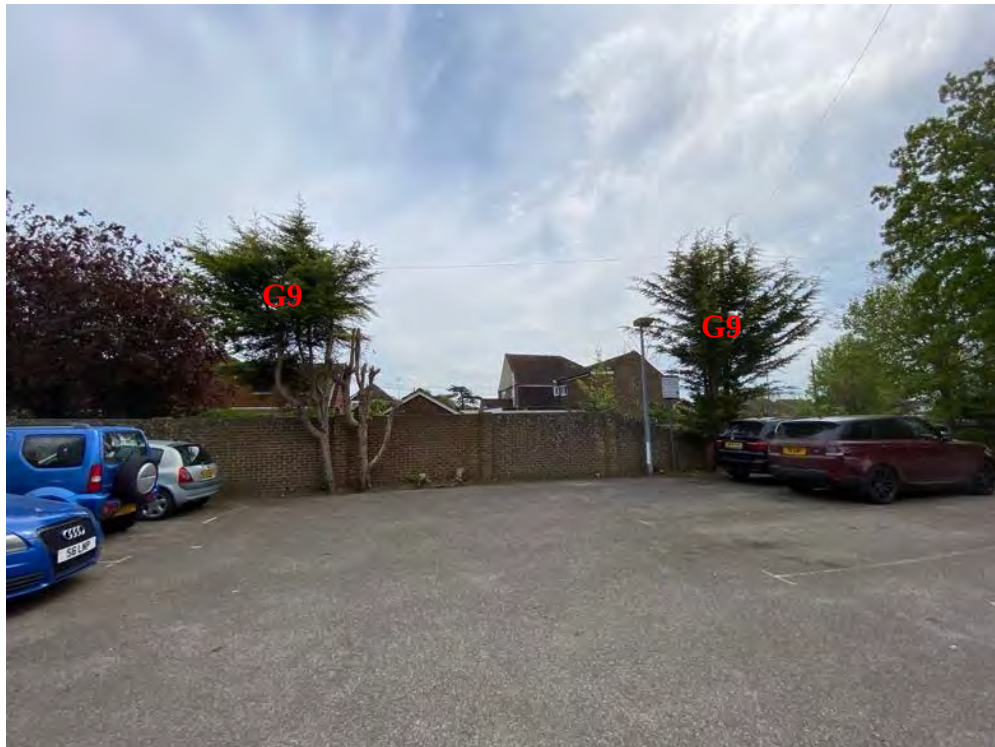
| Ref no. | Species | Ht. (m) | Stem | | | | Category Grading | Crown Spread (m) | | | | | | | | Life stage | ULE | Physiological Condition | Structural Condition | General Observations and Notes |
|---|---|---|---|---|---|---|---|---|---|---|---|---|---|---|---|---|---|---|---|---|
| T9 | Cypress | 5.0 | 1 | 240 | 2.9 | 26 | C1 | 1.5 | 1.5 | 1.5 | 1.5 | N/A | - | N/A | 1.0 | EM | <10 | Fair | Poor | Two cypress, northern cypress has been topped and has dead southern stem, south cypress growing by electric pole, topped in past and pruned, |

Photoview 4: View east at G9.

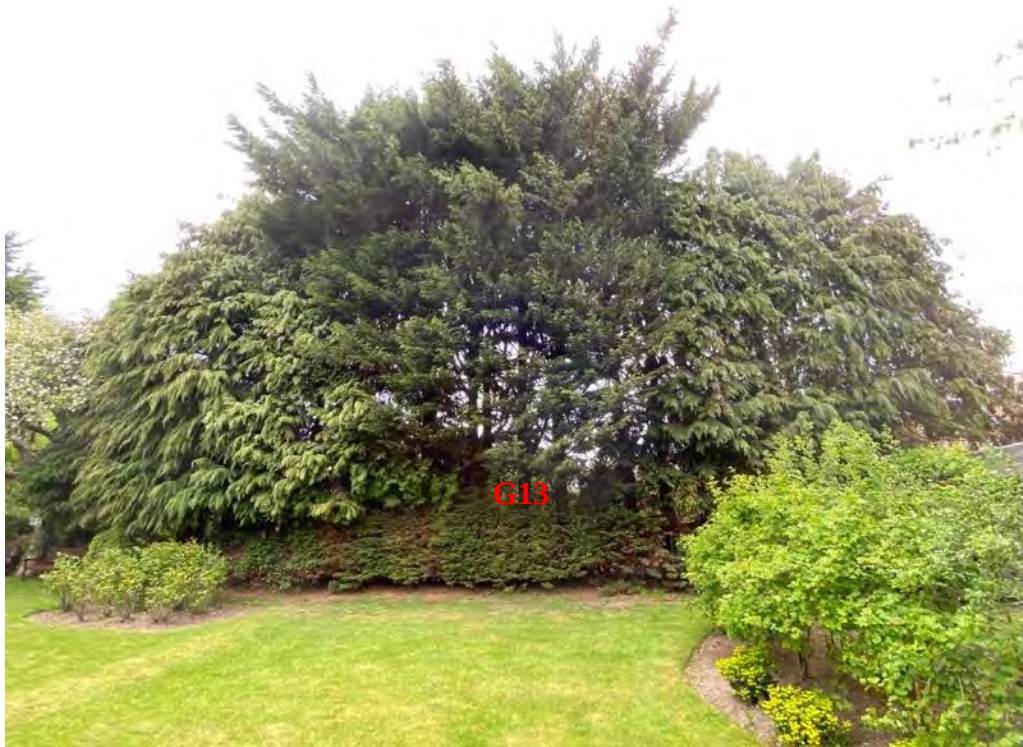
| Ref no. | Species | Ht. (m) | Stem | | | | Category Grading | Crown Spread (m) | | | | | | | | Life stage | ULE | Physiological Condition | Structural Condition | General Observations and Notes |
|---|---|---|---|---|---|---|---|---|---|---|---|---|---|---|---|---|---|---|---|---|
| G13 | Cypress | 9.0 | 4 | 300 | 3.6 | 41 | C2 | As on plan | | | | N/A | - | N/A | 0.0 | EM | 10+ | Fair | Fair | Line of cypress, lower canopy pruned back, topped in the past, |

Photoview 5: View north at G13.

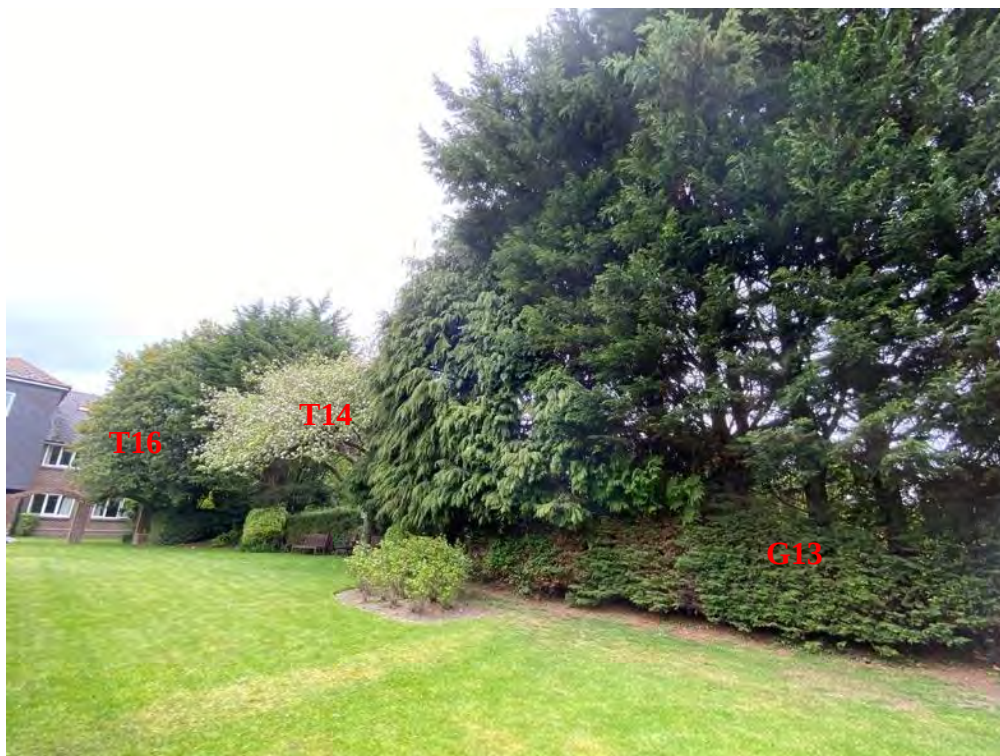
Photoview 6: View looking north west towards G13 and T14.

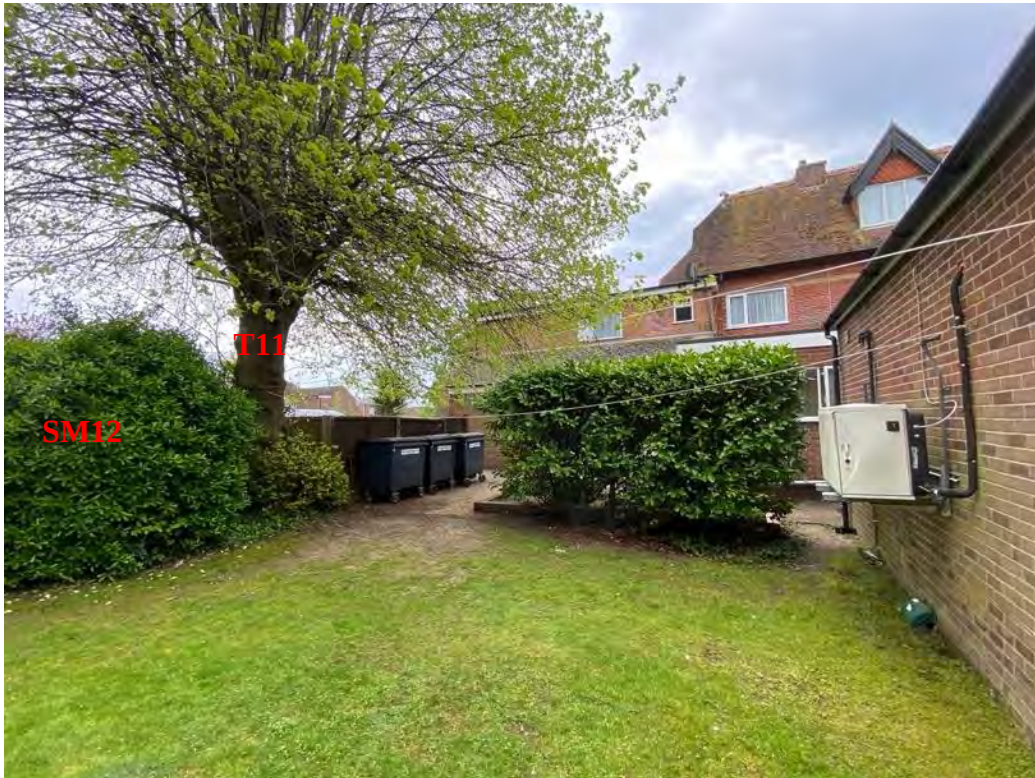
| Ref no. | Species | Ht. (m) | Stem | | | | Category Grading | Crown Spread (m) | | | | | | | | Life stage | ULE | Physiological Condition | Structural Condition | General Observations and Notes |
|---|---|---|---|---|---|---|---|---|---|---|---|---|---|---|---|---|---|---|---|---|
| T11 | Lime | 13.5 | 1 | 800 | 9.6 | 290 | B1 | 6.0 | 5.0 | 5.0 | 6.0 | N/A | - | N/A | 2.5 | M | 20+ | Good | Fair | Large lime, old historic pollard which appears to have been reduced at a higher point in the past. , washing line attached to stem, cavity west side below knuckle, dense crown. |

Photoview 7: View south at T11.

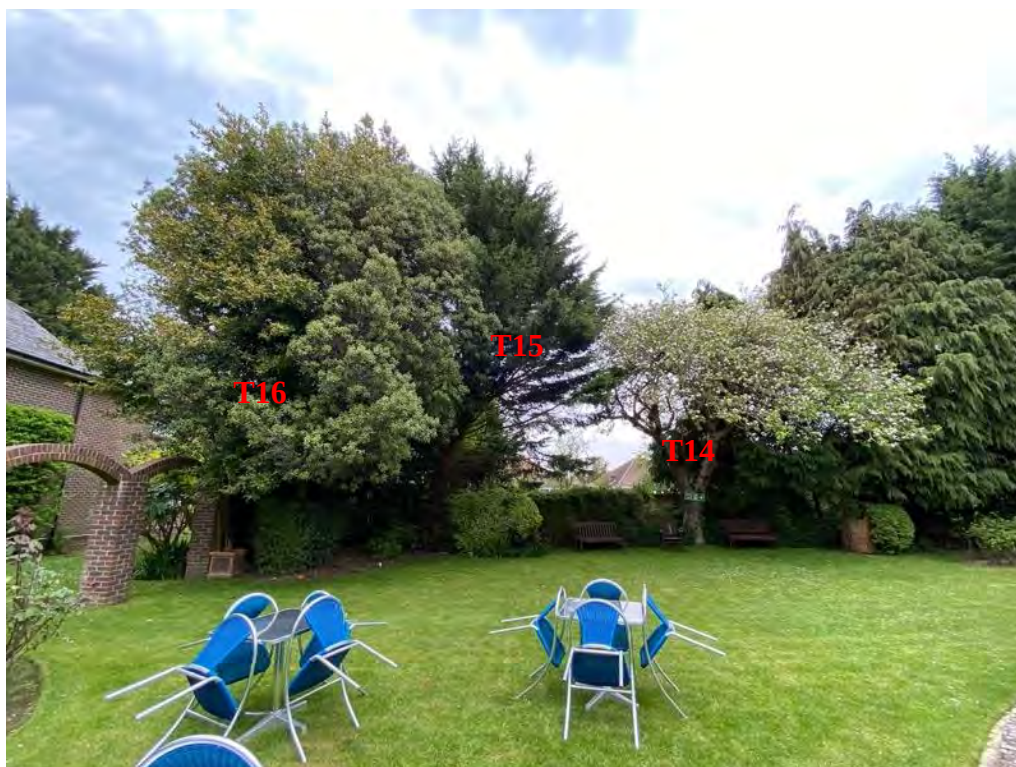
| Ref no. | Species | Ht. (m) | Stem | | | | Category Grading | Crown Spread (m) | | | | | | | | Life stage | ULE | Physiological Condition | Structural Condition | General Observations and Notes |
|---|---|---|---|---|---|---|---|---|---|---|---|---|---|---|---|---|---|---|---|---|
| T14 | Apple | 9.0 | 1 | 550 | 6.6 | 137 | C1 | 4.0 | 4.0 | 5.0 | 4.0 | N/A | - | N/A | 3.0 | M | <10 | Fair | Poor | U shaped union from 1.6m, pruned in past, cavities in multiple pruning wounds, canopy favouring south, stem sounds hollow, cavity in stem south west side has decay and powdered wood and was probed beyond 500mm into the stem, cavities in old pruning points on stem hollow and probed beyond 500mm. |
| T15 | Cypress | 10.0 | 1 | 400 | 4.8 | 72 | C1 | 3.0 | 4.0 | 4.0 | 1.0 | N/A | - | N/A | 2.0 | EM | 10+ | Fair | Poor | Supressed to west, pruned in past, may have been topped historically. |
| T16 | Bay laurel | 9.0 | 4 | 381 | 4.6 | 66 | C1 | 2.0 | 3.0 | 4.0 | 3.0 | N/A | - | N/A | 1.5 | M | 10+ | Fair | Poor | Multi-stemmed, supressed to north, central stem has split in it from branch union, crossing branches |

Photoview 8: View north at T14-T16.

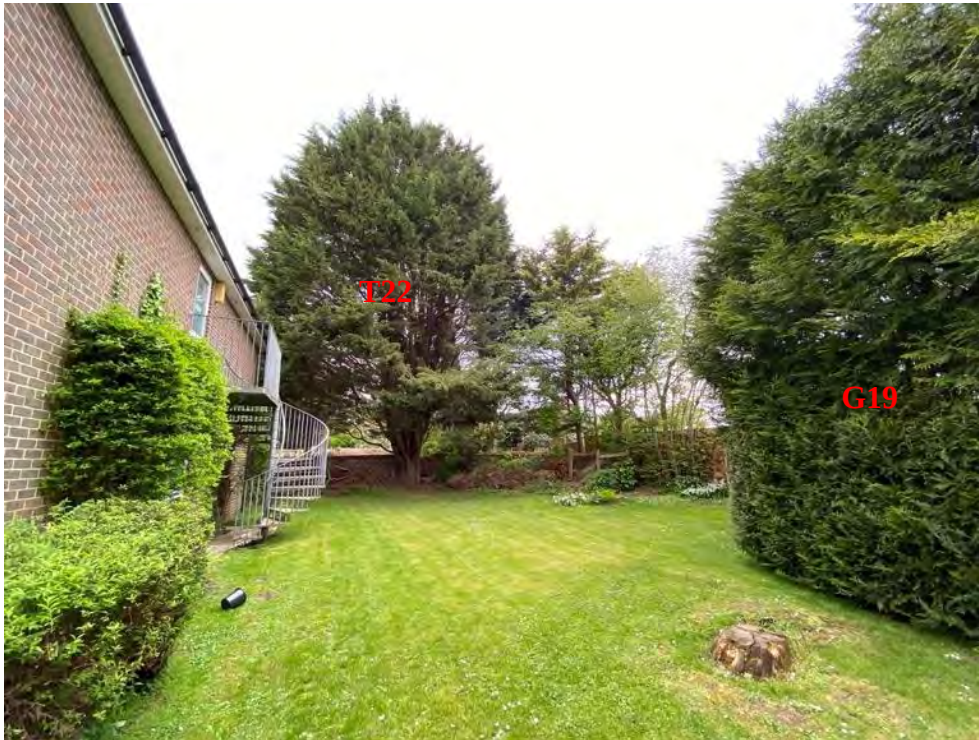
| Ref no. | Species | Ht. (m) | Stem | | | | Category Grading | Crown Spread (m) | | | | | | | | Life stage | ULE | Physiological Condition | Structural Condition | General Observations and Notes |
|---|---|---|---|---|---|---|---|---|---|---|---|---|---|---|---|---|---|---|---|---|
| G19 | Cypress | 8.0 | 5+ | 300 | 3.6 | 41 | C1 | As on plan | | | | N/A | - | N/A | 0.0 | M | 10+ | Fair | Fair | Line of cypress, snapped and topped. Stems to 300m with one appearing 600mm but unable to access. |

Photoview 9: View west at G19.

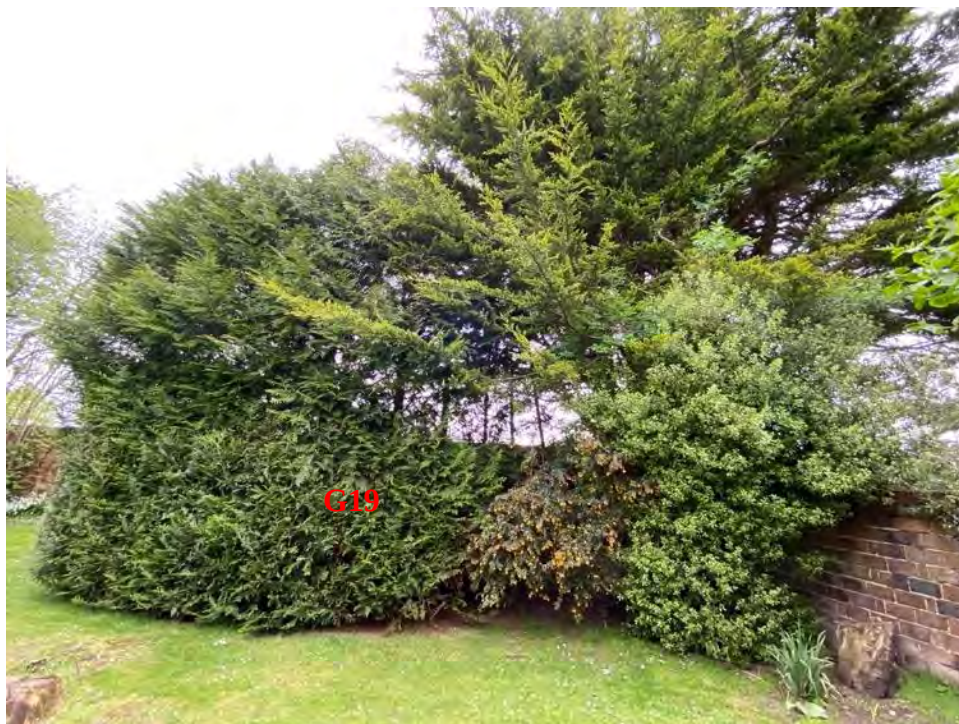
Photoview 10: View north at G19.

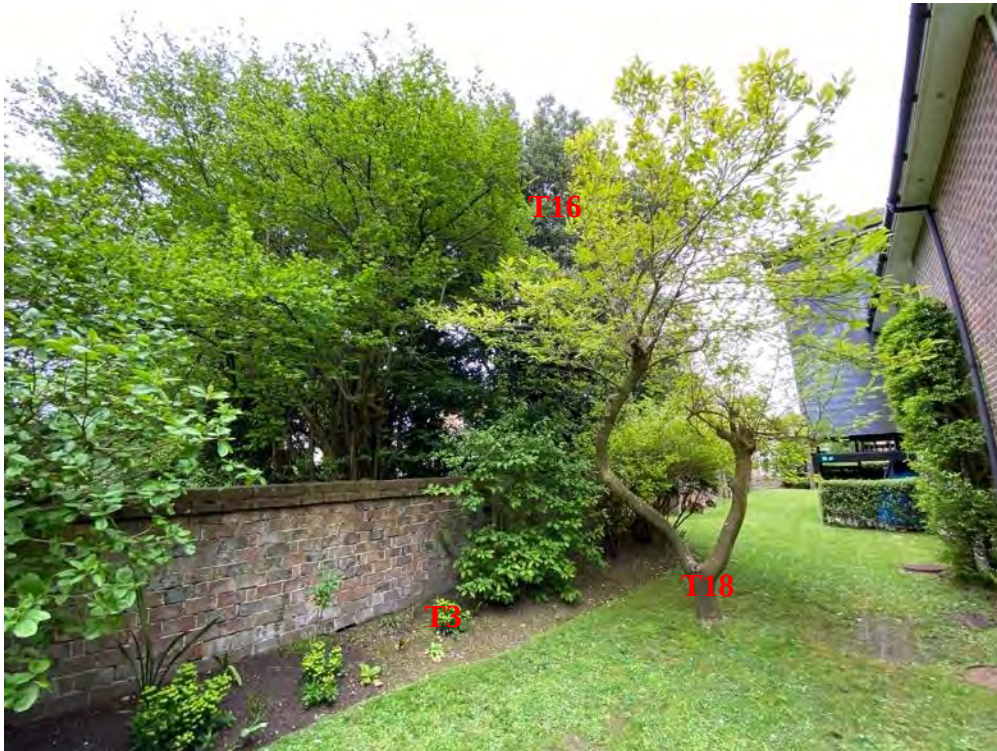
| Ref no. | Species | Ht. (m) | Stem | | | | Category Grading | Crown Spread (m) | | | | | | | | Life stage | ULE | Physiological Condition | Structural Condition | General Observations and Notes |
|---|---|---|---|---|---|---|---|---|---|---|---|---|---|---|---|---|---|---|---|---|
| T18 | Magnolia | 5.0 | 2 | 141 | 1.7 | 9 | C1 | 2.0 | 2.5 | 1.5 | 2.0 | N/A | - | N/A | 1.5 | M | 10+ | Fair | Poor | Small garden magnolia, twin stem from 0.5m, western stem pollarded, poor form. |

Photoview 11: View south at T18.

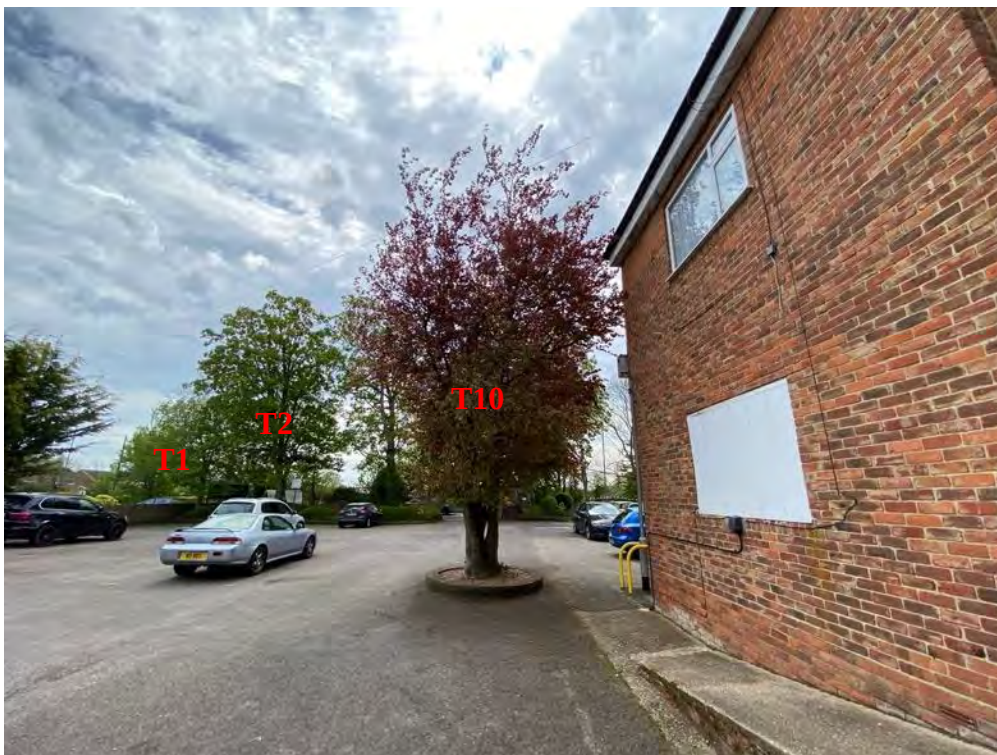
| Ref no. | Species | Ht. (m) | Stem | | | | Category Grading | Crown Spread (m) | | | | | | | | Life stage | ULE | Physiological Condition | Structural Condition | General Observations and Notes |
|---|---|---|---|---|---|---|---|---|---|---|---|---|---|---|---|---|---|---|---|---|
| T10 | Beech | 6.5 | 1 | 444 | 5.3 | 89 | C1 | 2.0 | 2.0 | 2.0 | 2.0 | N/A | - | N/A | 1.5 | M | 10+ | Fair | Poor | Twin stem from base, eastern stem splits again and has dead stem and second with large wound with decay, set in brick planter. |

Photoview 12: View south at T10.

- 5.2 Proposals will require the removal of T10 and existing bamboo and laurel shrubs at the rear of the hotel. T10 is a small beech assessed as Category C, and therefore should not be viewed as a constraint to development. T10 could be replaced.
- 5.3 From a tree retention/loss perspective proposals are considered acceptable because no high-quality trees require removal.
- 5.4 A Landscape Plan is shown in Appendix 7. As shown, proposals retain the majority of existing areas of landscaping, except for the loss of T10 and shrubs at the rear. To replace T10 removed a new tree could be planted in the rear of the hotel by G20 and another replanted at the frontage by H6.

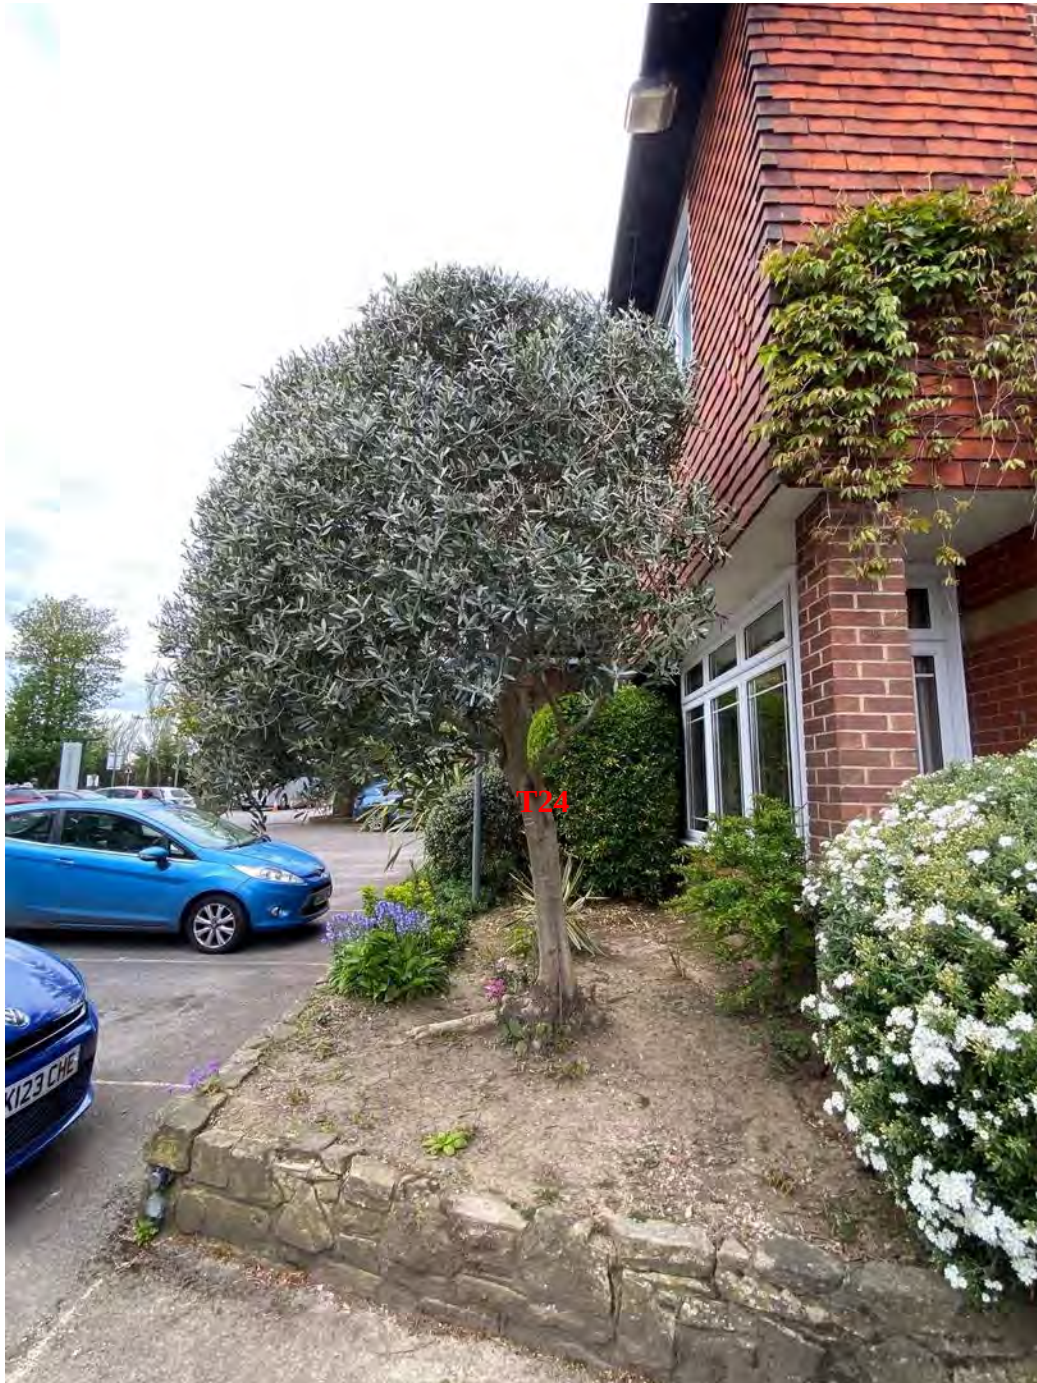
| Ref no. | Species | Ht. (m) | Stem | | | | Category Grading | Crown Spread (m) | | | | | | | | Life stage | ULE | Physiological Condition | Structural Condition | General Observations and Notes |
|---|---|---|---|---|---|---|---|---|---|---|---|---|---|---|---|---|---|---|---|---|
| T24 | Olive | 4.0 | 1 | 160 | 1.9 | 12 | C1 | 1.0 | 1.0 | 1.5 | 1.0 | N/A | - | N/A | 0.0 | EM | 10+ | Fair | Fair | Set in planting bed, shaped crown. |

Photoview 13: View west at T24.

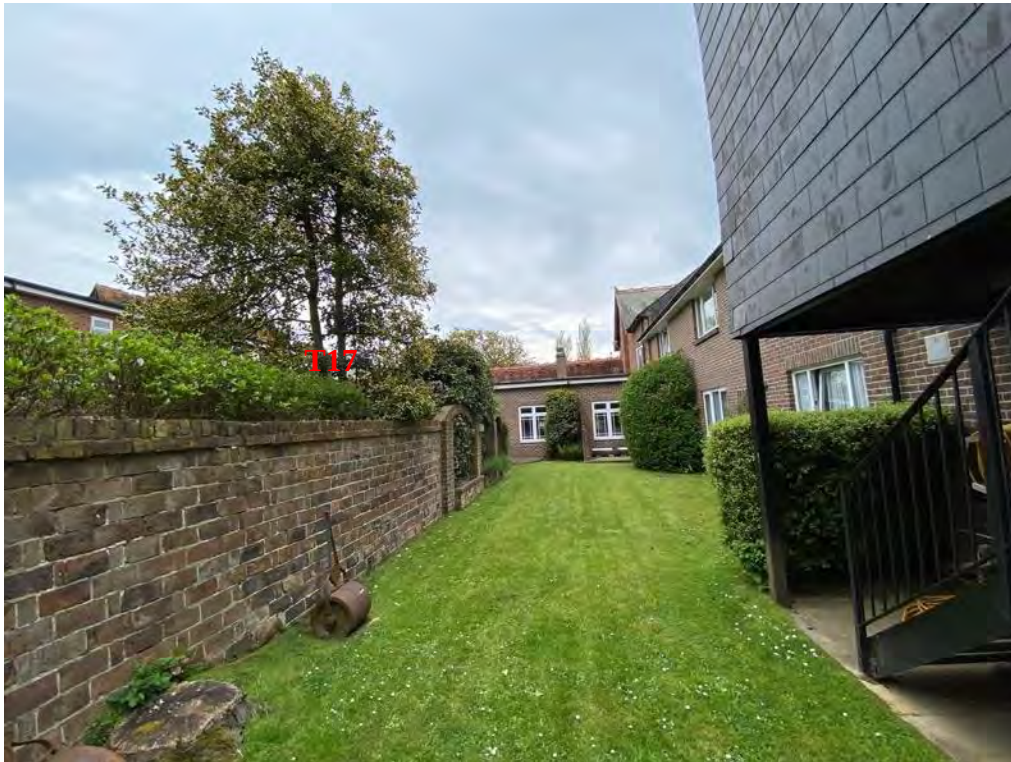
| Ref no. | Species | Ht. (m) | Stem | | | | Category Grading | Crown Spread (m) | | | | | | | | Life stage | ULE | Physiological Condition | Structural Condition | General Observations and Notes |
|---|---|---|---|---|---|---|---|---|---|---|---|---|---|---|---|---|---|---|---|---|
| T17 | Holly | 5.0 | 2 | 141 | 1.7 | 9 | C1 | 2.0 | 1.5 | 1.0 | 1.5 | N/A | - | N/A | 1.0 | SM | 10+ | Fair | Poor | Twin stem from base. Small holly in shrub bed. |

Photoview 14: View south at T17.

6.4 At the rear of the hotel, protection fencing is shown as a precaution to protect T17 for creation of outdoor seating.

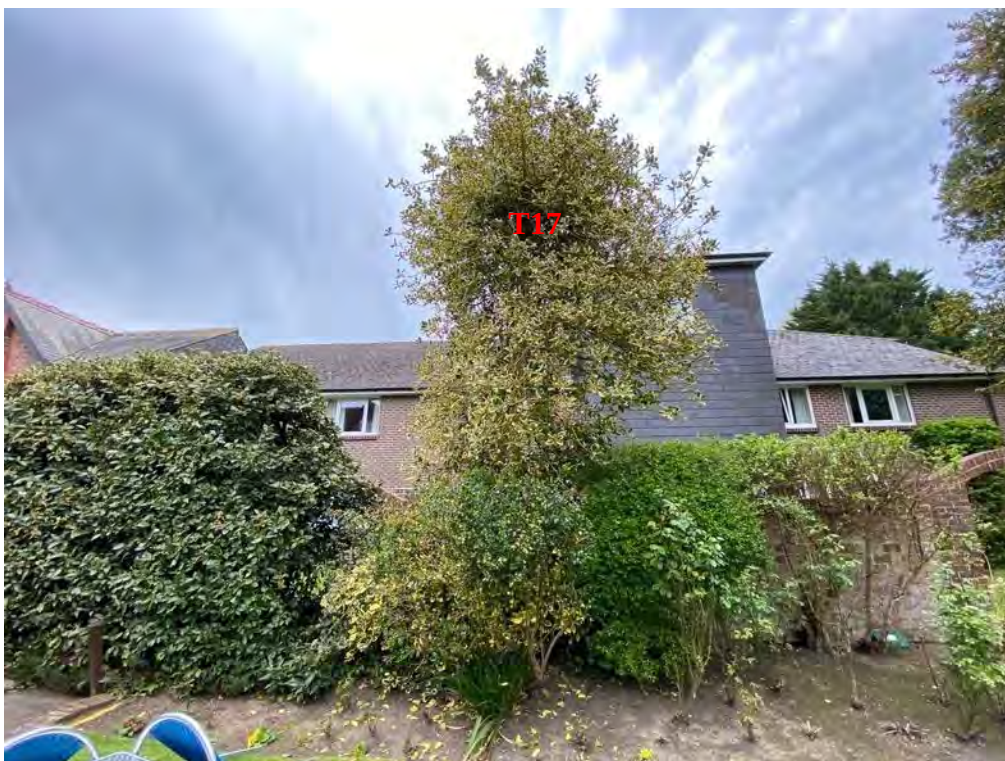
Photoview 15: View west at T17.

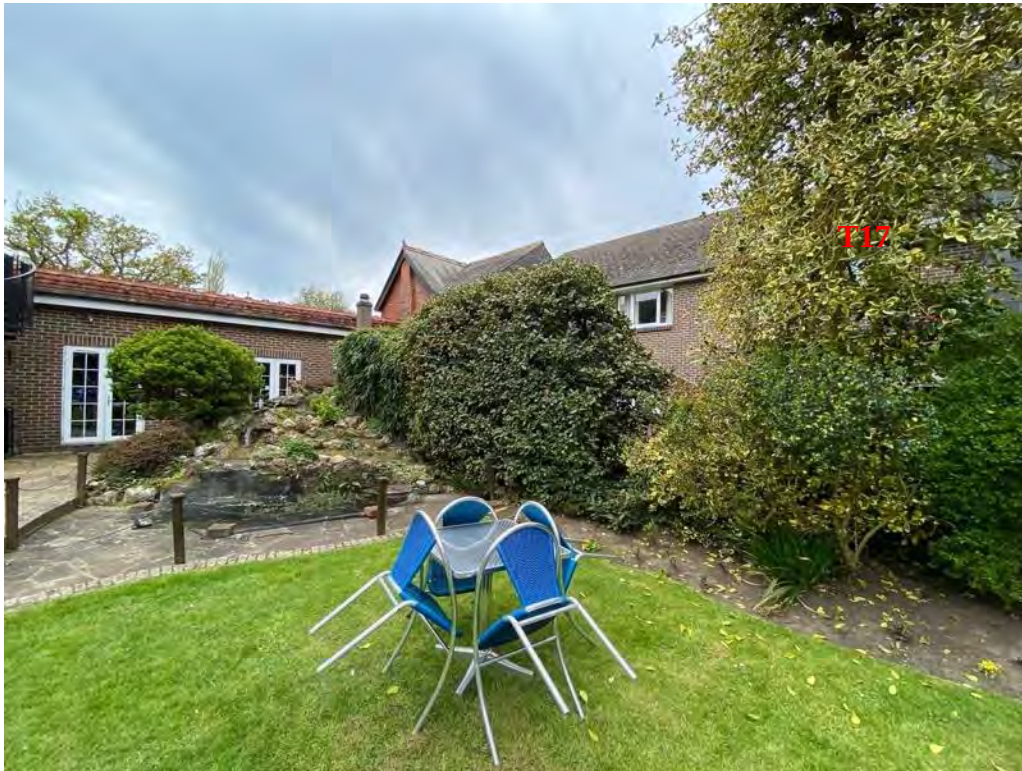
Photoview 16: View south at shrubs by T17.
