## Arboricultural Statement & Tree Works

**Date:** 30<sup>th</sup> November 2022

**Site:** Heath Mansion, 136 London Road, Waterlooville Hampshire PO7 5SU

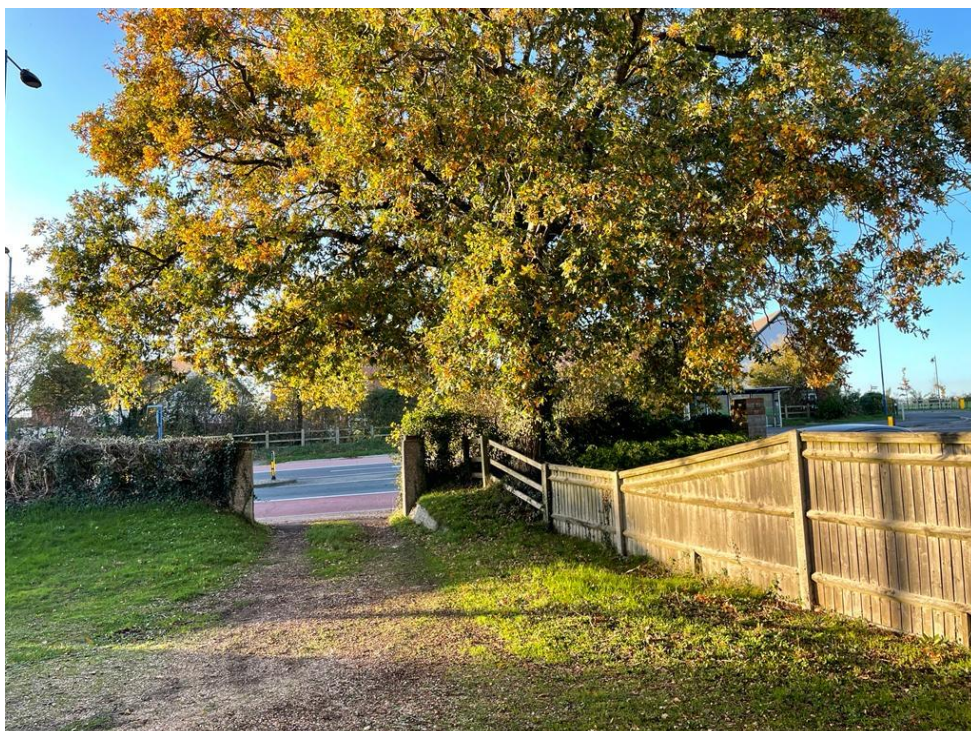
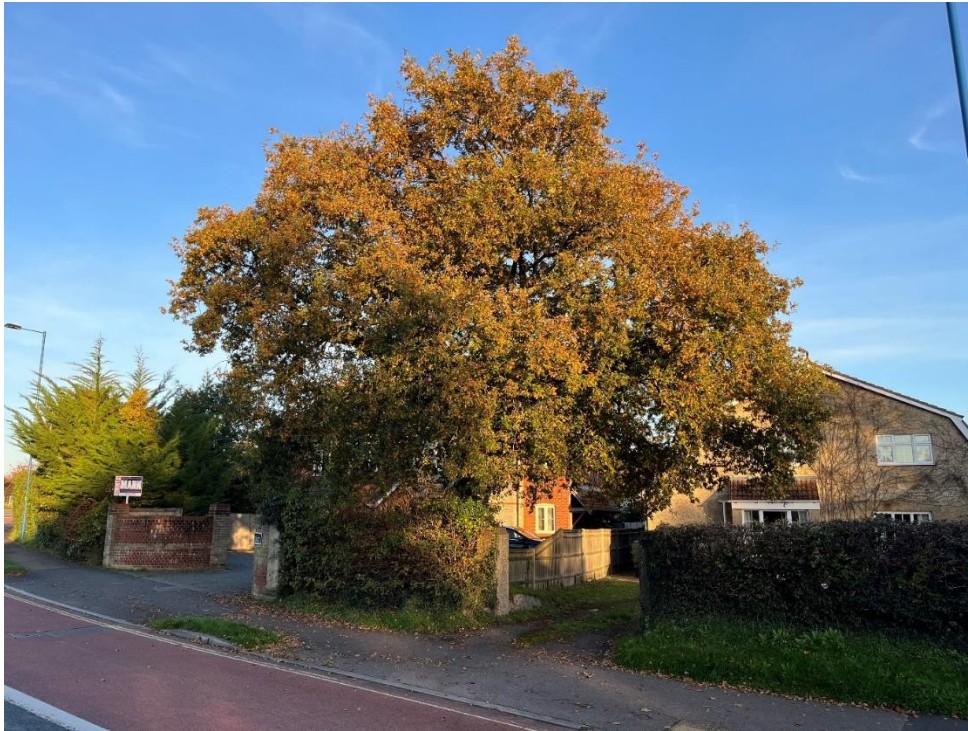
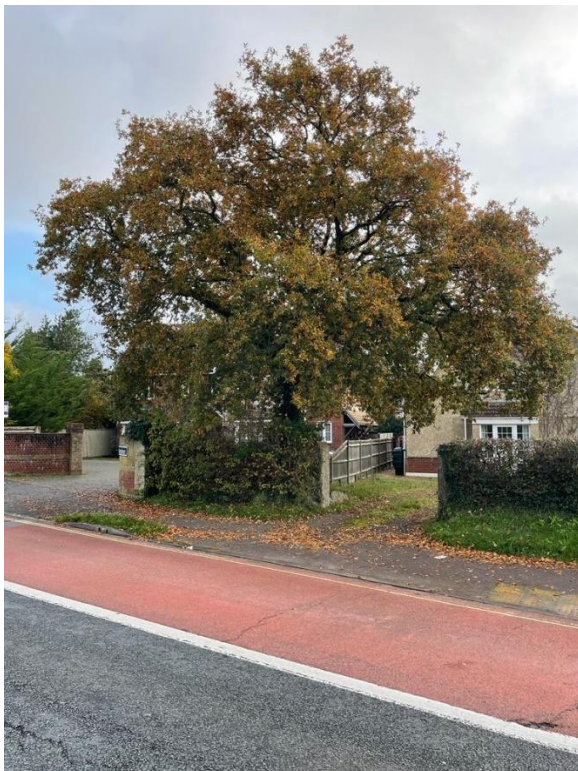
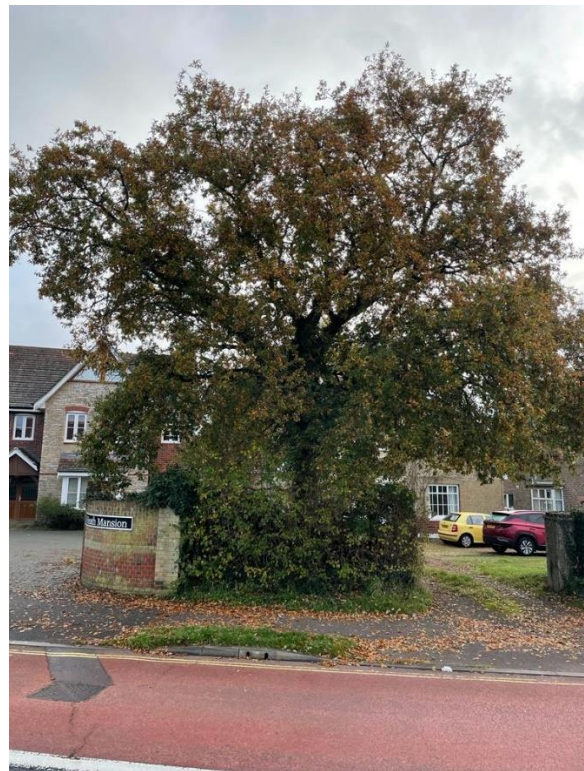
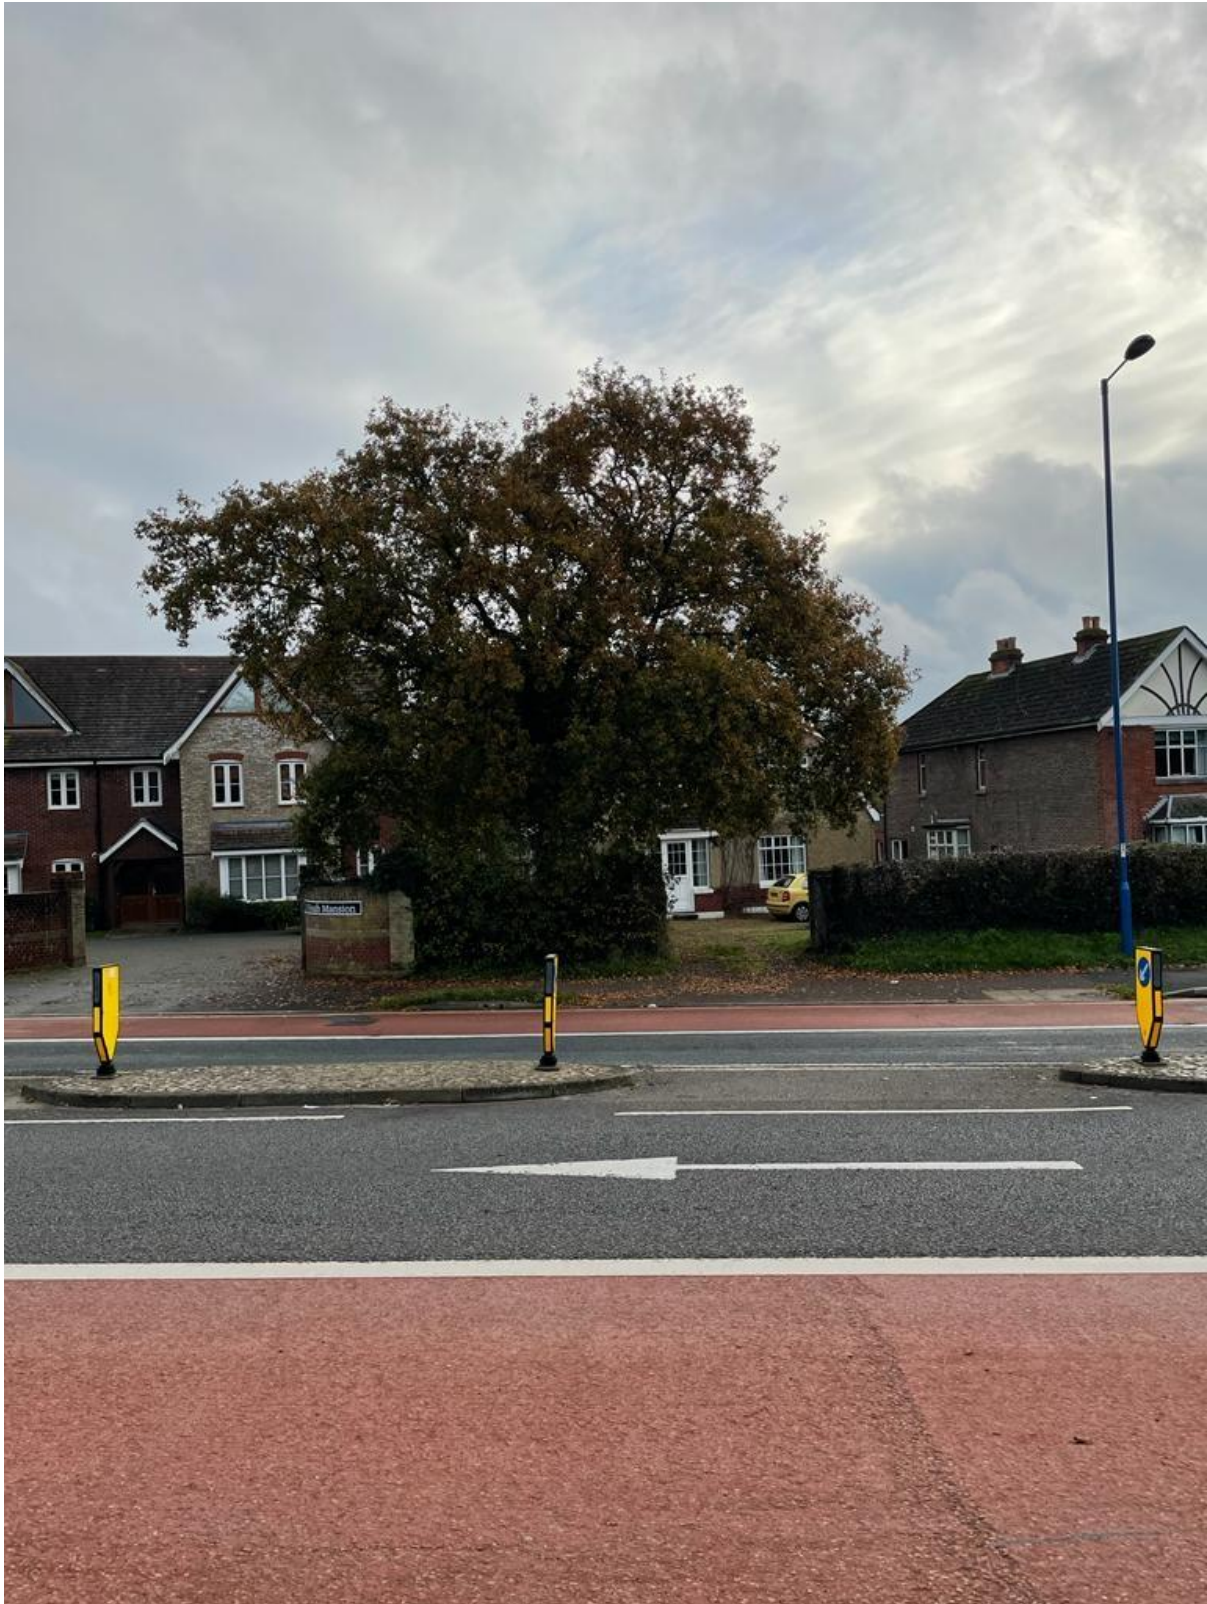
T1, seen in images (1 to 7), is overhanging its boundary into the property of 134 London Road. The overhanging branches are impeding good and reasonable access to the property. The overhanging has become a distinct cause for concern in terms of safety for the property owners and general public accessing and using the site. It is thought that any larger vehicle or plant machinery needing to enter or exit the site could cause damage to the tree.

| Tree | Type | Status | Approximate Size | Observations |
|---|---|---|---|---|
| T1 | Common Oak | Tree of moderate quality with an estimated remaining life expectancy of at least 20 years | Canopy height 15m<br>Crown spread 16m | (i) Root ball raised above general ground level by approx. 1m.<br><br>(ii) Unsympathetic management and storm damage |

Cut back the growth overhanging the driveway on 134 London Road. Crown lift the tree to achieve access on the Southern side. Lower branches of the tree will be removed during the crown raise to clear the pavement outside the property, but only up to the border between 134 and 136 London Road. Conducting the work will raise the crown to approximately 5 metres. Marked approximate cutting points of the lateral limbs are marked in images A & B, below.

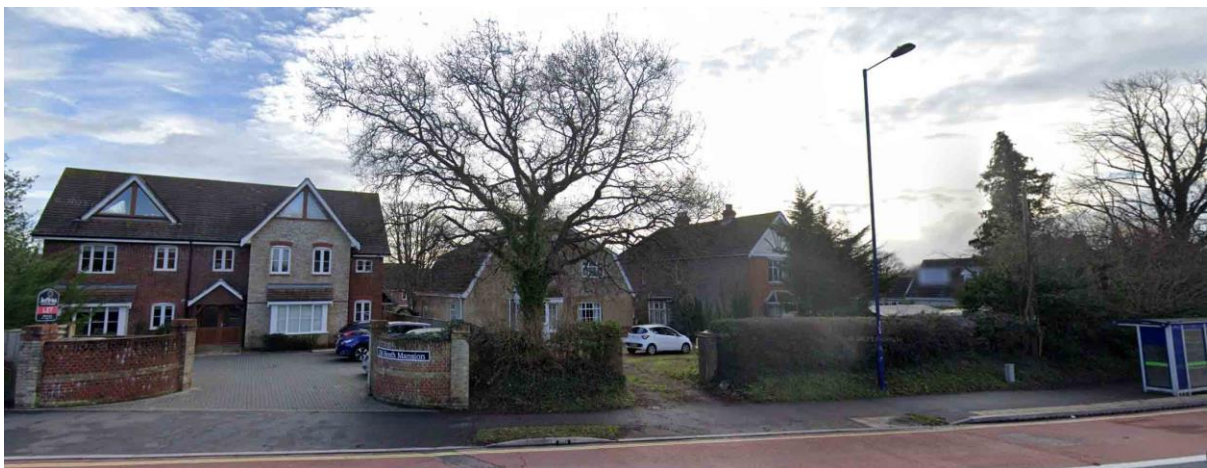
Above, street View, showing TPO oak tree within neighbouring property boundary.
